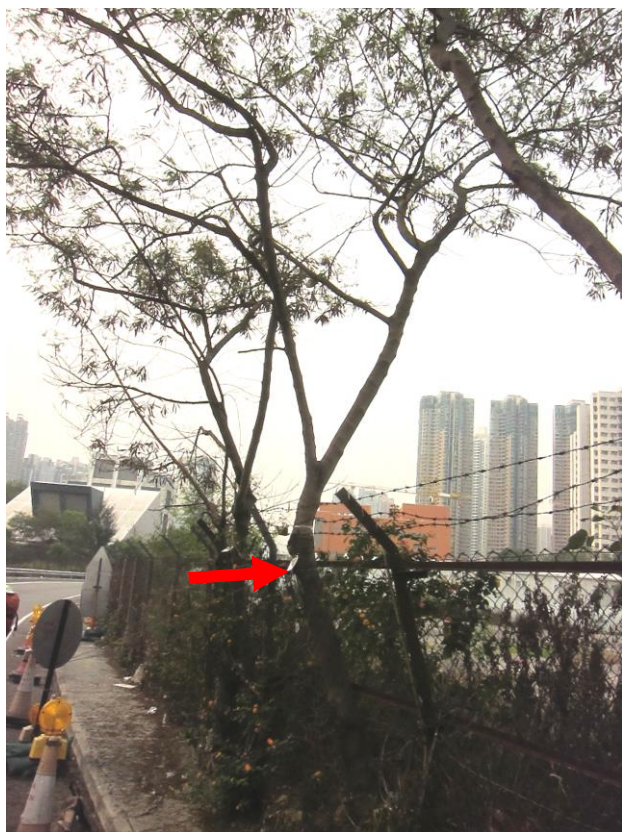
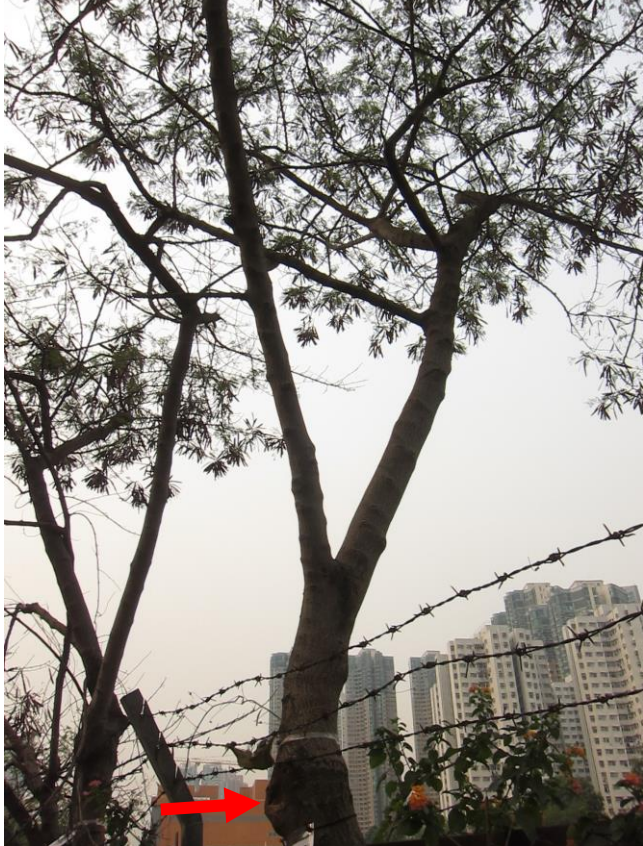
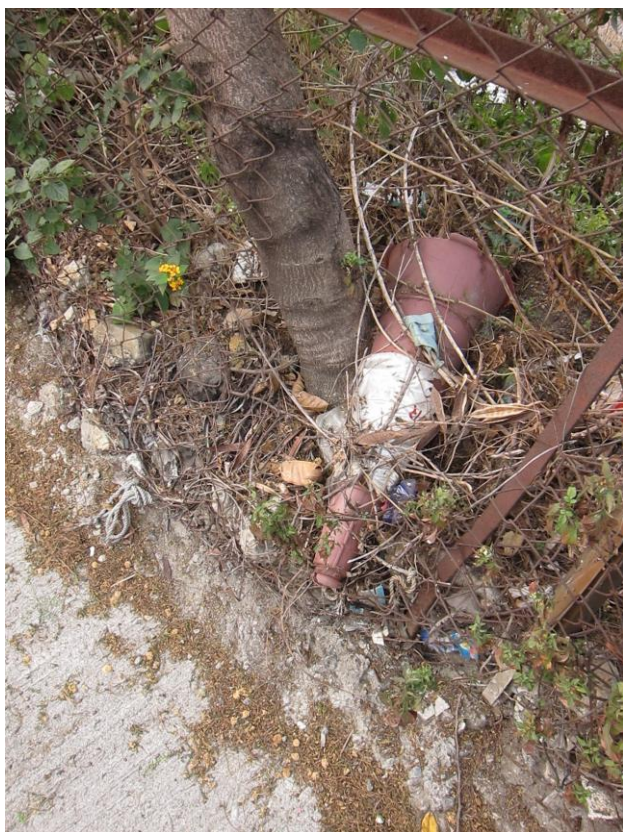
| YMT/T2779- 1 Retain<br>Scientific Name: <i>Leucaena leucocephala</i> | YMT/T2779- 2<br>Dead branches and Broken branches | YMT/T2779- 3<br>Wound on trunk by girdling | YMT/T2779- 4 |

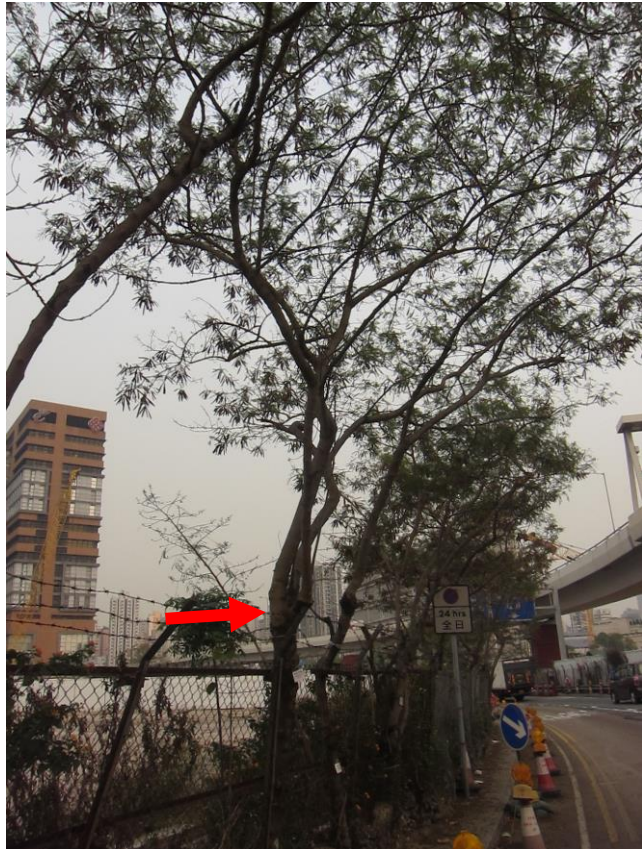
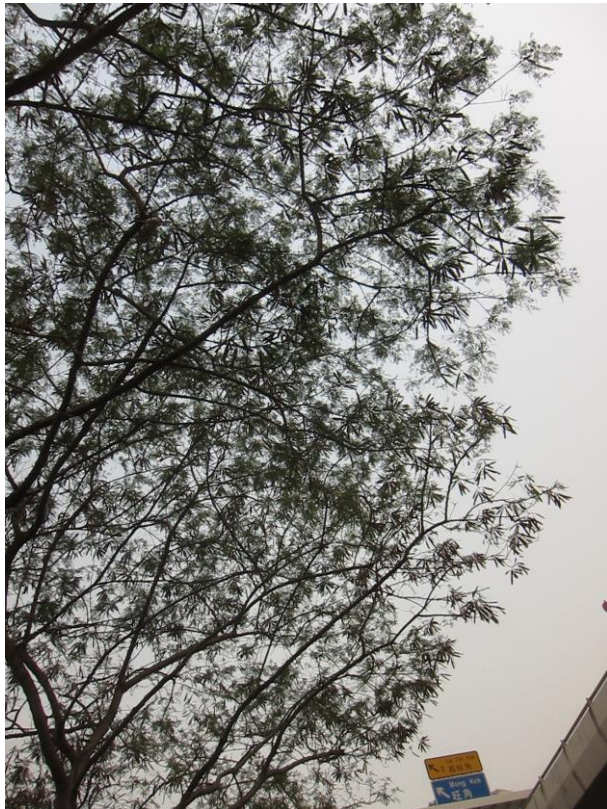
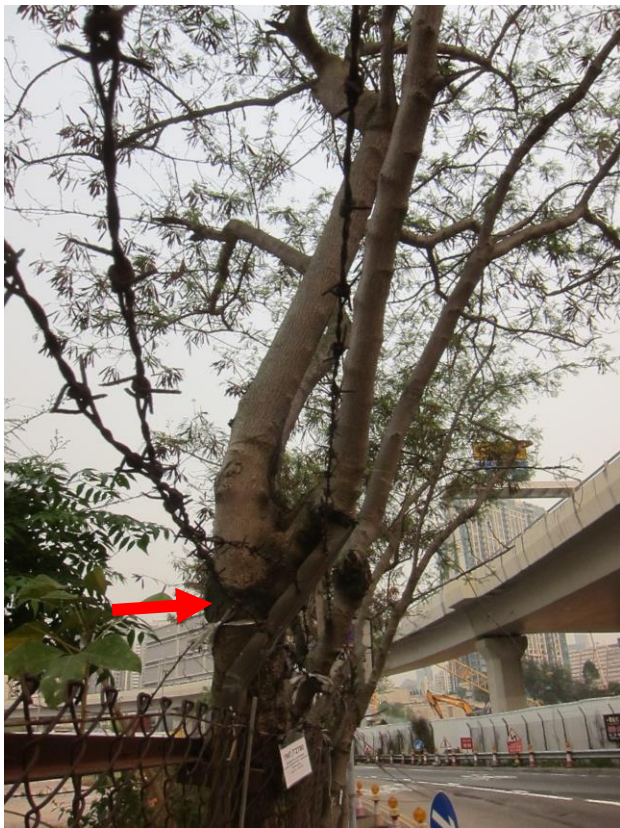
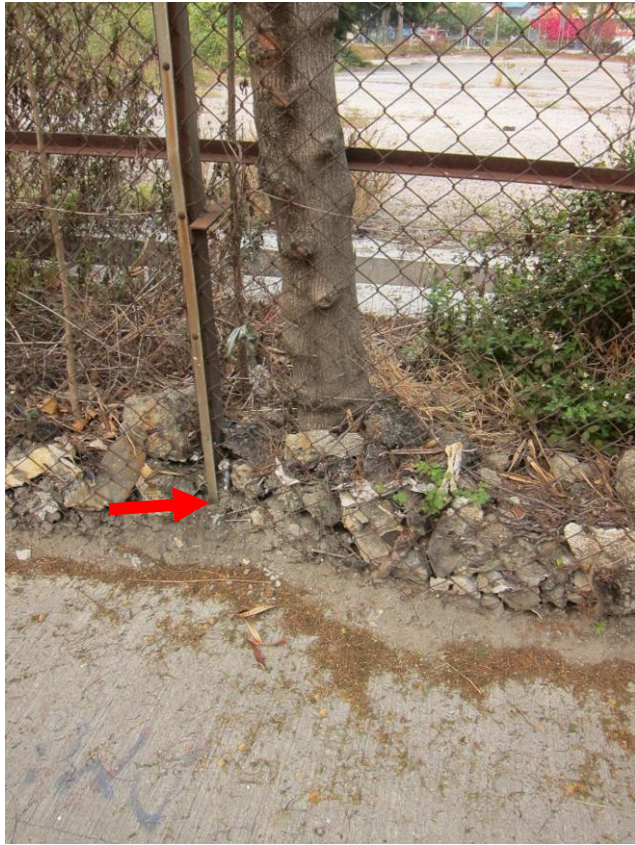
| YMT/T2780- 1 Retain<br>Scientific Name: <i>Leucaena leucocephala</i> | YMT/T2780- 2<br>Dead branches | YMT/T2780- 3<br>Wound on trunk by girdling | YMT/T2780- 4<br>Restricted by concrete at base |

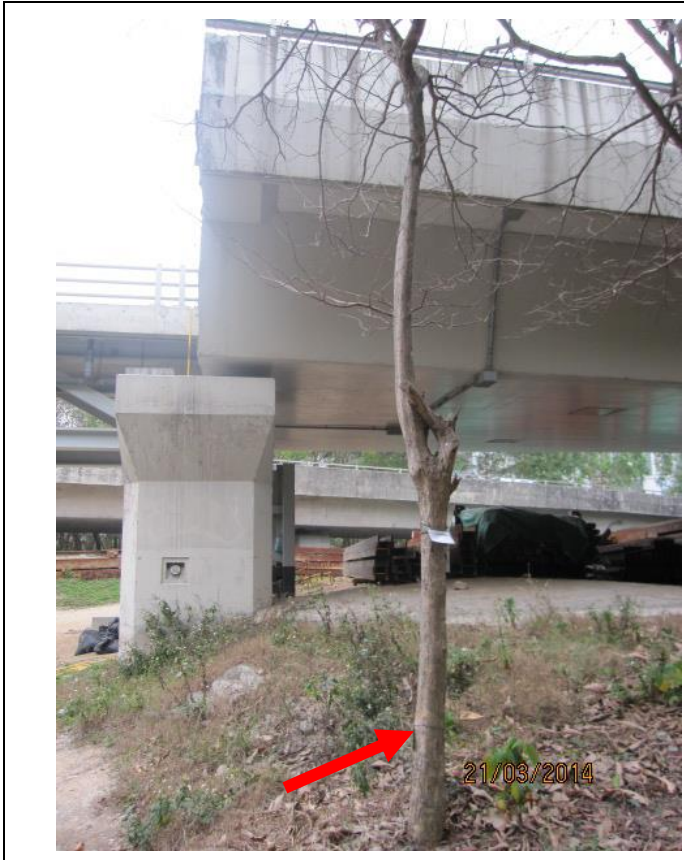
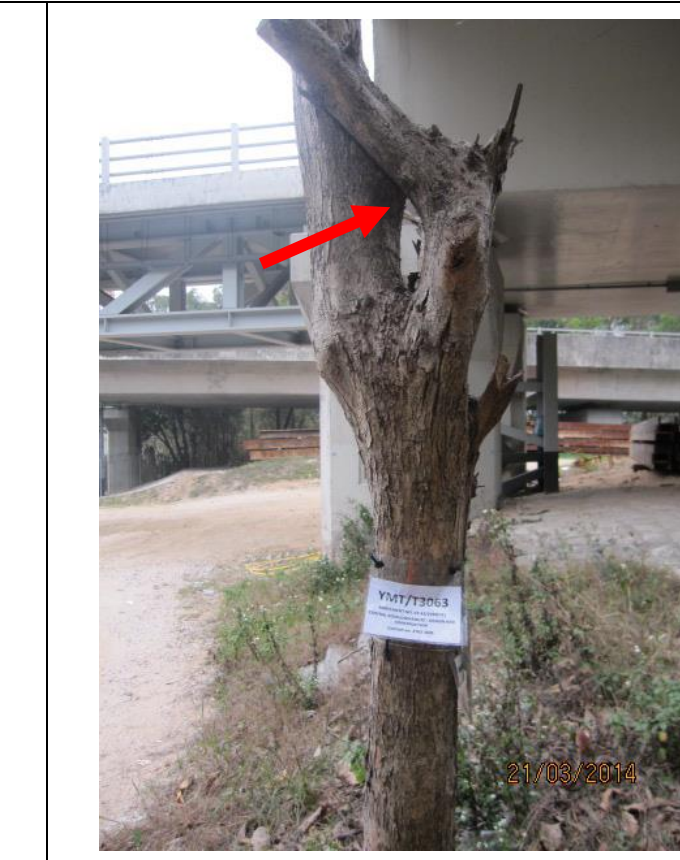
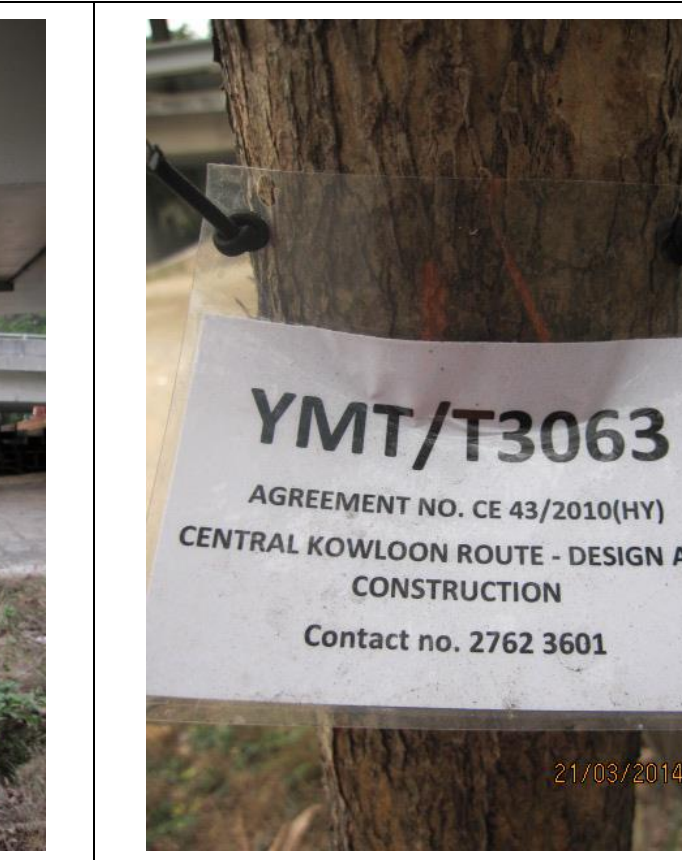
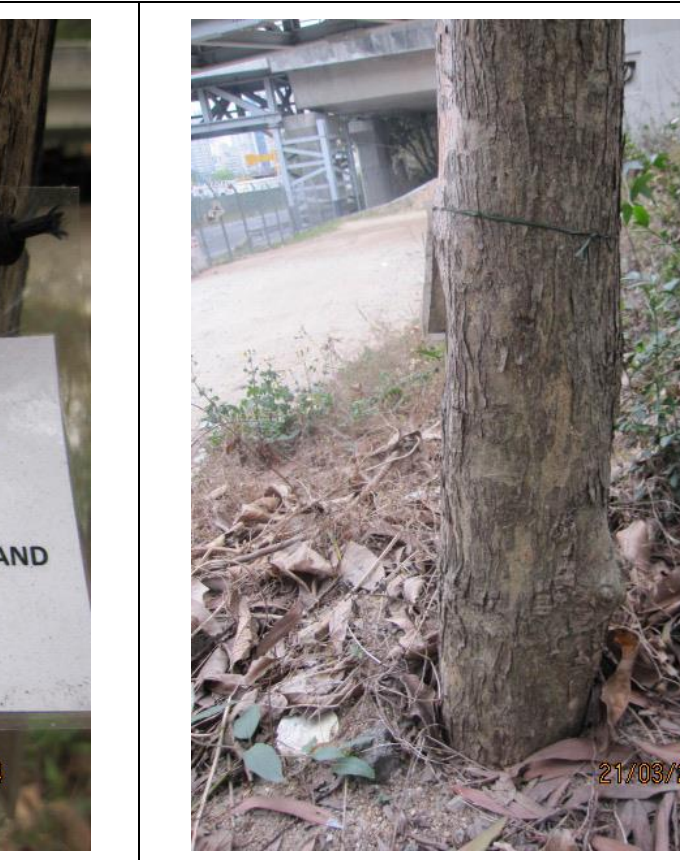
| YMT/T3063- 1-Retain<br>Scientific Name: <i>Lagerstroemia speciosa</i> | YMT/T3063-2<br>Broken branches | YMT/T3063-3 | YMT/T3063-4 |

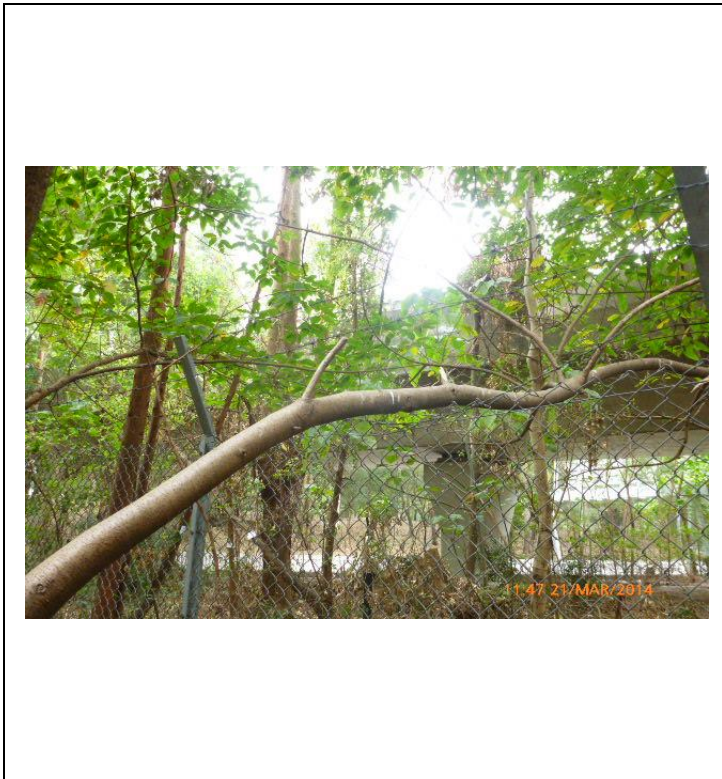
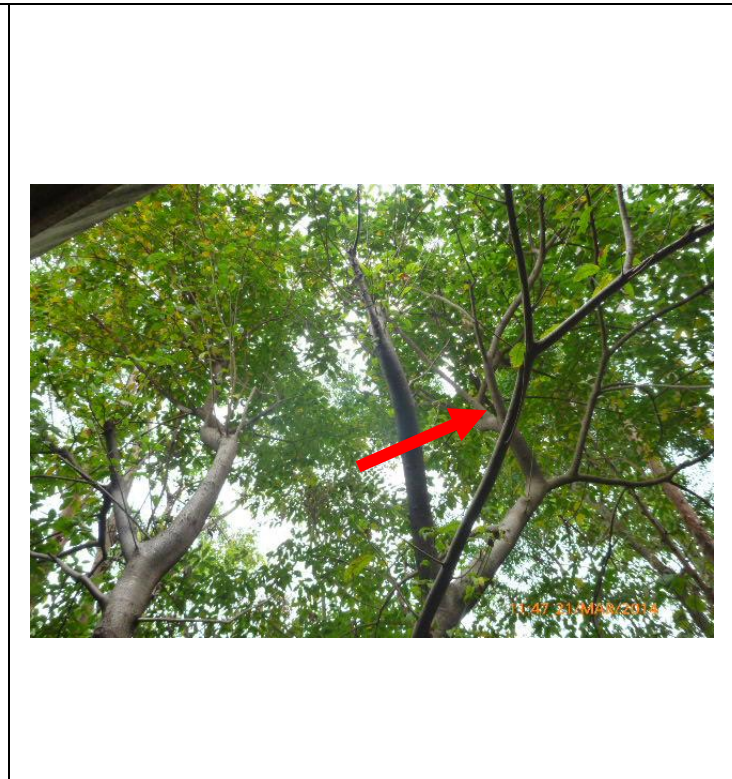
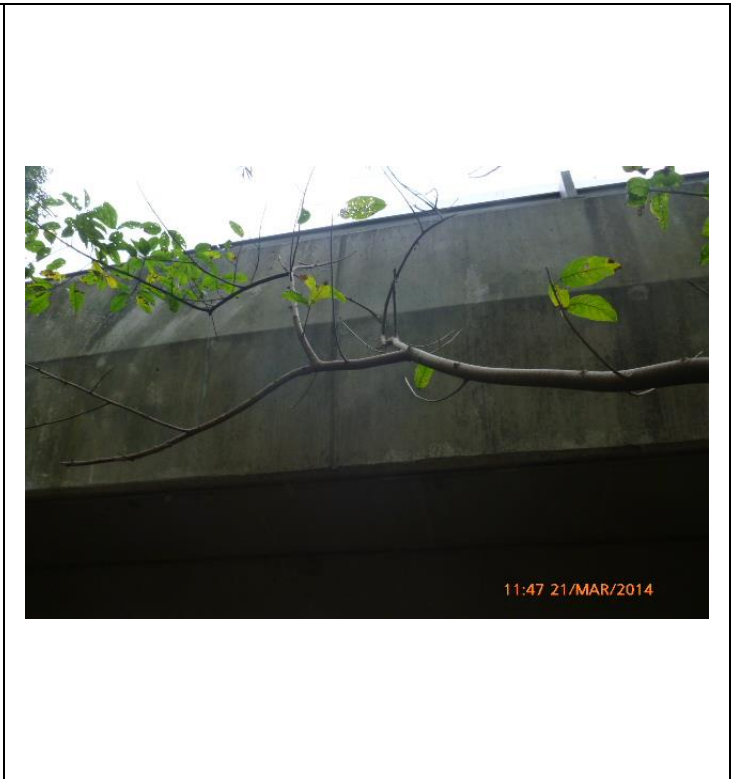
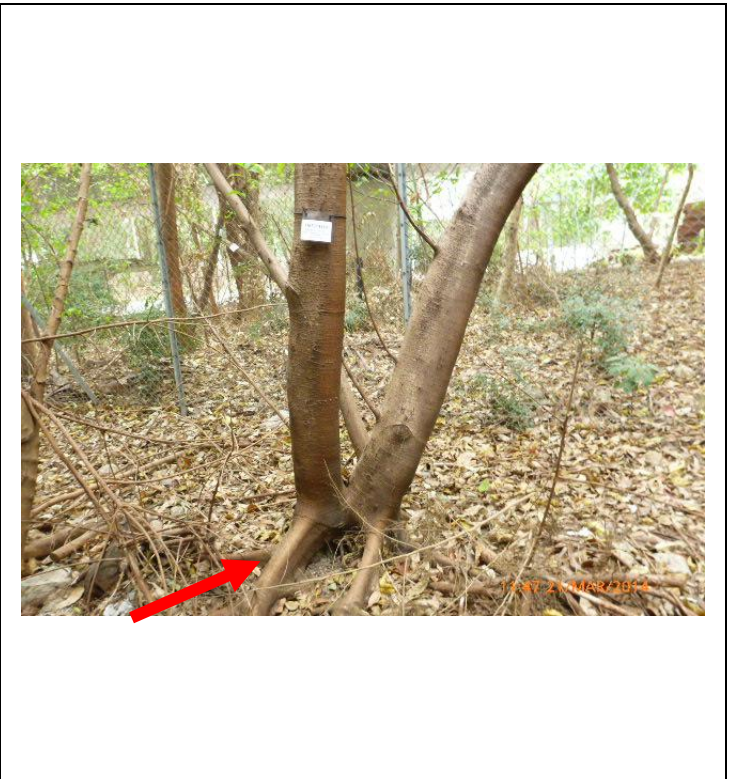
| YMT/ T3159- 1- Retain<br>Scientific Name: <i>Ficus virens</i> | YMT/ T3159- 2<br>Broken branches | YMT/ T3159- 3 | YMT/ T3159- 4<br>Exposed root |

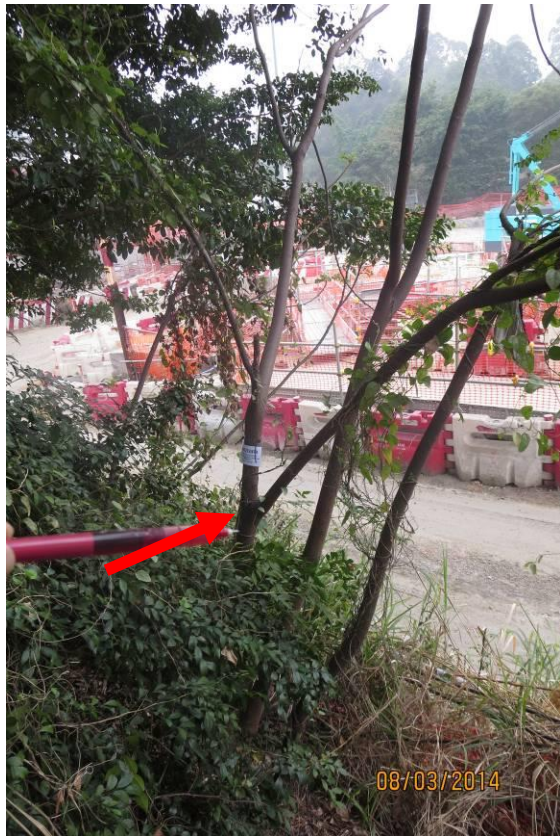
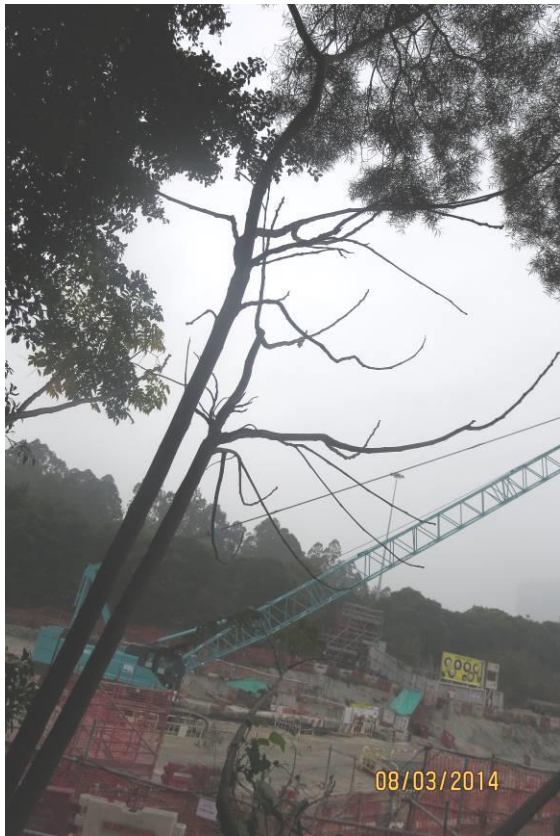
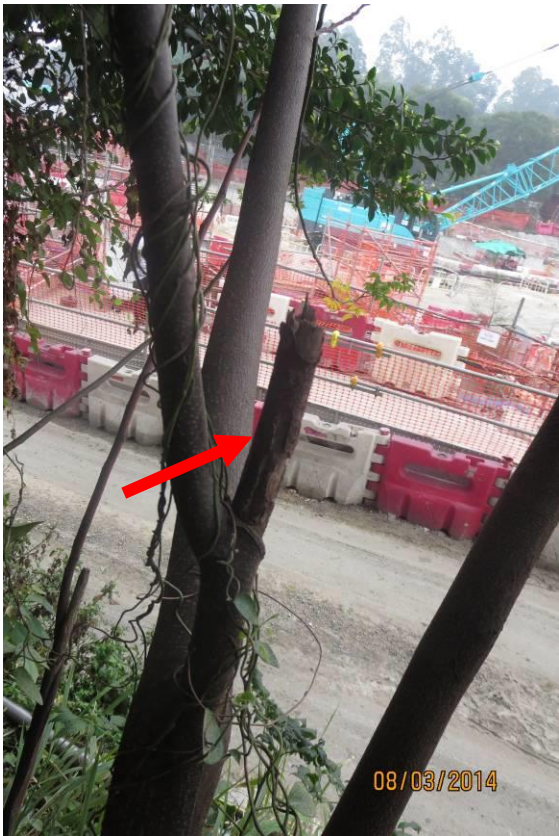
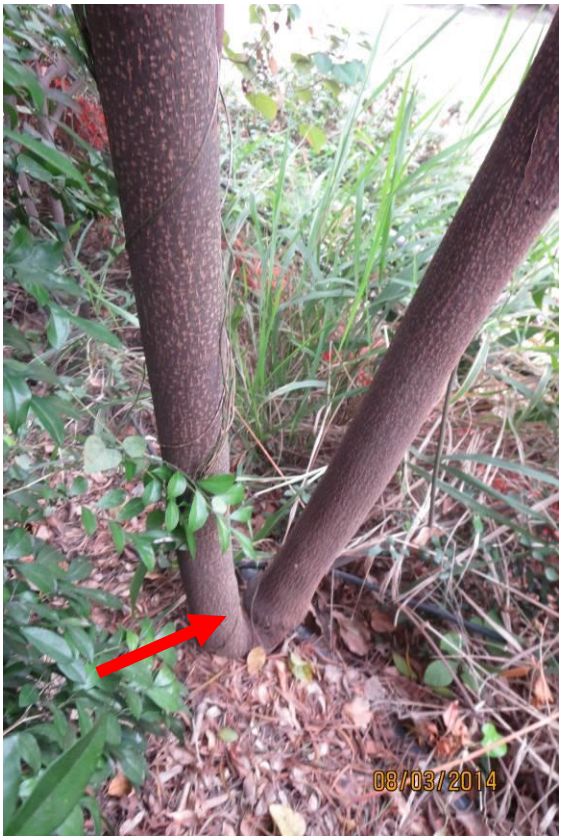
| YMT/T3373-1-Fell<br>Scientific Name: <i>Melia azedarach</i> | YMT/T3373-2 | YMT/T3373-3<br>Broken branches | YMT/T3373-4<br>Co-dominant trunk |

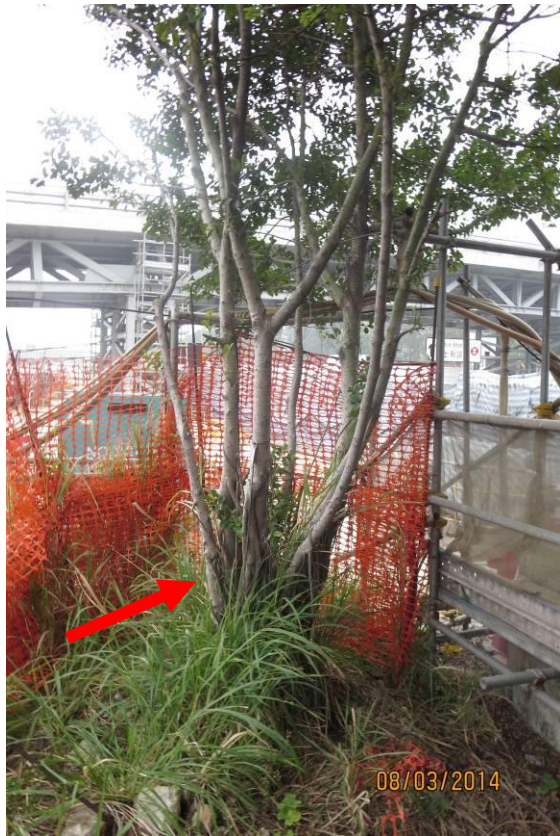
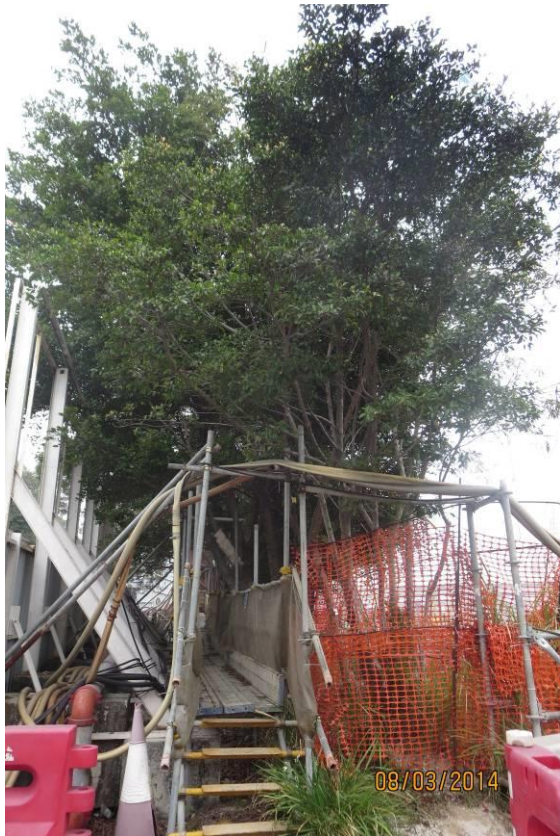
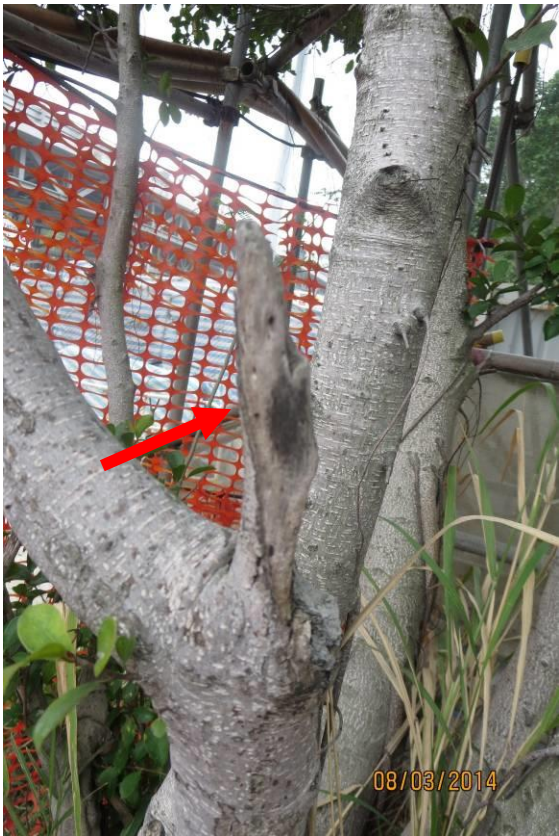
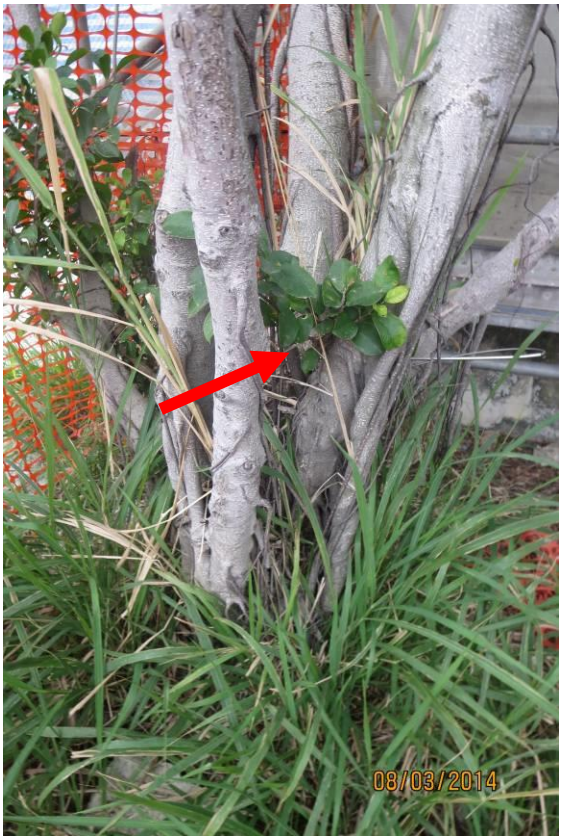
| YMT/T3377-1-Fell<br>Scientific Name: <i>Ficus microcarpa</i> | YMT/T3377-2 | YMT/T3377-3<br>Broken branches | YMT/T3377-4<br>Epicormics |

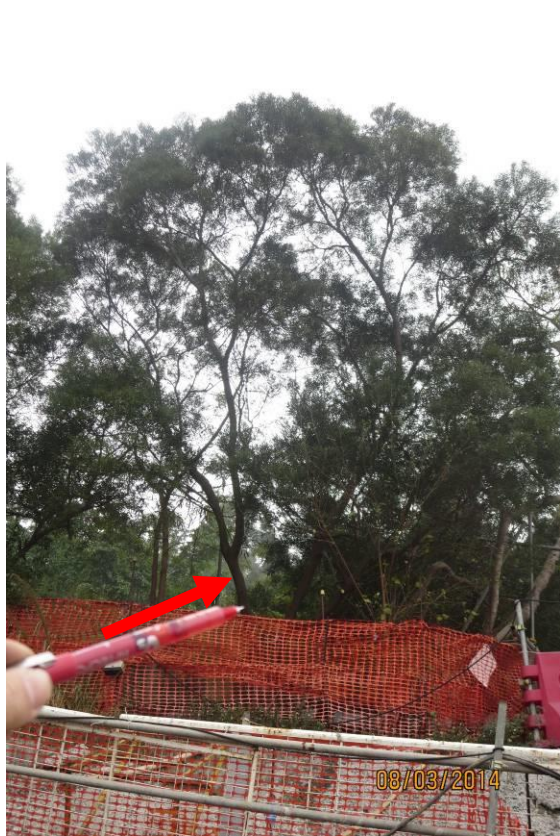
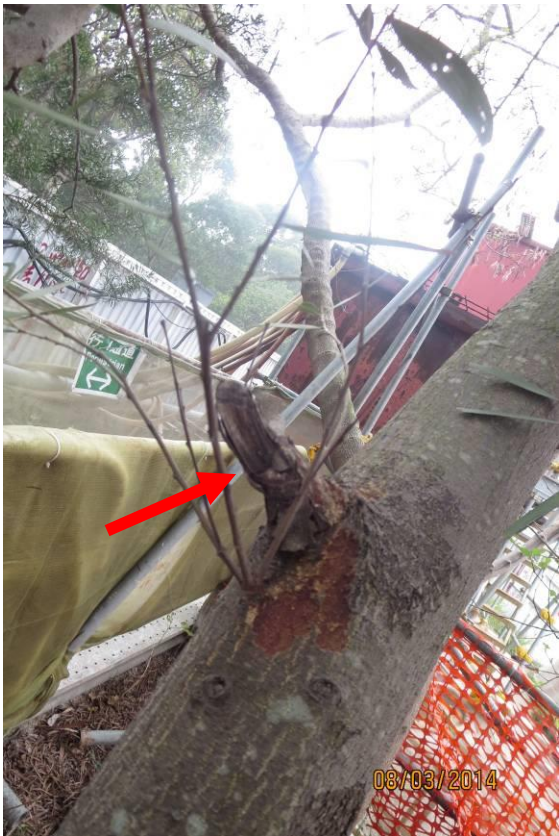
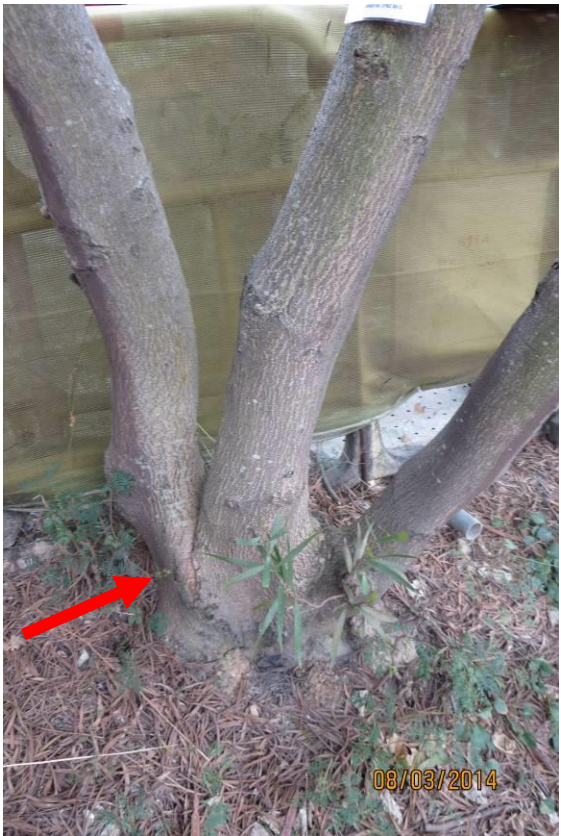
| YMT/T3384-1-Fell<br>Scientific Name: <i>Acacia confusa</i> | YMT/T3384-2<br>Dead branches | YMT/T3384-3<br>Broken branches | YMT/T3384-4<br>Co-dominant trunk |

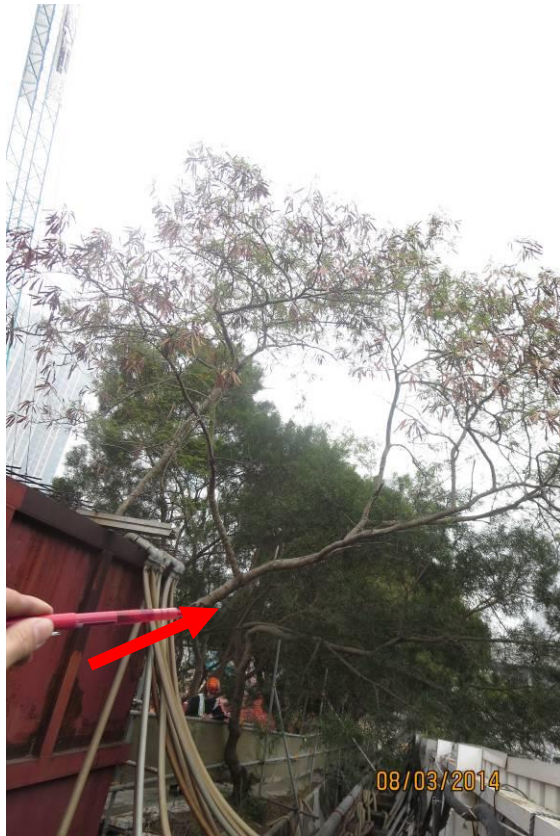
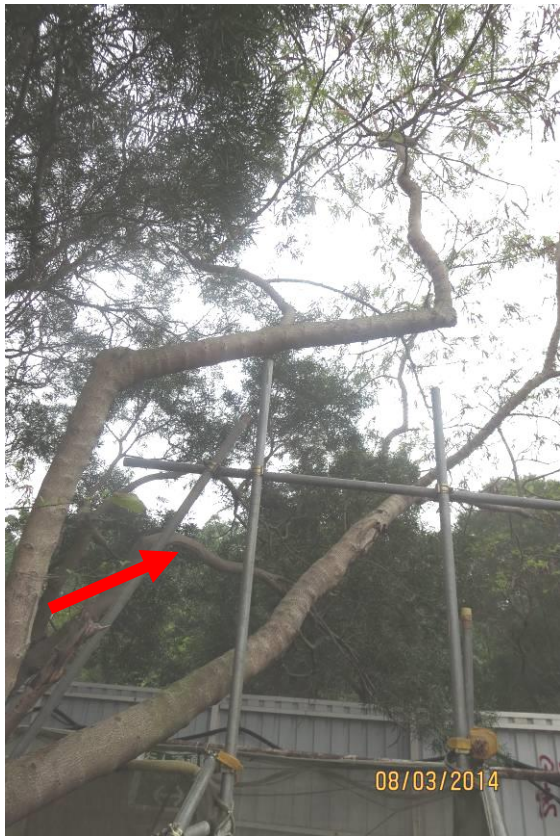
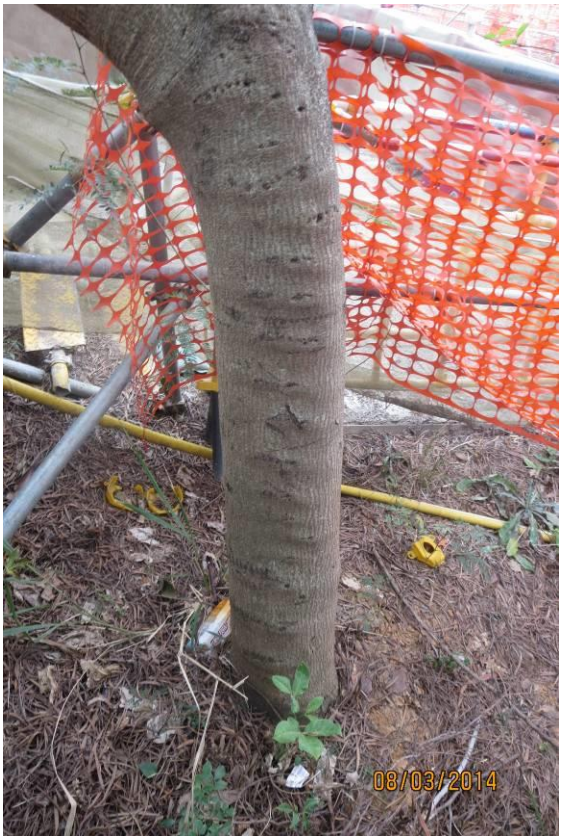
| YMT/T3385-1-Fell<br>Scientific Name: <i>Acacia confusa</i> | YMT/T3385-2<br>Dead branches | YMT/T3385-3<br>mechanical damage | YMT/T3385-4 |

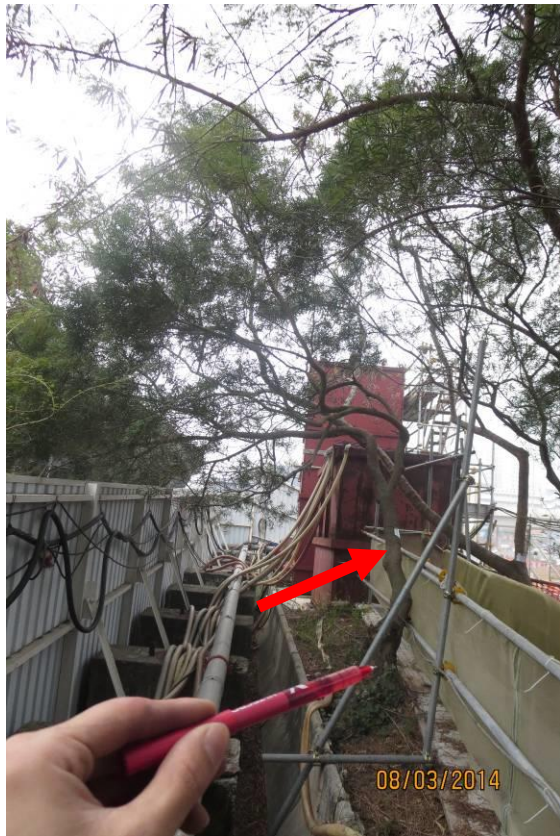
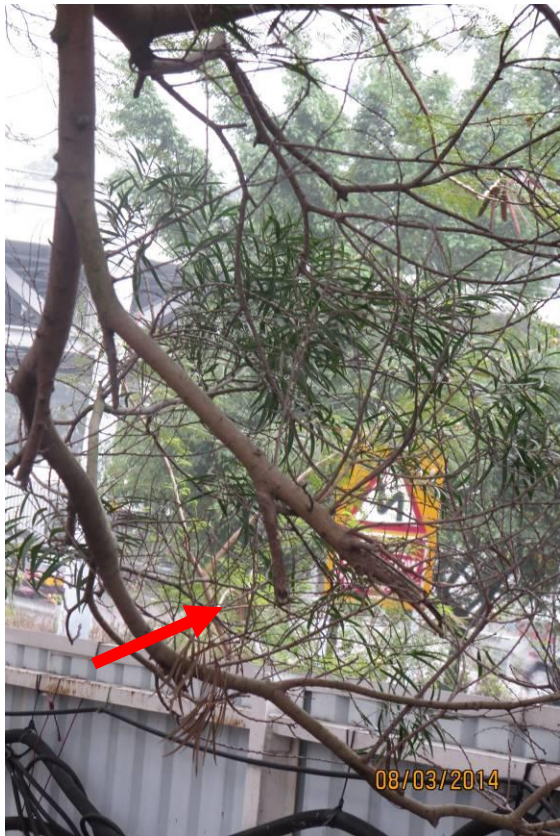
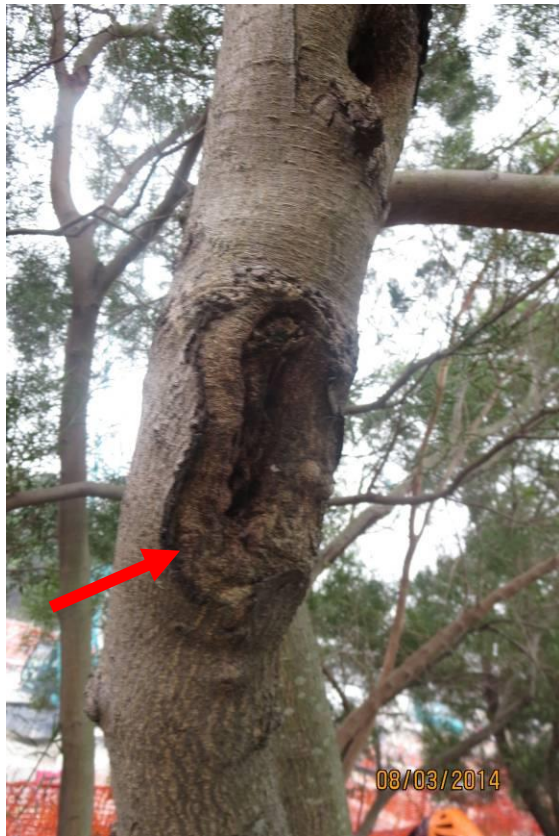
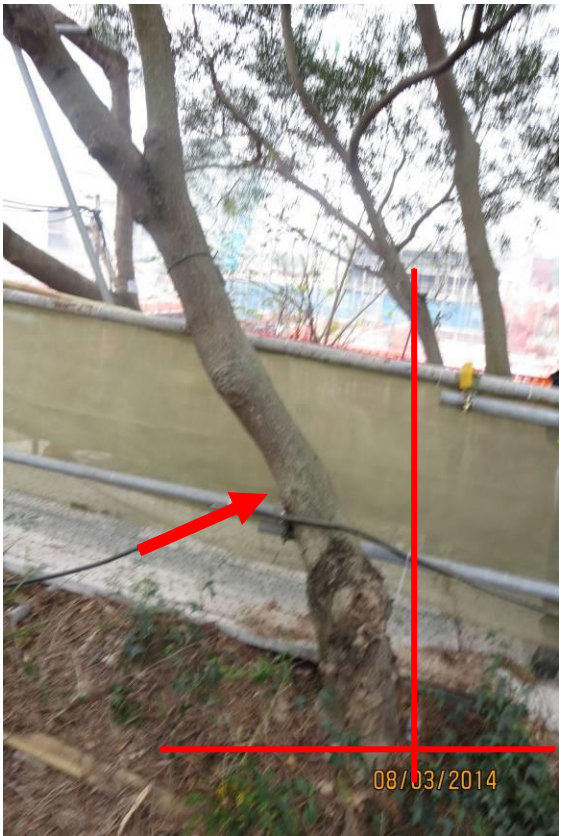
| YMT/T3386-1-Fell<br>Scientific Name: <i>Acacia confusa</i> | YMT/T3386-2<br>Dead branches | YMT/T3386-3<br>Wound | YMT/T3386-4<br>Leaning |

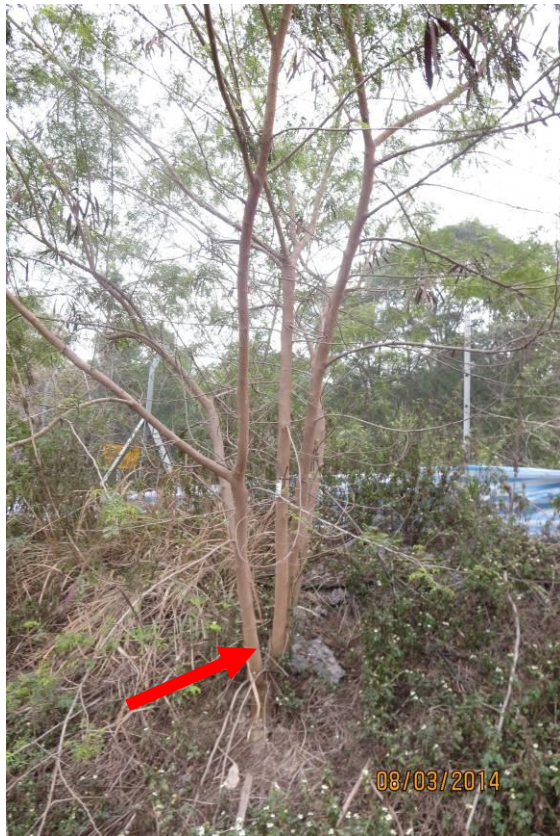
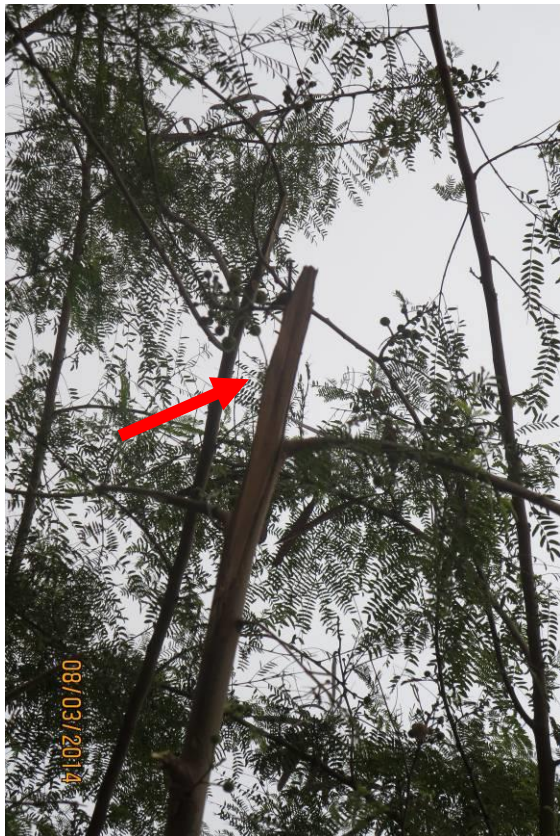
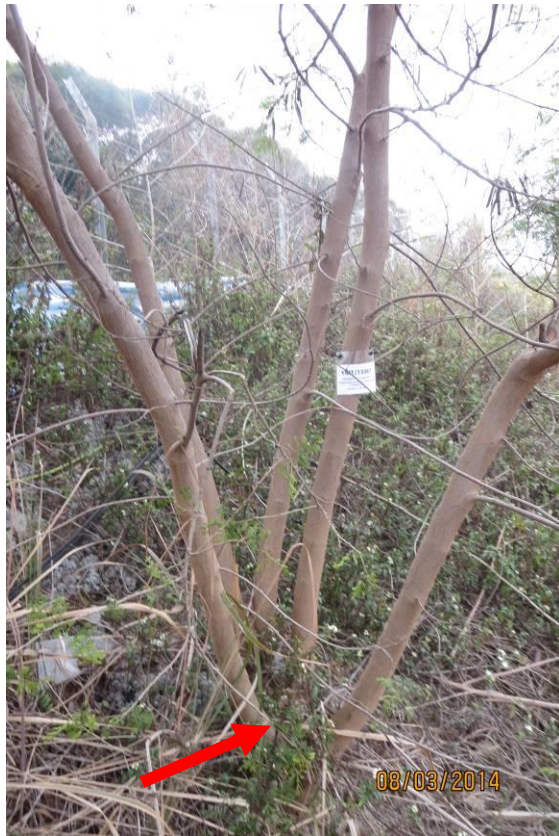
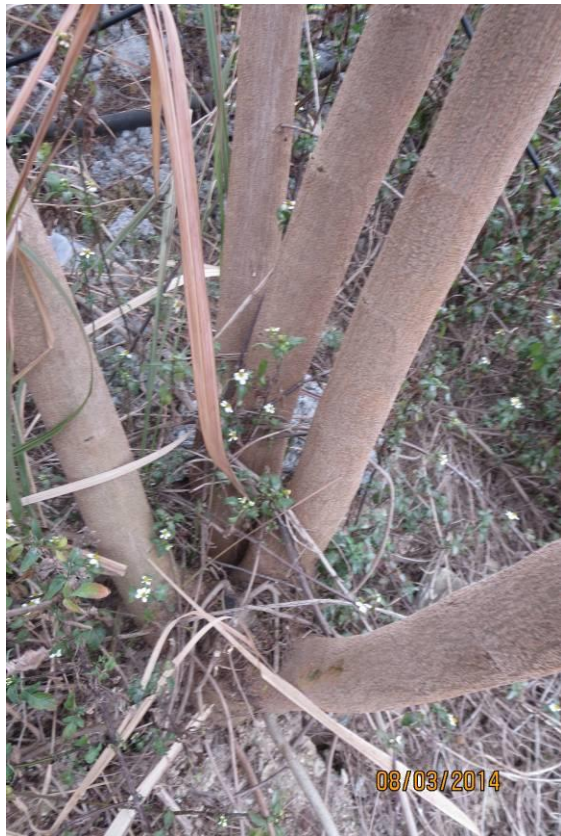
| YMT/T3387-1- Retain<br>Scientific Name: <i>Leucaena leucocephala</i> | YMT/T3387-2<br>Broken branches | YMT/T3387-3<br>Co-dominant trunk | YMT/T3387-4 |

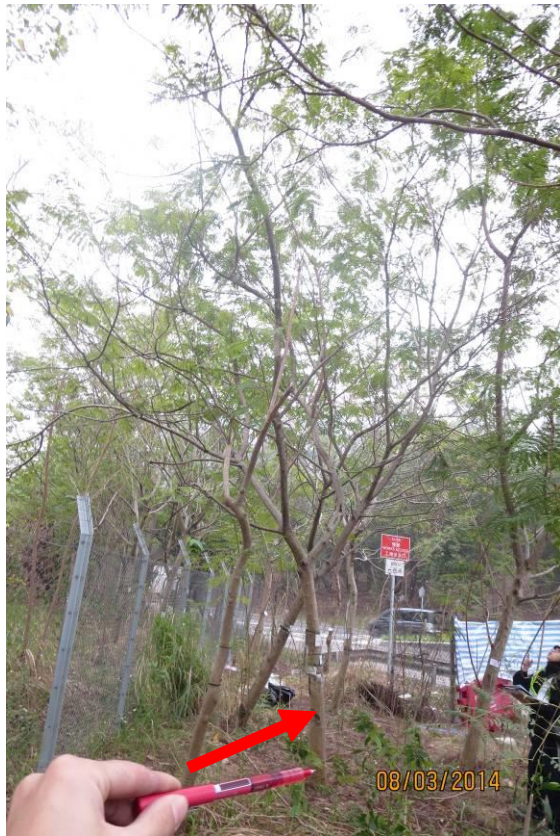
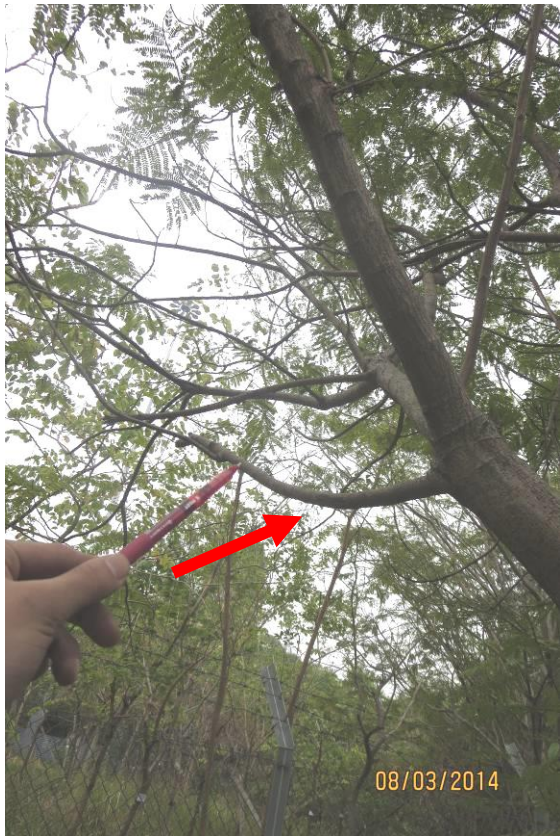
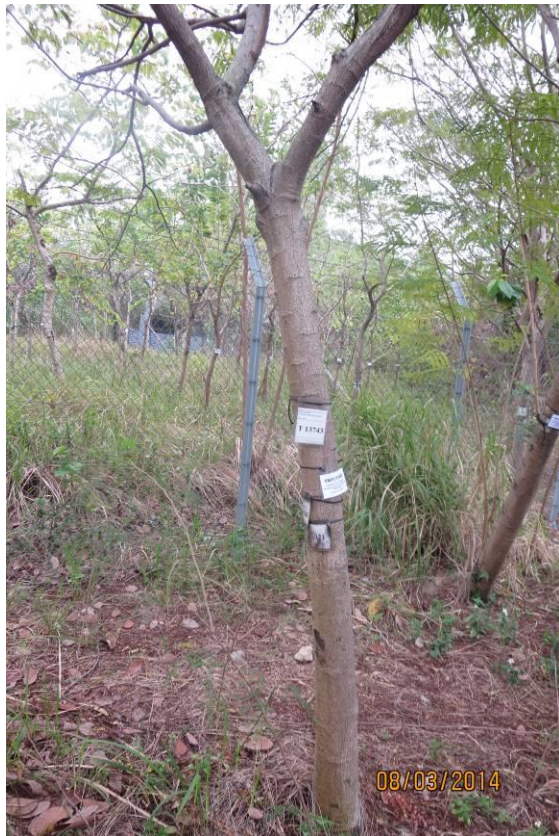
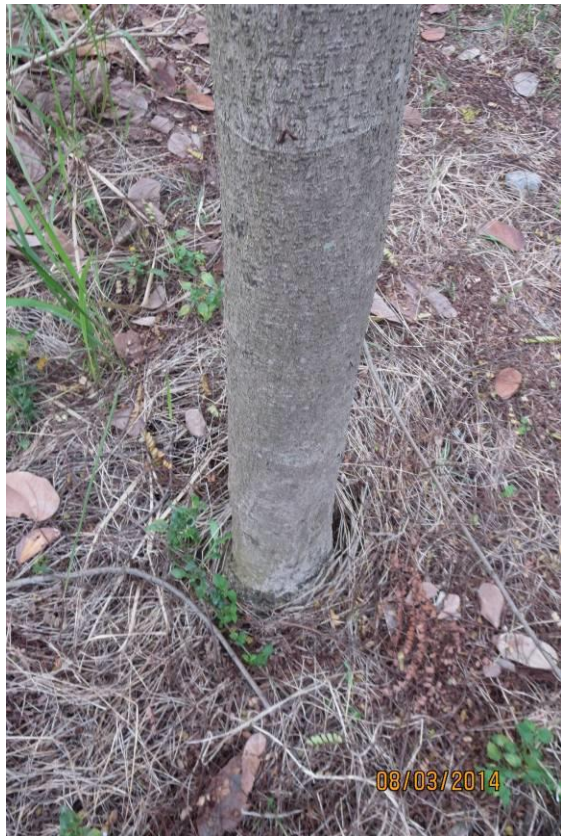
| YMT/T3405-1-Fell<br>Scientific Name: <i>Leucaena leucocephala</i> | YMT/T3405-2<br>Dead branches | YMT/T3405-3 | YMT/T3405-4 |
