**Power Interruption Incident at the
Hong Kong International Airport –
Final Report Submitted by the Airport Authority**

REPORT ON POWER INTERRUPTION ON 10 JUNE 2004

**POWER INTERRUPTION IN
PASSENGER TERMINAL BUILDING
ON 10 JUNE 2004**

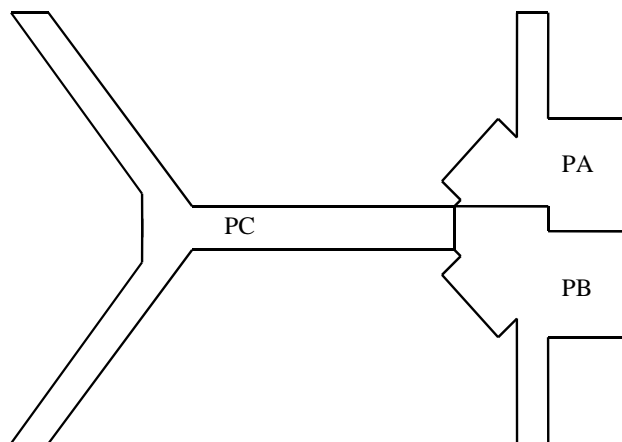
The current distribution network is serving the areas as shown:

Any power failure to HV substation “PA”, “PB” or “PC” will affect one third of the terminal operation. The Authority will reconfigure the power distribution network so that if there is any power failure to one of the substations, it will not result in total power loss of one third of the terminal.

The revised network will have the entire building configured as one zone and any single substation failure will result in the loss of about 25% of the power distributed across the building.

Emphasis will be placed to ensure that critical systems or areas will continue to operate. Standby power distribution system will be modified to provide non interruptible air conditioning supply to the building.

This enhancement project involves significant amount of new cabling and alteration to electrical switchboards. It will take 1 year to complete.
