Architectural Services Department

Asbestos Investigation Report for Demolition of Existing Superstructures at Caroline Hill Road Site, Causeway Bay, Hong Kong

(Version 3.0)

August 2016

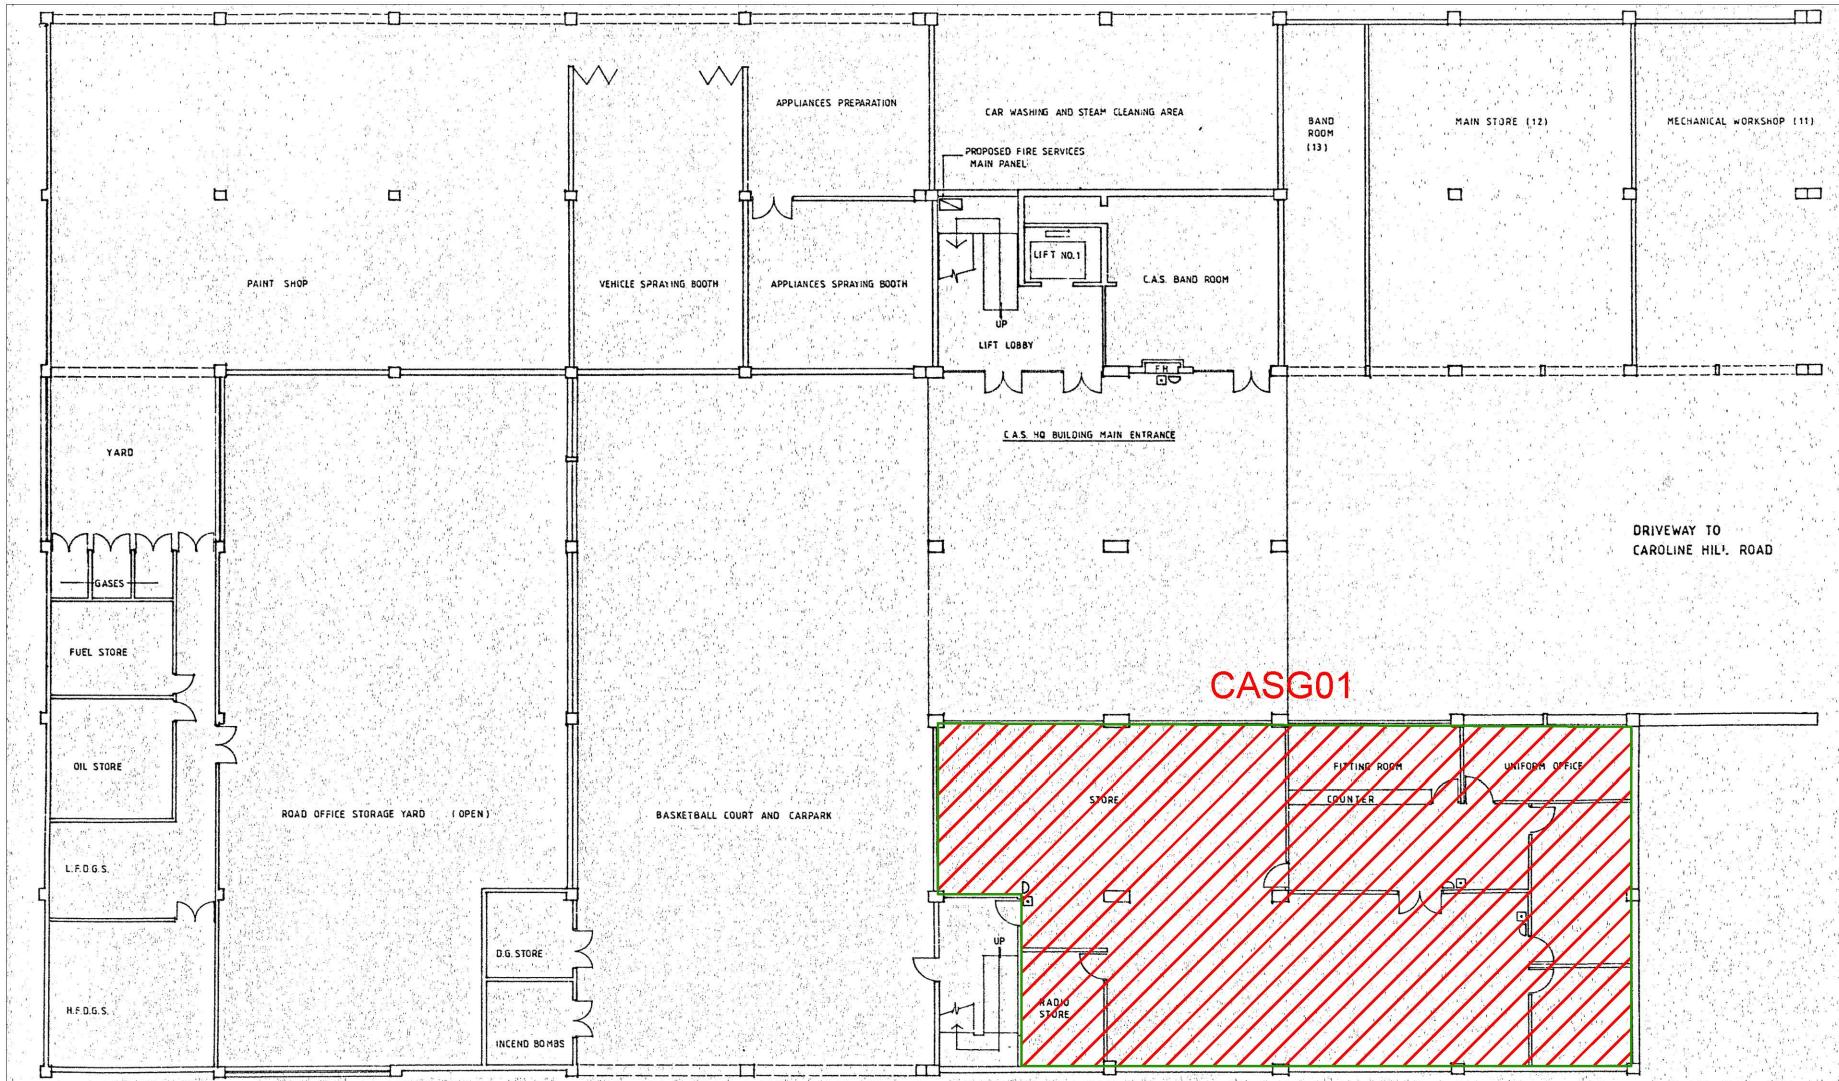
Vinyl floor tile with
mastic containing ACM

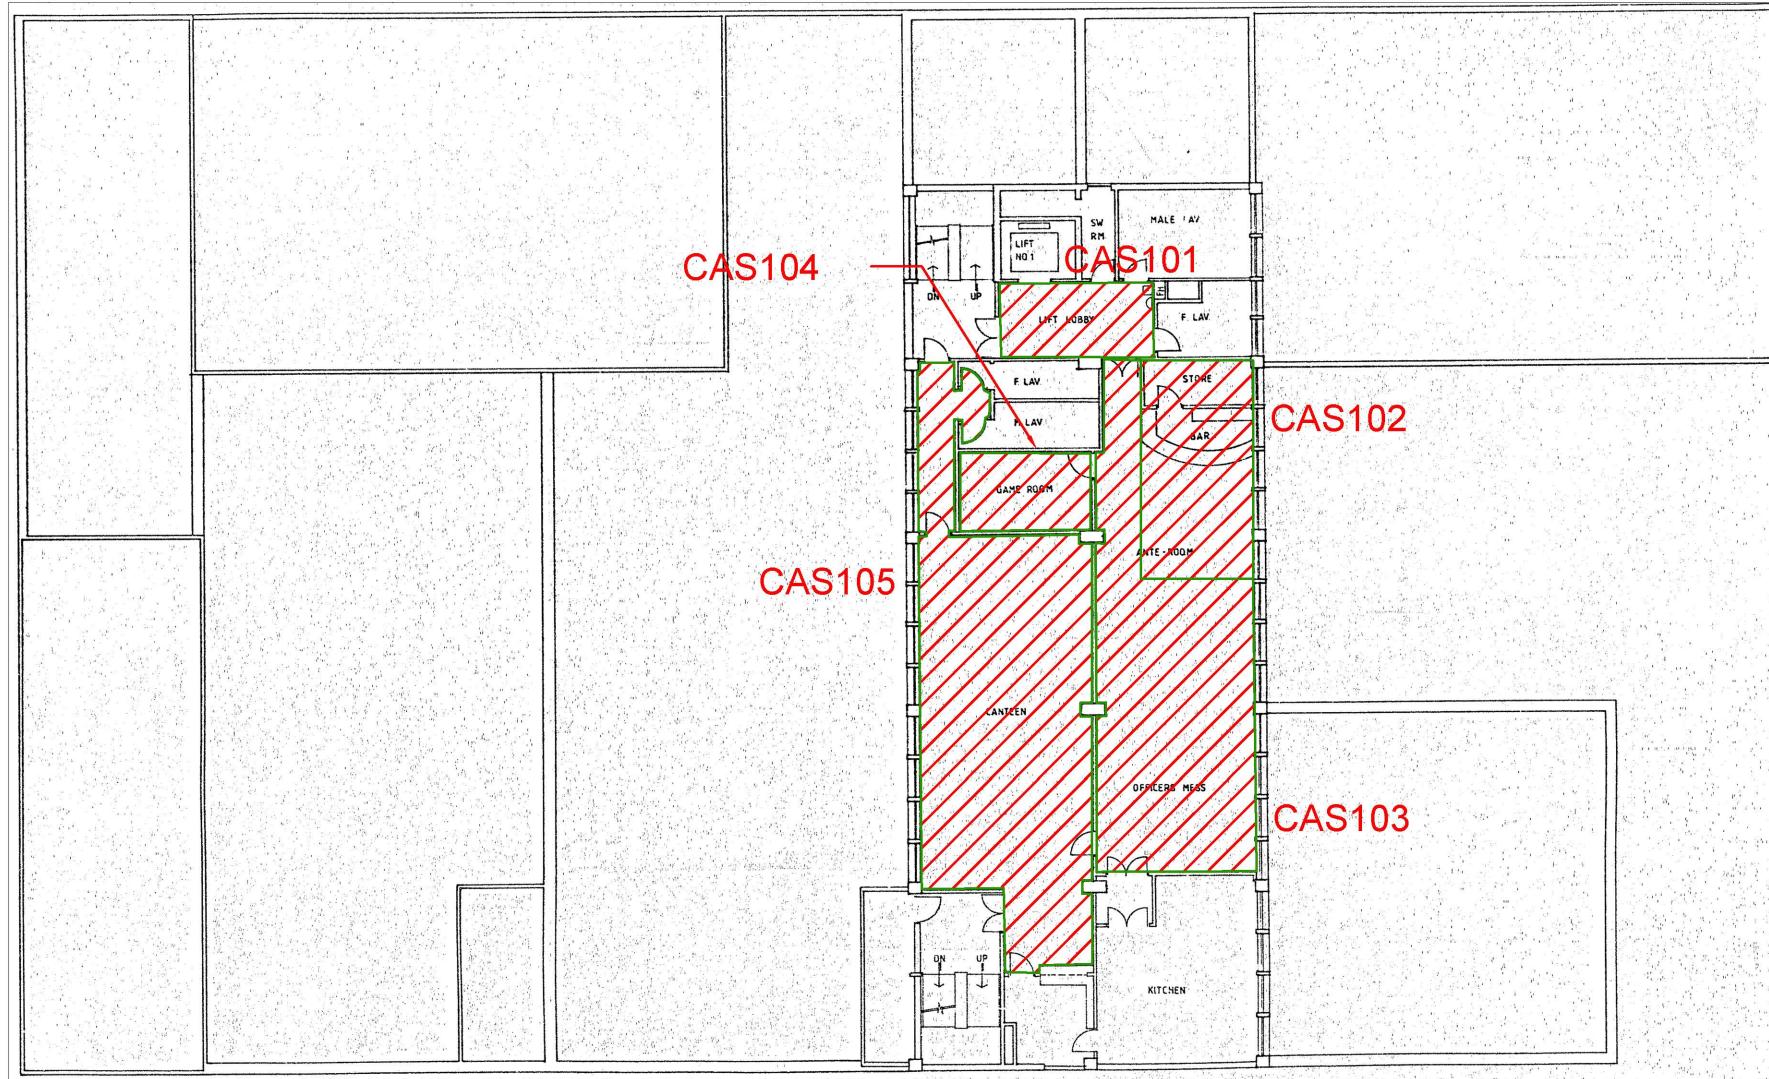
Switch box with ACM
containing arc cloth
