**Legislative Council
Panel on Environmental Affairs**

**Electrical Incidents of
CLP Power Hong Kong Limited in 2024**

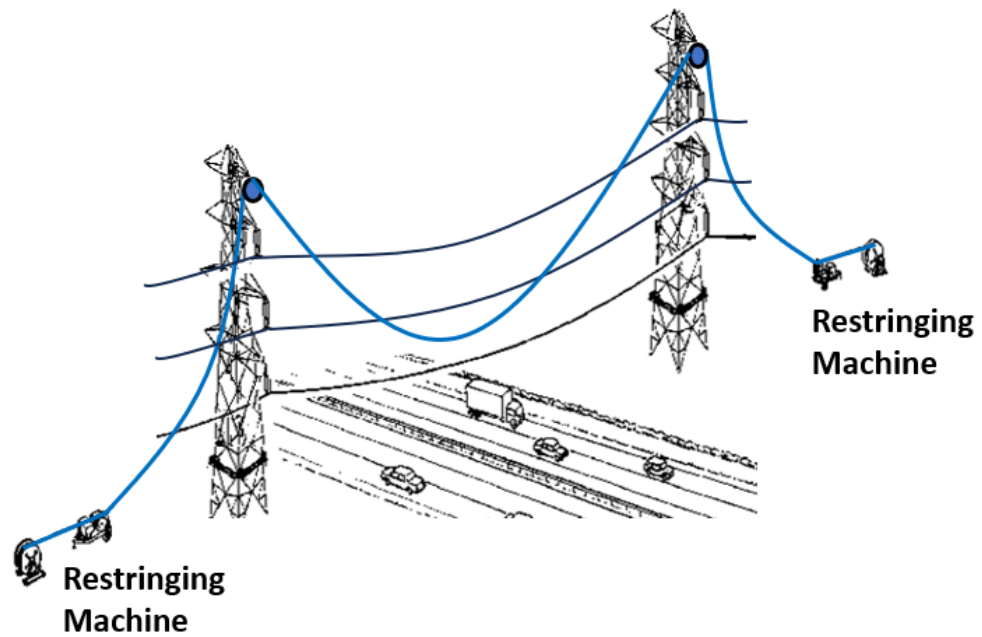
According to the method statement and risk assessment prepared by JPPC and reviewed by CLP, JPPC would adopt a "double-pulley system" as a fall prevention system to protect restringing work crossing high-risk areas like highways and railways. A "double-pulley system" consists of a high strength rope with pulleys attached to it to provide backup support in case a wire loses tension and sags. The working principle is illustrated in the diagrams below. Such "double-pulley system" is a fall prevention measure for overhead line work commonly adopted in the industry, a safe and practicable option for crossing highways regardless of day or night work. Despite lighter traffic, restringing at night would cause workers facing increased risk of falls due to reduced visibility, thus not implemented at the location concerned.

Over-sagged guide wire without a "double-pulley system"

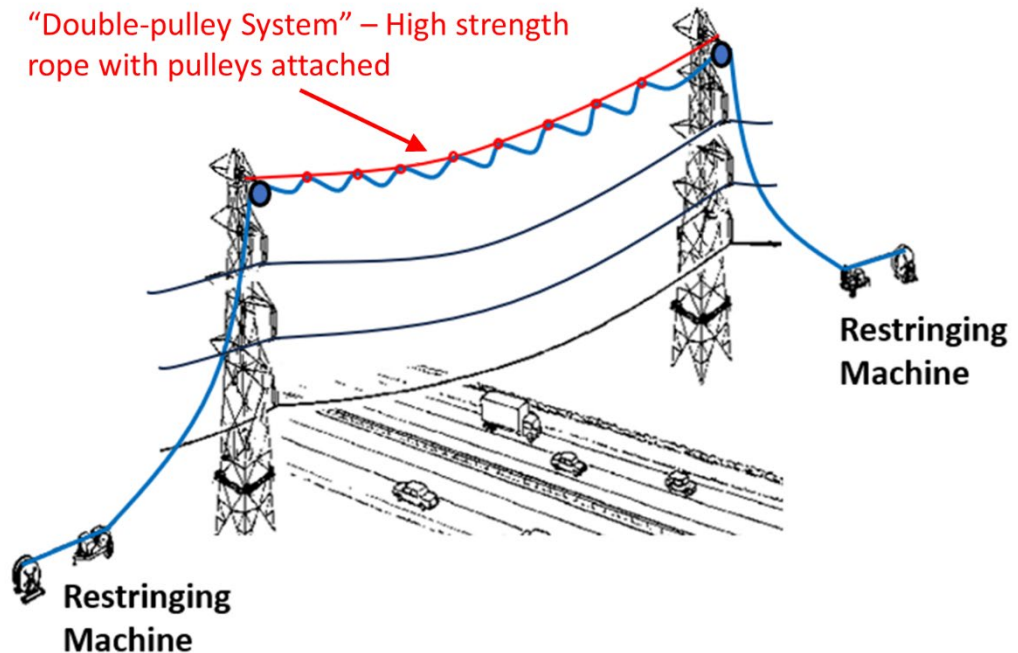
Over-sagged guide wire with a "double-pulley system"

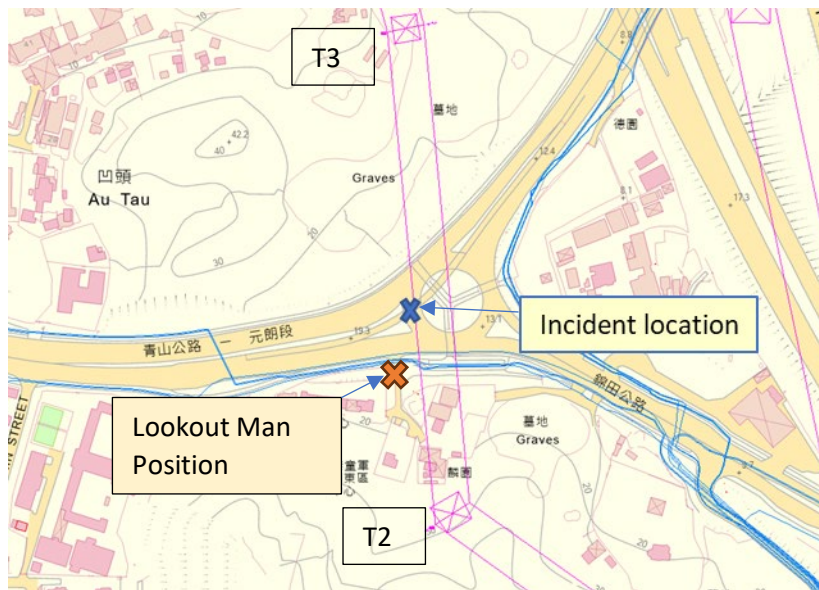
The observation position of the lookout man between T2 and T3, however, was not at an optimal level which impaired his judgment of the distance of guide wire above ground. At the time he noted the over-sagging, his request to re-tension the guide wire via the walkie-talkie was too late to remedy the over-sagging.

Position of lookout man at line section T2-T3 on 19 March 2024

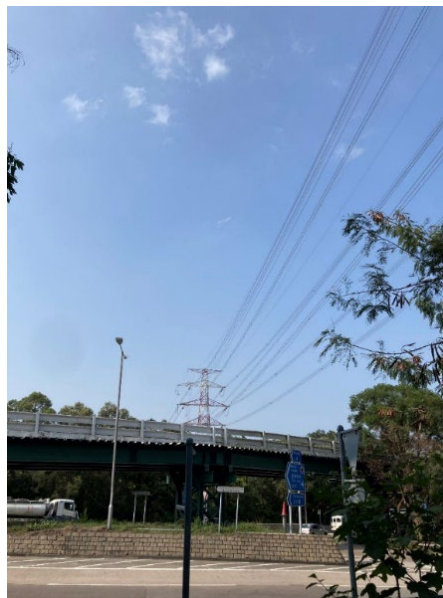
View of T3 and line section T2-T3 from position of the lookout man

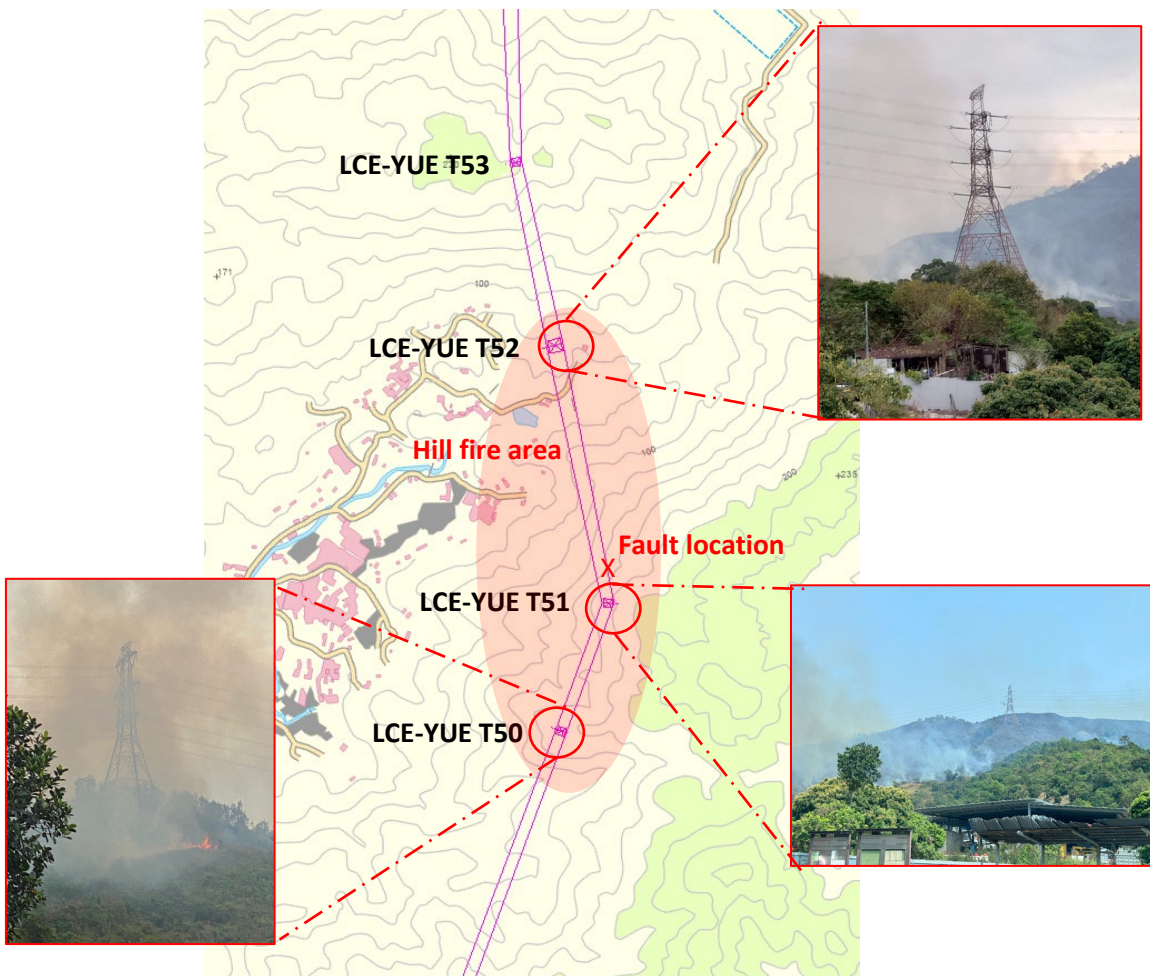
According to a media report, a hill fire broke out in Shap Pat Heung, Yuen Long at around noon time on 30 March 2024. It covered an area of about 50 metres by 60 metres with a fire line stretching approximately 200 metres. The fire was only extinguished at around 01:30 hours on 31 March 2024. CLP’s OHL patrol team present at the hill fire scene noted the fire line had passed an OHL section between T50 and T52 of LCE – YUE No. 2 circuit.

Fault location analysis suggested a fault had occurred at approximately 2.4km ± 0.2km from Yuen Long 400kV Substation, which was on an OHL span between towers T50 and T52. This coincided with the hill fire area affecting the LCE - YUE No. 2 circuit.

Figure 1: Affected area by hill fire

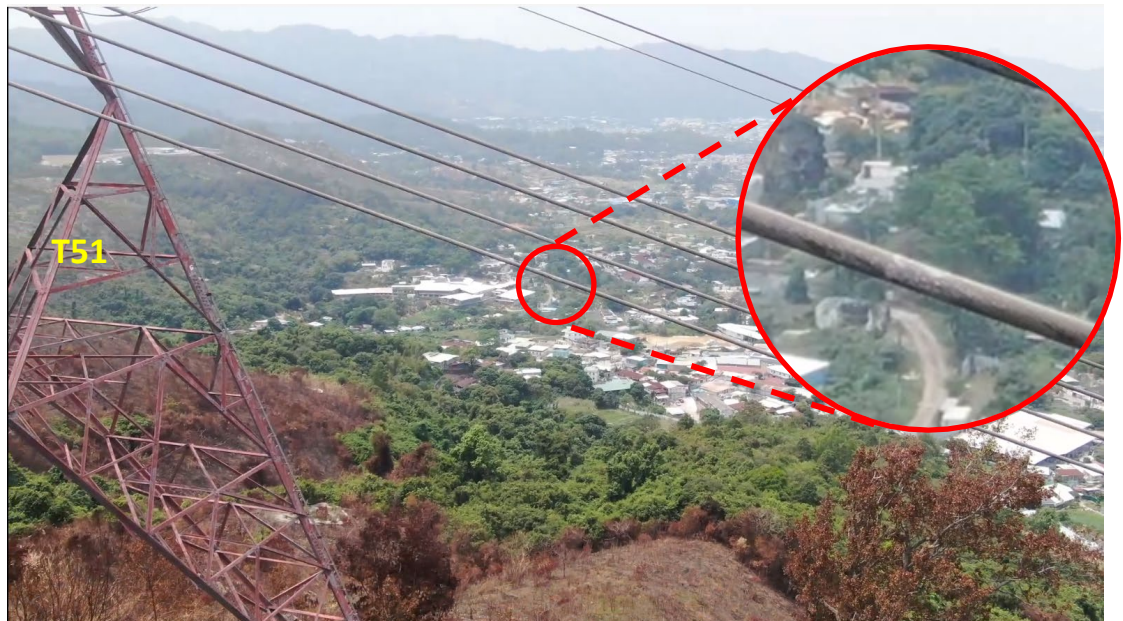
Partial discharge measurements and close inspection on OHL facilities at the towers identified no damage. However, a flashover mark was found on the L3 phase conductor (the bottommost phase conductor) at 18m away from T51 (Figure 2). There was a burnt tree underneath the flashover mark, with about 7m clearance from the bottommost conductor (Figure 3).

Figure 2: Flashover marks on L3 phase conductor near T51

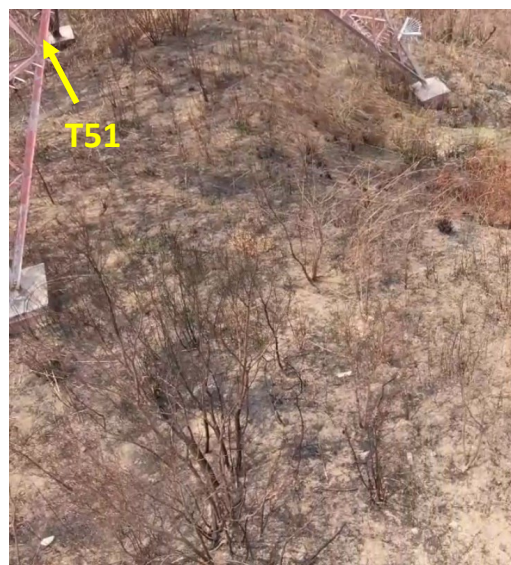
Figure 3: Burnt tree underneath the flashover mark on L3 phase conductor

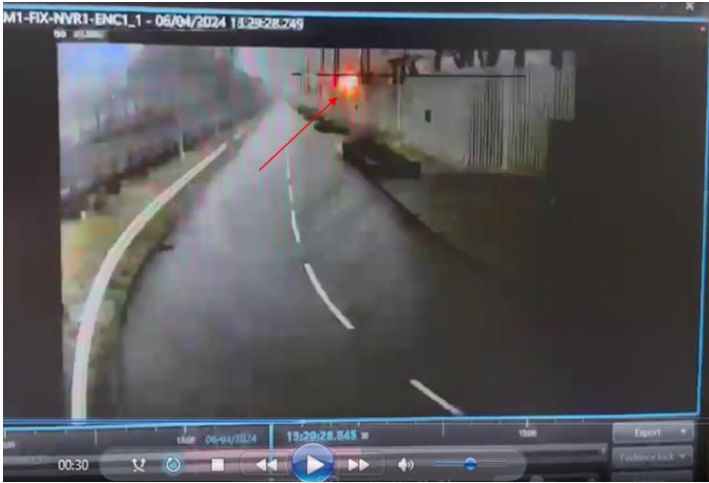
At the same time, a thunderstorm warning signal was in force and lightning strikes were recorded at areas near BPPS. From the nearby CCTV footage, two occurrences with sign of lightning and discharge were observed at the C5 and C6 generator transformer compounds which coincided with the operation of C5 and C6 protection systems. In addition, another flash of bright light near C6 transformer compound was observed around 3 seconds prior to tripping of C6. It was checked and confirmed there was no engineering work in the vicinity that will emit bright light during the incident. Therefore, it is believed that the occurrence of bright light was a lightning strike hitting close to the transformer compounds.

Figure 3 Discharge of around 0.6 seconds at C5 Generator Transformer Compound

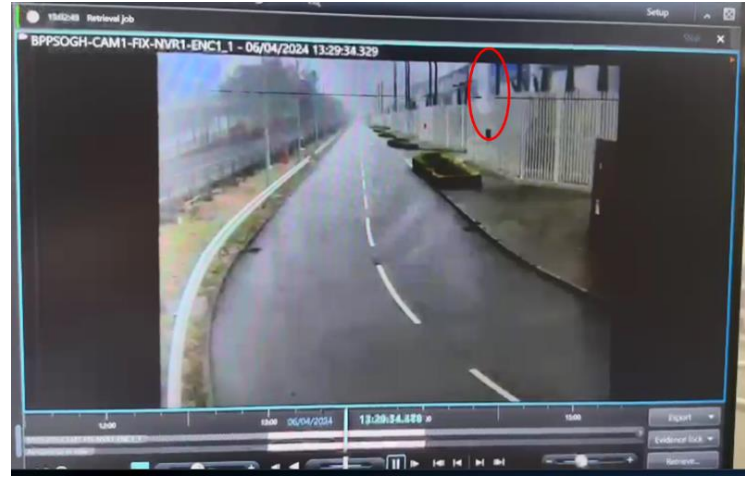
Figure 4 Lightning Observed at the Vicinity of C6 Generator Transformer Compound around 3 seconds prior to Discharge at C6

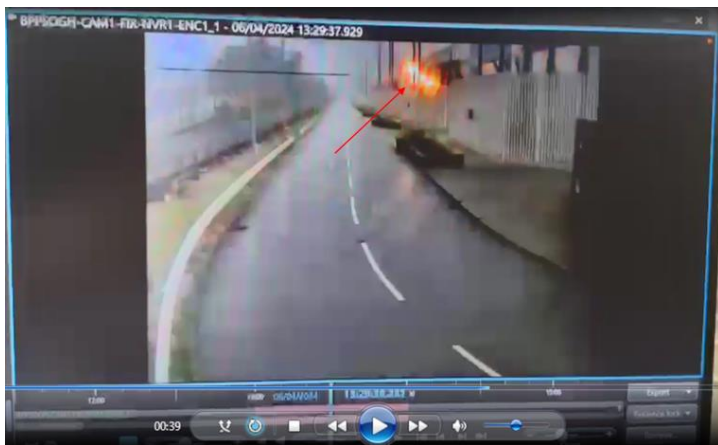
Figure 5 Discharge of around 0.8 seconds at C6 Generator Transformer Compound

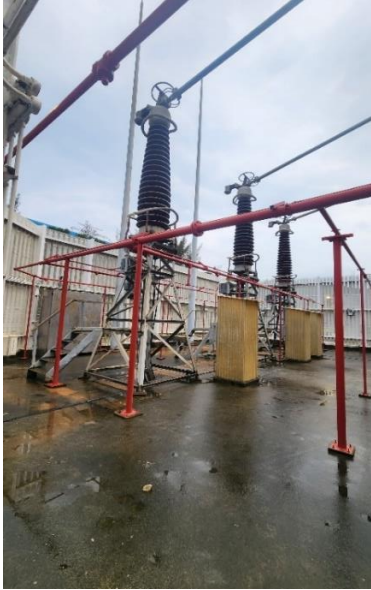
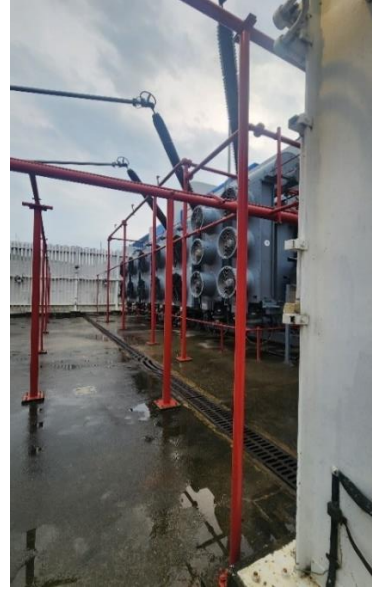
After the voltage dips and unit tripping, inspection of equipment was carried out immediately and no debris nor leaked insulation oil were observed inside C5 & C6 generator transformer compounds.

Figure 6 C5 Generator Transformer Compound after Voltage Dip on 6 April

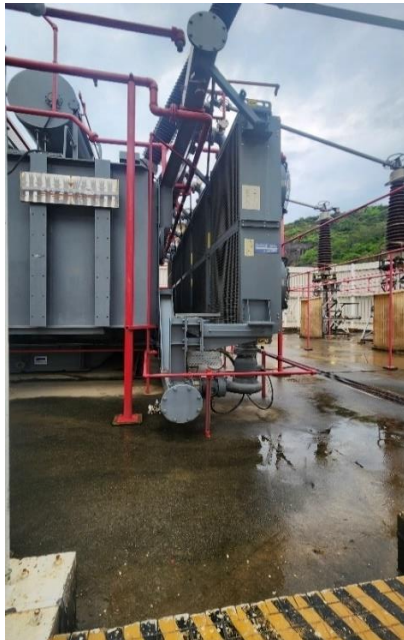
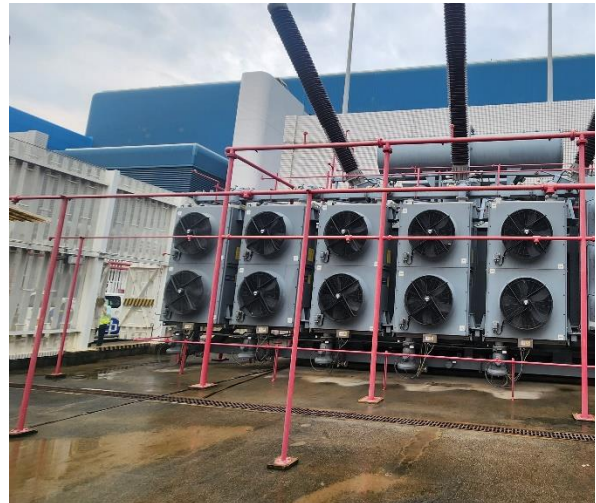
Figure 8 C6 Generator Transformer Compound after Voltage Dip on 6 April

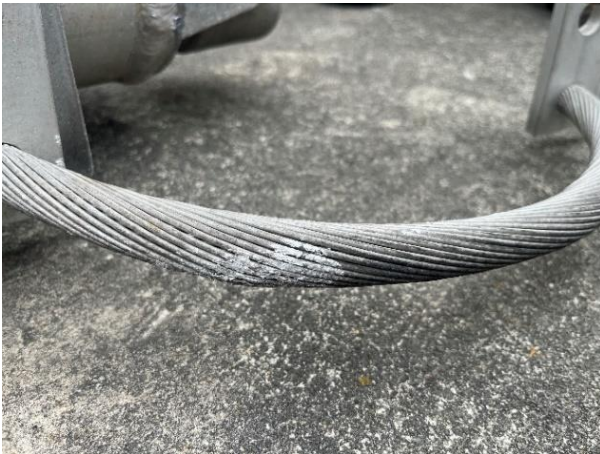
Site inspections revealed that there was no damage to other equipment and installations inside the generator transformer compounds except some localized burn marks and metal loss at the flexible conductors of the generator transformers' HV outlet at unit C5 & C6 phase L1 respectively. Some metal patches could also be found at surrounding electrical components.

Upon metallurgical analysis by in-house laboratory, the burn marks were located at the outer surface of the flexible conductors and confirmed to be created by melting of aluminum (material of the flexible conductors) by high localized energy release. Given there is no significant physical or mechanical damage and the amount of metal loss were localized at the outer surface, it is believed that the slight damage was a consequence of the external lightning or discharge instead of internal equipment fault.

Figure 11 Localized Burn Marks at Flexible Conductors of C5

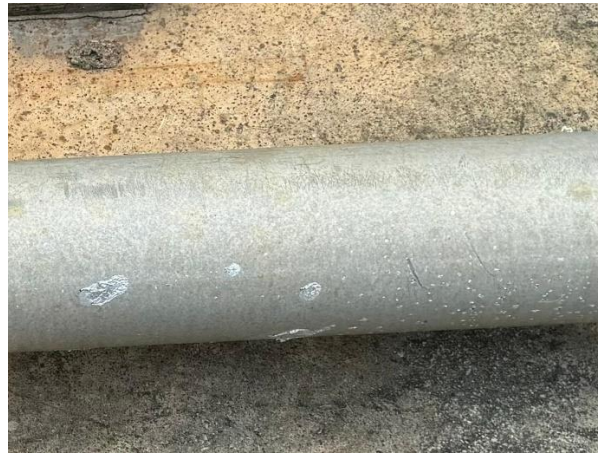
Figure 12 Patches of Metal on C5 HV Jumper

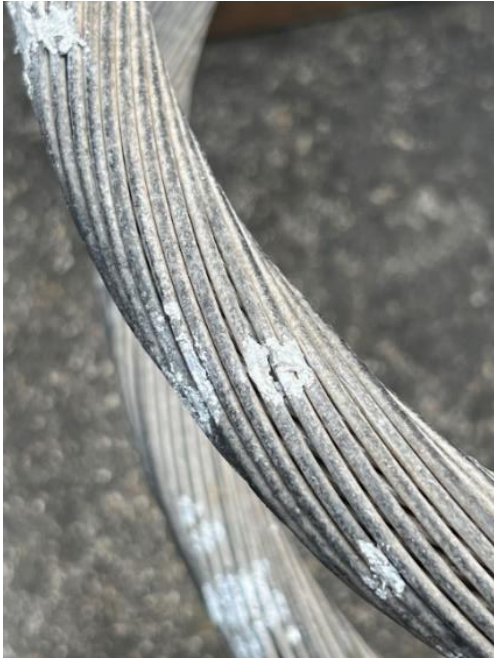
Figure 13 Localized Burn Marks at Flexible Conductors of C6

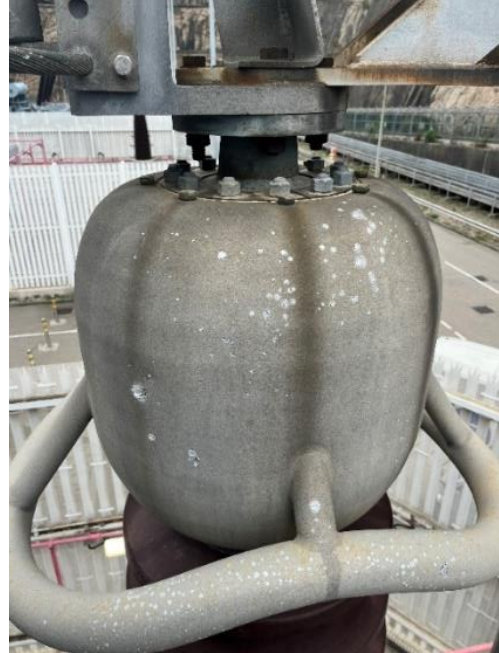
Figure 14 Patches of Metal on C6 Connector Head

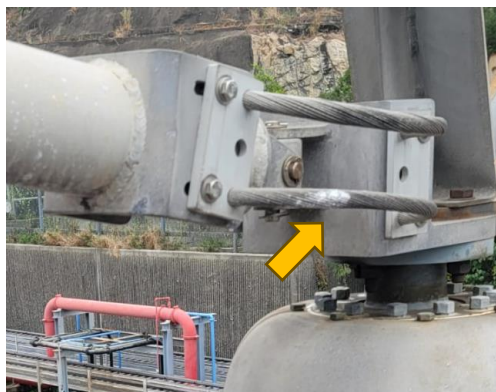
- iv) According to the Hong Kong Observatory, lightning was recorded in the Tuen Mun area around the same time.
- v) The flexible conductors of the L1 phase of HV outlet of units C5 and C6 were found slightly damaged with localized burn marks. Given there is no significant physical or mechanical damage and the amount of metal loss was localized at the outer surface, it is believed that the slight damage was a consequence of the external lightning or discharge instead of internal equipment fault.

Figure 15 C5 Damage at Flexible Conductor near HV Outlet

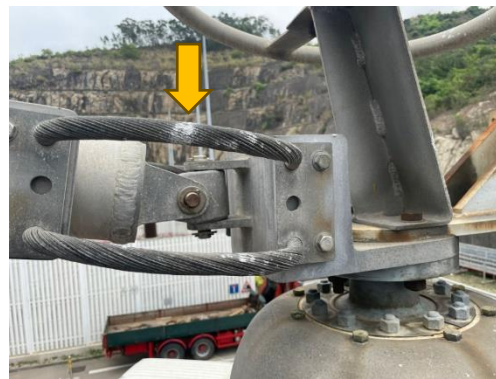
Figure 16 C6 Damage at Flexible Conductor near HV Outlet
