**Electrical Incidents of CLP Power Hong Kong Limited  
in Tsing Yi in January 2024**

# Power Supply Interruption Incident at On Mei House, Tsing Yi On 7 January 2024

## INCIDENT INVESTIGATION REPORT

# **Nga Ying Chau Street Substation Voltage Dip Incident On 1 January 2024**

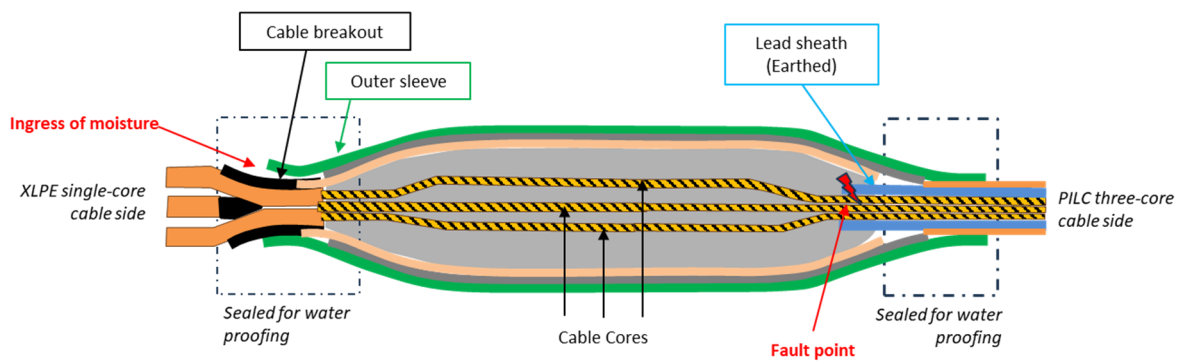
Investigation revealed that the water proofing capability of the tri-joint was impaired. The outer sleeve and the cable breakout which were supposed to tightly adhere to each other for water proofing was found peeled off at the XLPE cable side, leaving a gap that allowed ingress of moisture.

Moisture was present inside the joint evidenced by sign of corrosion on the metallic part inside the tri-joint body. Deterioration in insulation was observed, in particular at the earthed lead sheath of the PILC cable that formed a weak point where insulation breakdown developed over time, and a fault eventually occurred at the tri-joint.

Based on the investigation findings, it appears that there was premature aging of the joint material that led to deterioration of the sealing at the outer sleeve as such the hydrophobic (water proofing) capability of the tri-joint was impaired.

However, with the impaired hydrophobic capability, moisture entered the joint through the sealing gaps which then seeped into the inner part of the tri-joint, and all inner components including the lead sheath were directly exposed to corrosion effect caused by the moisture. The insulation integrity deteriorated over time thus leading to the insulation breakdown.

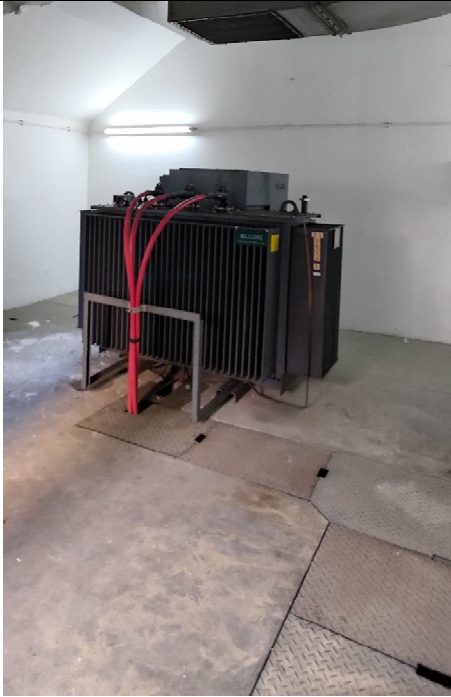
<p>A photograph of an indoor substation. It features a large, dark-colored transformer with red high-voltage cables connected to it. The transformer is mounted on a metal frame. The room has white walls, a concrete floor with a metal grate, and a fluorescent light fixture on the ceiling.</p> <p>Environment of On Mei House 'B' Substation</p>

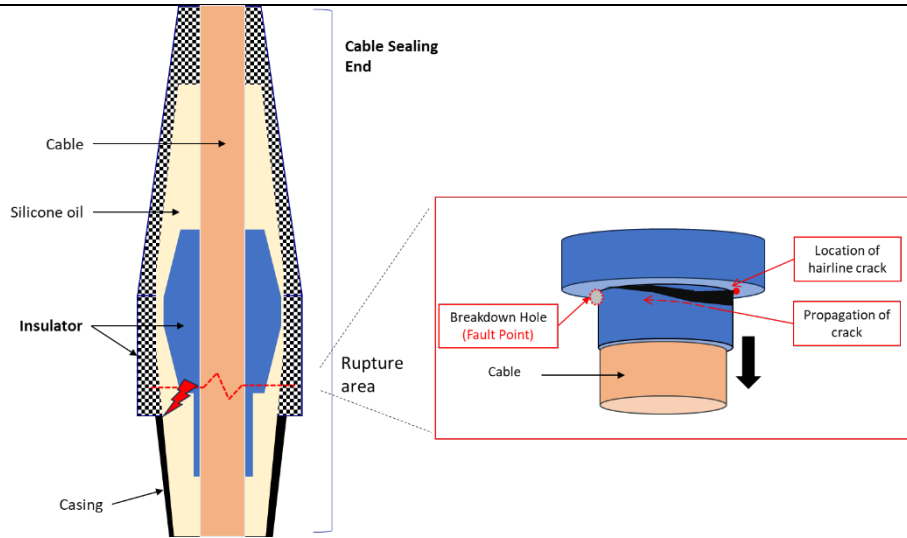
132kV RMU L3 Phase CSE

Upon site investigation on 1 January 2024, only the L3 phase CSE of the RMU was damaged while all other components were checked in good condition. Fragments of the insulator were found in the vicinity of the CSE and traces of insulating oil were spread on the wall of the RMU bay at a level aligned with the installation height of the damaged part of the CSE.

A detailed investigation into the faulty CSE by dissection at CLP workshop was conducted on 8 January and 9 January 2024. Insulation oil within the broken insulator was leaked out. The insulator ruptured with its lower part detached.

A hairline crack was found on the lower part of the insulator which propagated horizontally to a breakdown hole, sign of electric discharge was identified on the cable immediately beneath the breakdown hole which was inferred the fault point. The other two phases, i.e. L1 phase and L2 phase CSE connected to the same RMU were also dissected, no similar crack nor other abnormality found.

The investigation suggests a material flaw inside the CSE to be the root cause of the fault.

The origination of the hairline crack could not be confirmed. Such crack was not expected during installation, and the CSE had not been reopened since commissioning, it is uncertain when it was formed. CLP's prevailing installation procedures ensure inspection and commissioning tests are done to confirm installation quality, it is reasonable to infer that the hairline crack was developed after the time of commissioning. Investigation into the two other L1 and L2 phases CSE found no similar hairline crack, which confirmed not a type defect but a standalone case.

The CSE is consistently subject to thermal cycling and mechanical stress during operation. Such temperature variations and mechanical stress cause movement and extra stress could exert on any weak point like the hairline crack found on the insulator. Over time, the small crack developed into a more severe one, which degraded the insulation material and eventually resulted in electric discharge that failed the CSE.

Upon examination and testing at site, the concerned RMU remained intact, the faulty CSE will be replaced with a new one which is planned for completion by 31 January 2024, without need for any power shutdown to customers.
