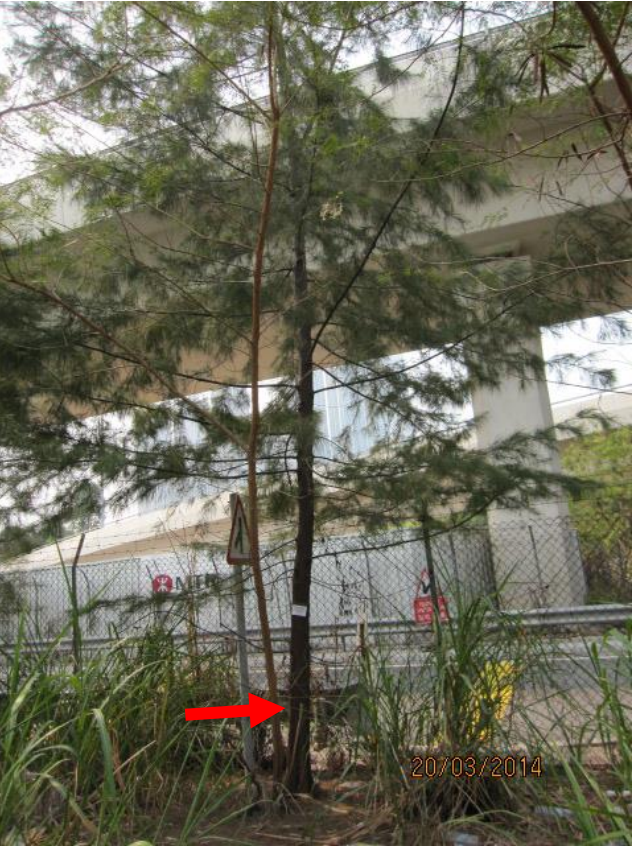
| YMT/T2763- 1 Fell<br>Scientific Name: <i>Casuarina equisetifolia</i> | YMT/T2763- 2 | YMT/T2763- 3 | YMT/T2763- 4 |

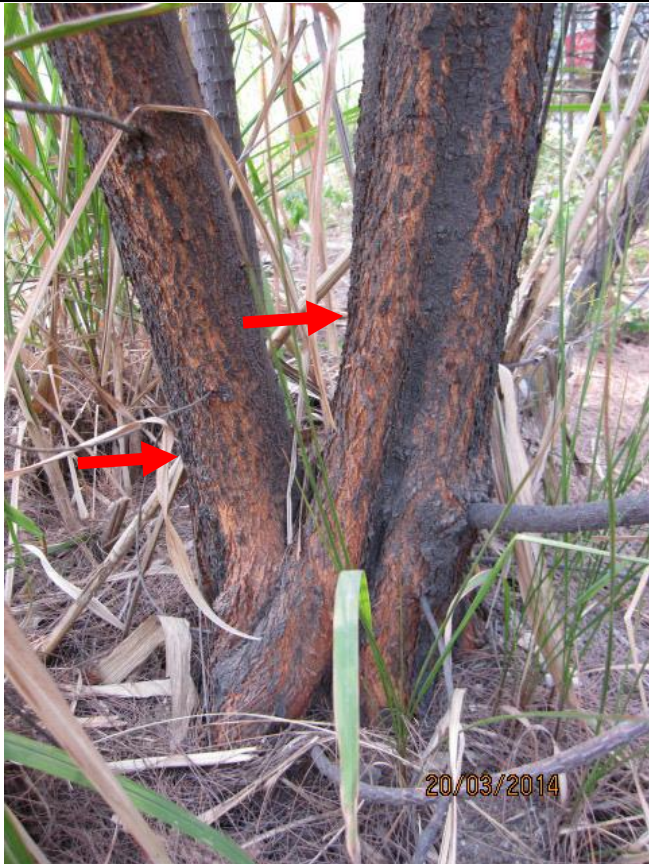
| YMT/T2766- 1 Retain<br>Scientific Name: <i>Casuarina equisetifolia</i> | YMT/T2766- 2 | YMT/T2766- 3 | YMT/T2766- 4<br>Co-dominant trunks |

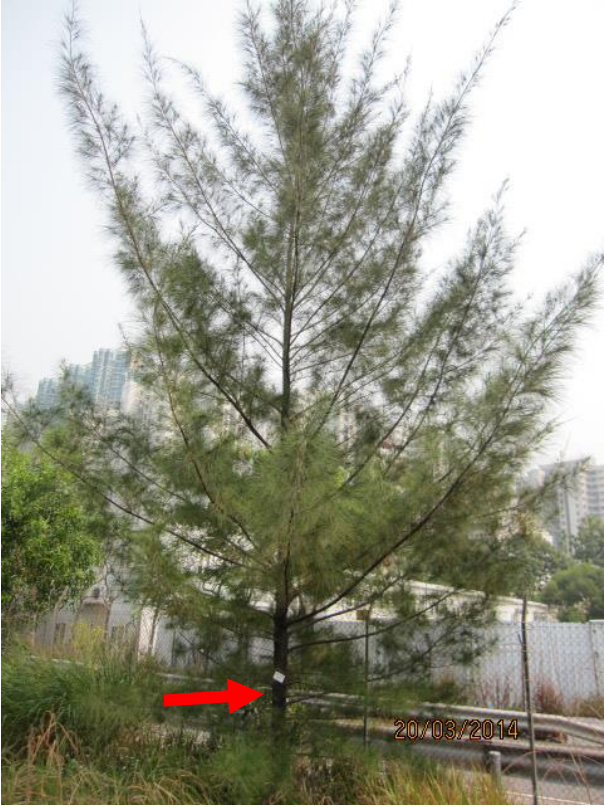
| YMT/T2768- 1 Fell<br>Scientific Name: <i>Casuarina equisetifolia</i> | YMT/T2768- 2 | YMT/T2768- 3 | YMT/T2768- 4 |

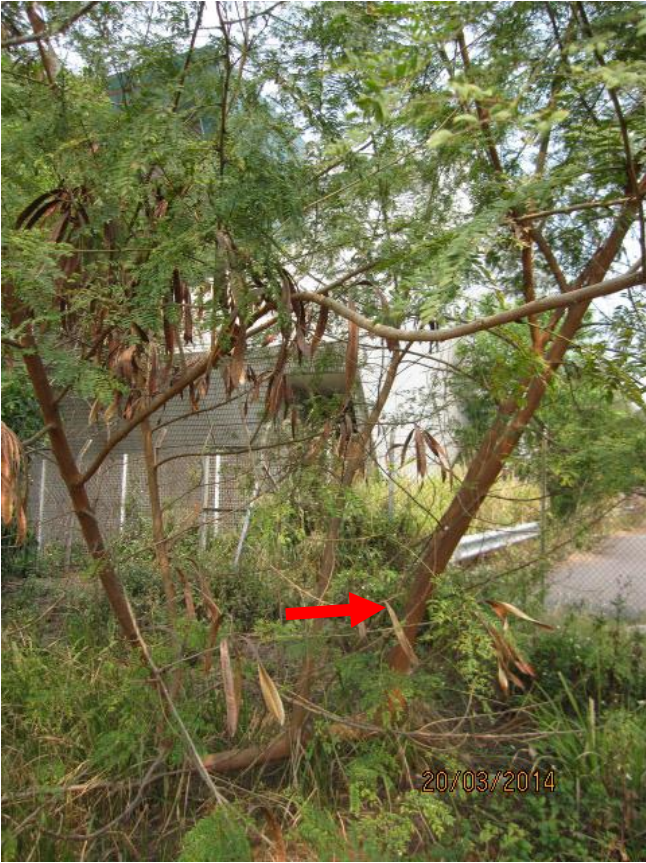
| YMT/T2769- 1 Fell<br>Scientific Name: <i>Leucaena leucocephala</i> | YMT/T2769- 2<br>Leaning | YMT/T2769- 3<br>Co-dominant trunks | YMT/T2769- 4<br>Exposed root plate |

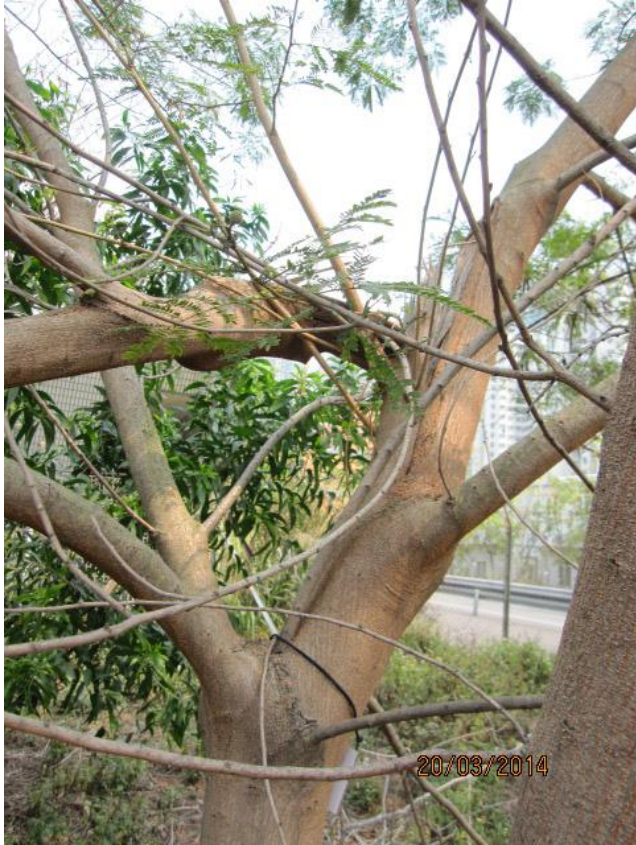
| YMT/T2770- 1 Retain<br>Scientific Name: <i>Leucaena leucocephala</i> | YMT/T2770- 2<br>Dead branches | YMT/T2770- 3<br>Co-dominant trunks | YMT/T2770- 4 |

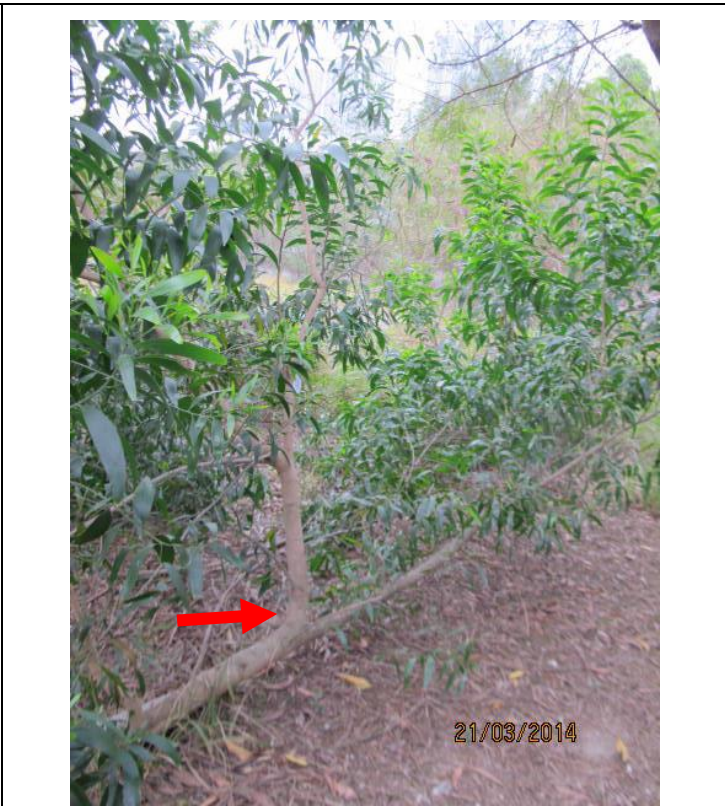
| YMT/T2771-1 Retain<br>Scientific Name: <i>Acacia mangium</i> | YMT/T2771- 2<br>Leaning and collapsed | YMT/T2771- 3<br>Dead branches | YMT/T2771- 4 |

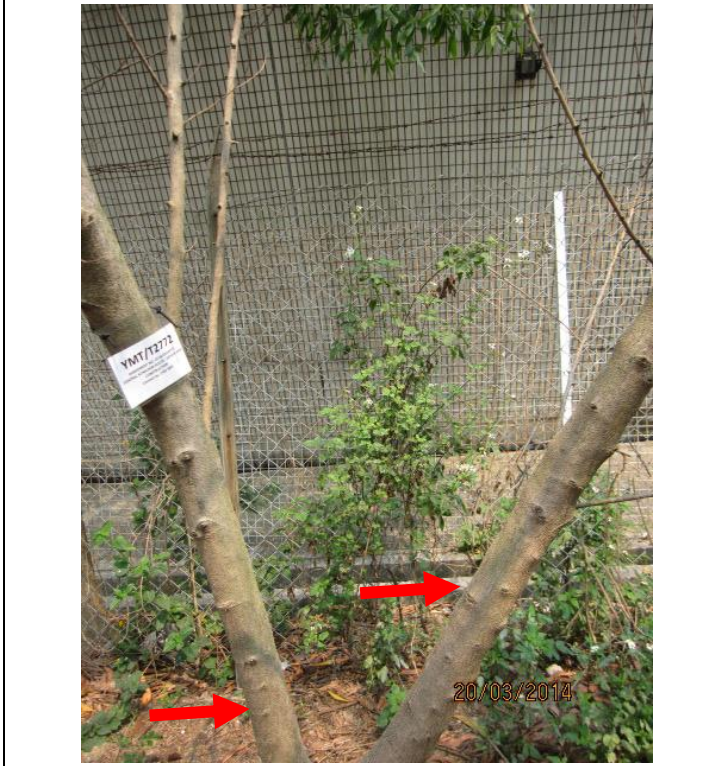
| YMT/T2772- 1 Retain<br>Scientific Name: <i>Leucaena leucocephala</i> | YMT/T2772- 2 | YMT/T2772- 3<br>Co-dominant trunks | YMT/T2772- 4 |

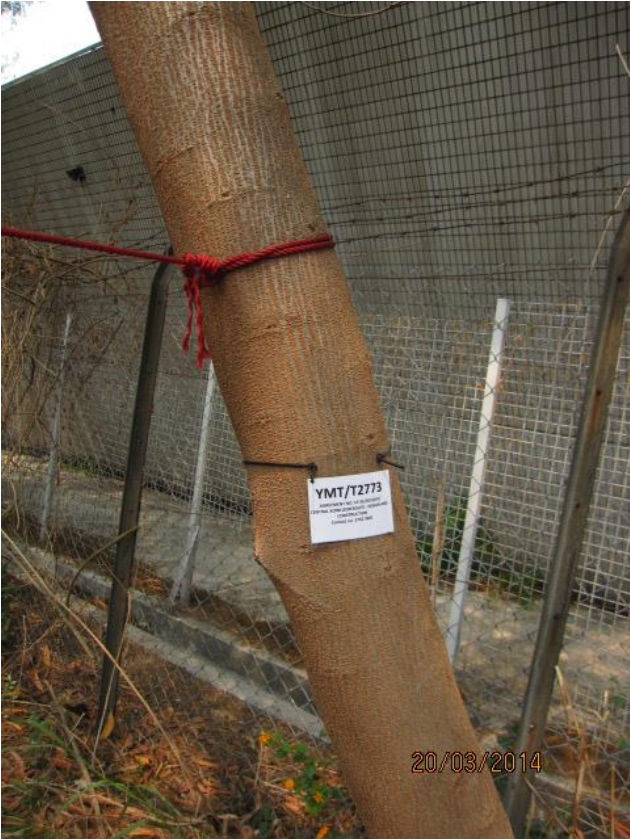
| YMT/T2773- 1 Retain<br>Scientific Name: <i>Leucaena leucocephala</i> | YMT/T2773- 2 | YMT/T2773- 3<br>Leaning | YMT/T2773- 4 |

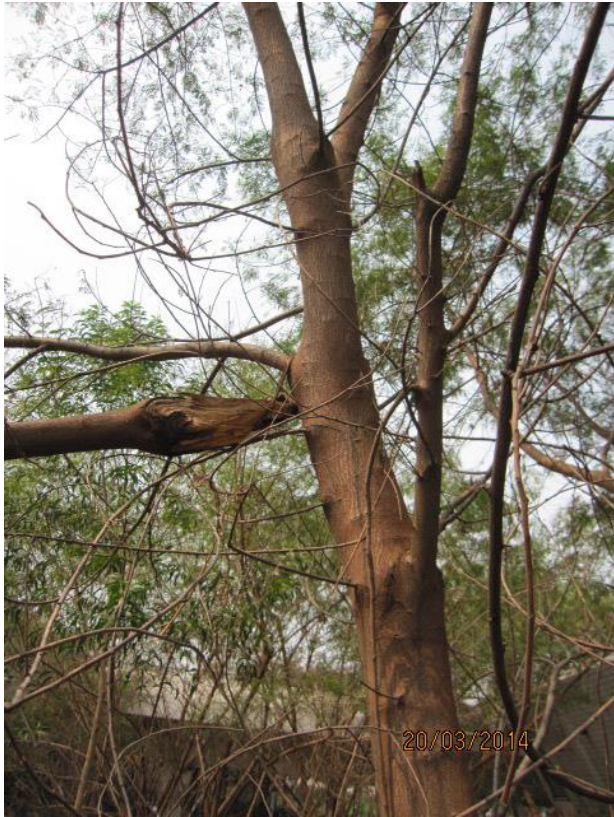
| YMT/T2774- 1 Retain<br>Scientific Name: <i>Leucaena leucocephala</i> | YMT/T2774-2 | YMT/T2774- 3<br>Dead branches | YMT/T2774- 4<br>Leaning |

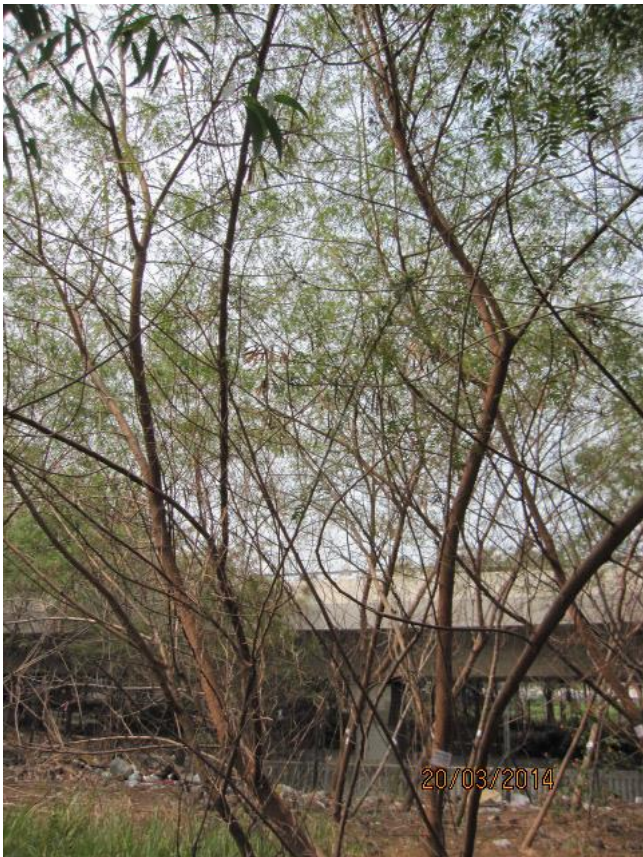
| YMT/2775- 1 Retain<br>Scientific Name: <i>Leucaena leucocephala</i> | YMT/T2775- 2<br>Leaning | YMT/T2775- 3<br>Dead branches | YMT/T2775- 4<br>Co-dominant trunks |

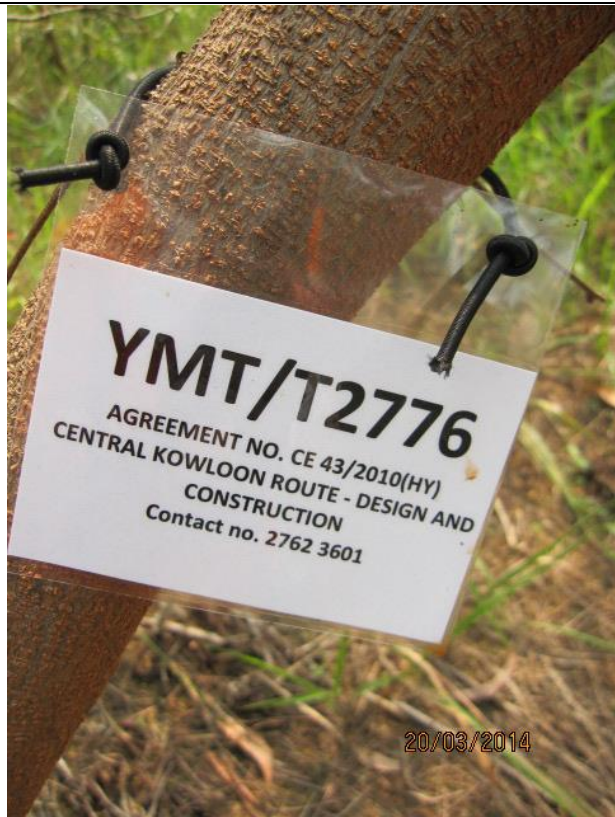
| YMT/T2776- 1- Retain<br>Scientific Name: <i>Leucaena leucocephala</i> | YMT/T2776- 2<br>Leaning | YMT/T2776- 3<br>Dead branches | YMT/T2776- 4<br>Whole tree collapsed on ground |

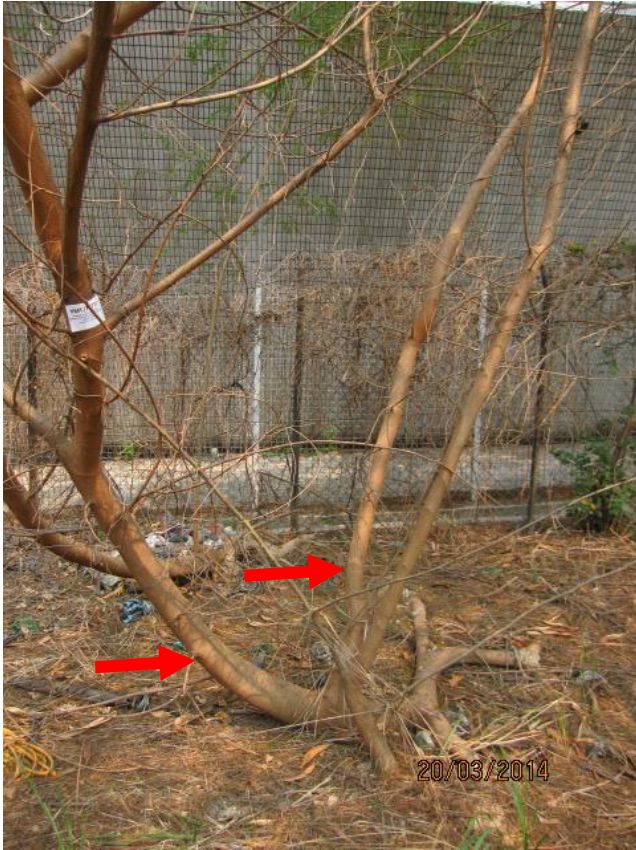
| YMT/T2777- 1 -Retain<br>Scientific Name: <i>Leucaena leucocephala</i> | YMT/T2777- 2<br>Co-dominant trunks | YMT/T2777- 3<br>Leaning | YMT/T2777- 4<br>Root exposed |

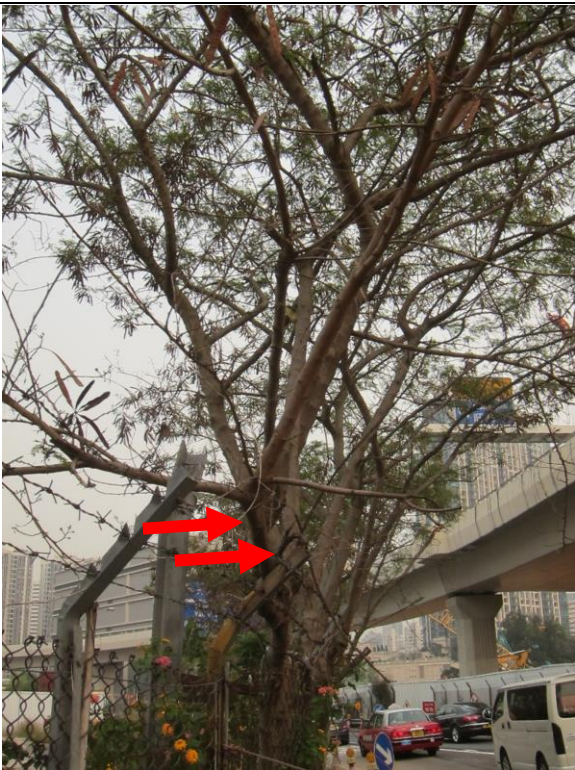
| YMT/T2778- 1 Retain<br>Scientific Name: <i>Leucaena leucocephala</i> | YMT/T2778- 2<br>Dead branches and cross branches | YMT/T2778- 3<br>Fence included, wound on trunk | YMT/T2778- 4<br>Restricted by concrete |

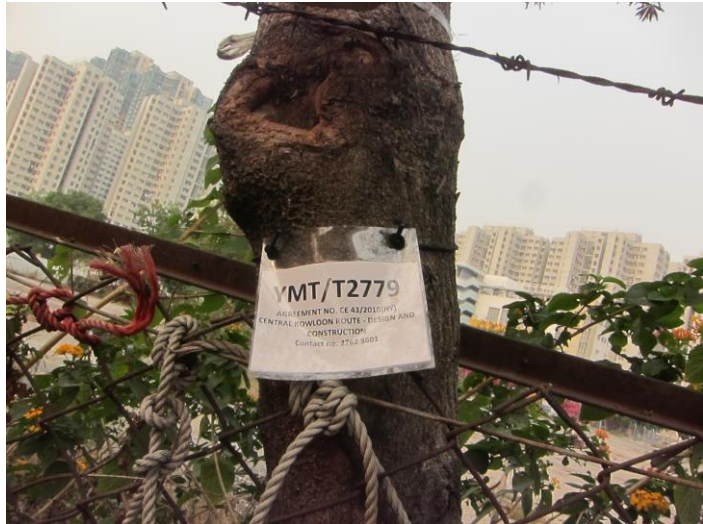
| YMT/T2779- 1 Retain<br>Scientific Name: <i>Leucaena leucocephala</i> | YMT/T2779- 2<br>Dead branches and Broken branches | YMT/T2779- 3<br>Wound on trunk by girdling | YMT/T2779- 4 |

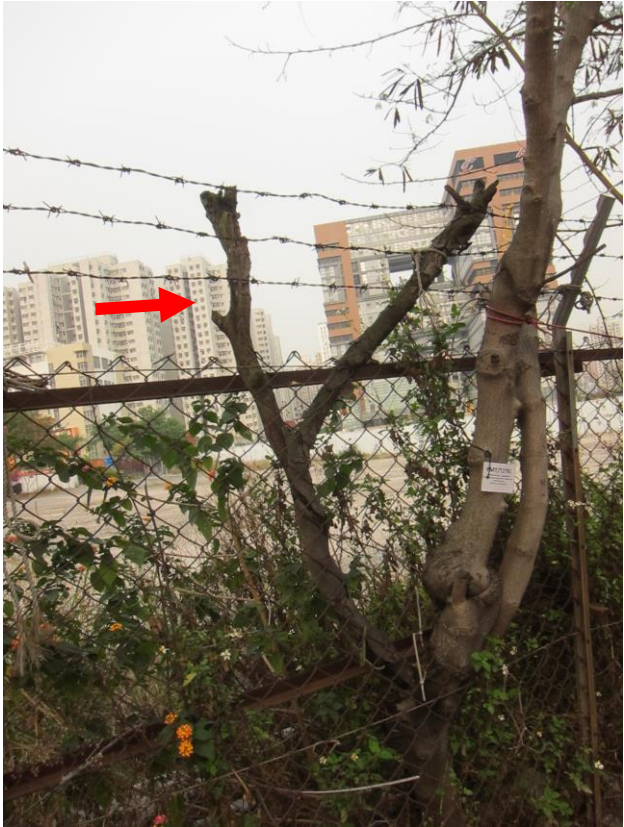
| YMT/T2781- 1 Retain<br>Scientific Name: <i>Leucaena leucocephala</i> | YMT/T2781- 2 | YMT/T2781- 3<br>Dead branches | YMT/T2781- 4<br>Restricted by concrete |

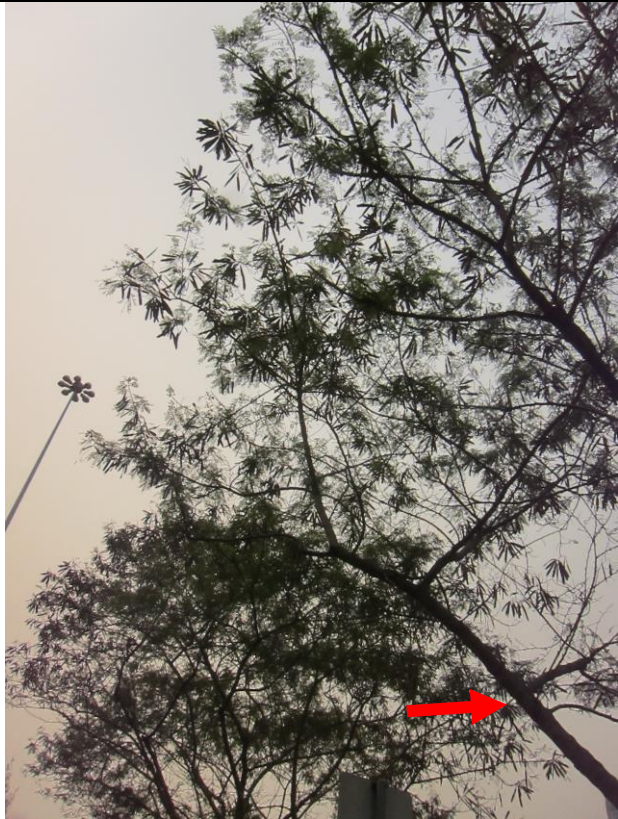
| YMT/T2782- 1 Retain<br>Scientific Name: <i>Leucaena leucocephala</i> | YMT/T2782- 2<br>Dead branches | YMT/T2782- 3 | YMT/T2782- 4<br>Restricted by concrete |

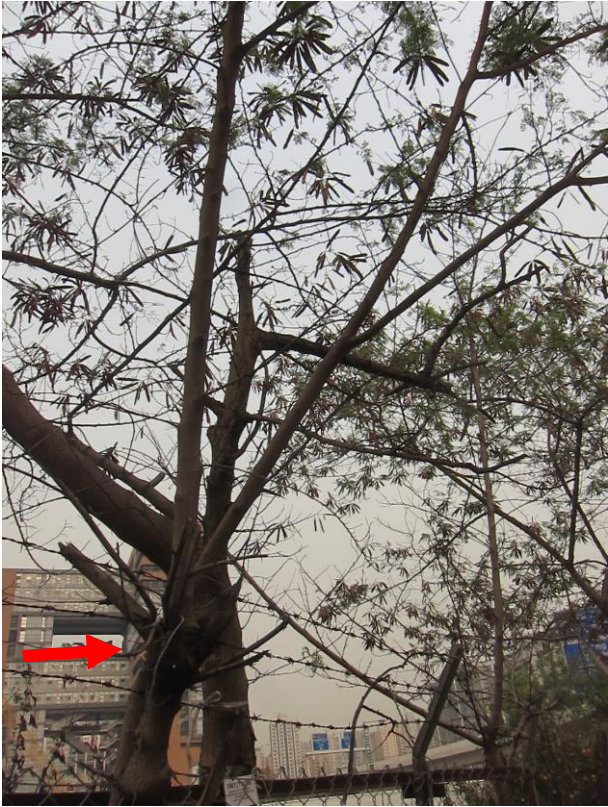
| YMT/T2783- 1 Retain<br>Scientific Name: <i>Leucaena leucocephala</i> | YMT/T2783- 2<br>Dead branches | YMT/T2783- 3<br>Wound on trunk | YMT/T2783- 4<br>Co-dominant trunks |

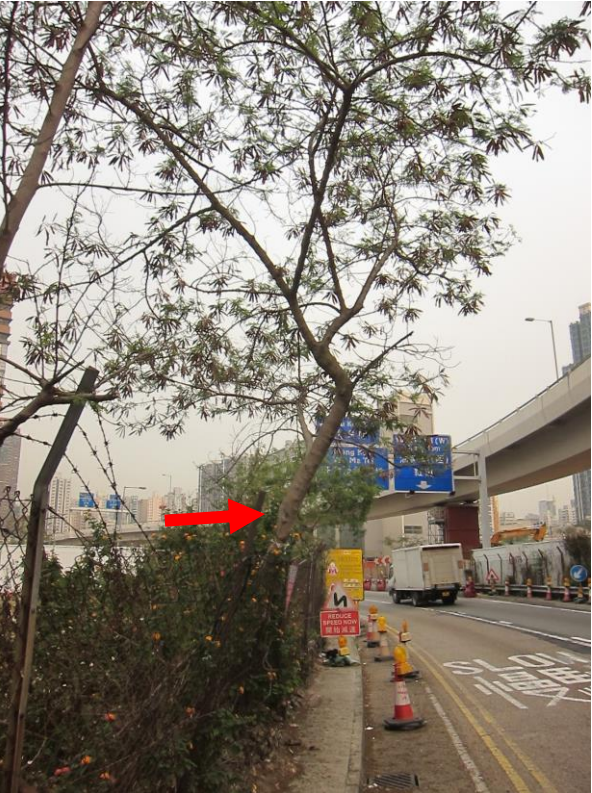
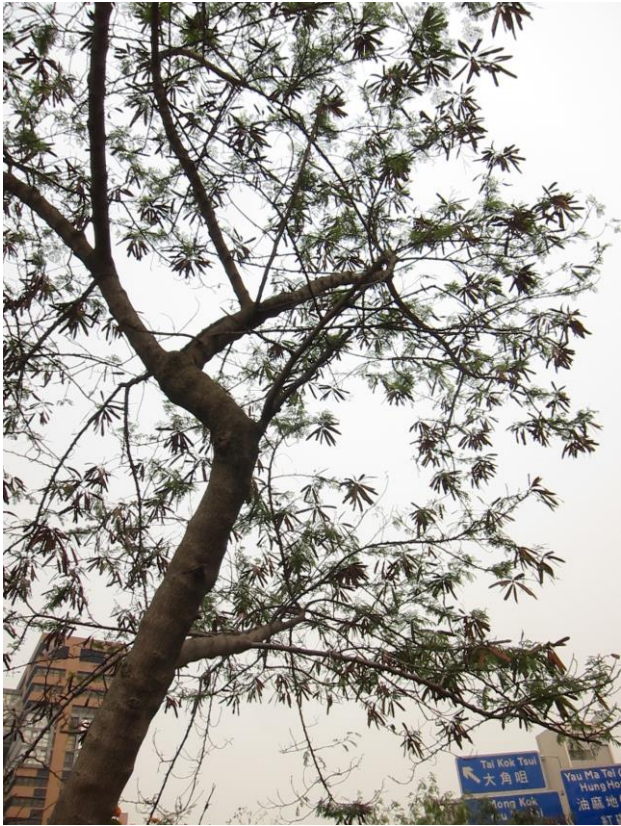
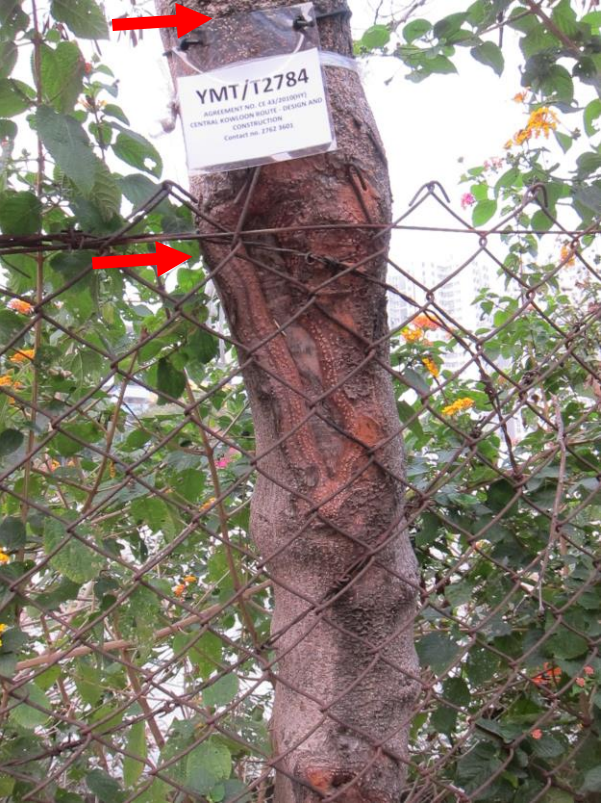
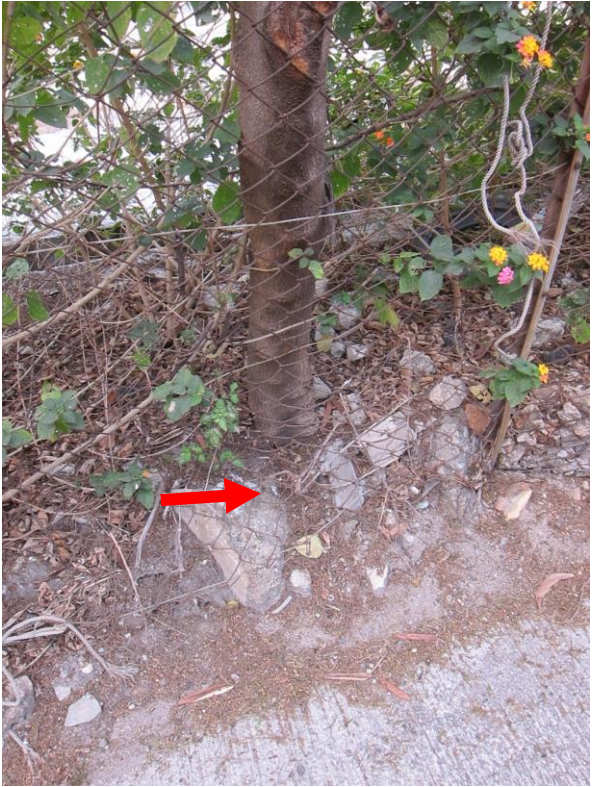
| YMT/T2784- 1 Retain<br>Scientific Name: <i>Leucaena leucocephala</i> | YMT/T2784- 2<br>Dead branches | YMT/T2784- 3<br>Wound on trunk by girdling | YMT/T2784- 4<br>Restricted by concrete |

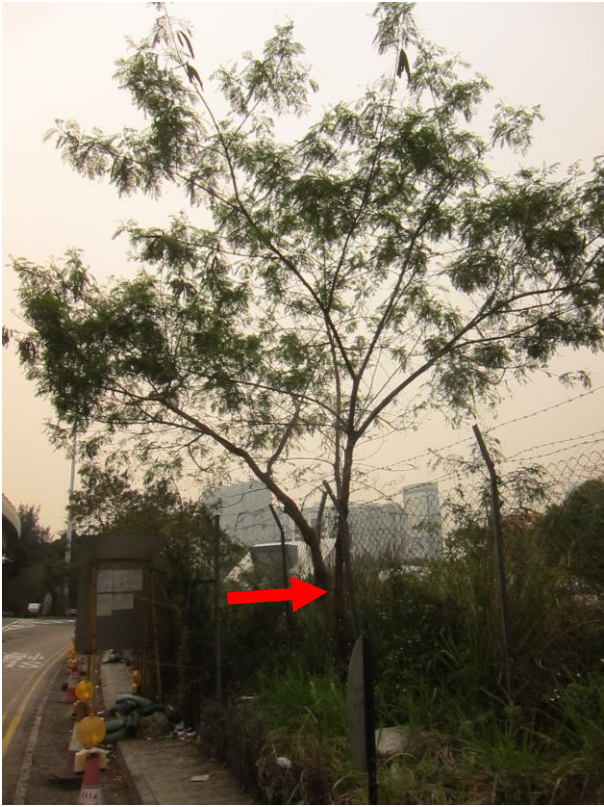
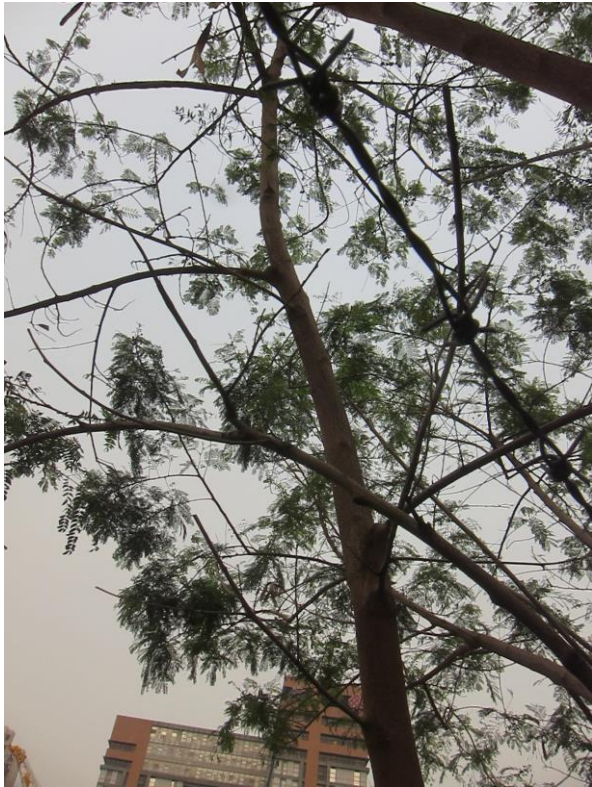
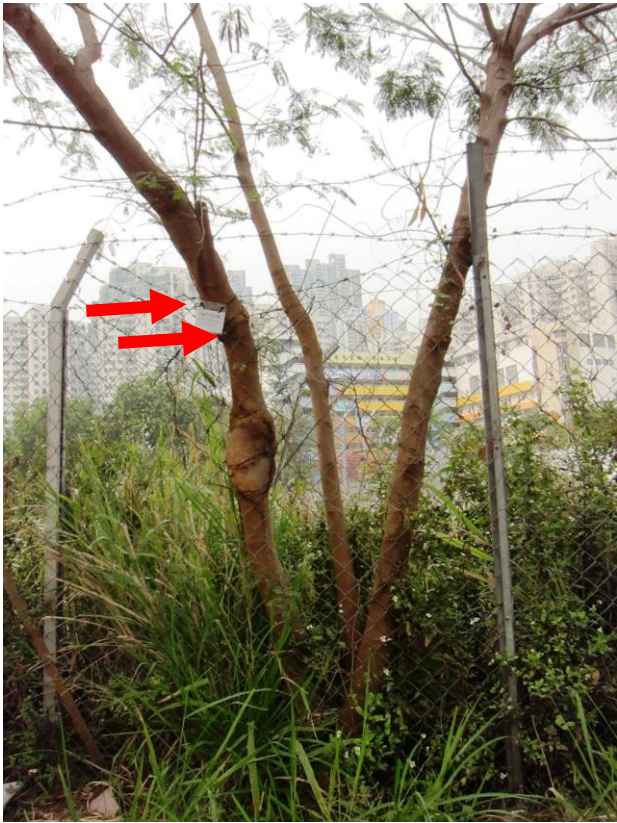
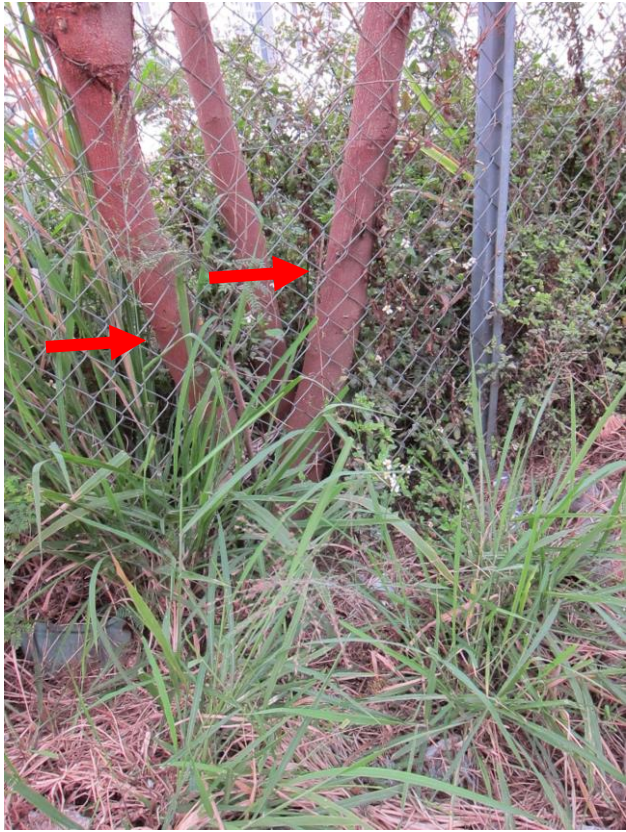
| YMT/T2785- 1 Retain<br>Scientific Name: <i>Leucaena leucocephala</i> | YMT/T2785- 2<br>Dead branches | YMT/T2785- 3<br>Wound on trunk by fence girdling | YMT/T2785- 4<br>Co-dominant trunks |

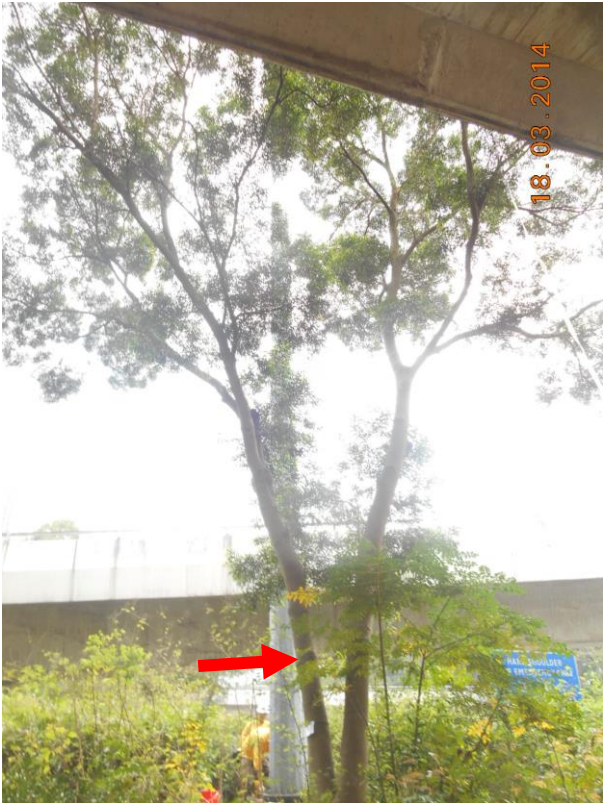
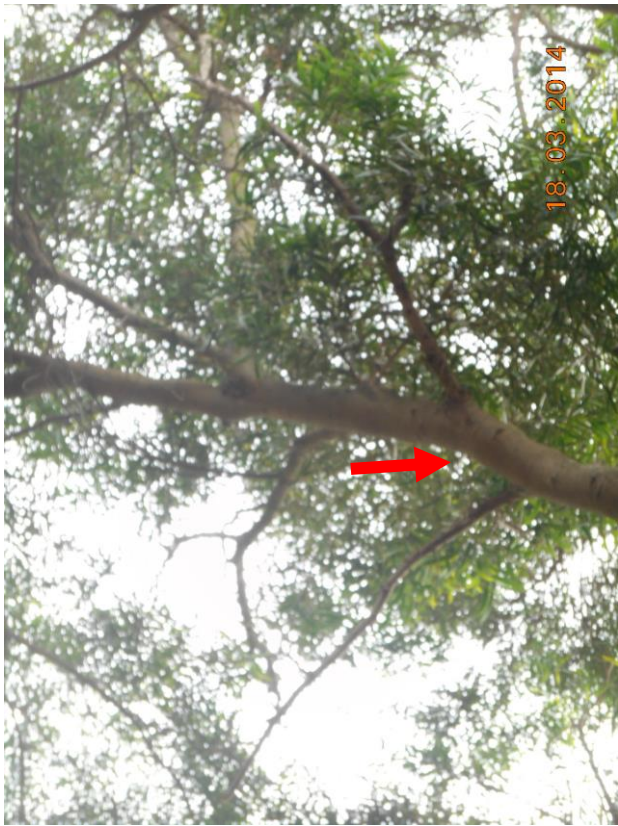
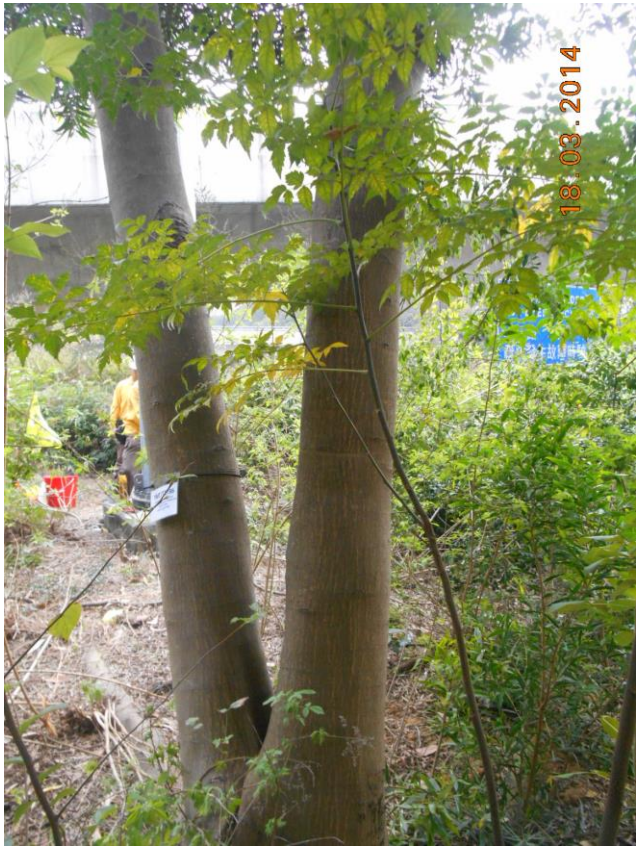
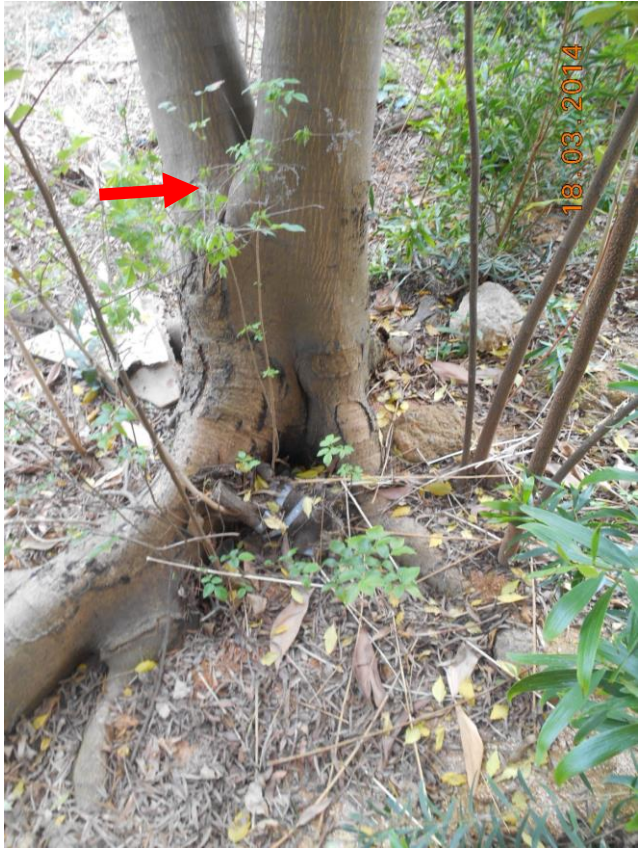
| YMT/T2786- 1 - Retain<br>Scientific Name: <i>Acacia confusa</i> | YMT/T2786- 2<br>Dead branches | YMT/T2786- 3 | YMT/T2786- 4<br>Co-dominant trunks |

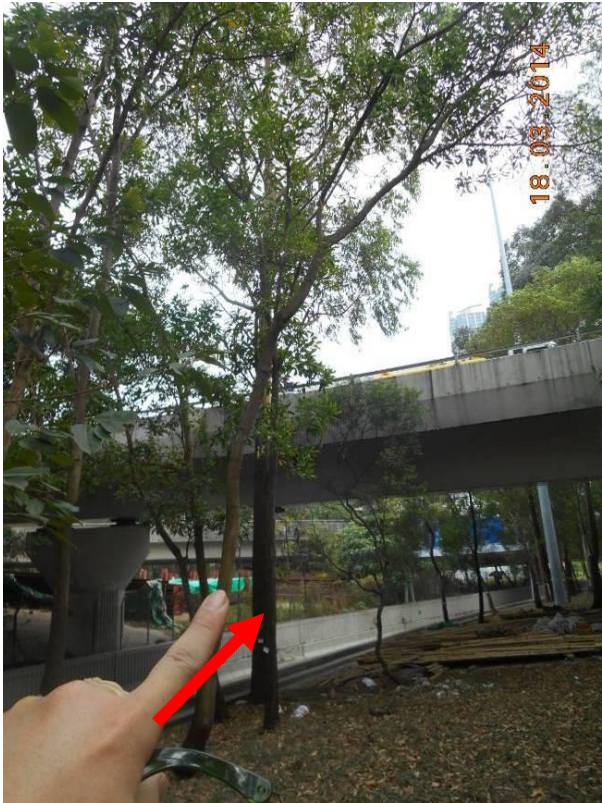
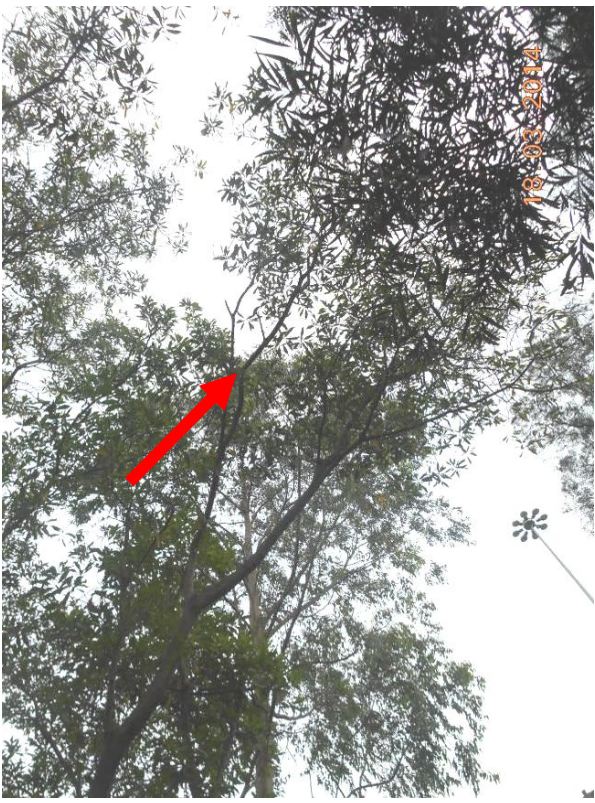
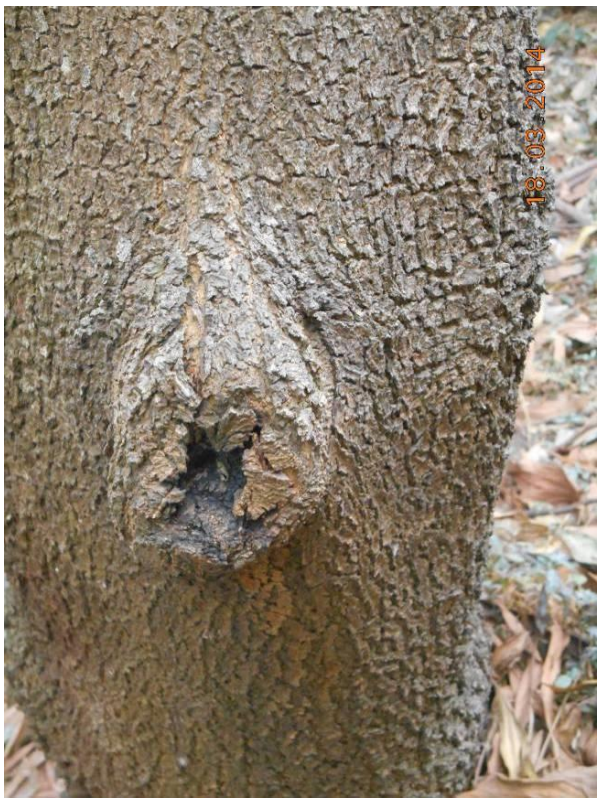
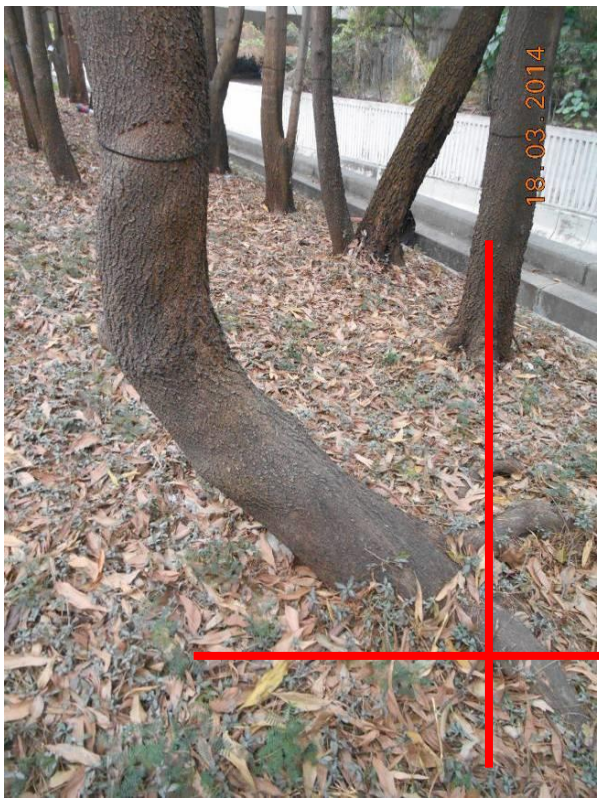
| YMT/ T2809- 1 - Retain<br>Scientific Name: <i>Acacia mangium</i> | YMT/ T2809- 2<br>Dead branches | YMT/ T2809- 3 | YMT/ T2809- 4<br>Leaning |

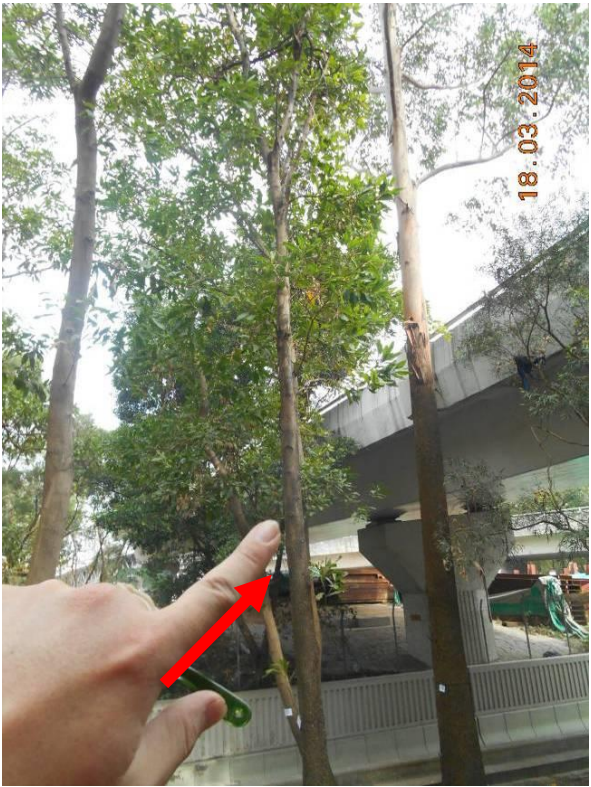
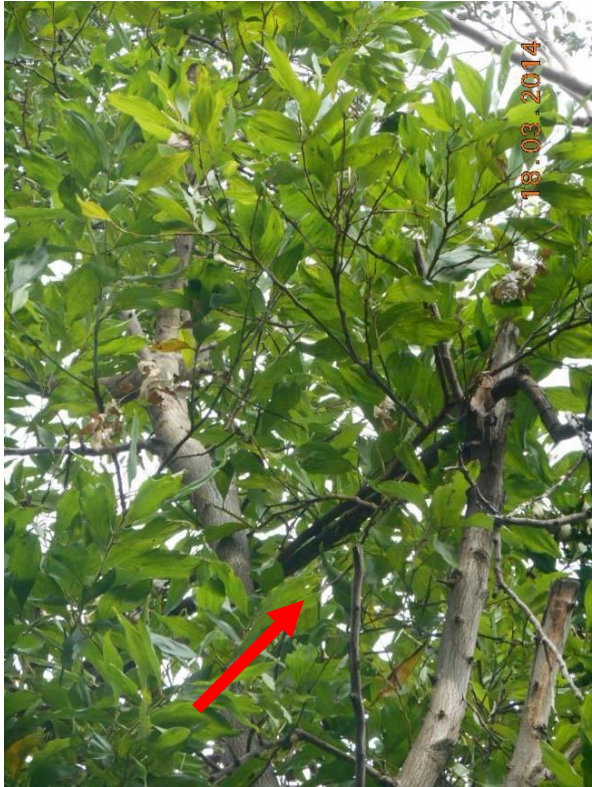
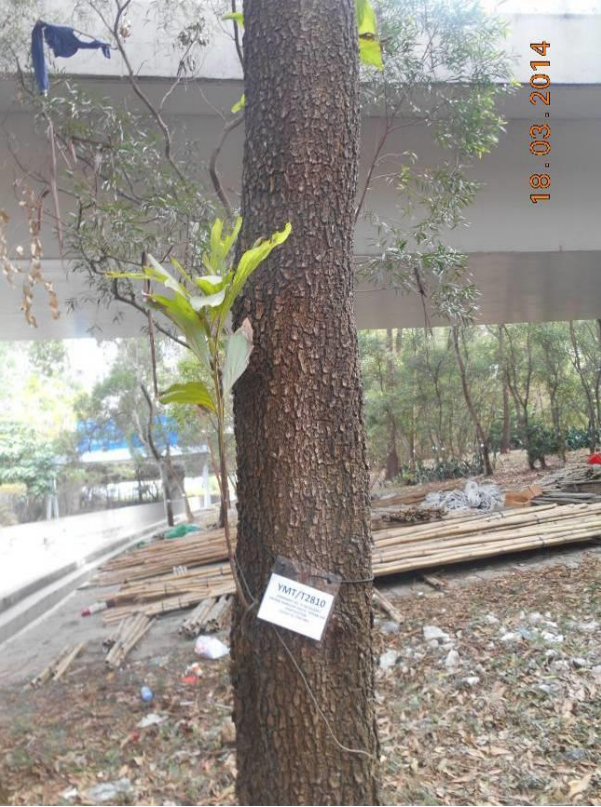
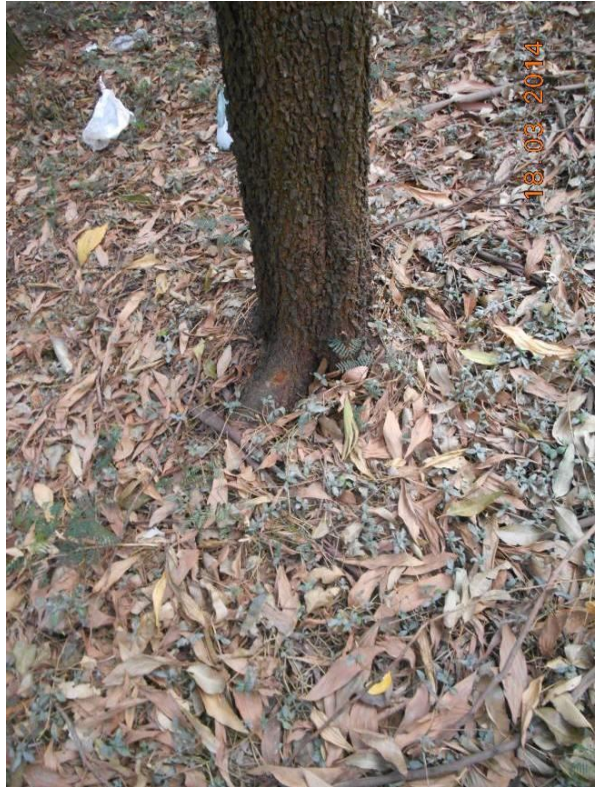
| YMT/ T2810- 1 - Retain<br>Scientific Name: <i>Acacia mangium</i> | YMT/ T2810- 2<br>Dead branches | YMT/ T2810- 3 | YMT/ T2810- 4 |

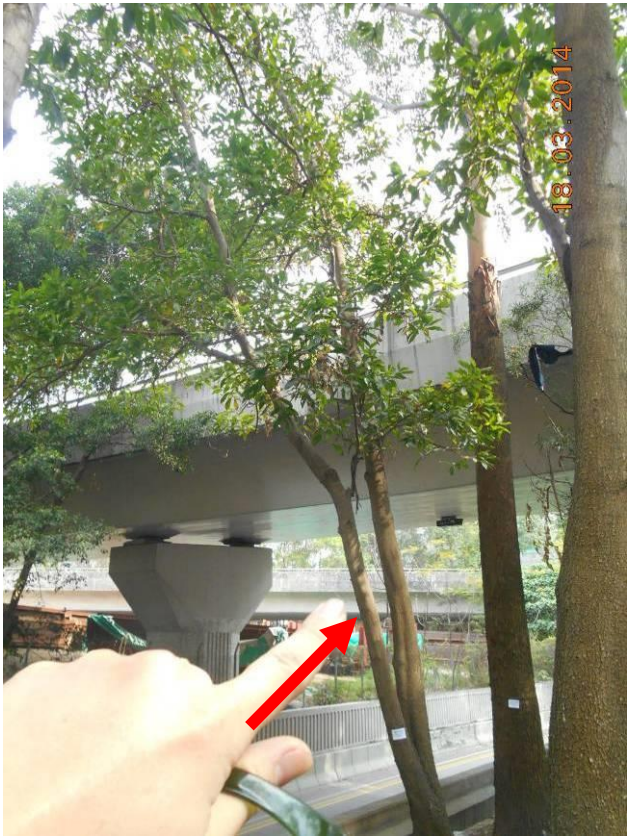
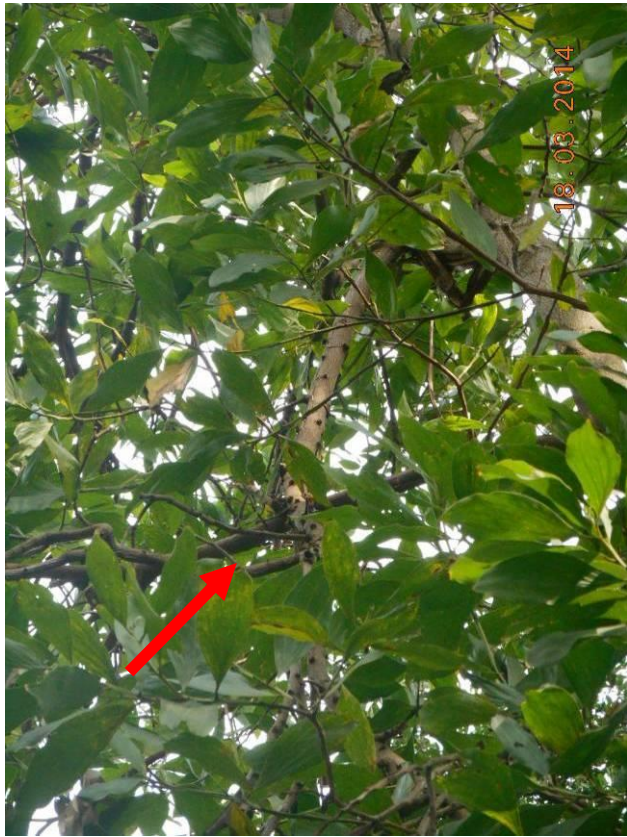
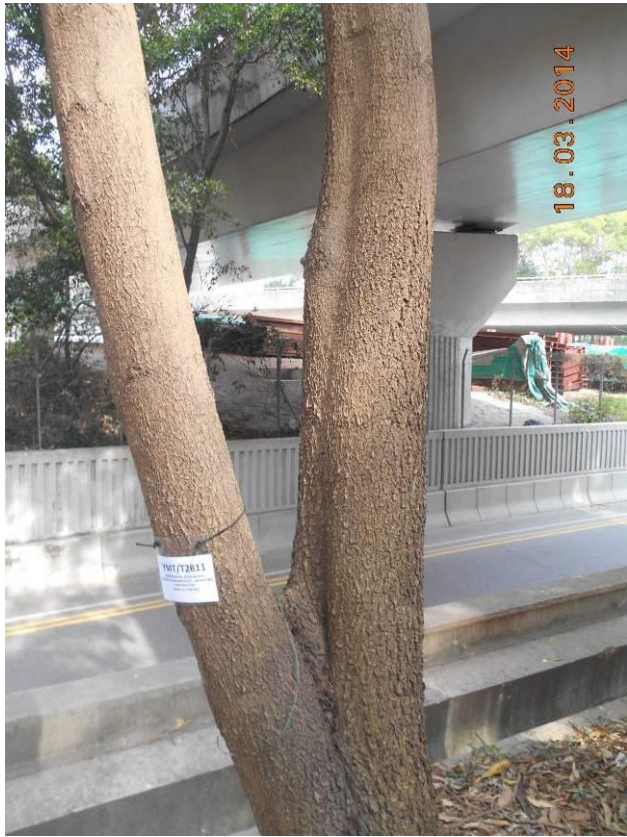
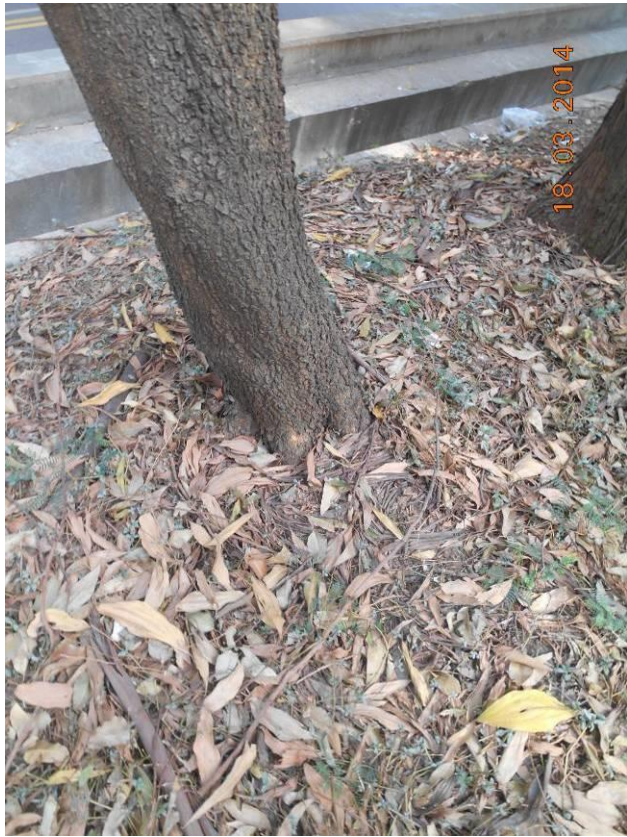
| YMT/ T2811- 1- Retain<br>Scientific Name: <i>Acacia mangium</i> | YMT/ T2811- 2<br>Dead branches | YMT/ T2811- 3 | YMT/ T2811- 4 |
