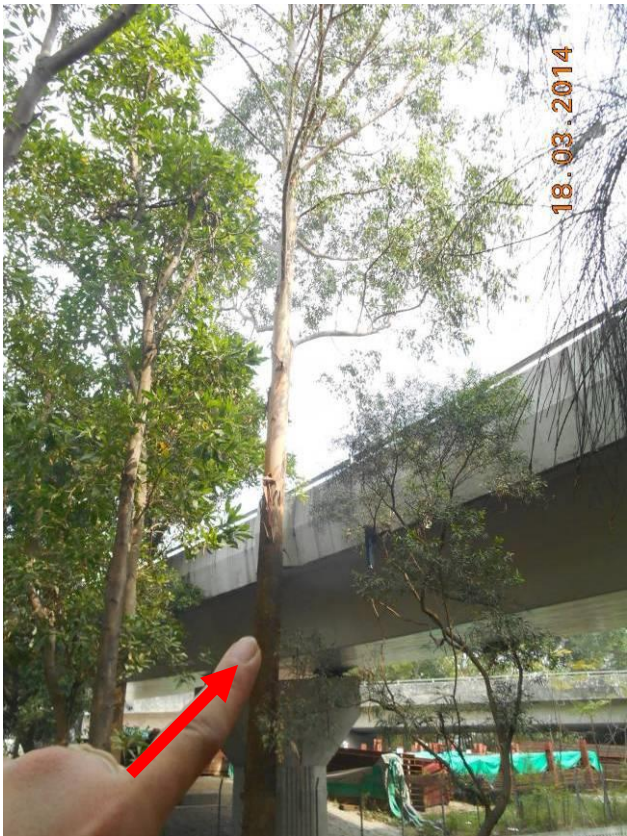
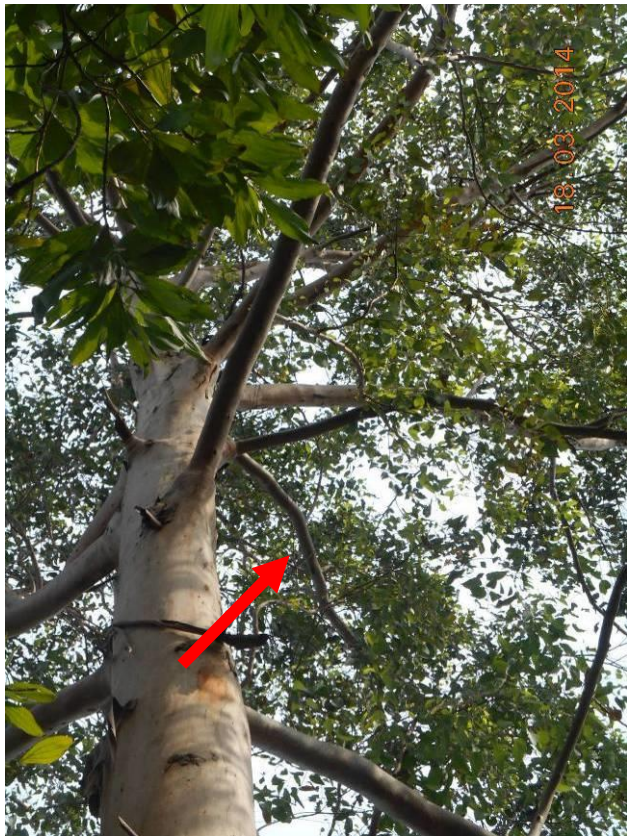
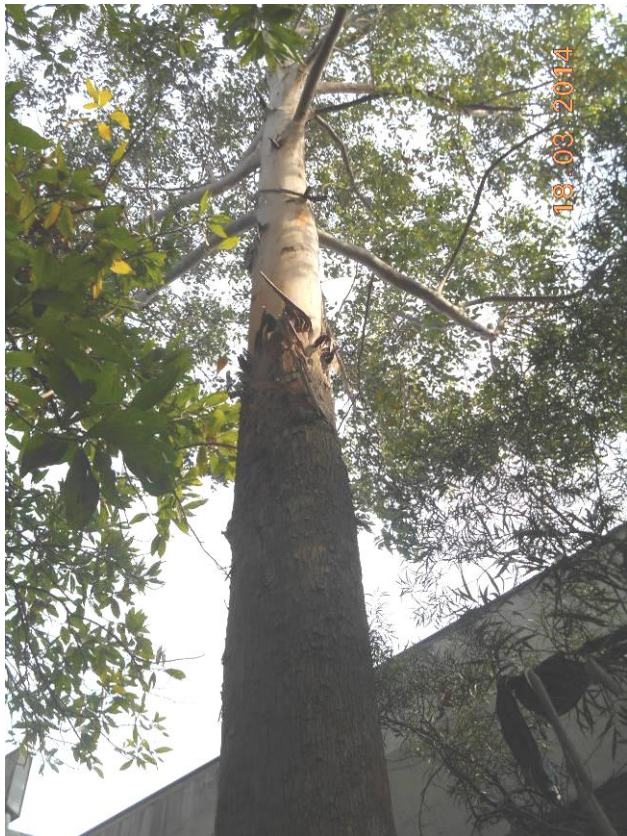
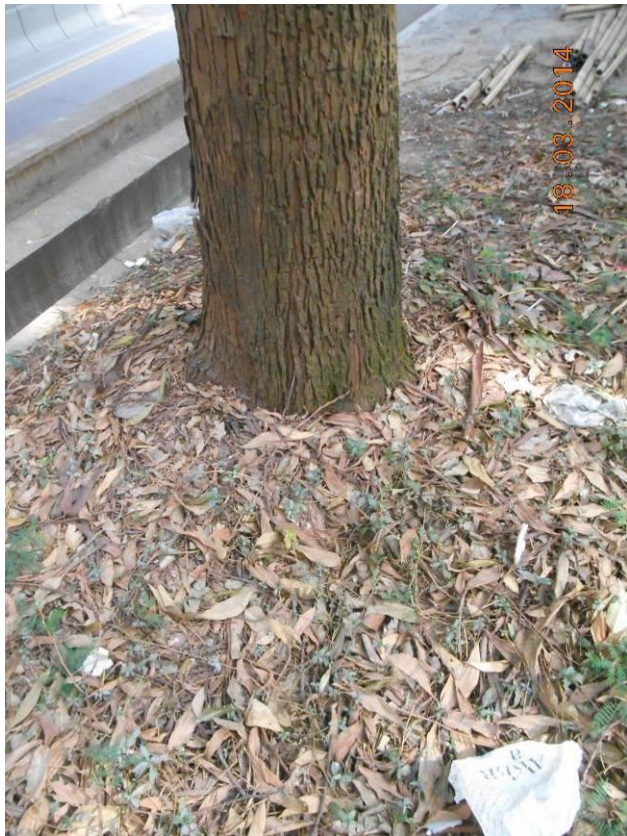
| YMT/ T2812- 1- Retain<br>Scientific Name: <i>Eucalyptus camaldulensis</i> | YMT/ T2812- 2<br>Dead branches | YMT/ T2812- 3 | YMT/ T2812- 4 |

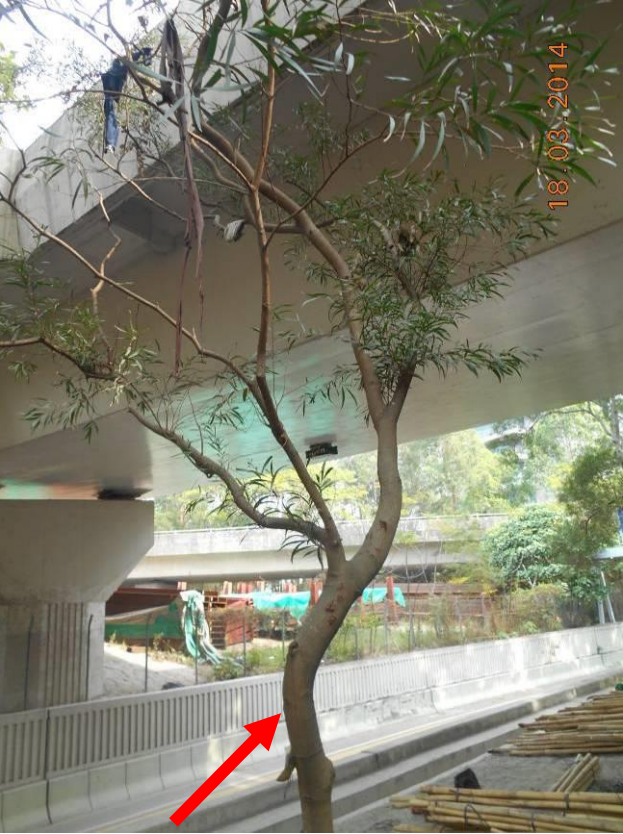
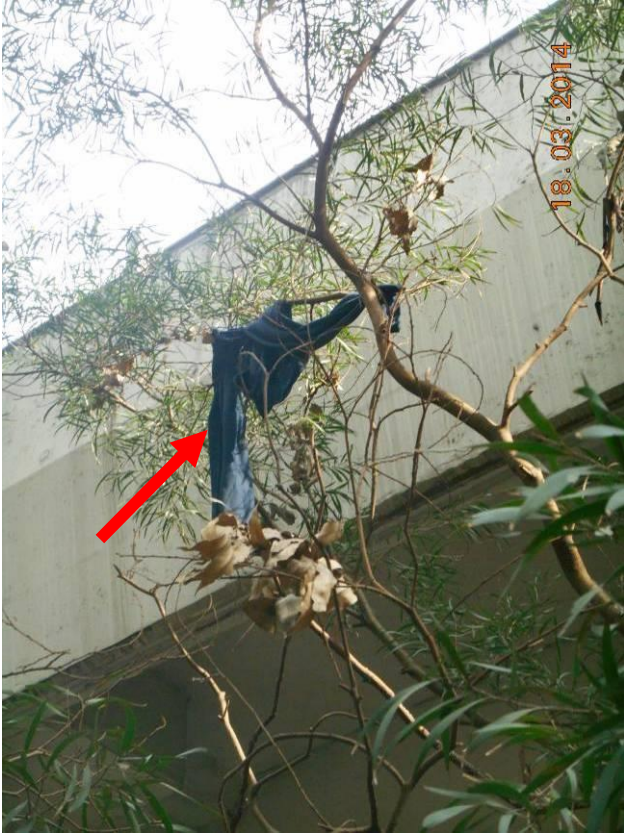
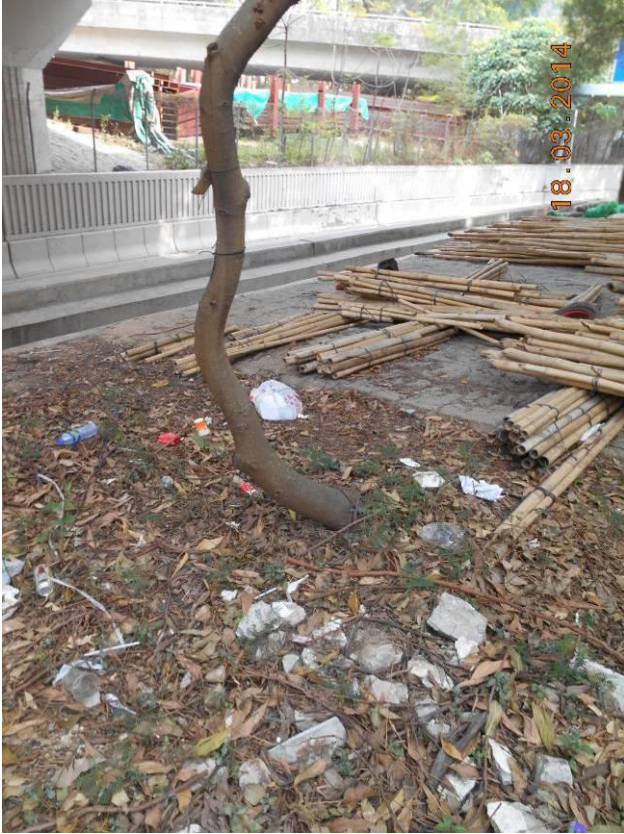
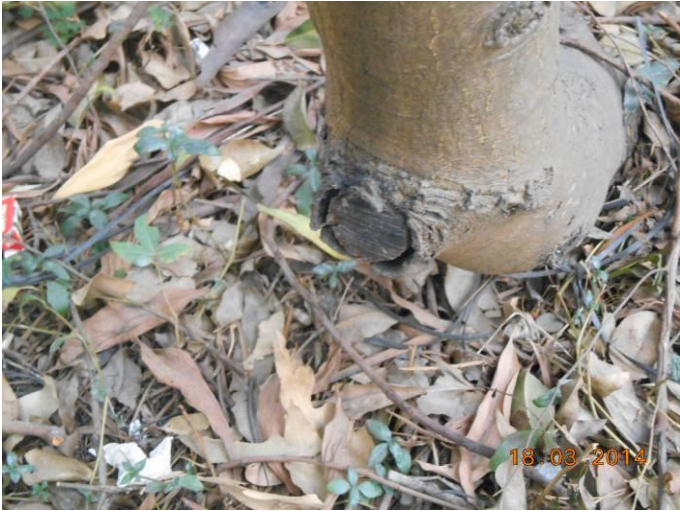
| YMT/ T2813- 1- Retain<br>Scientific Name: <i>Acacia confusa</i> | YMT/ T2813- 2<br>Dead branches | YMT/ T2813- 3 | YMT/ T2813- 4 |

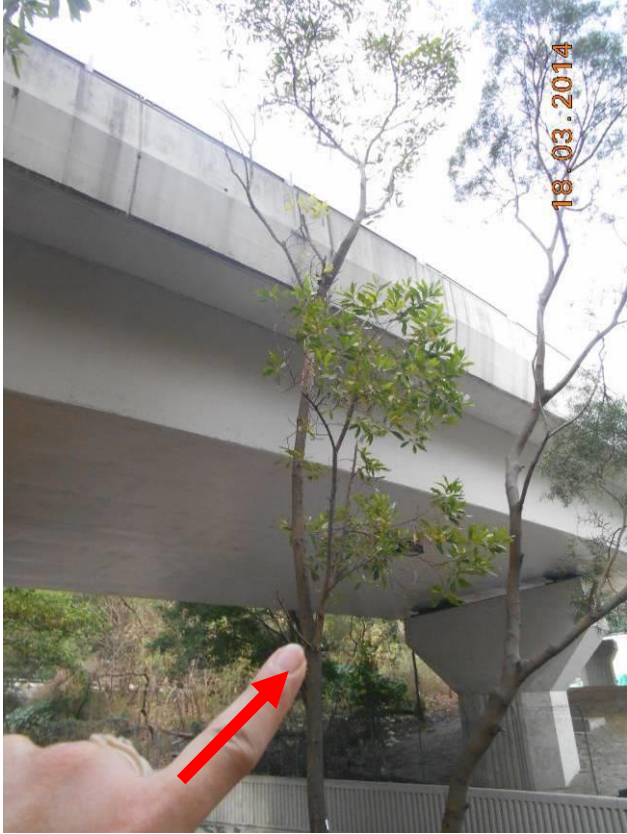
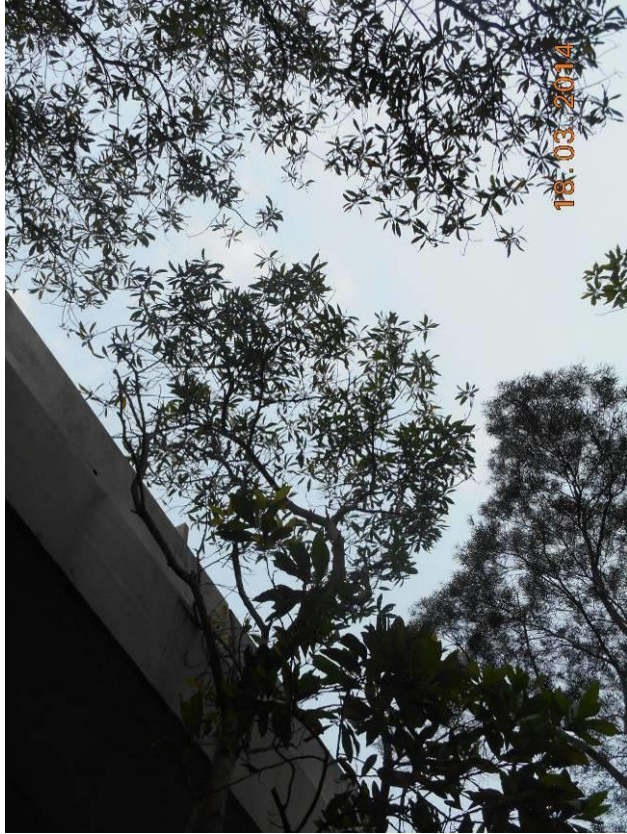
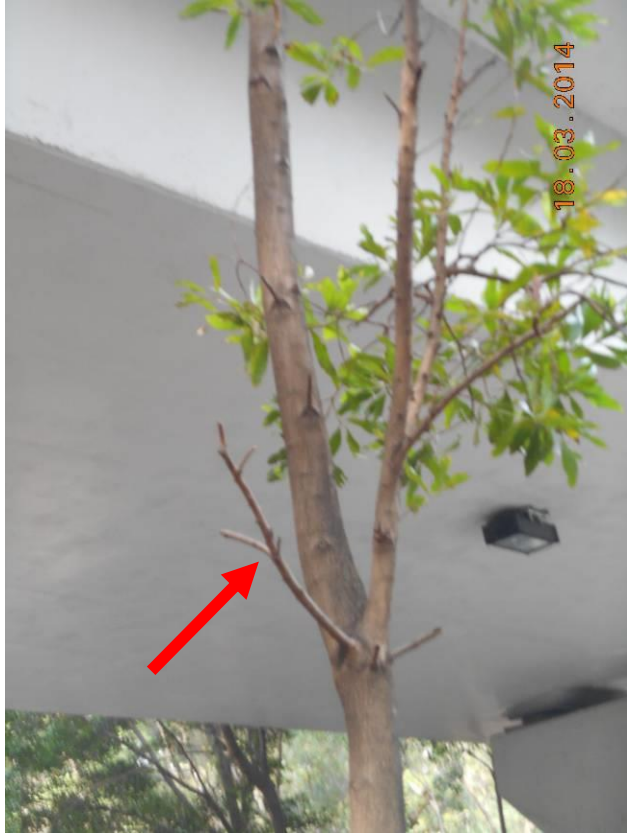
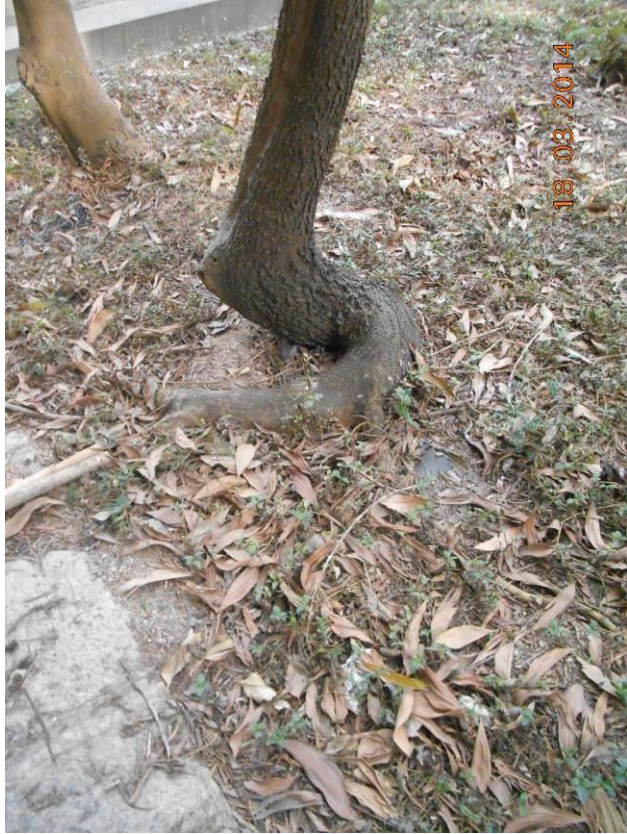
| YMT/ T2815- 1- Retain<br>Scientific Name: <i>Acacia mangium</i> | YMT/ T2815- 2 | YMT/ T2815- 3<br>Dead branches | YMT/ T2815- 4 |

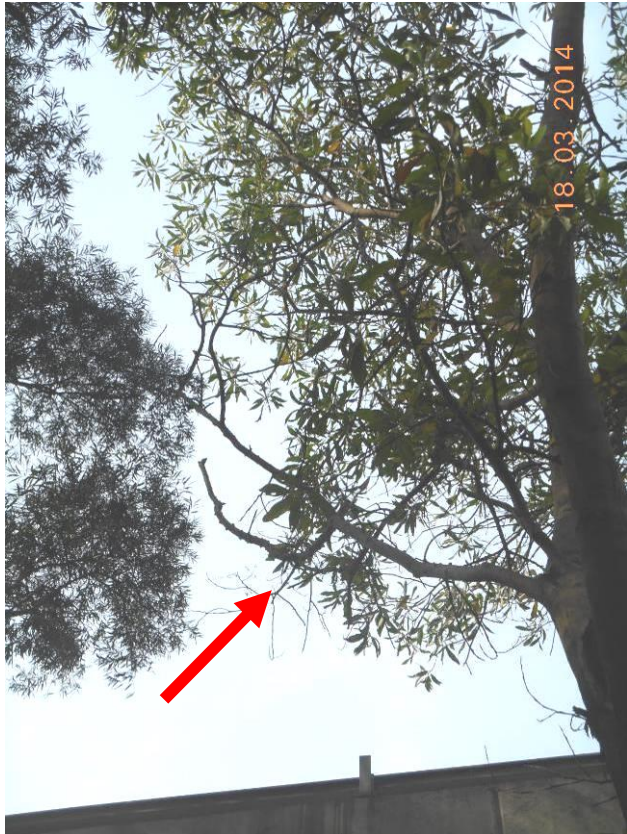
| YMT/ T2816- 1- Retain<br>Scientific Name: <i>Acacia mangium</i> | YMT/ T2816- 2<br>Dead branches | YMT/ T2816- 3 | YMT/ T2816- 4 |

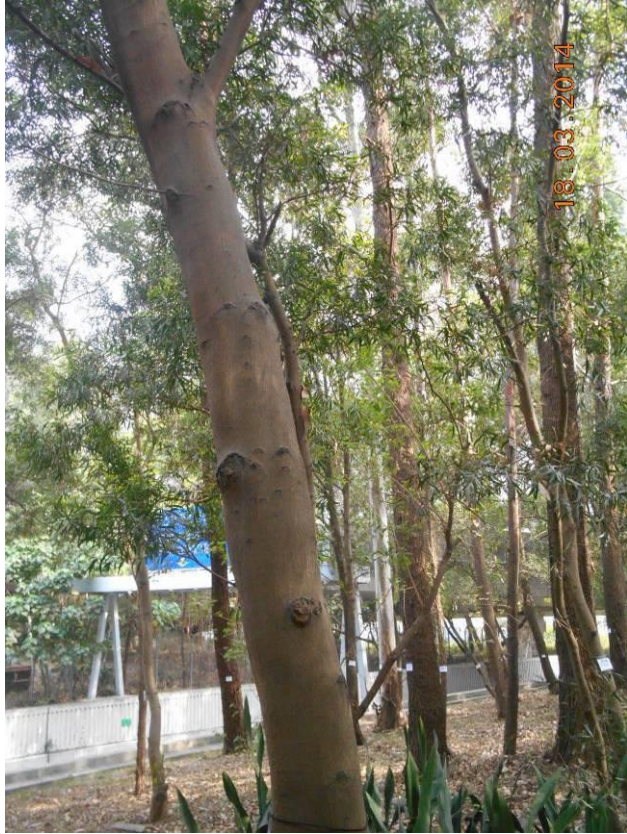
| YMT/ T2817- 1- Retain<br>Scientific Name: <i>Acacia confusa</i> | YMT/ T2817- 2<br>Dead branches | YMT/ T2817- 3<br>Cross branches | YMT/ T2817- 4 |

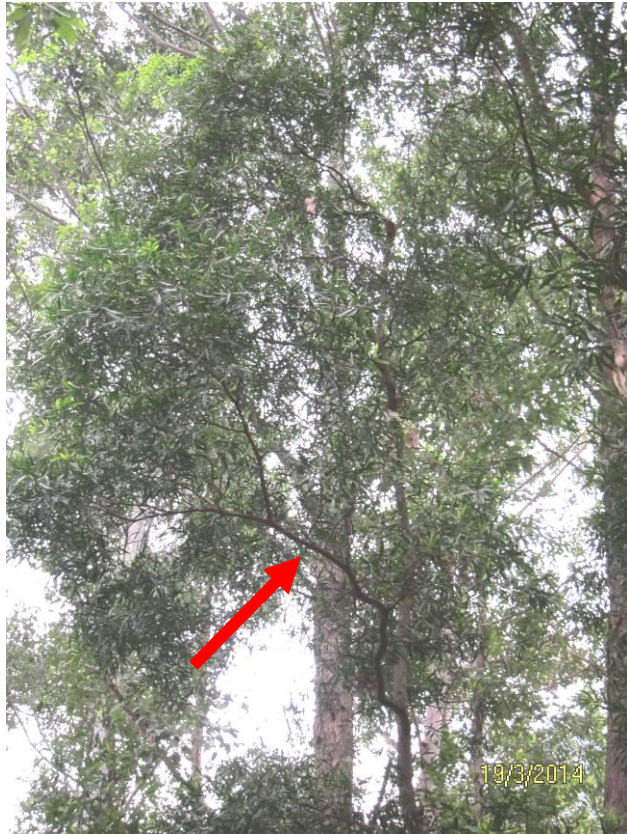
| YMT/ T2829- 1- Retain<br>Scientific Name: <i>Acacia confusa</i> | YMT/ T2829- 2<br>Dead branches | YMT/ T2829- 3 | YMT/ T2829- 4 |

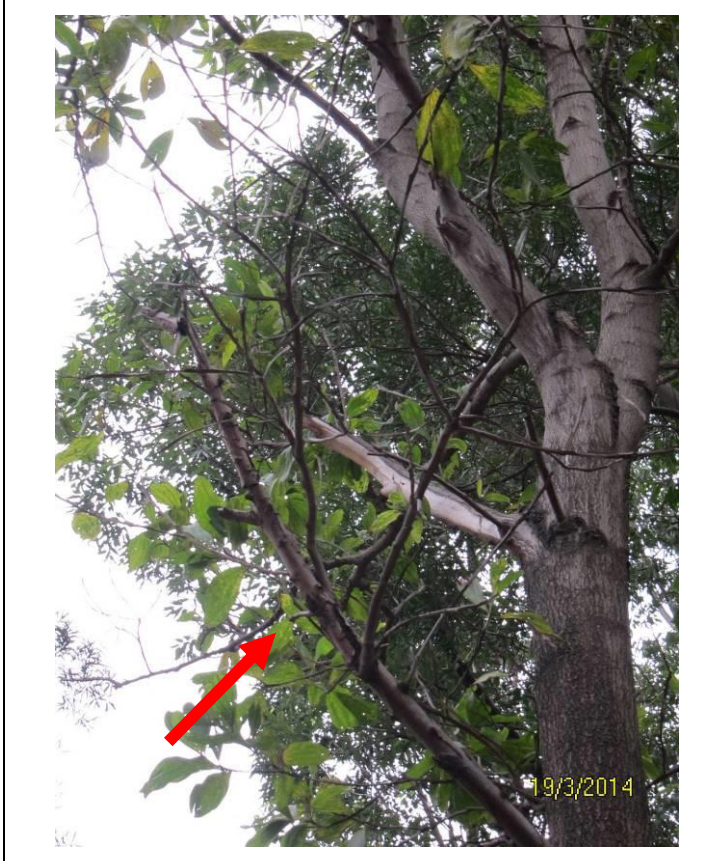
| YMT/ T2830- 1- Retain<br>Scientific Name: <i>Acacia mangium</i> | YMT/ T2830- 2 | YMT/ T2830- 3<br>Dead branches | YMT/ T2830- 4 |

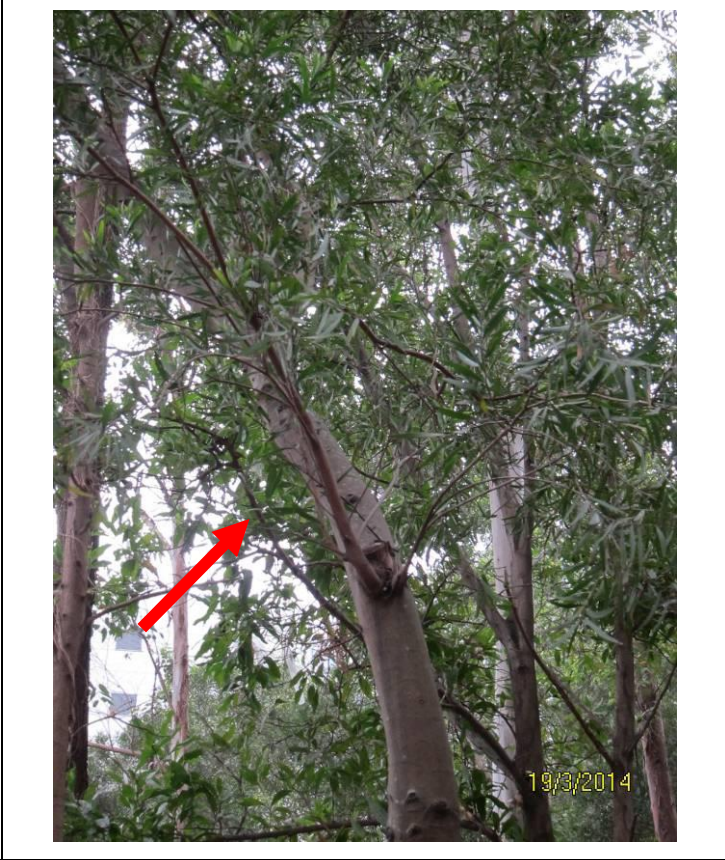
| YMT/ T2831- 1- Retain<br>Scientific Name: <i>Acacia confusa</i> | YMT/ T2831- 2<br>Dead branches | YMT/ T2831- 3 | YMT/ T2831- 4 |

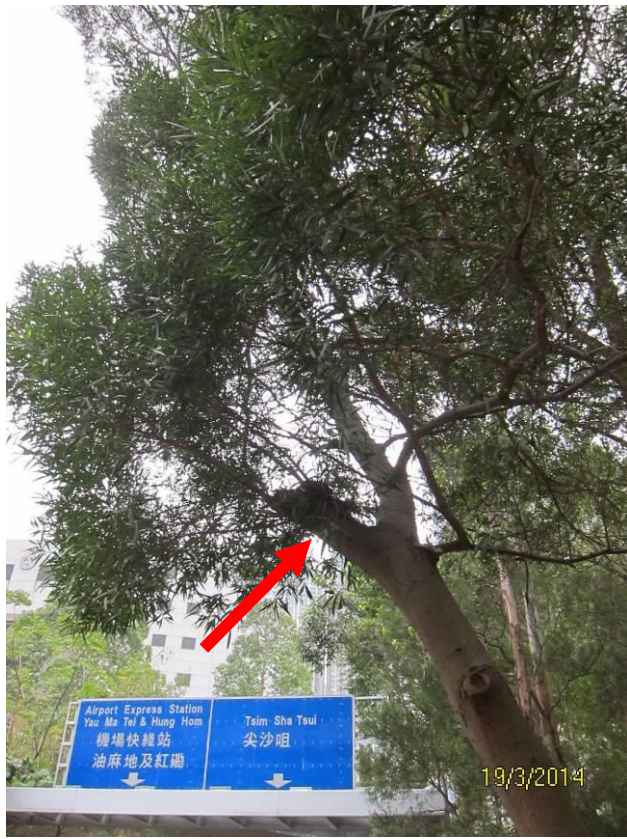
| YMT/ T2832- 1- Retain<br>Scientific Name: <i>Acacia confusa</i> | YMT/ T2832- 2<br>Dead branches | YMT/ T2832- 3 | YMT/ T2832- 4 |

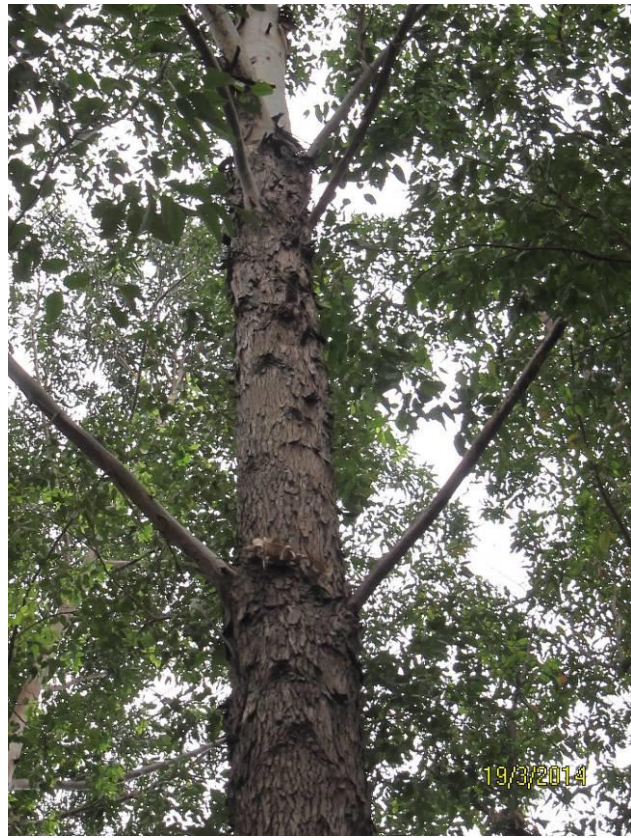
| YMT/ T2834- 1- Retain<br>Scientific Name: <i>Eucalyptus camaldulensis</i> | YMT/ T2834- 2 | YMT/ T2834- 3<br>Dead branches | YMT/ T2834- 4 |

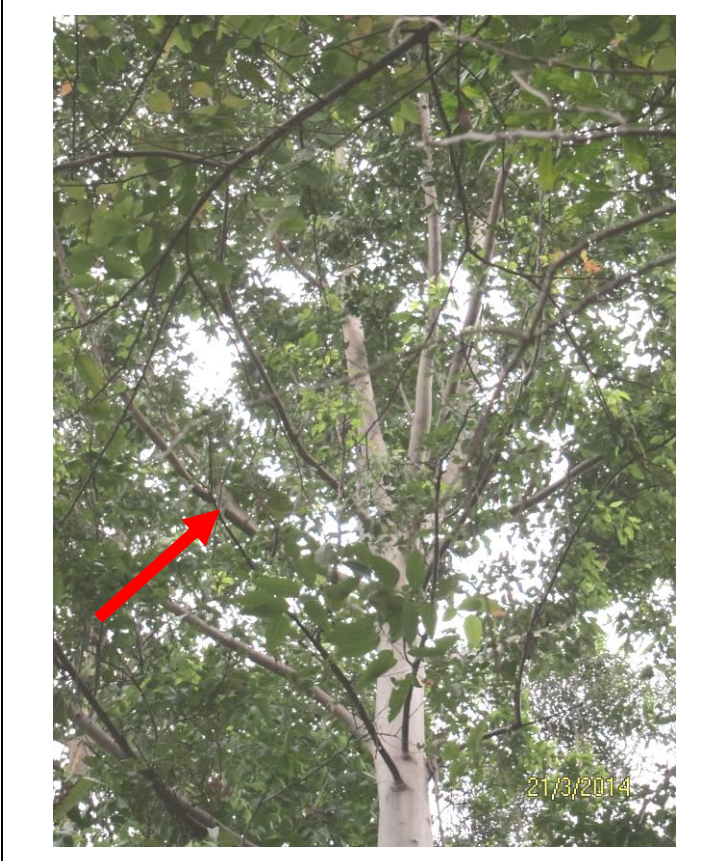
| YMT/ T2867- 1- Retain<br>Scientific Name: <i>Eucalyptus camaldulensis</i> | YMT/ T2867- 2<br>Dead branches | YMT/ T2867- 3 | YMT/ T2867- 4 |

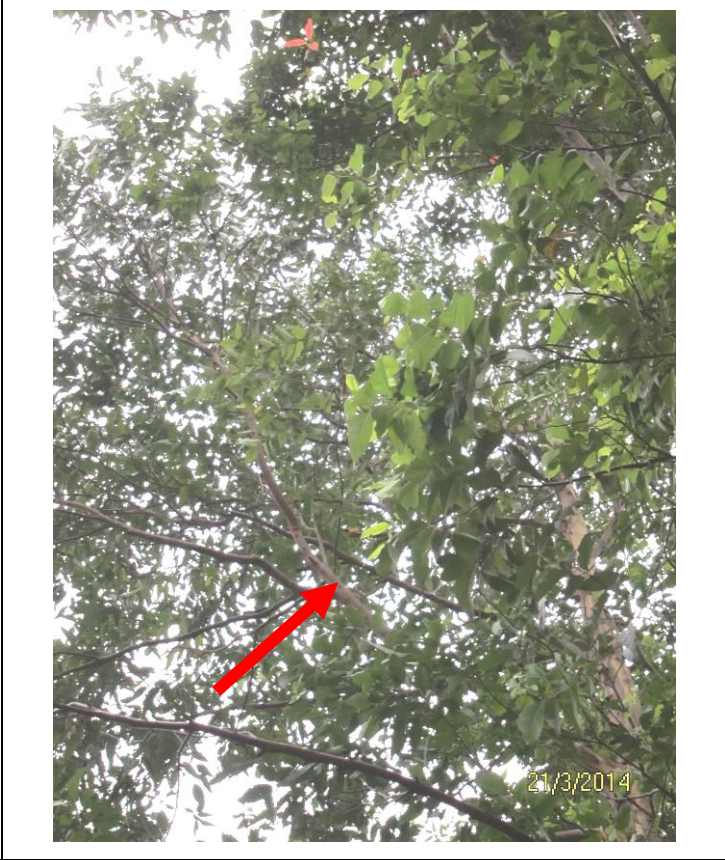
| YMT/ T2868- 1- Retain<br>Scientific Name: <i>Eucalyptus camaldulensis</i> | YMT/ T2868- 2<br>Dead branches | YMT/ T2868- 3 | YMT/ T2868- 4<br>Co-dominant trunks |

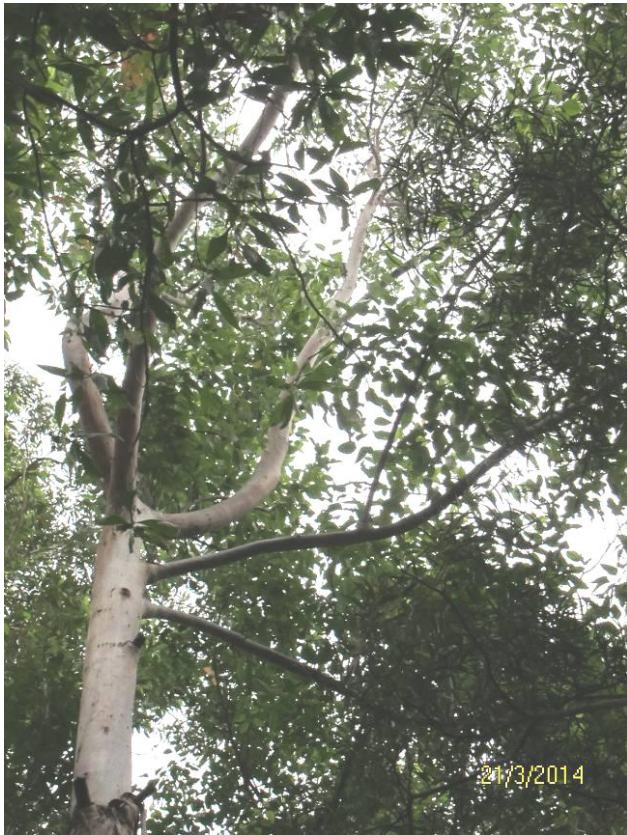
| YMT/ T2870- 1- Retain<br>Scientific Name: <i>Eucalyptus camaldulensis</i> | YMT/ T2870- 2<br>Dead branches | YMT/ T2870- 3 | YMT/ T2870- 4 |

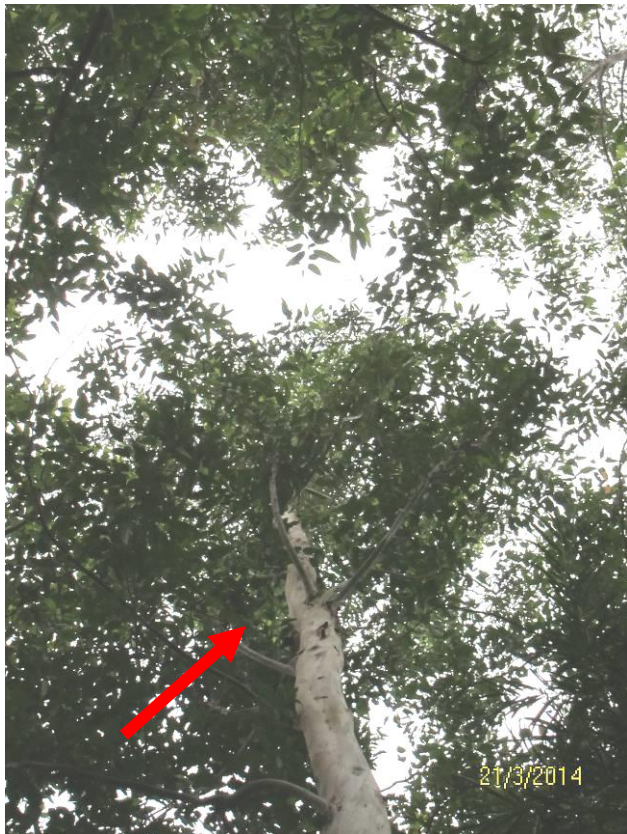
| YMT/ T2871- 1- Retain<br>Scientific Name: <i>Eucalyptus camaldulensis</i> | YMT/ T2871- 2<br>Dead branches | YMT/ T2871- 3 | YMT/ T2871- 4 |

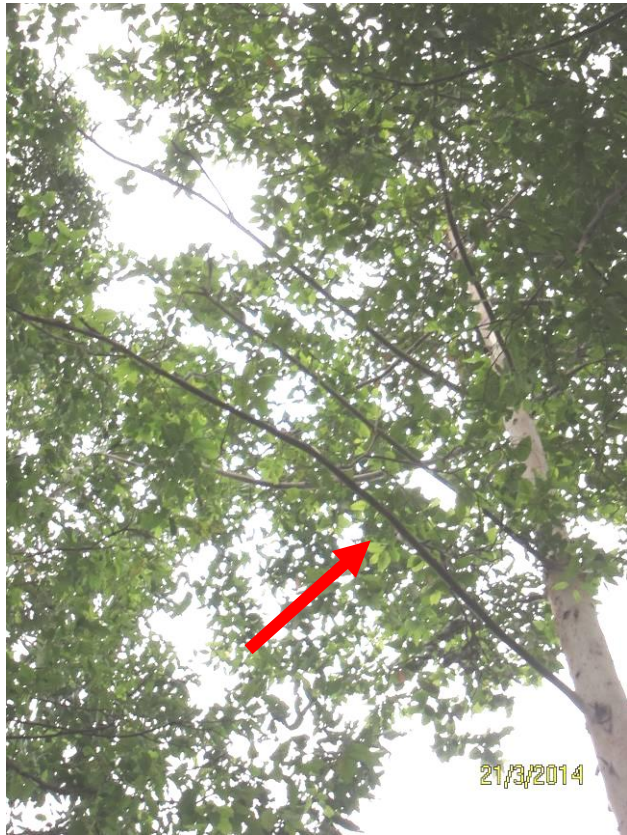
| YMT/ T2872- 1- Retain<br>Scientific Name: <i>Eucalyptus camaldulensis</i> | YMT/ T2872- 2<br>Dead branches | YMT/ T2872- 3 | YMT/ T2872- 4 |

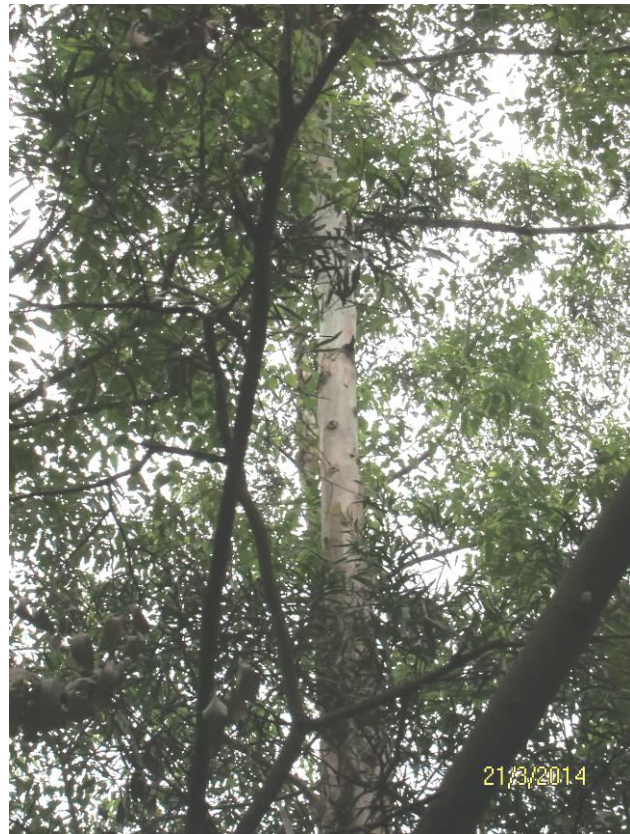
| YMT/ T2874- 1- Retain<br>Scientific Name: <i>Acacia confusa</i> | YMT/ T2874- 2<br>Dead branches | YMT/ T2874- 3 | YMT/ T2874- 4<br>Co-dominant trunks |

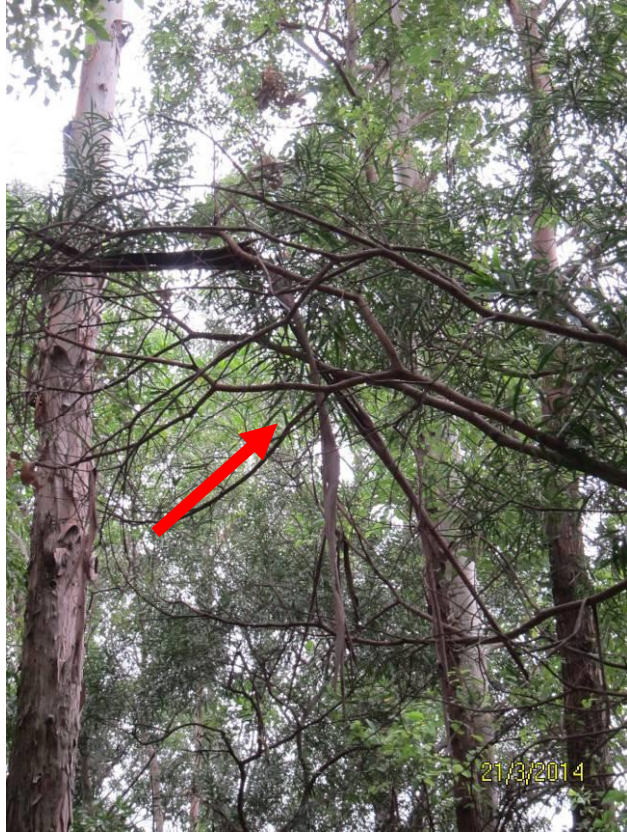
| <p>YMT/ T2880- 1- Retain<br/>Scientific Name: <i>Eucalyptus camaldulensis</i></p> | <p>YMT/ T2880- 2<br/>Dead branches</p> | <p>YMT/ T2880- 3</p> | <p>YMT/ T2880- 4</p> |

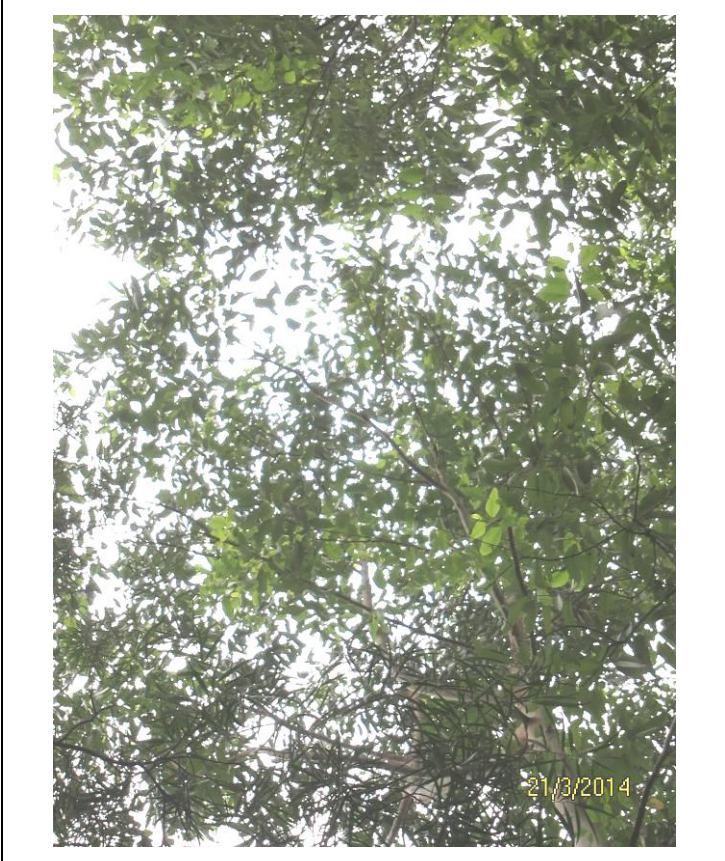
| <p>YMT/ T2881- 1- Retain<br/>Scientific Name: <i>Acacia confusa</i></p> | <p>YMT/ T2881- 2<br/>Dead branches</p> | <p>YMT/ T2881- 3<br/>Co-dominant trunks</p> | <p>YMT/ T2881- 4<br/>Leaning</p> |

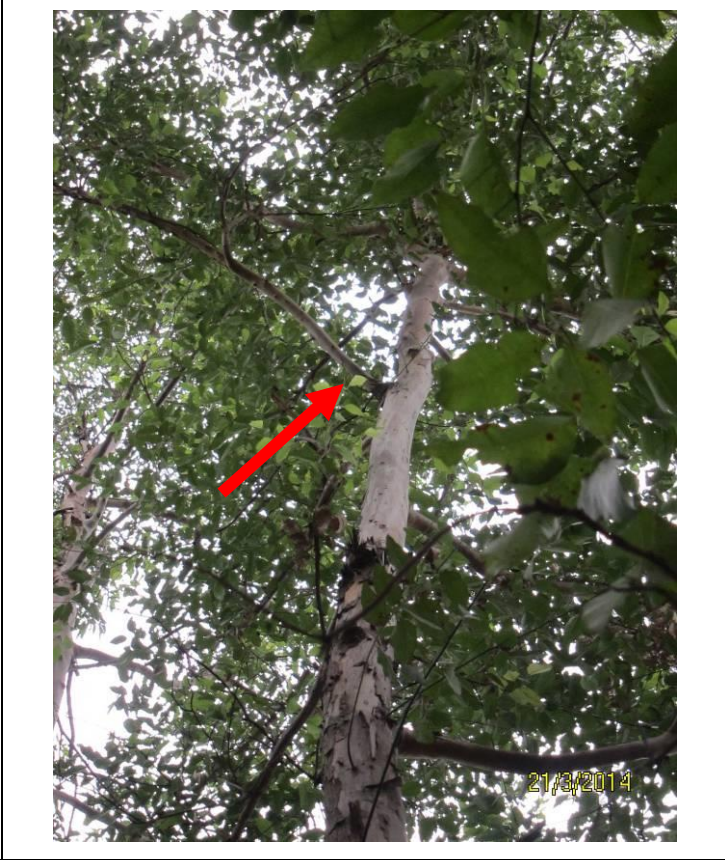
| YMT/ T2882- 1- Retain<br>Scientific Name: <i>Eucalyptus camaldulensis</i> | YMT/ T2882- 2<br>Dead branches | YMT/ T2882- 3 | YMT/ T2882- 4 |

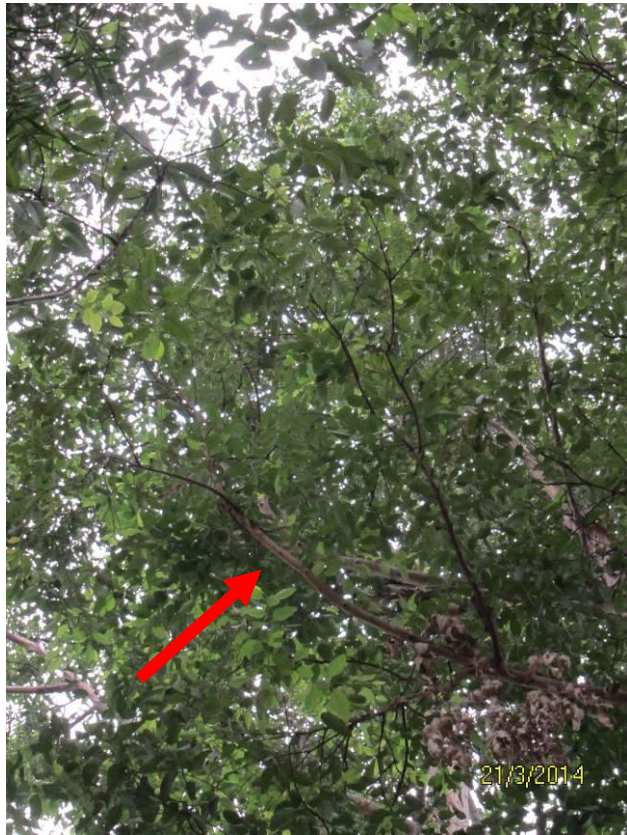
| YMT/ T2883- 1- Retain<br>Scientific Name: <i>Eucalyptus camaldulensis</i> | YMT/ T2883- 2<br>Dead branches | YMT/ T2883- 3 | YMT/ T2883- 4 |

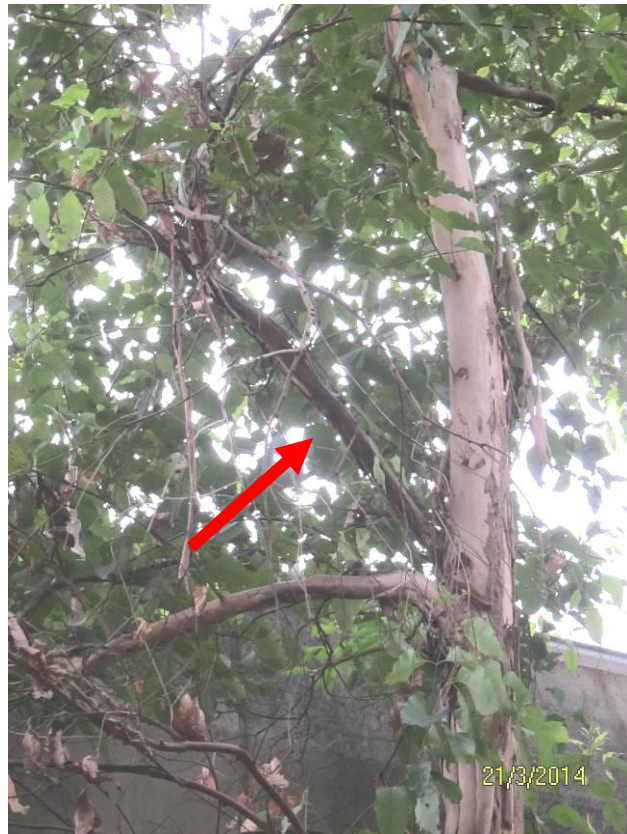
| YMT/ T2885- 1- Retain<br>Scientific Name: <i>Eucalyptus camaldulensis</i> | YMT/ T2885- 2 | YMT/ T2885- 3<br>Dead branches | YMT/ T2885- 4 |

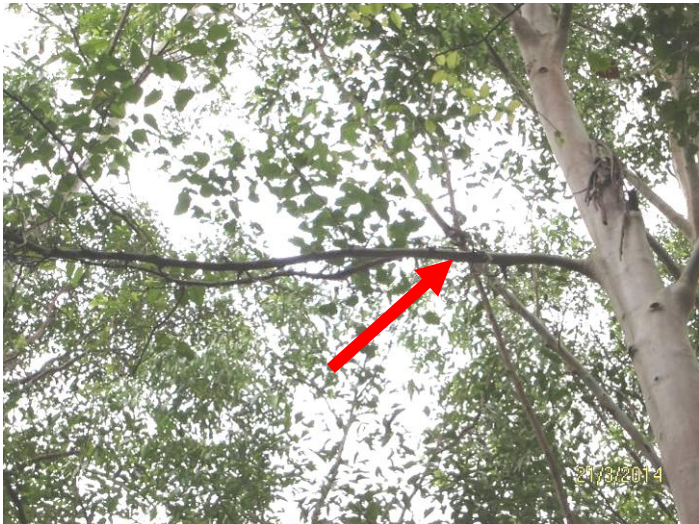
| YMT/ T2888- 1- Retain<br>Scientific Name: <i>Eucalyptus camaldulensis</i> | YMT/ T2888- 2<br>Dead branches | YMT/ T2888- 3 | YMT/ T2888- 4<br>Leaning |

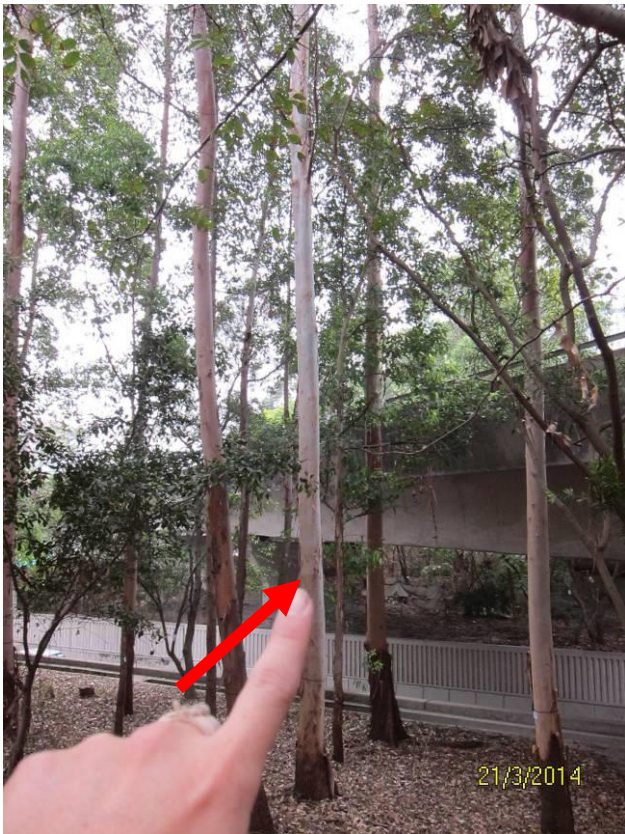
| YMT/ T2889- 1- Retain<br>Scientific Name: <i>Eucalyptus camaldulensis</i> | YMT/ T2889- 2<br>Dead branches | YMT/ T2889- 3 | YMT/ T2889- 4 |

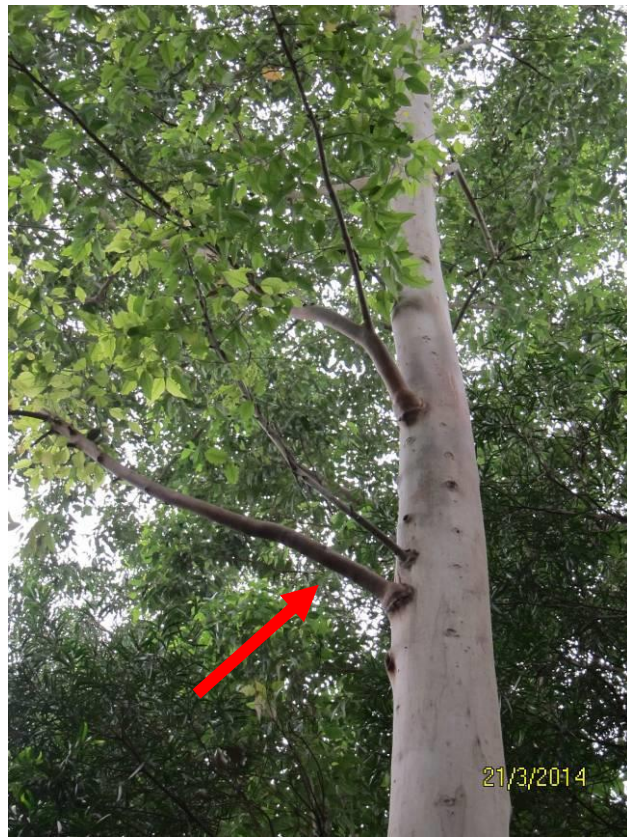
| YMT/ T2890- 1- Retain<br>Scientific Name: <i>Eucalyptus camaldulensis</i> | YMT/ T2890- 2 | YMT/ T2890- 3<br>Dead branches | YMT/ T2890- 4 |

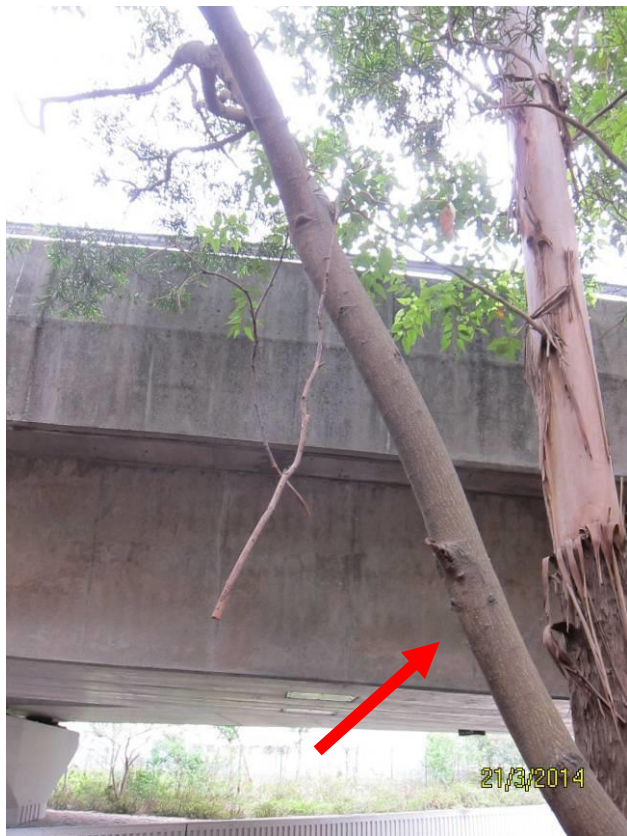
| YMT/ T2891- 1- Retain<br>Scientific Name: <i>Acacia confusa</i> | YMT/ T2891- 2<br>Dead branches | YMT/ T2891- 3<br>Co-dominant trunks | YMT/ T2891- 4 |

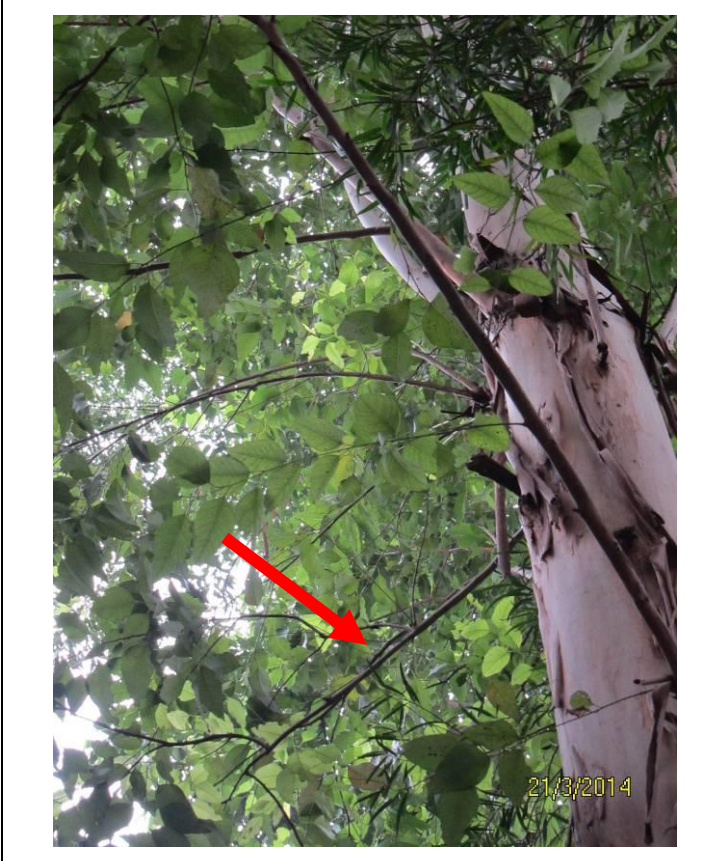
| YMT/ T2892- 1- Retain<br>Scientific Name: <i>Eucalyptus camaaldulensis</i> | YMT/ T2892- 2<br>Dead branches | YMT/ T2892- 3 | YMT/ T2892- 4 |

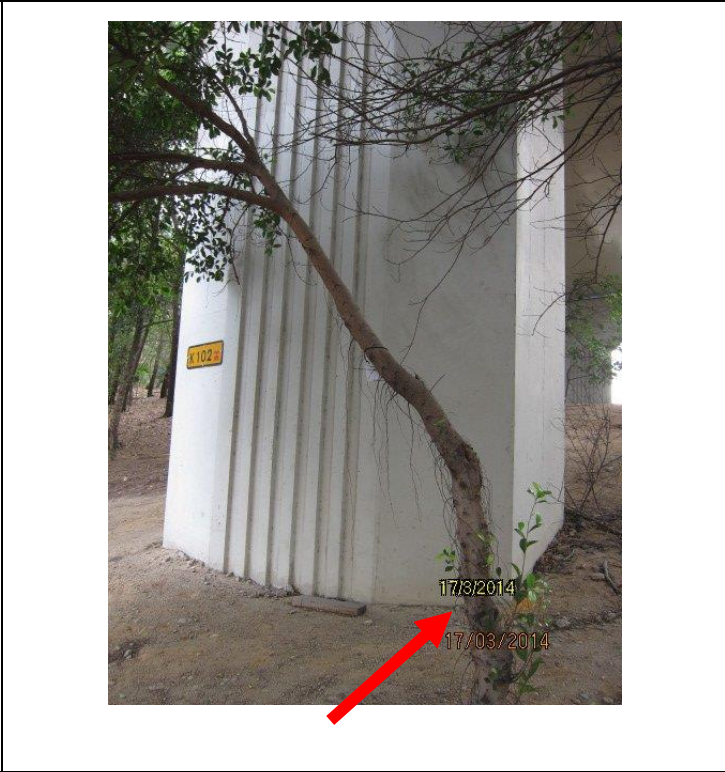
| YMT/ T2894- 1- Retain<br>Scientific Name: <i>Ficus microcarpa</i> | YMT/ T2894- 2<br>Leaning | YMT/ T2894- 3 | YMT/ T2894- 4 |

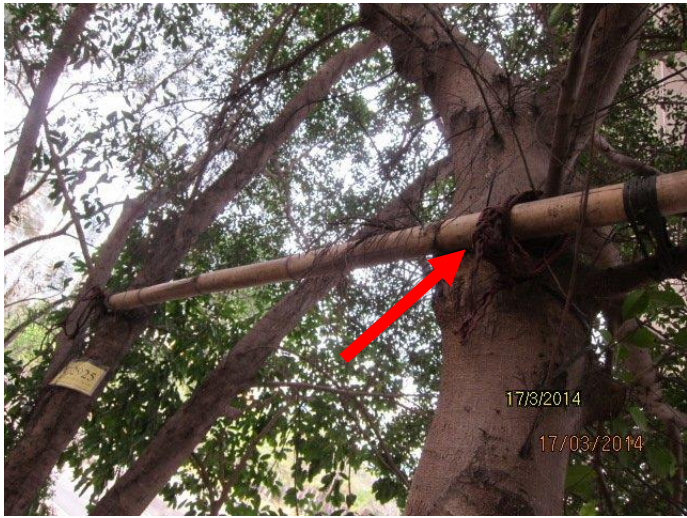
YMT/ T2895- 2  
Cross branches

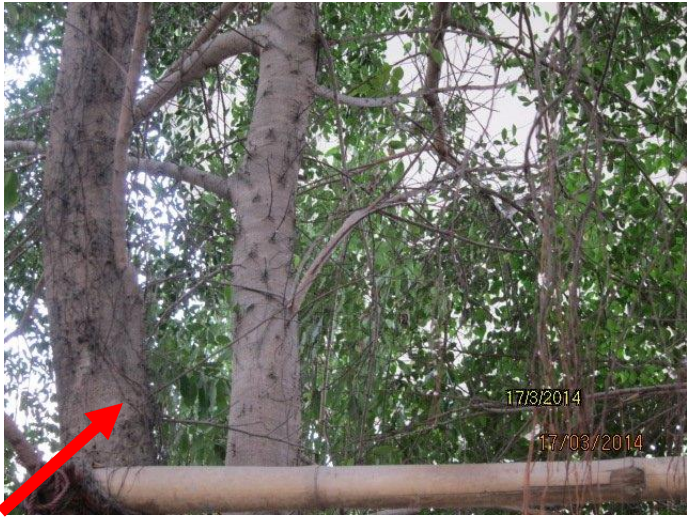
YMT/ T2896- 2  
Dead branches

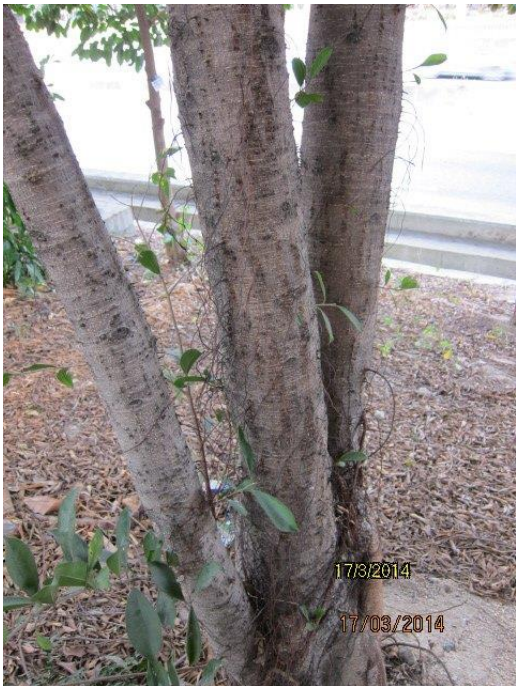
YMT/ T2896- 3  
Co-dominant trunks

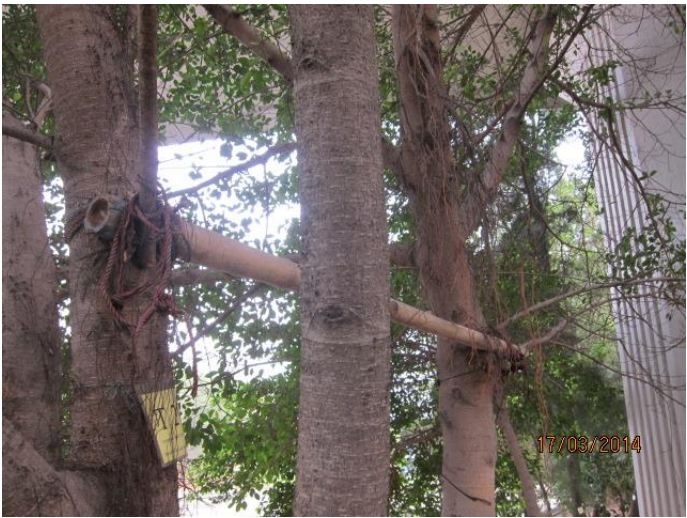
YMT/ T2896- 4  
Cross branches

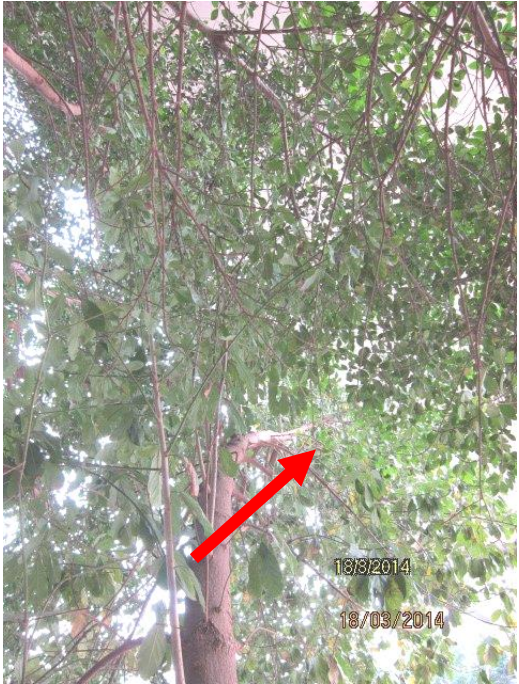
| YMT/T2897- 1- Retain<br>Scientific Name: <i>Schefflera actinophylla</i> | YMT/ T2897- 2<br>Dead branches | YMT/ T2897- 3 | YMT/ T2897- 4<br>Leaning |

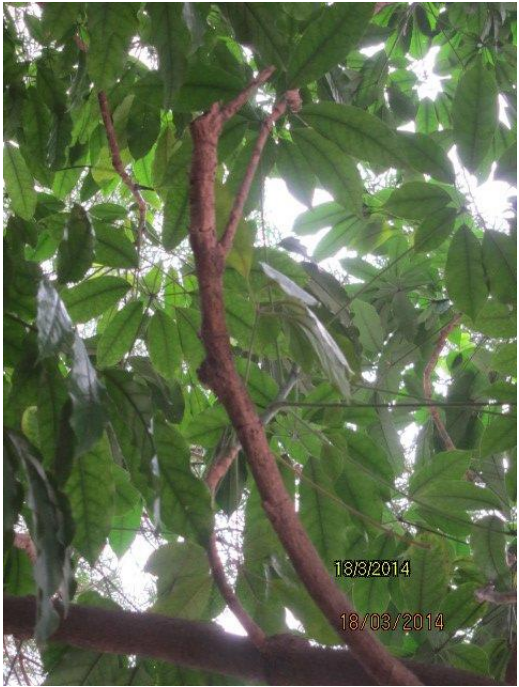
| YMT/ T2898- 1- Retain<br>Scientific Name: <i>Schefflera actinophylla</i> | YMT/ T2898- 2<br>Dead branches | YMT/ T2898- 3 | YMT/ T2898- 4 |

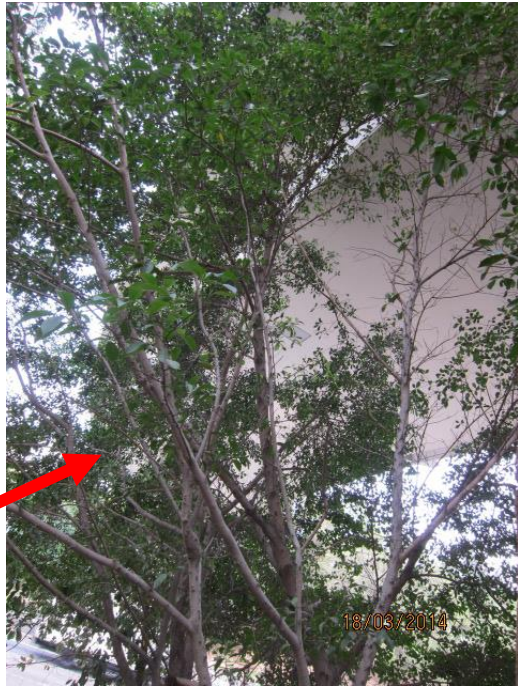
| YMT/T2906- 1- Retain<br>Scientific Name: <i>Ficus microcarpa</i> | YMT/T2906- 2<br>Dead branches | YMT/T2906- 3<br>Co-dominant trunk | YMT/T2906- 4 |
