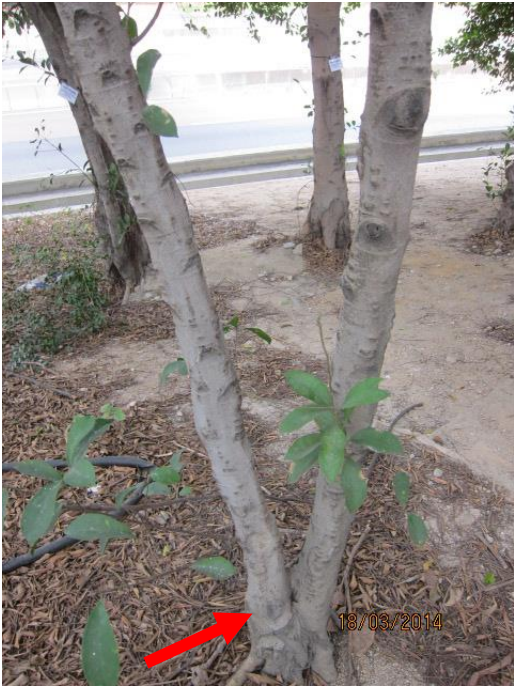
| YMT/T2906- 1- Retain<br>Scientific Name: <i>Ficus microcarpa</i> | YMT/T2906- 2<br>Dead branches | YMT/T2906- 3<br>Co-dominant trunk | YMT/T2906- 4 |

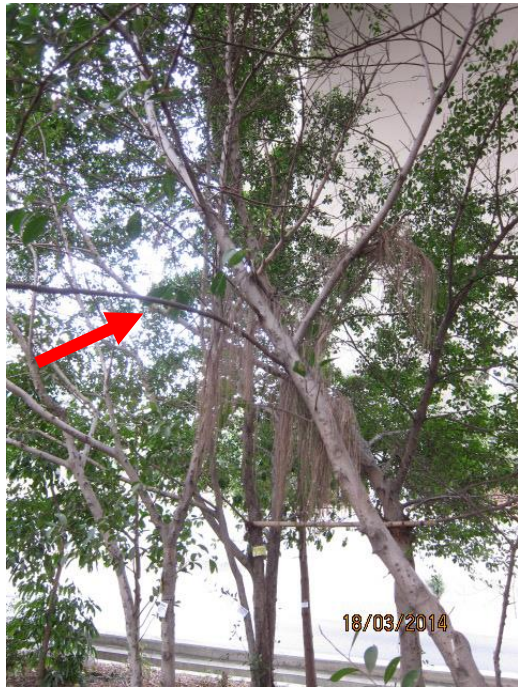
| YMT/T2907- 1- Retain<br>Scientific Name: <i>Ficus microcarpa</i> | YMT/T2907- 2<br>Cross branches | YMT/T2907- 3 | YMT/T2907- 4 |

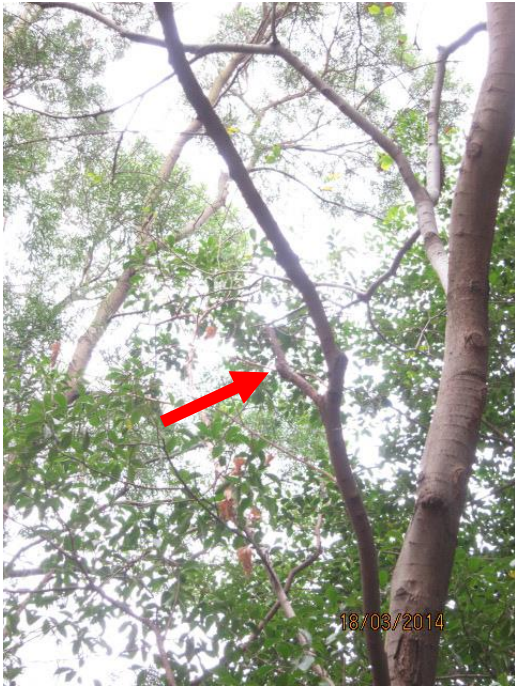
| YMT/T2908- 1- Retain<br>Scientific Name: <i>Celtis sinensis</i> | YMT/T2908- 2<br>Dead branches | YMT/T2908- 3 | YMT/T2908- 4<br>Exposed root |

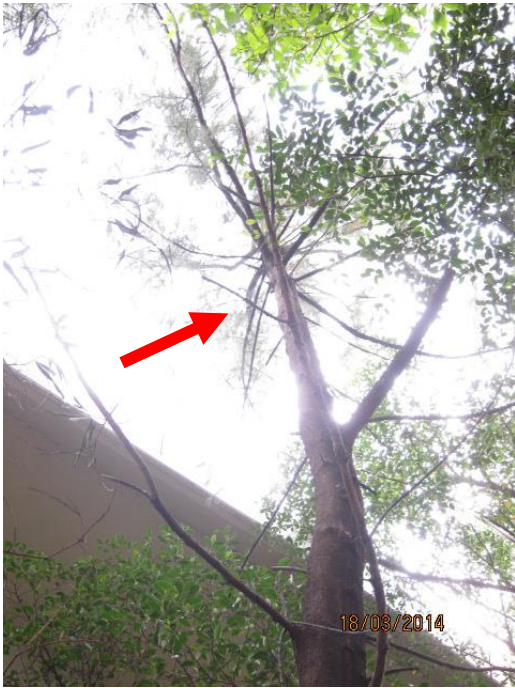
| YMT/T2912- 1- Retain<br>Scientific Name: <i>Casuarina equisetifolia</i> | YMT/T2912- 2<br>Dead branches | YMT/T2912- 3 | YMT/T2912- 4 |

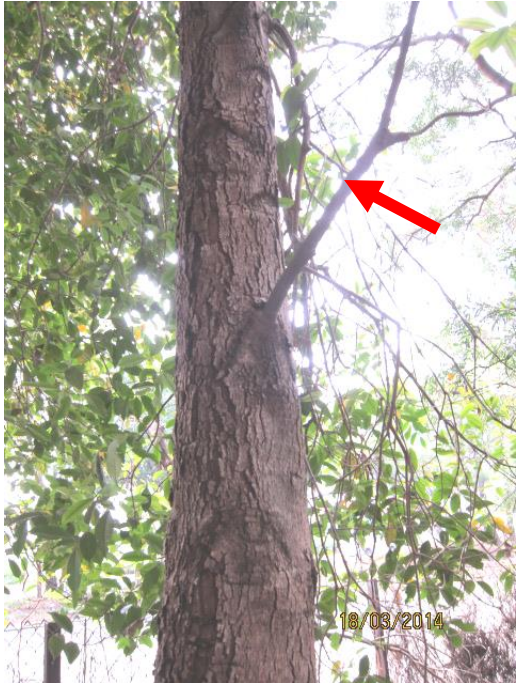
| YMT/T2924 1- Retain<br>Scientific Name: <i>Syzygium cumini</i> | YMT/T2924-2 | YMT/T2924- 3<br>Dead branches | YMT/T2924- 4 |

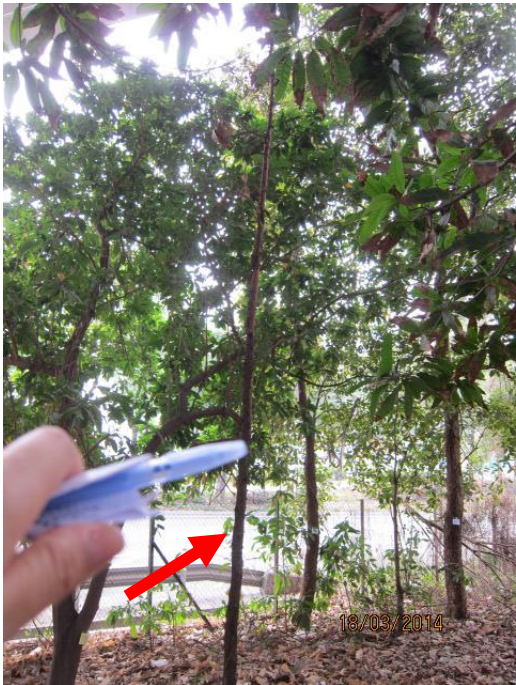
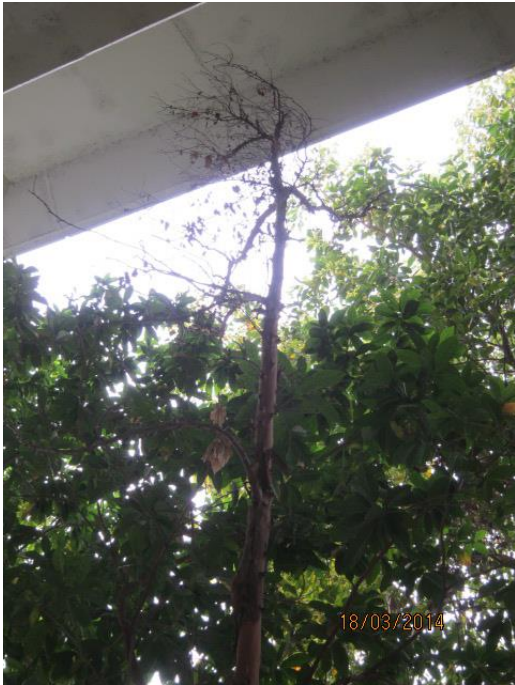
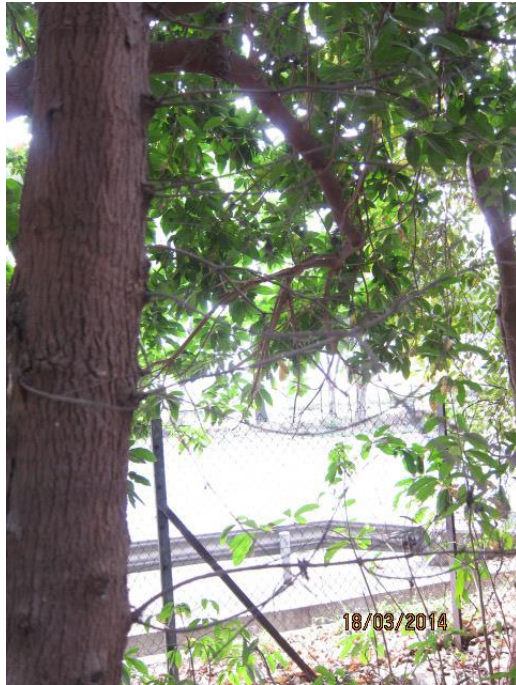
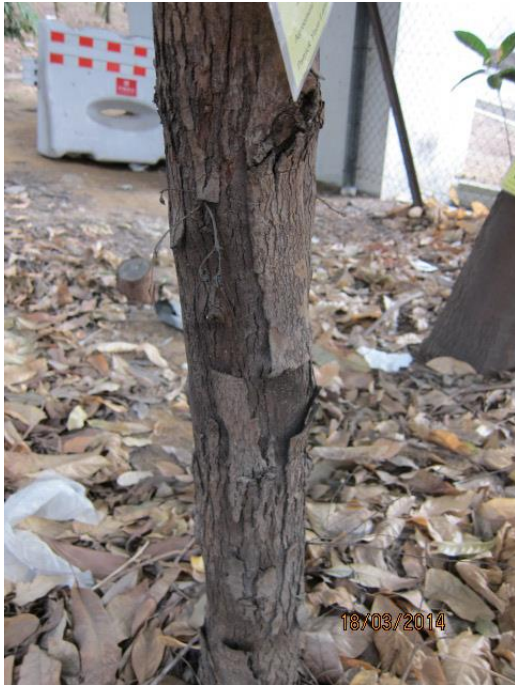
| YMT/T2926- 1- Retain<br>Dead tree | YMT/T2926- 2 | YMT/T2926- 3 | YMT/T2926- 4 |

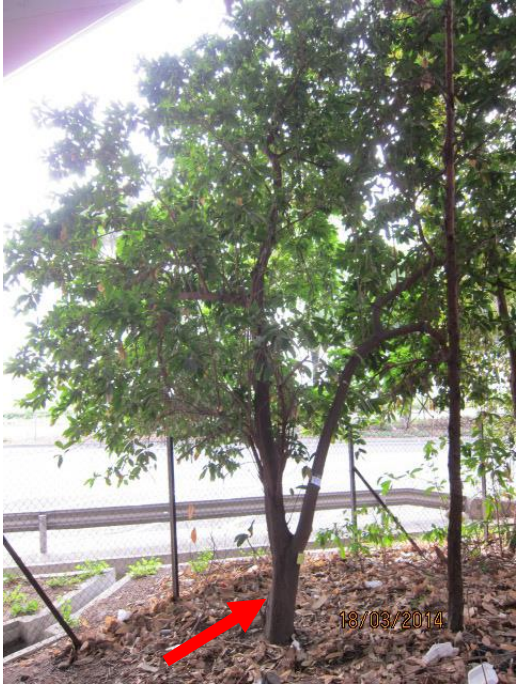
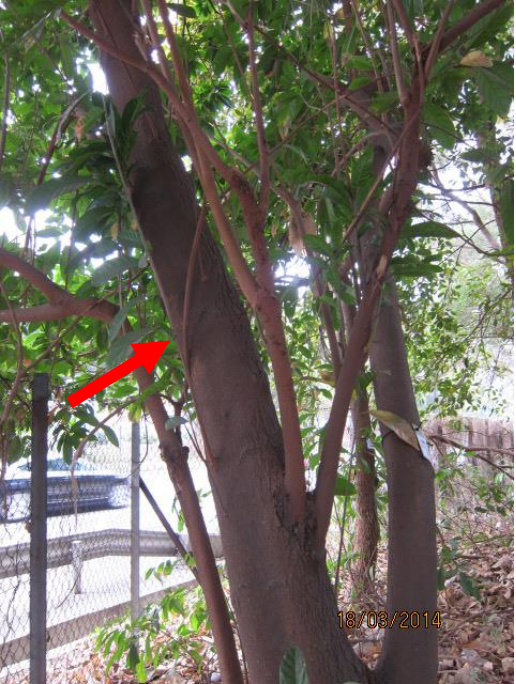
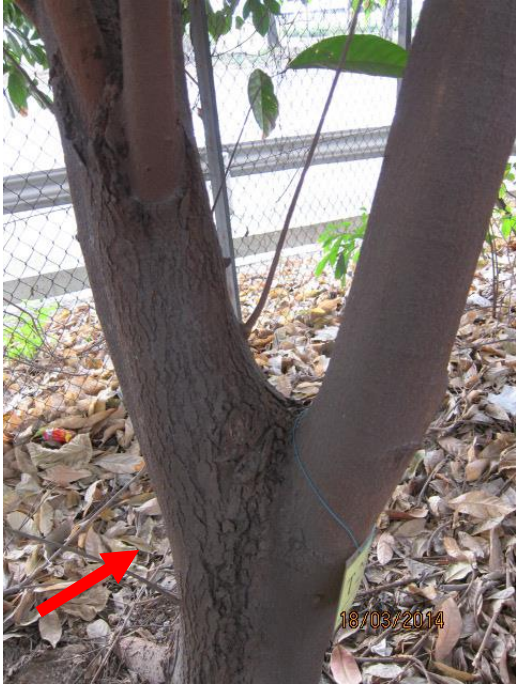
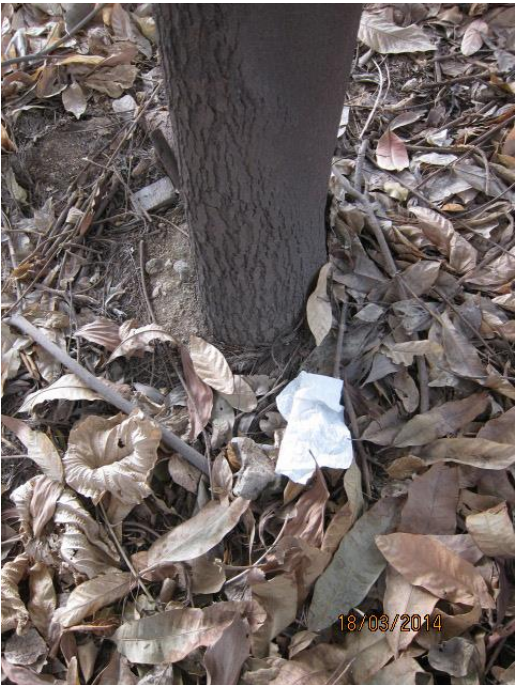
| YMT/T2927- 1- Retain<br>Scientific Name: <i>Mangifera indica</i> | YMT/T2927- 2<br>Dead branches | YMT/T2927- 3<br>Co-dominant trunk | YMT/T2927- 4 |

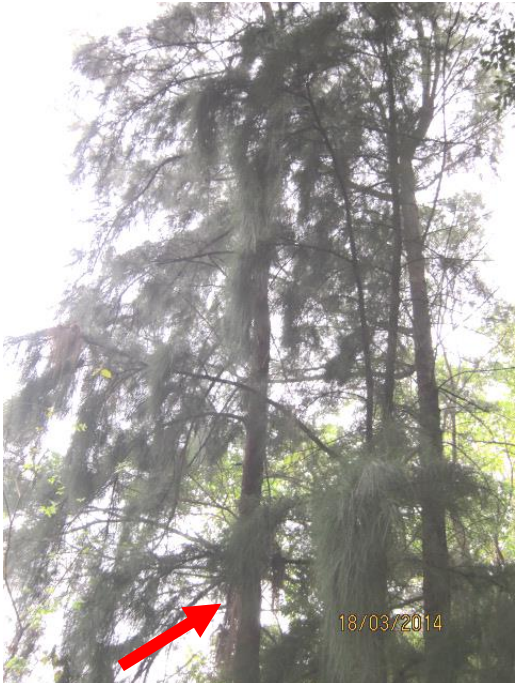
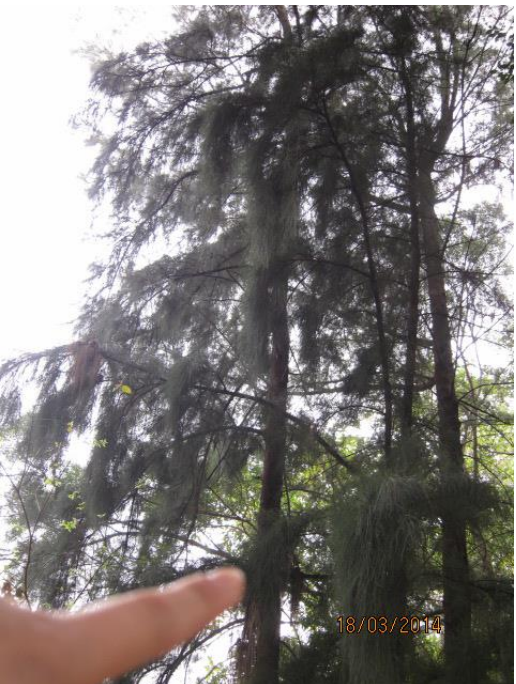
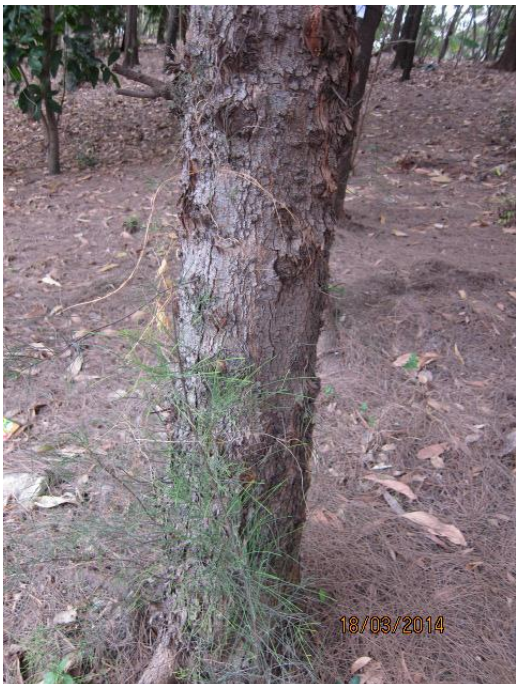
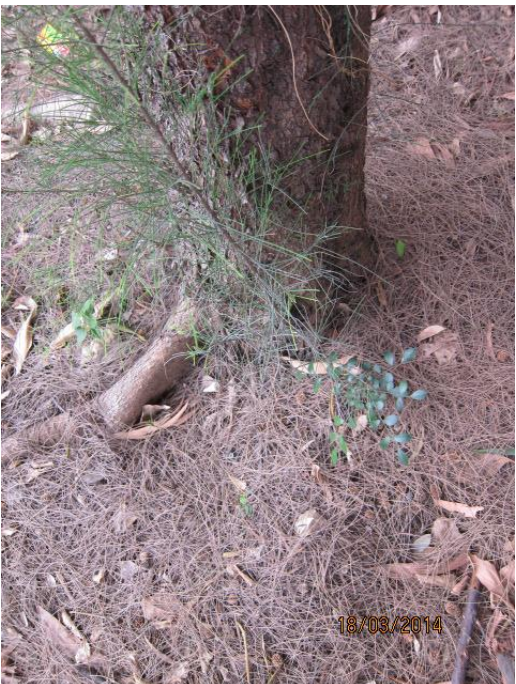
| YMT/T2929- 1- Retain<br>Scientific Name: <i>Casuarina equisetifolia</i> | YMT/T2929- 2<br>Dead branches | YMT/T2929- 3 | YMT/T2929- 4<br>Exposed root |

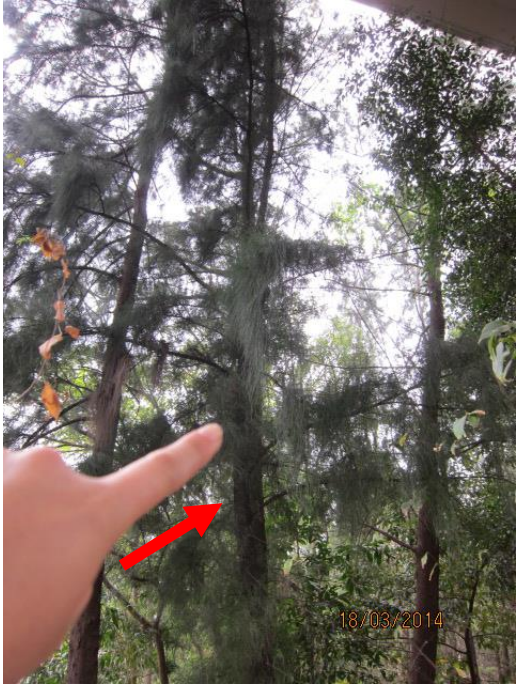
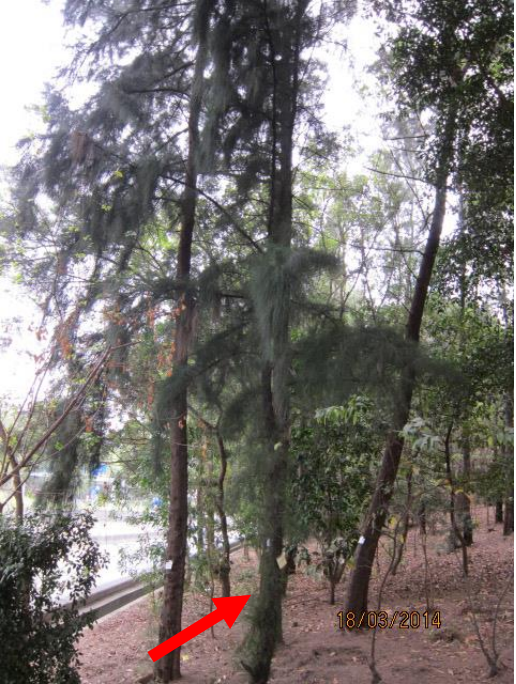
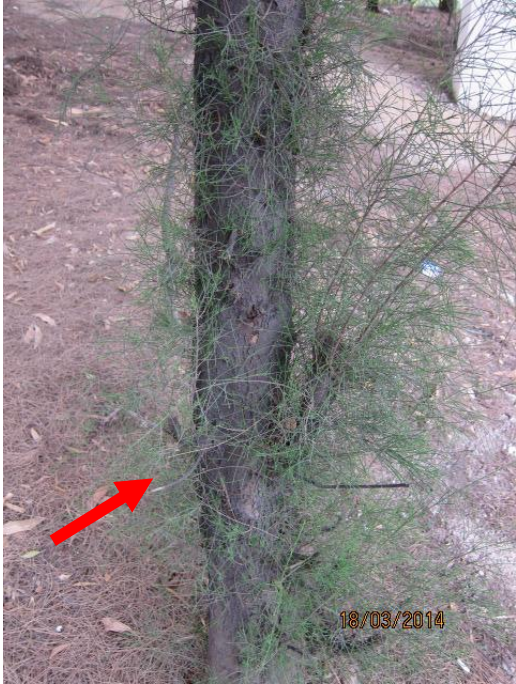
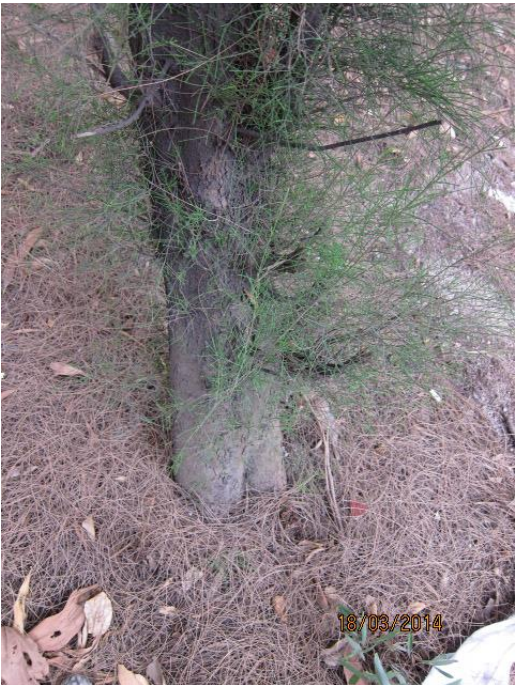
| YMT/T2930- 1- Retain<br>Scientific Name: <i>Casuarina equisetifolia</i> | YMT/T2930- 2 | YMT/T2930- 3<br>Epicormics | YMT/T2930- 4 |

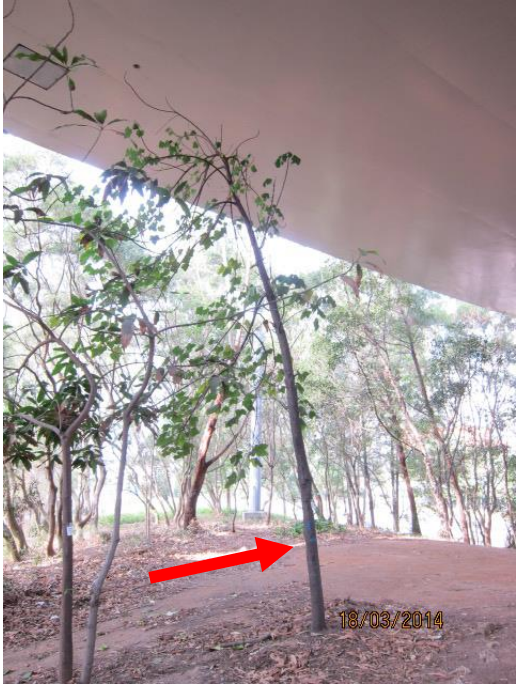
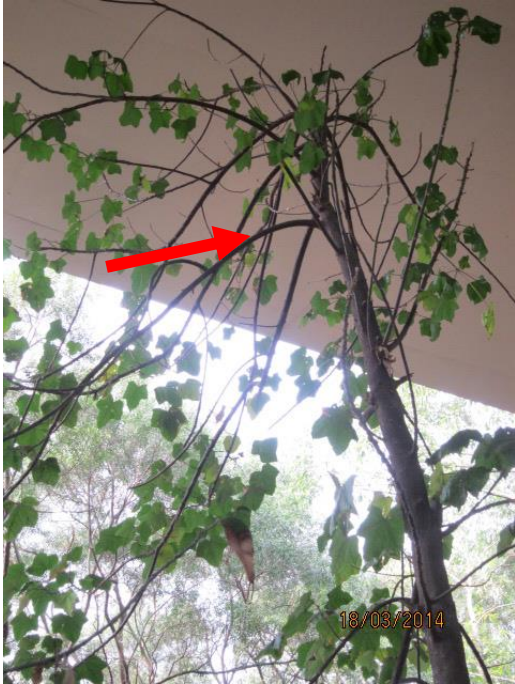
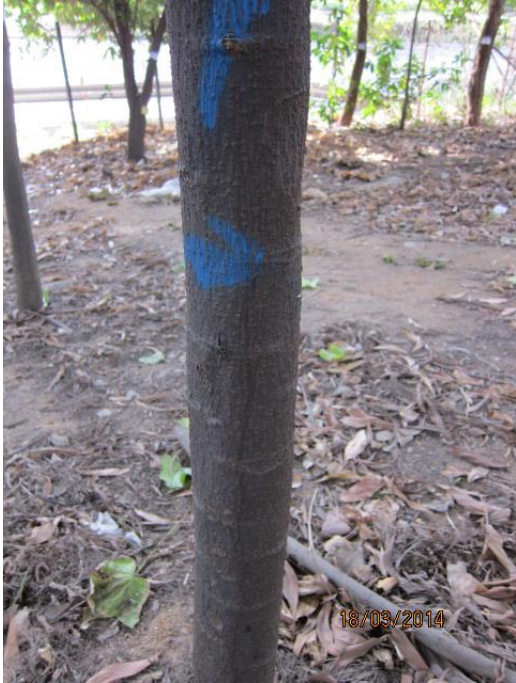
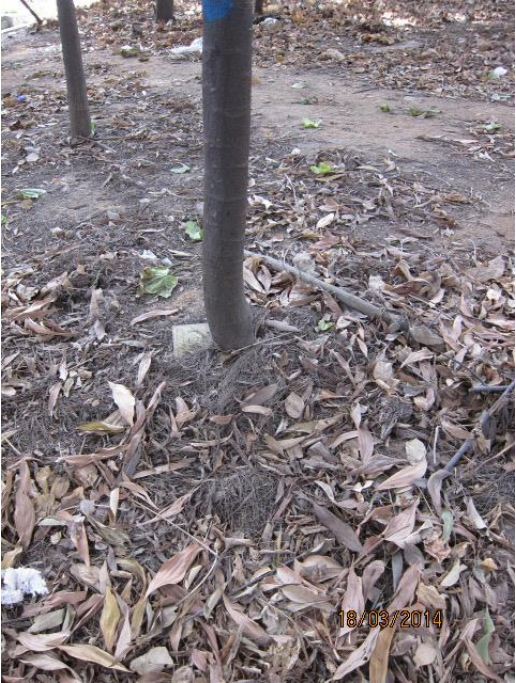
| YMT/T2942- 1- Retain<br>Scientific Name: <i>Aleurites moluccana</i> | YMT/T2942- 2<br>Epicormics | YMT/T2942- 3 | YMT/T2942- 4 |

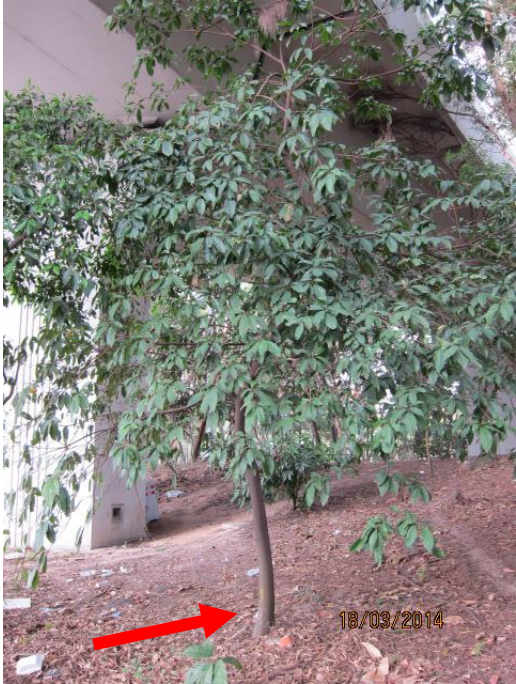
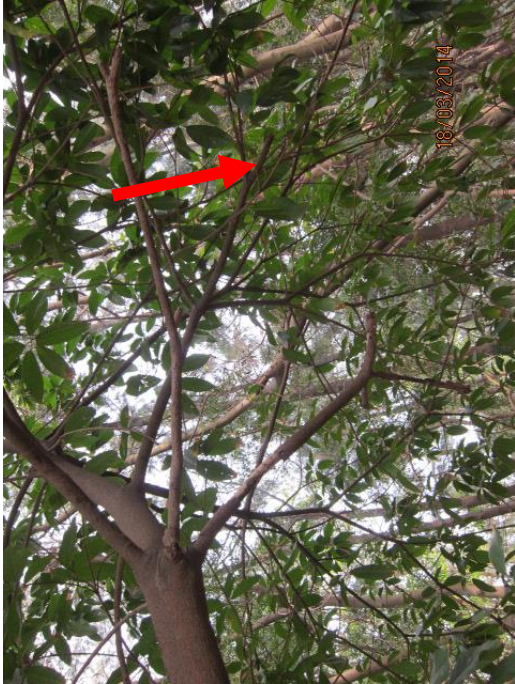
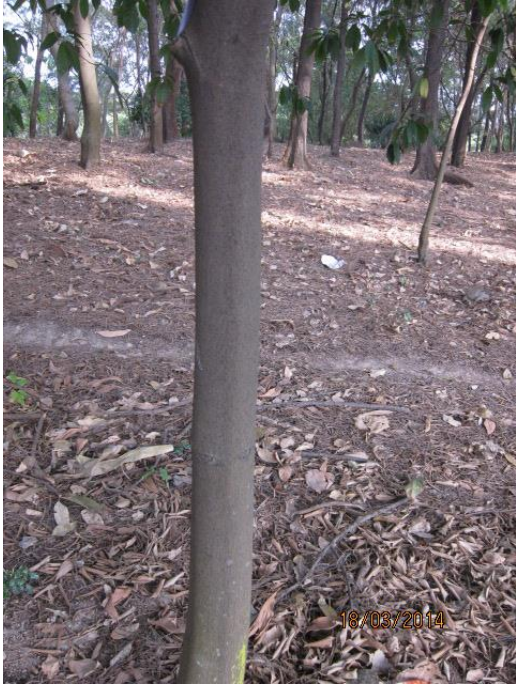
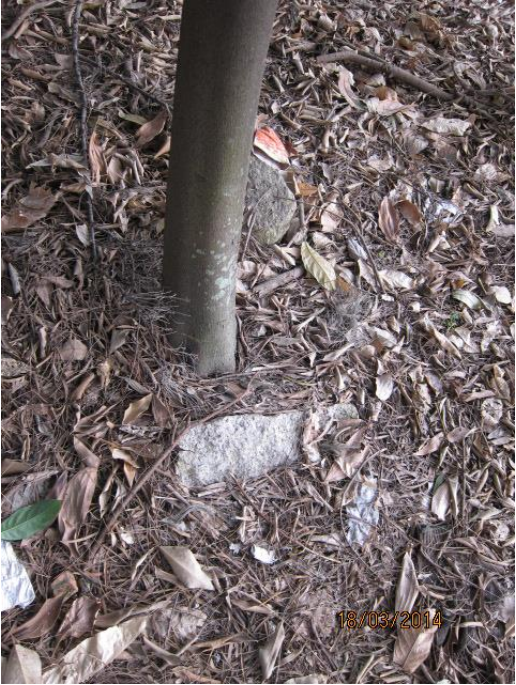
| YMT/T2945- 1- Retain<br>Scientific Name: <i>Mangifera indica</i> | YMT/T2945- 2<br>Dead branches | YMT/T2945- 3 | YMT/T2945- 4 |

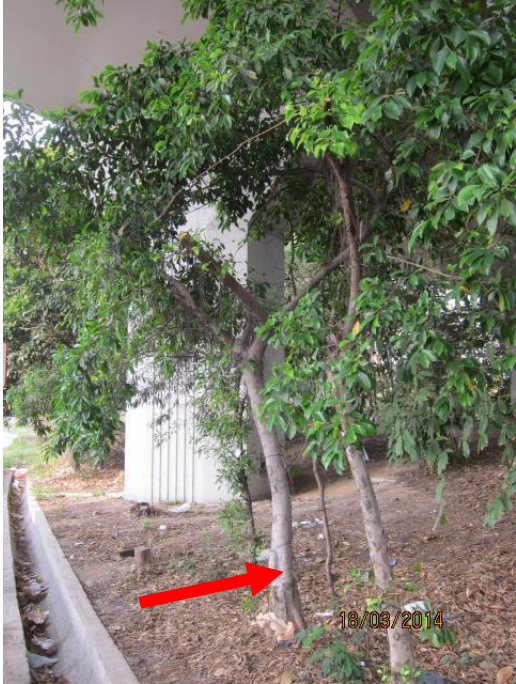
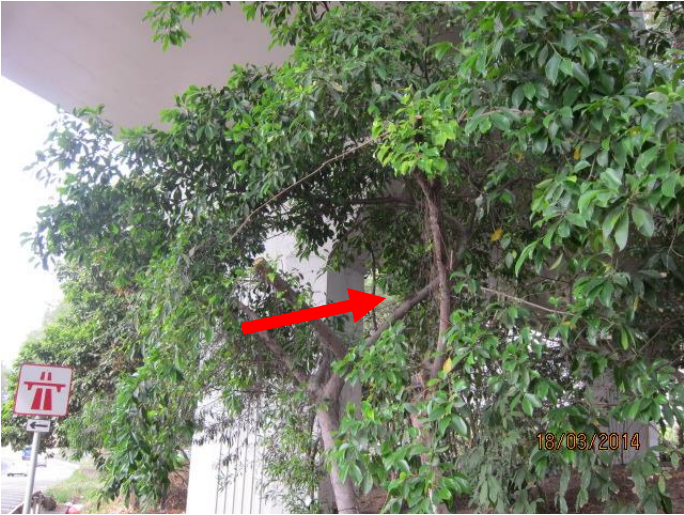
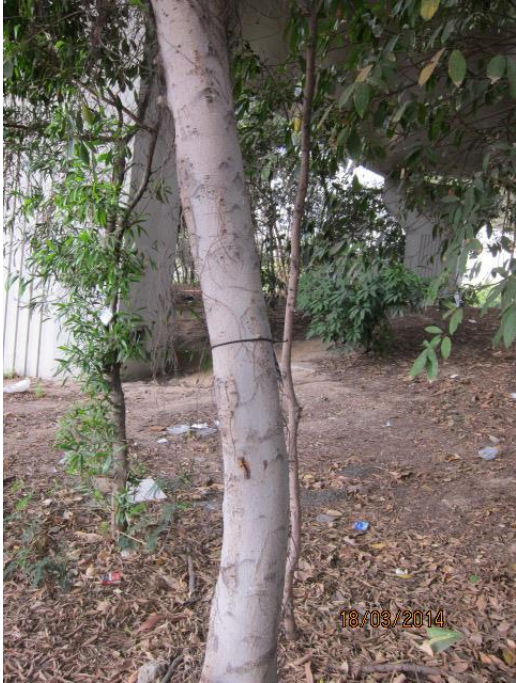
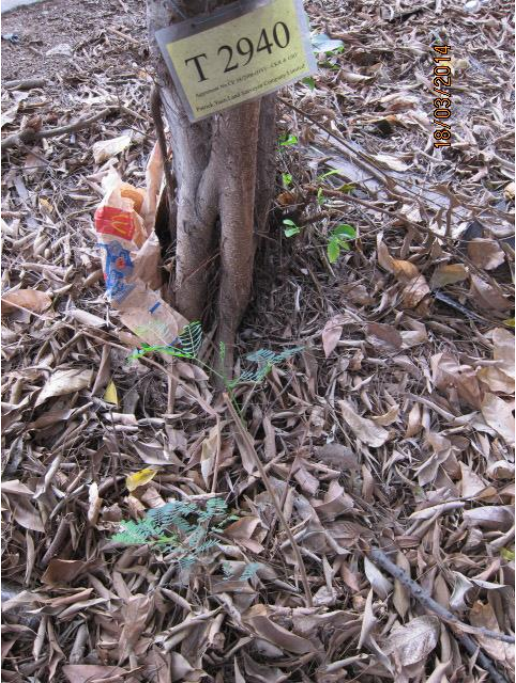
| YMT/T2946- 1- Retain<br>Scientific Name: <i>Ficus microcarpa</i> | YMT/T2946- 2<br>Dead branches | YMT/T2946- 3 | YMT/T2946- 4 |

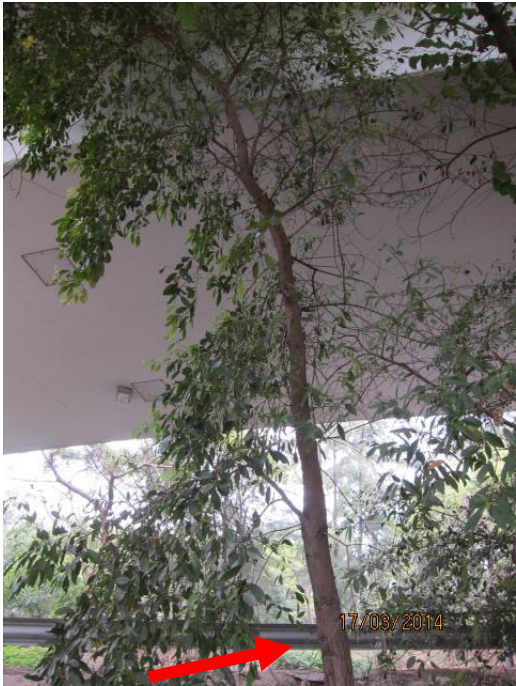
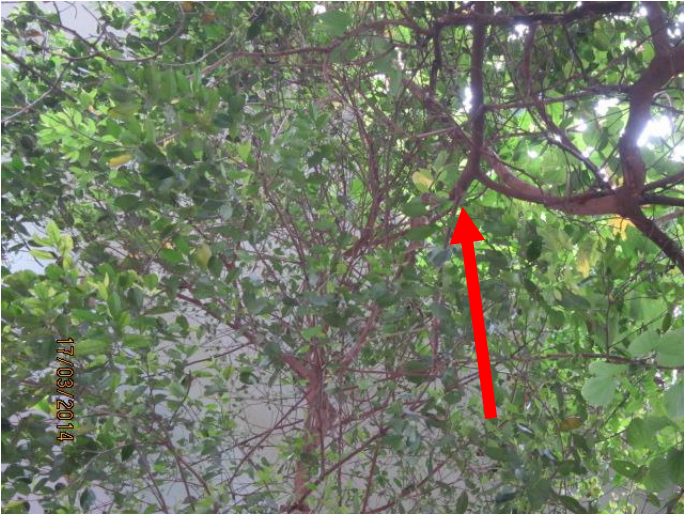
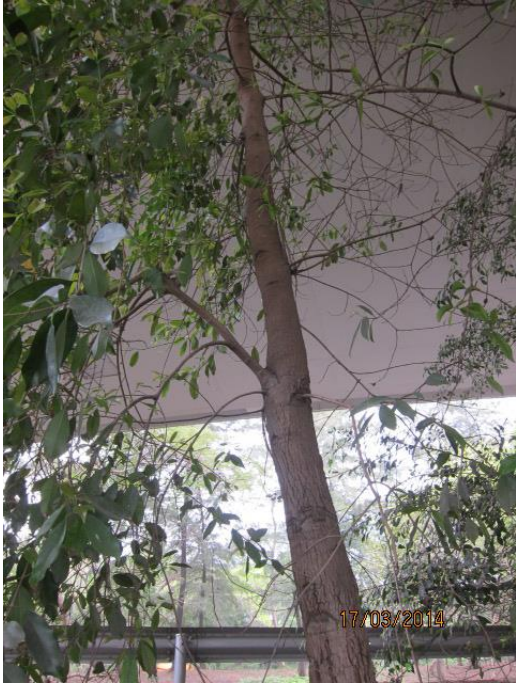
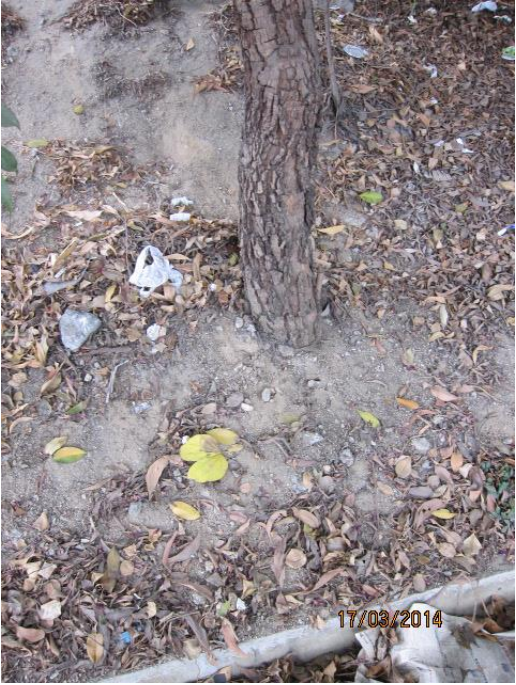
| YMT/T2954- 1- Retain<br>Scientific Name: <i>Eucalyptus camaldulensis</i> | YMT/T2954- 2<br>Cross branches | YMT/T2954- 3 | YMT/T2954- 4 |

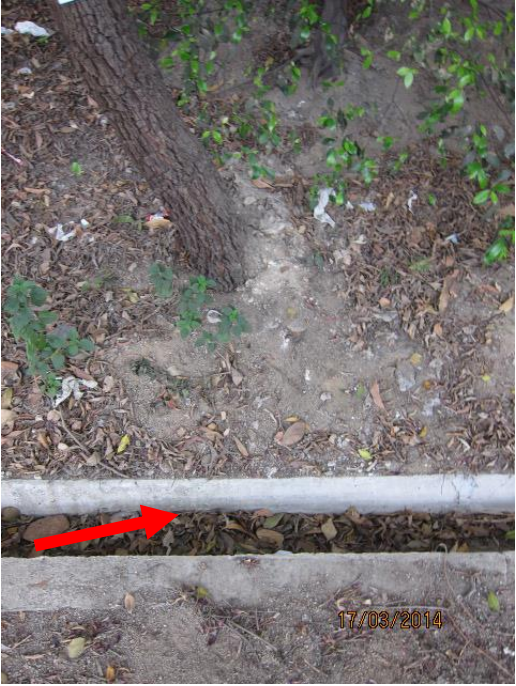
| YMT/T2955- 1- Retain<br>Scientific Name: <i>Eucalyptus camaldulensis</i> | YMT/T2955- 2 | YMT/T2955- 3 | YMT/T2955- 4<br>Concrete pavement |

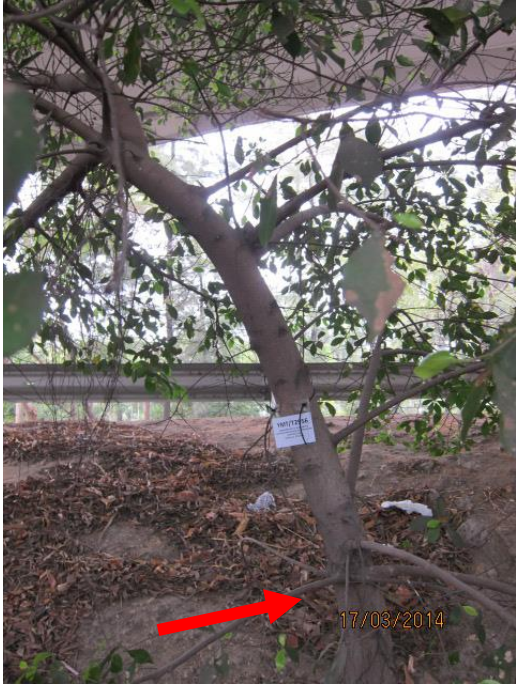
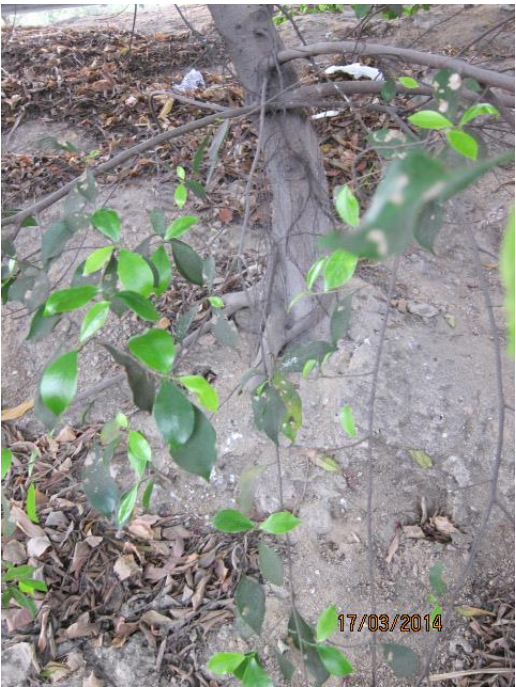
| YMT/T2956- 1- Retain<br>Scientific Name: <i>Ficus microcarpa</i> | YMT/T2956- 2 | YMT/T2956- 3<br>Exposed root | YMT/T2956- 4<br>Exposed root |

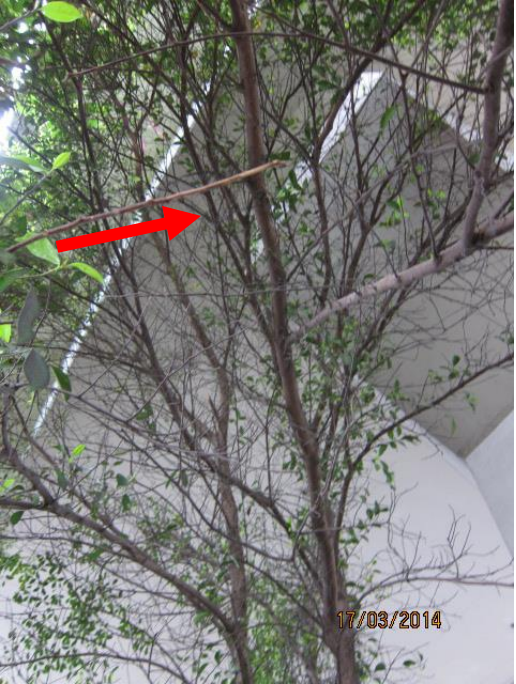
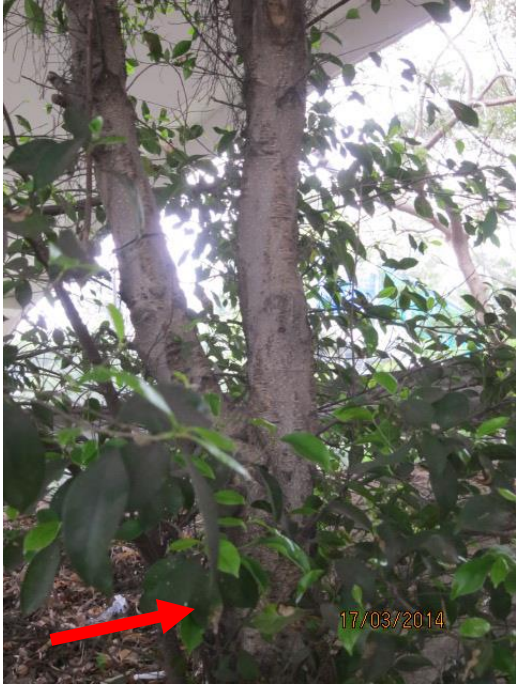
| YMT/T2957- 1- Retain<br>Scientific Name: <i>Ficus microcarpa</i> | YMT/T2957- 2<br>Epicormics | YMT/T2957- 3<br>Co-dominant trunk | YMT/T2957- 4 |

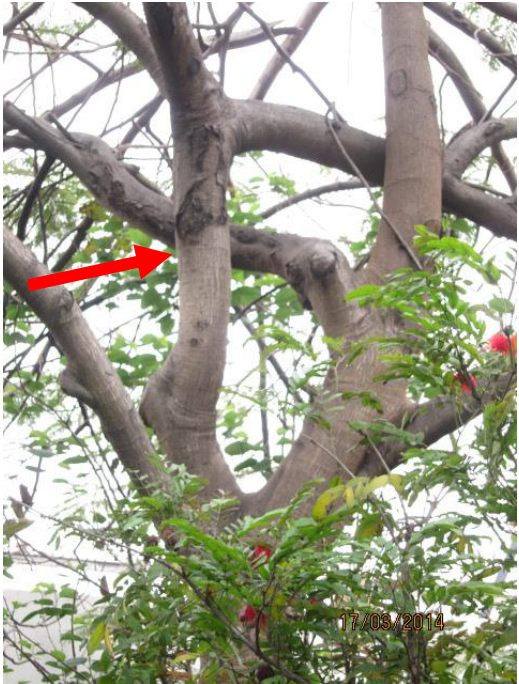
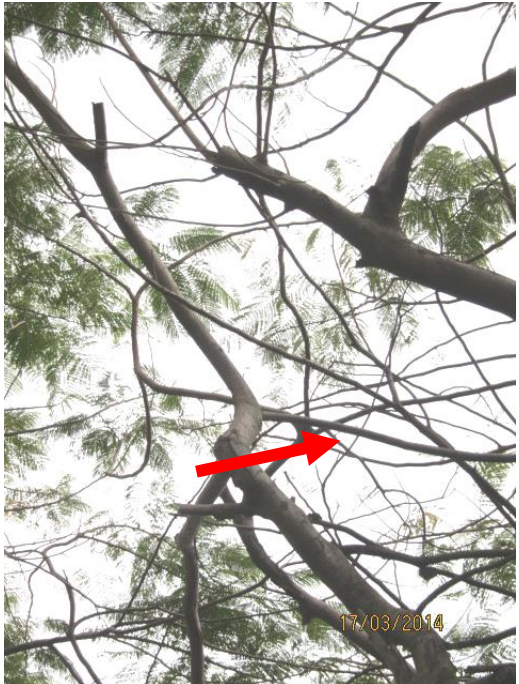
| YMT/T2958- 1- Retain<br>Scientific Name: <i>Acacia confusa</i> | YMT/T2958- 2<br>Cross branches | YMT/T2958- 3<br>Dead branches | YMT/T2958- 4<br>Road side |

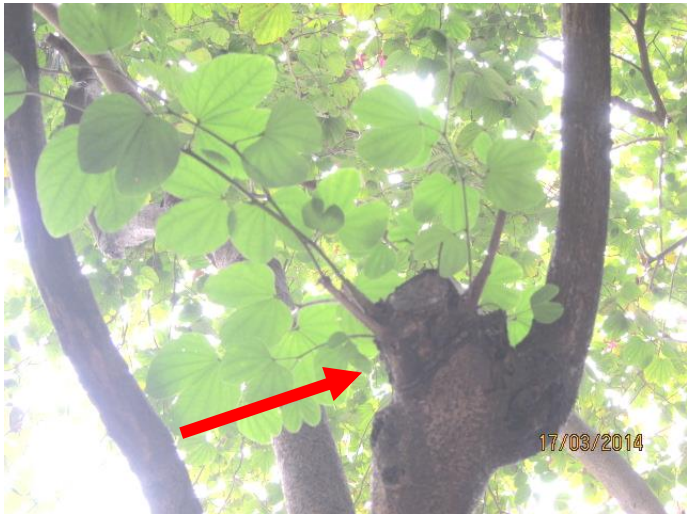
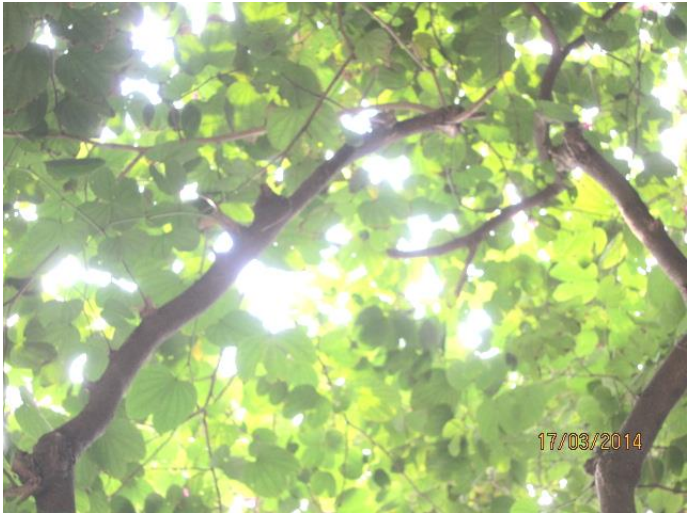
| YMT/T2985- 1- Retain<br>Scientific Name: <i>Bauhinia x blakeana</i> | YMT/T2985- 2<br>Broken branches | YMT/T2985- 3<br>Cross branches, crown suppressed | YMT/T2985- 4 |

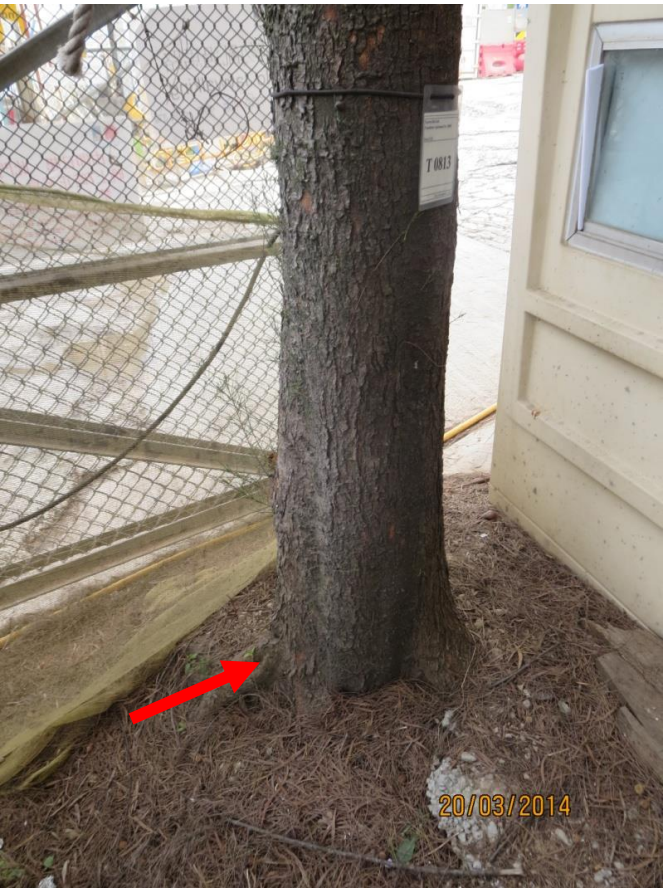
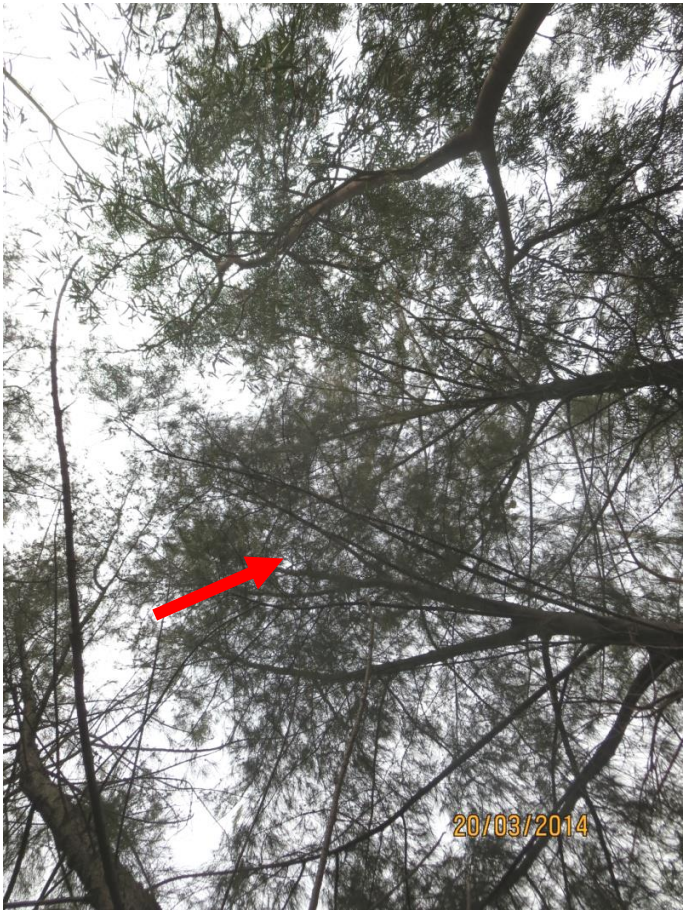
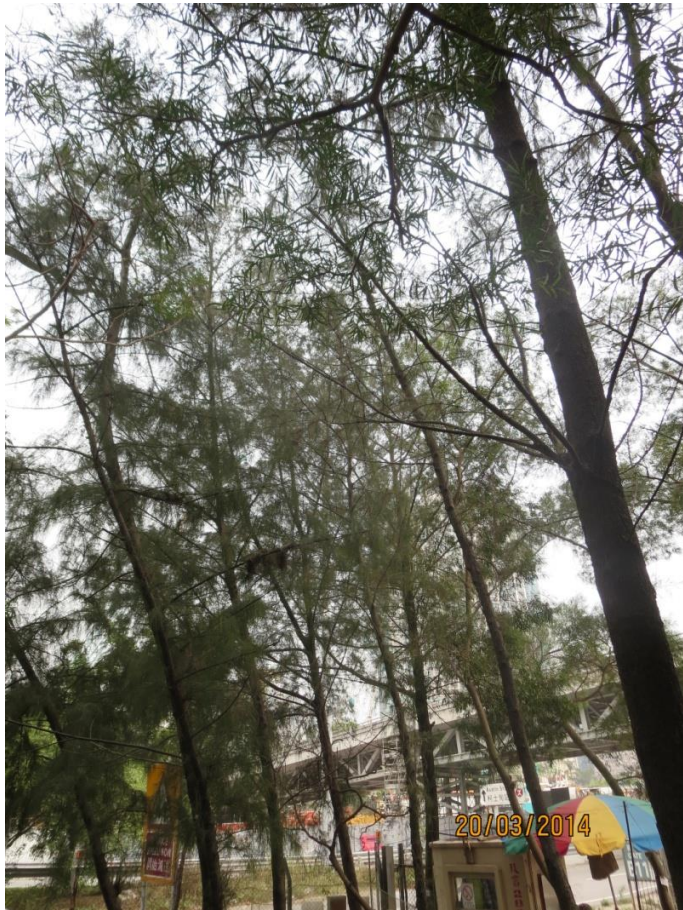
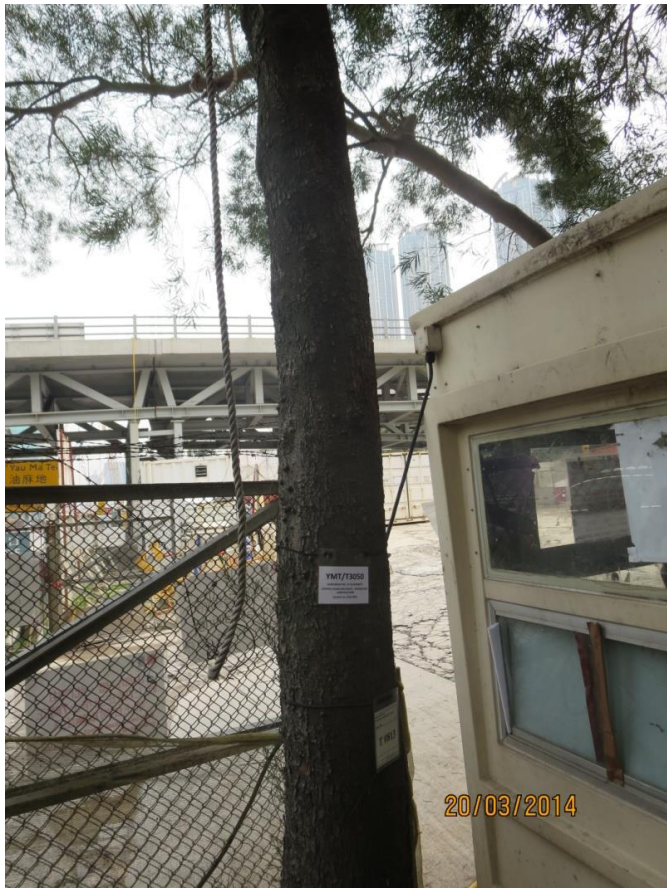
| YMT/T3050- 1- Retain<br>Scientific Name: <i>Causuarinaequisetifolia</i> | YMT/ T3050-2<br>dead branches | YMT/ T3050-3 | YMT/ T3050-4 |

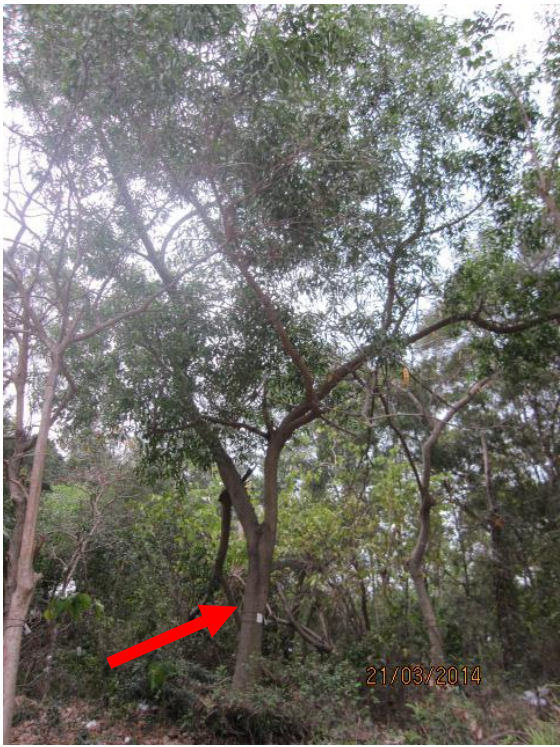
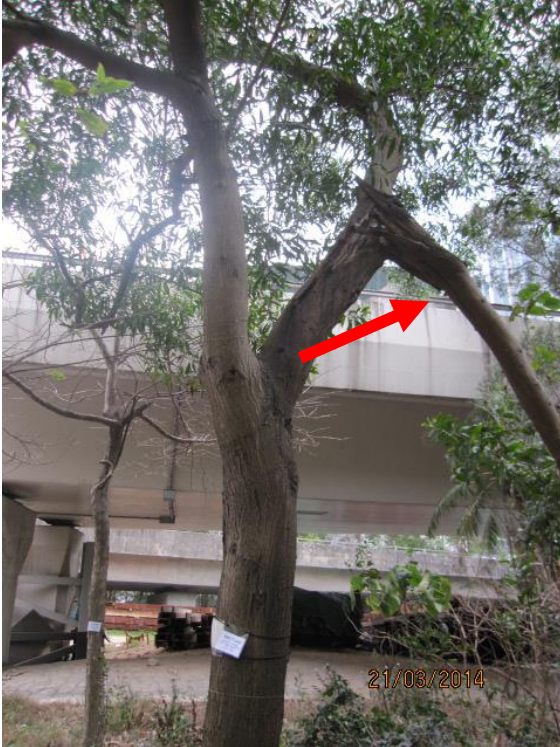
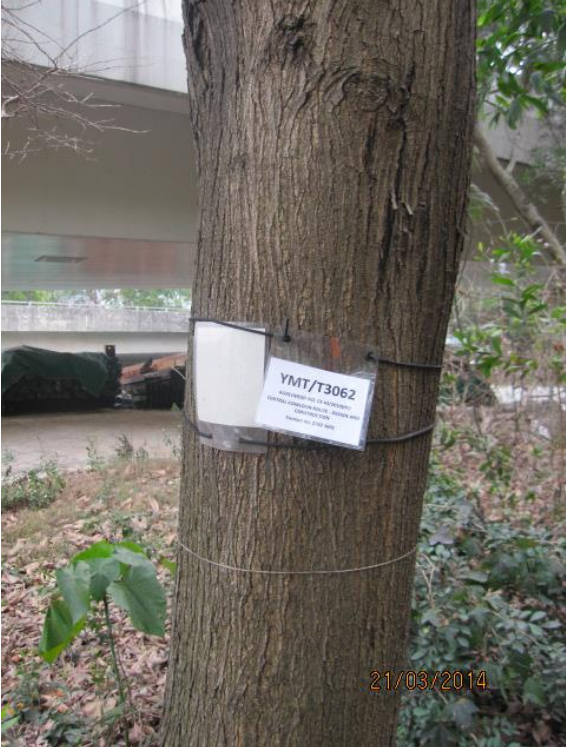
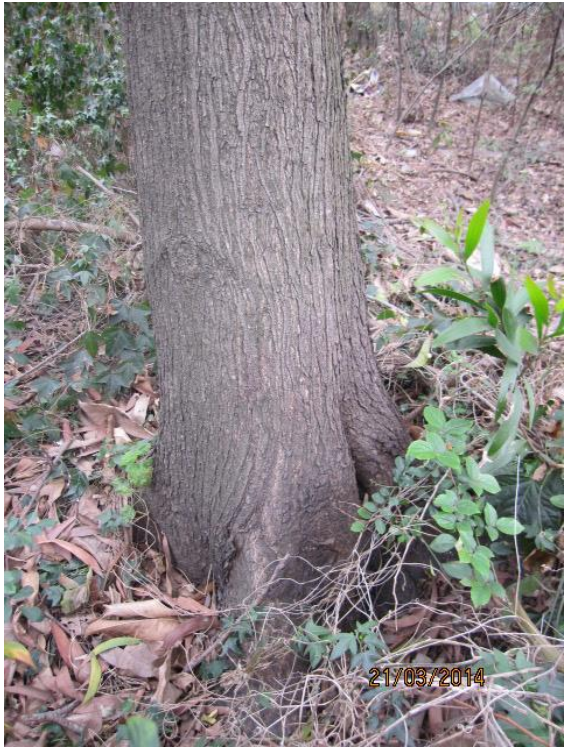
| YMT/T3062- 1-Retain<br>Scientific Name: <i>Acacia mangium</i> | YMT/T3062-2<br>Broken branches | YMT/T3062-3 | YMT/T3062-4 |
