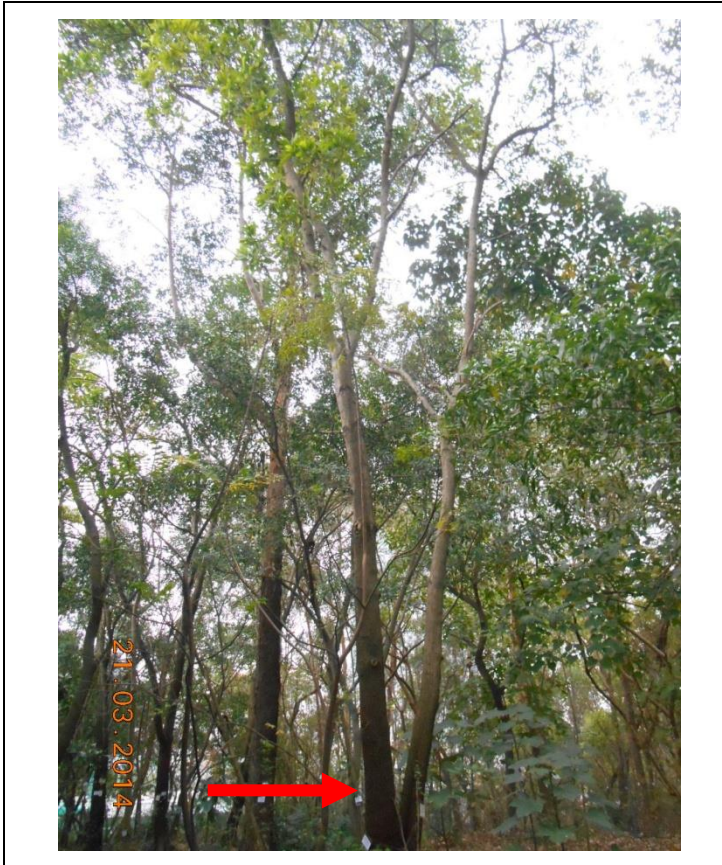
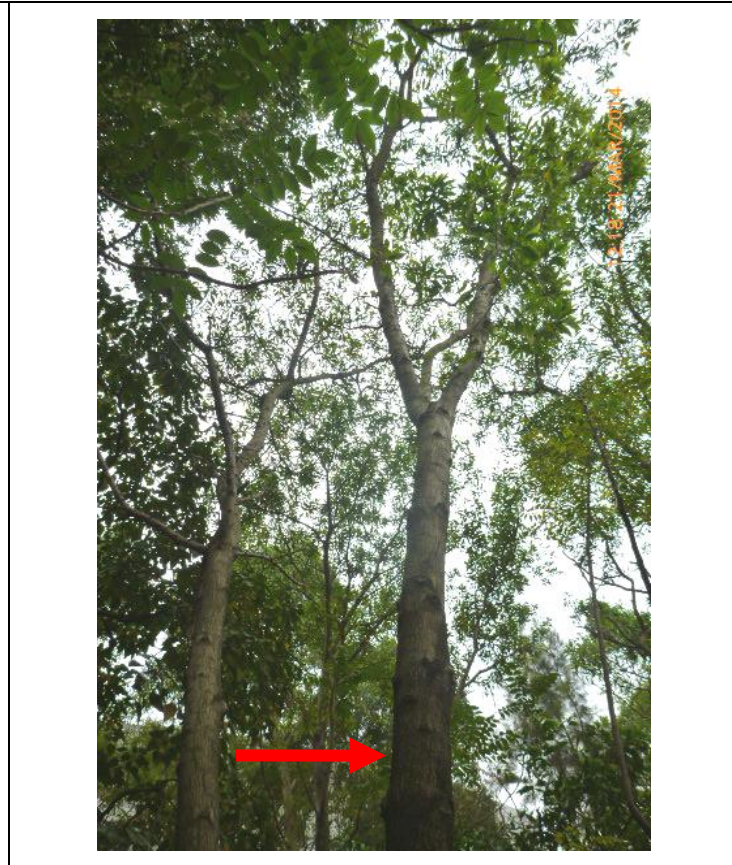
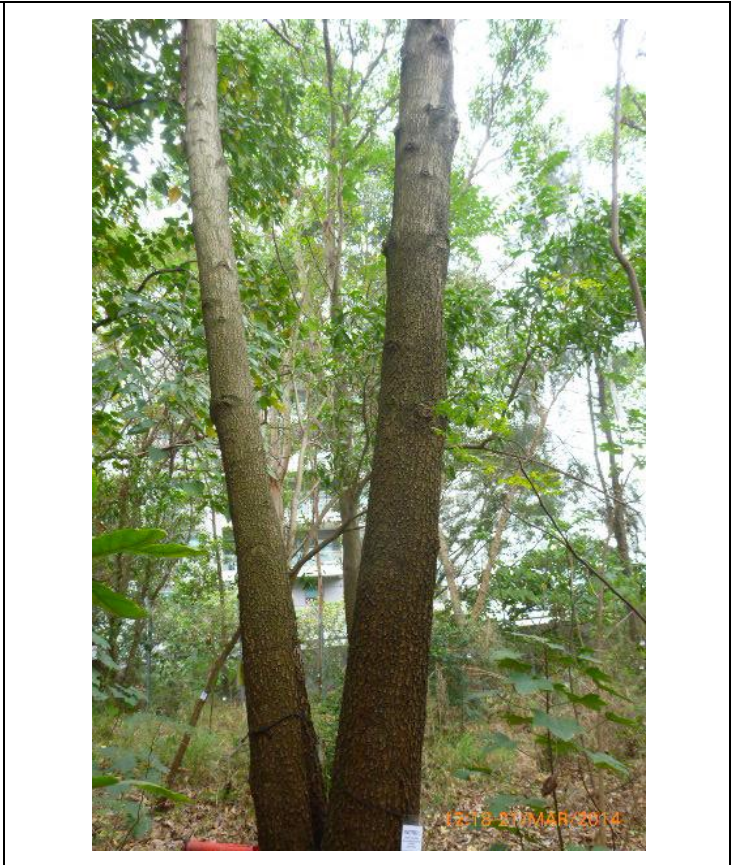
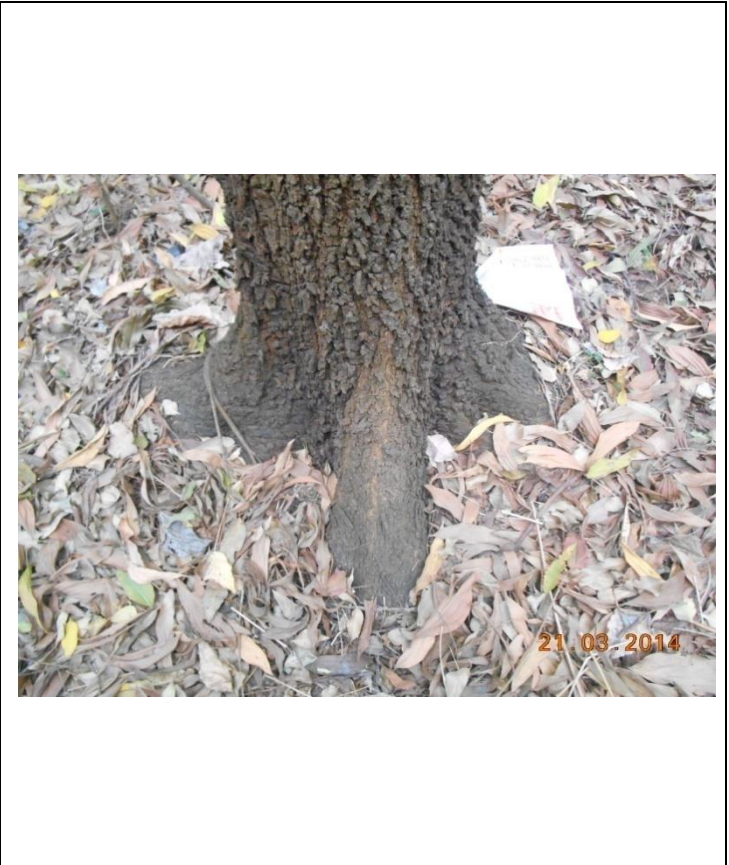
| YMT/T3071- 1-Fell<br>Scientific Name: <i>Acacia mangium</i> | YMT/T3071-2 | YMT/T3071-3<br>Co-dominant trunk | YMT/T3071-4 |

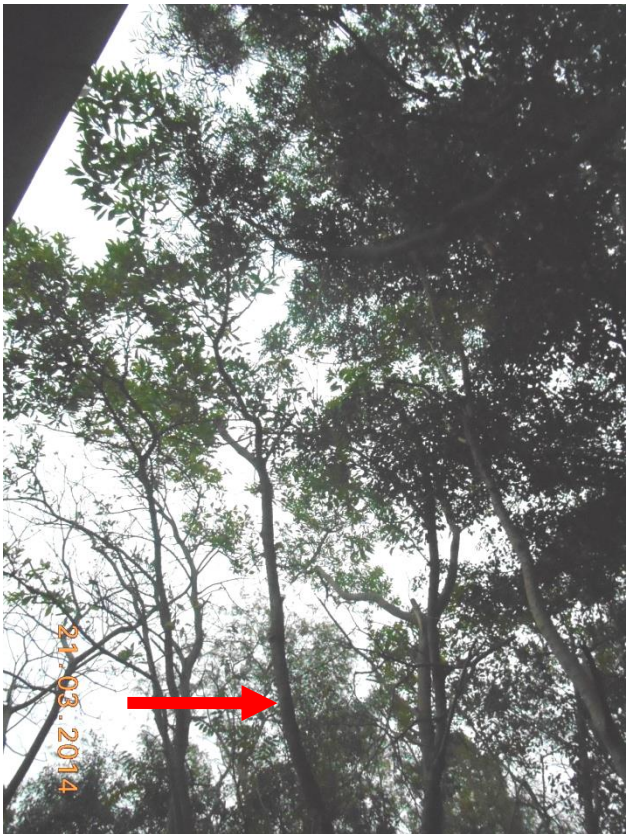
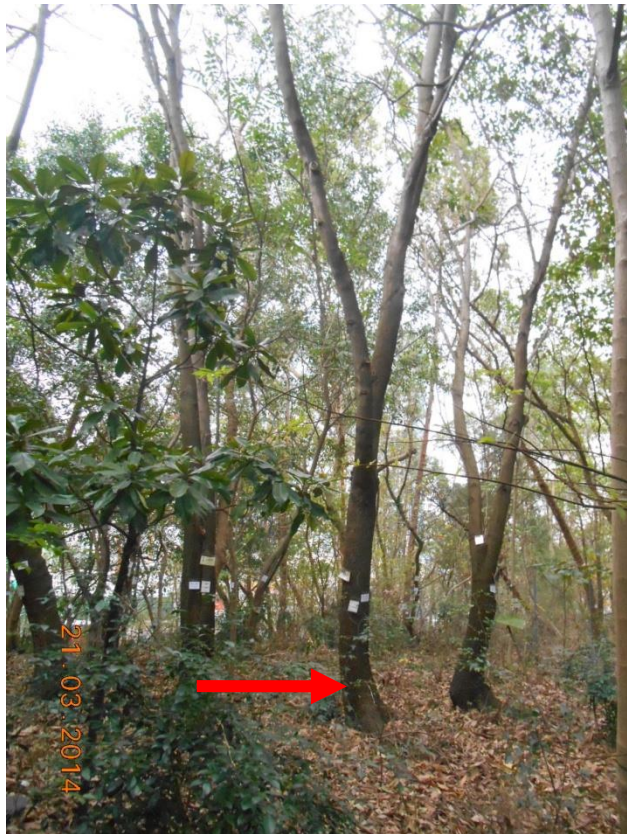
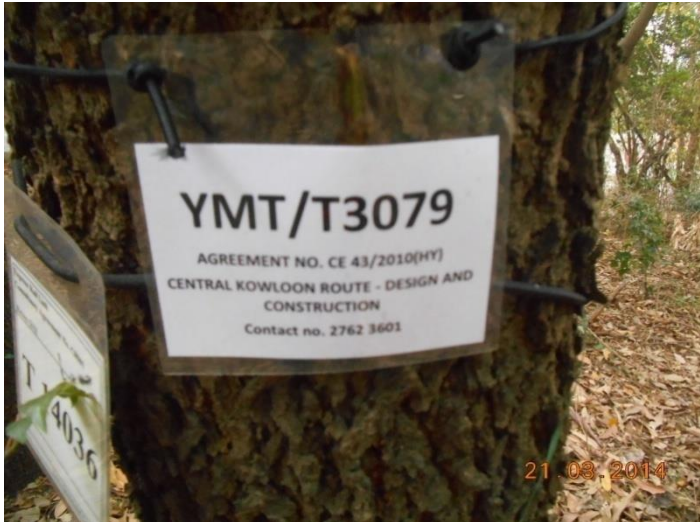
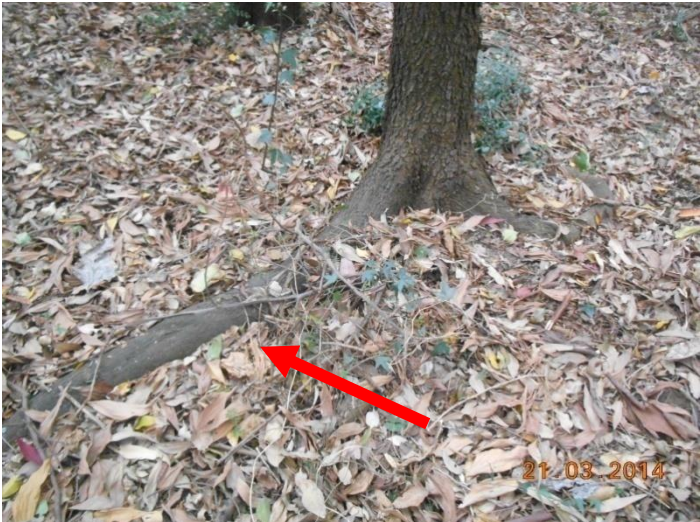
| YMT/T3079- 1-Retain<br>Scientific Name: <i>Acacia mangium</i> | YMT/T3079-2 | YMT/T3079-3 | YMT/T3079-4<br>Exposed root |

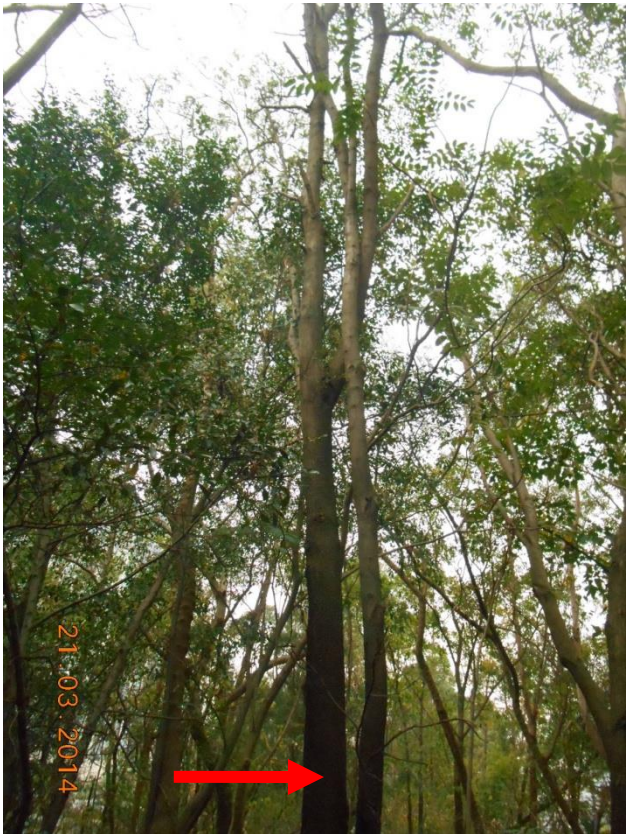
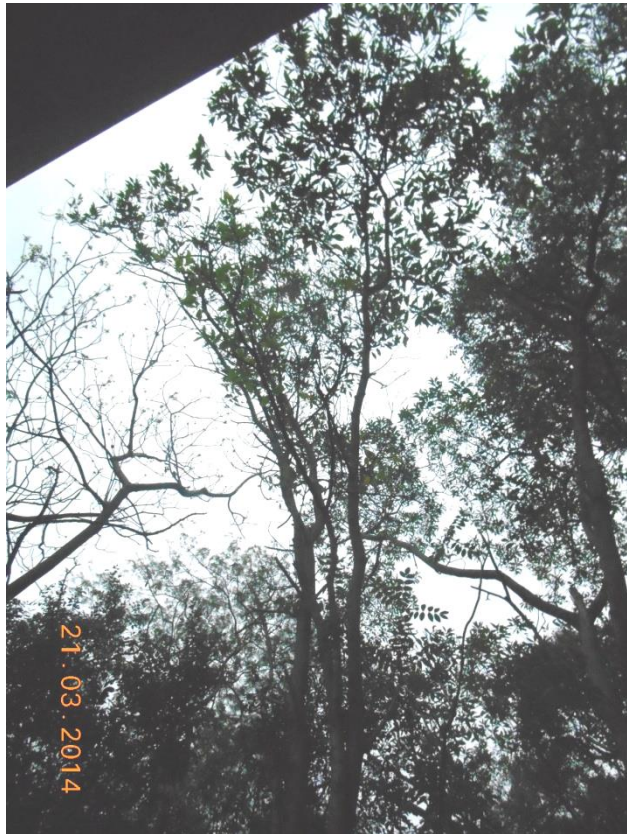
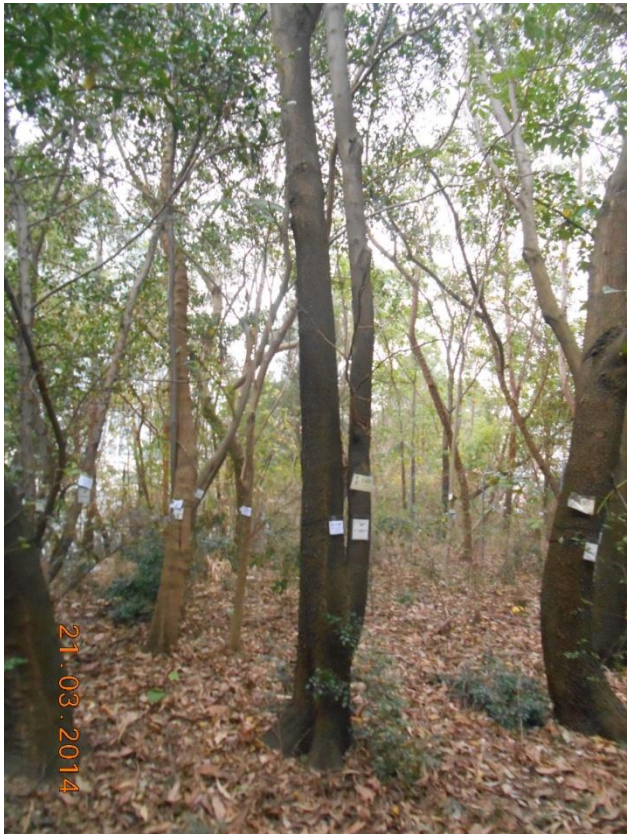
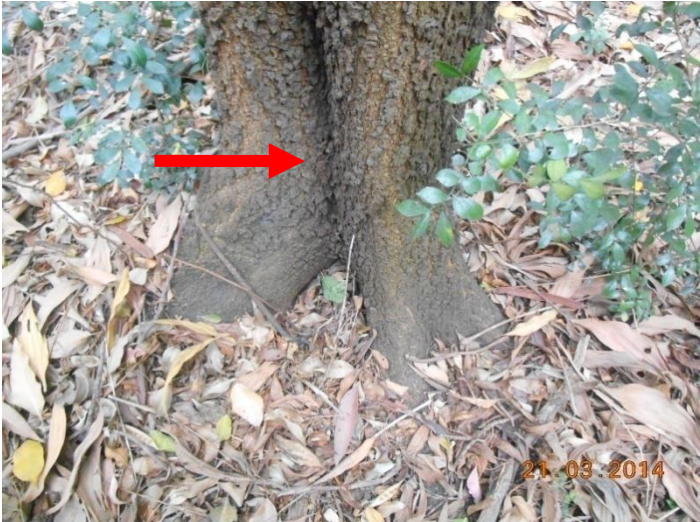
| YMT/T3080- 1-Fell<br>Scientific Name: <i>Acacia mangium</i> | YMT/T3080-2<br>Dead branches | YMT/T3080-3 | YMT/T3080-4<br>Included bark |

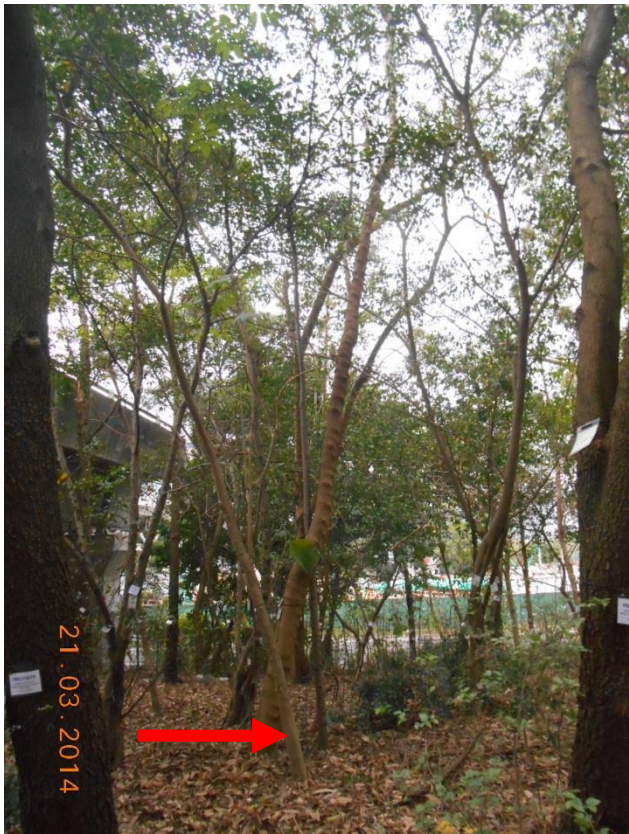
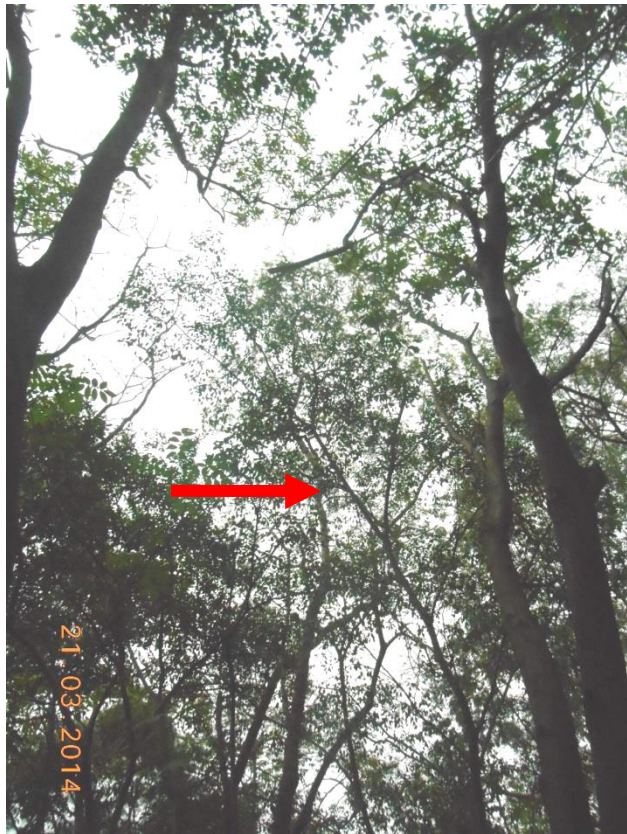
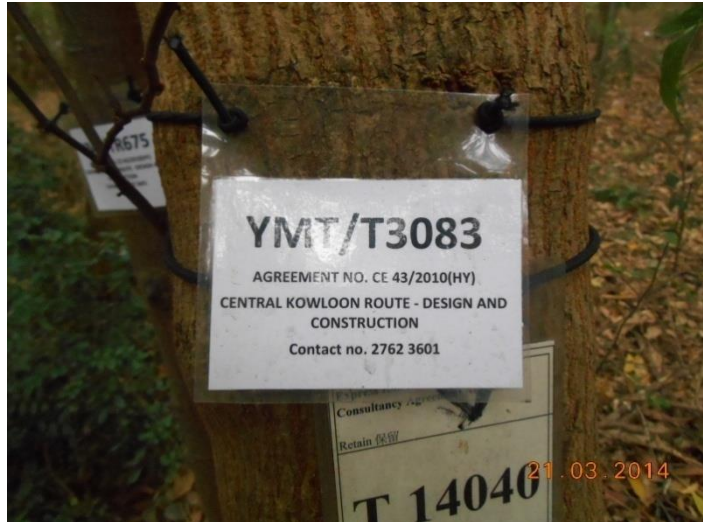
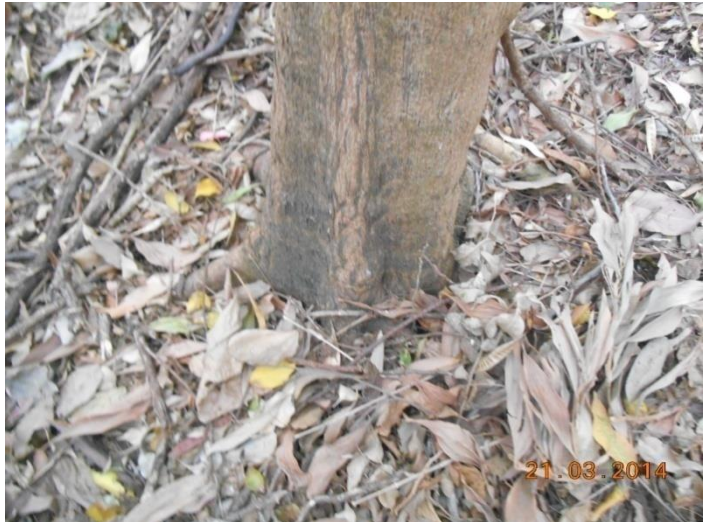
| YMT/T3083- 1-Fell<br>Scientific Name: <i>Leucaena leucocephala</i> | YMT/T3083-2<br>Dead branches | YMT/T3083-3 | YMT/T3083-4 |

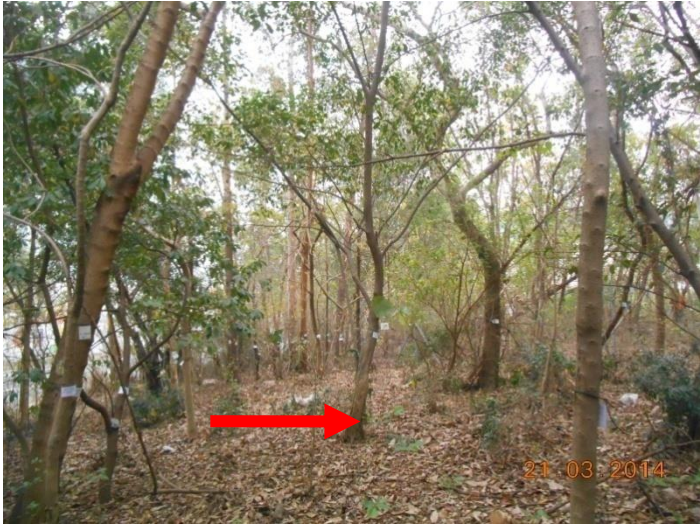
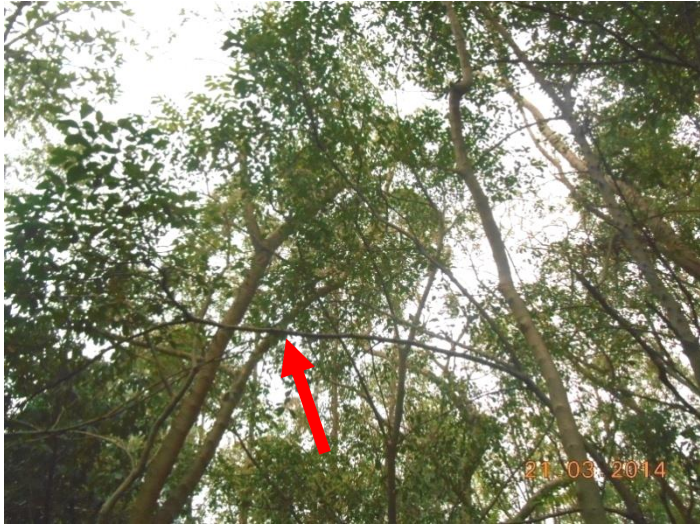
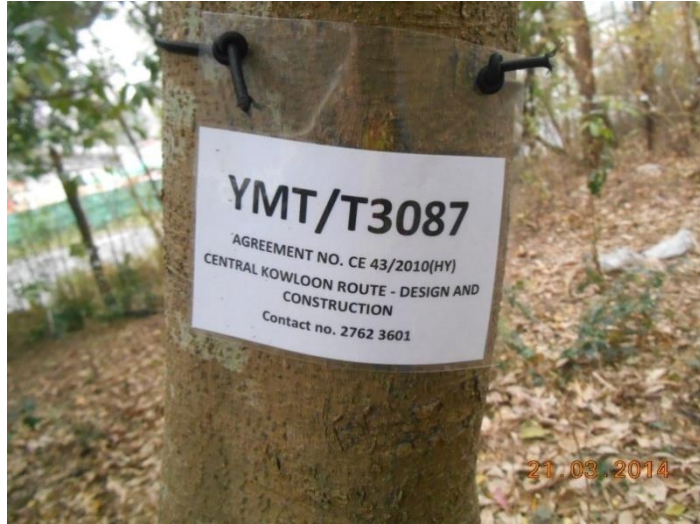
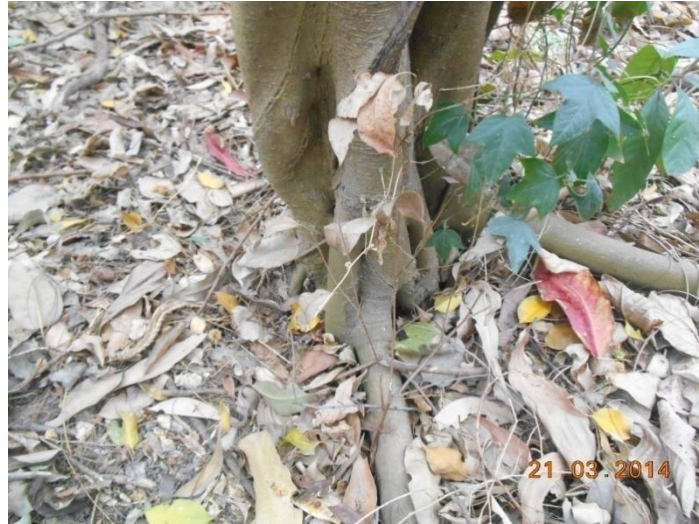
| YMT/T3087- 1-Fell<br>Scientific Name: <i>Ficus benjamina</i> | YMT/T3087-2<br>Cross branches | YMT/T3087-3 | YMT/T3087-4<br>Exposed root |

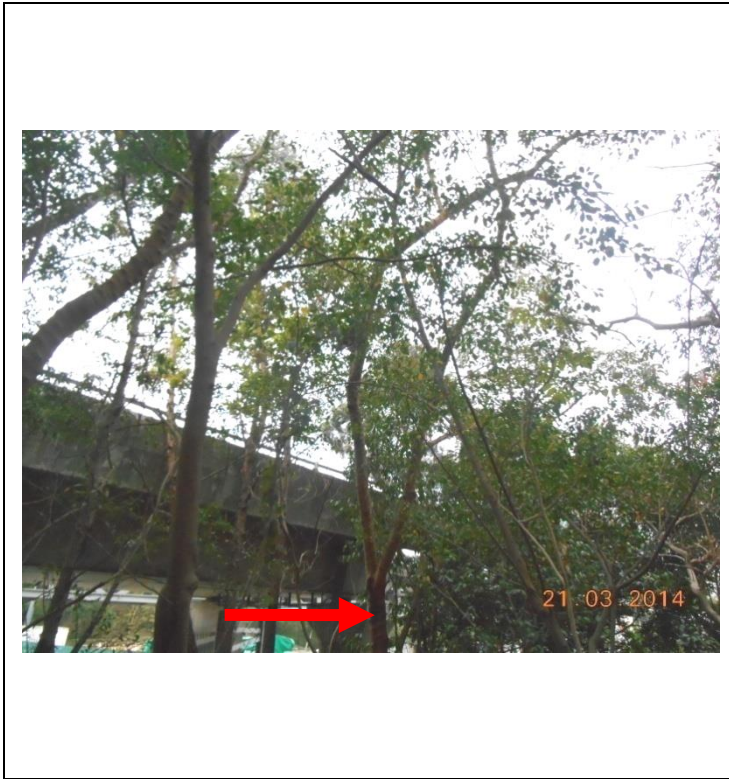
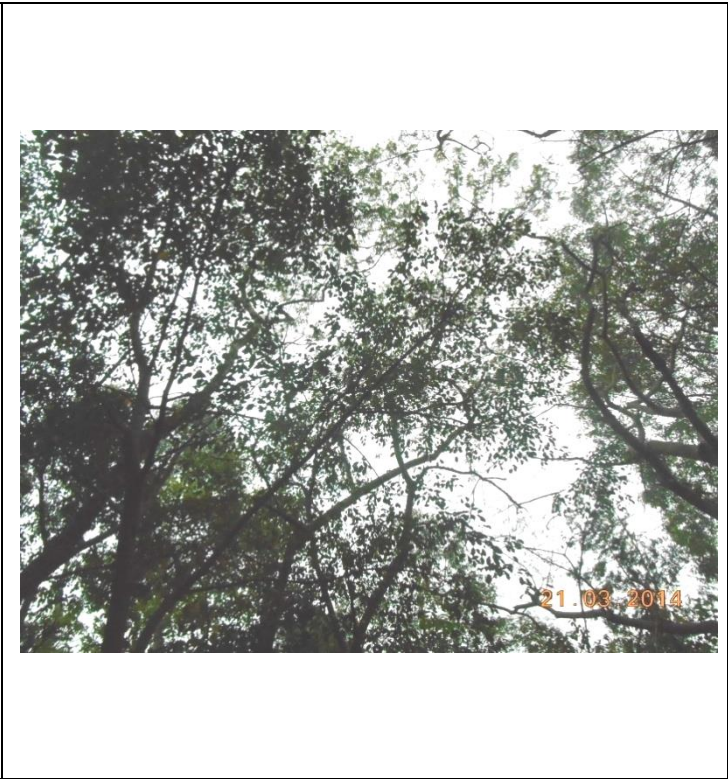
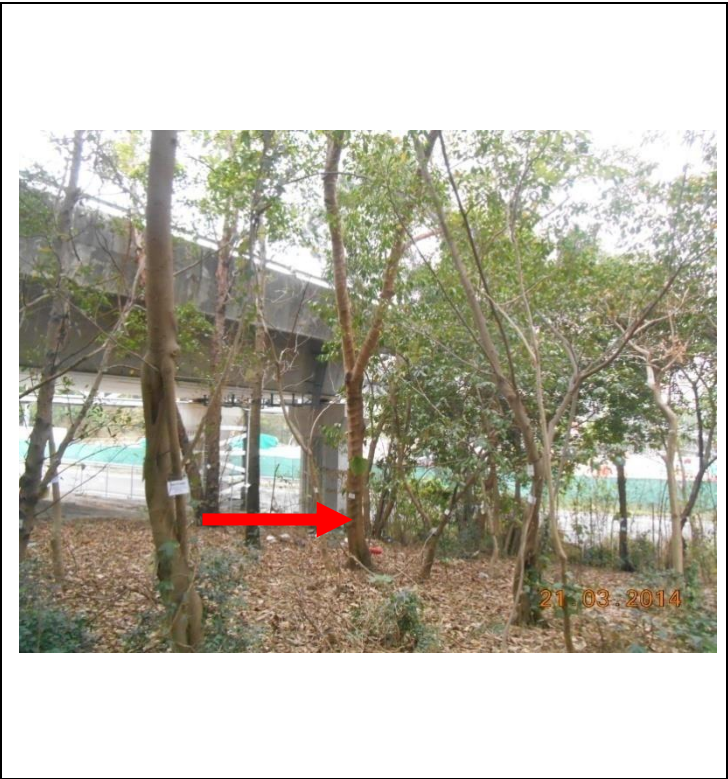
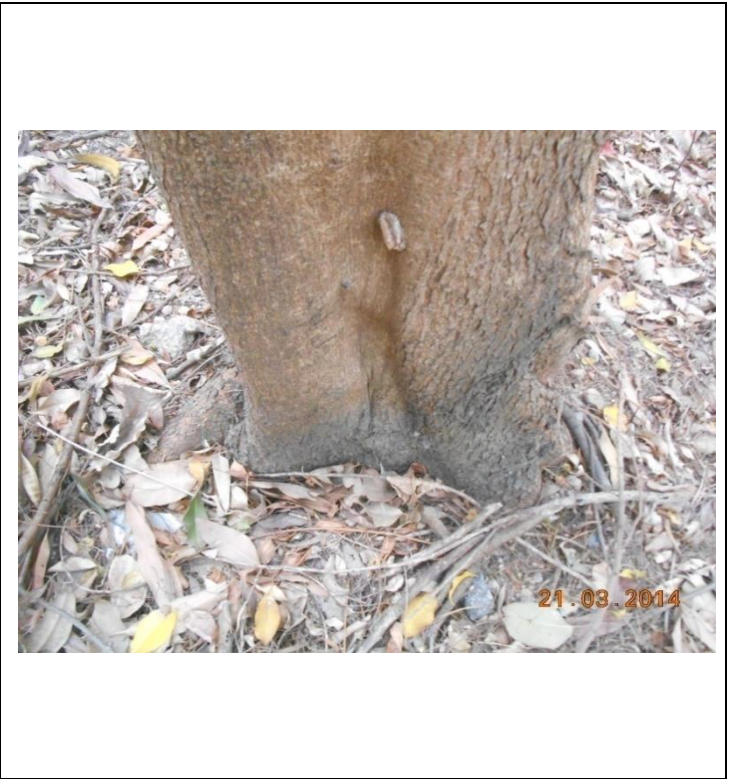
| YMT/T3089- 1-Fell<br>Scientific Name: <i>Leucaena leucocephala</i> | YMT/T3089-2<br>Dead branches | YMT/T3089-3 | YMT/T3089- 4 |

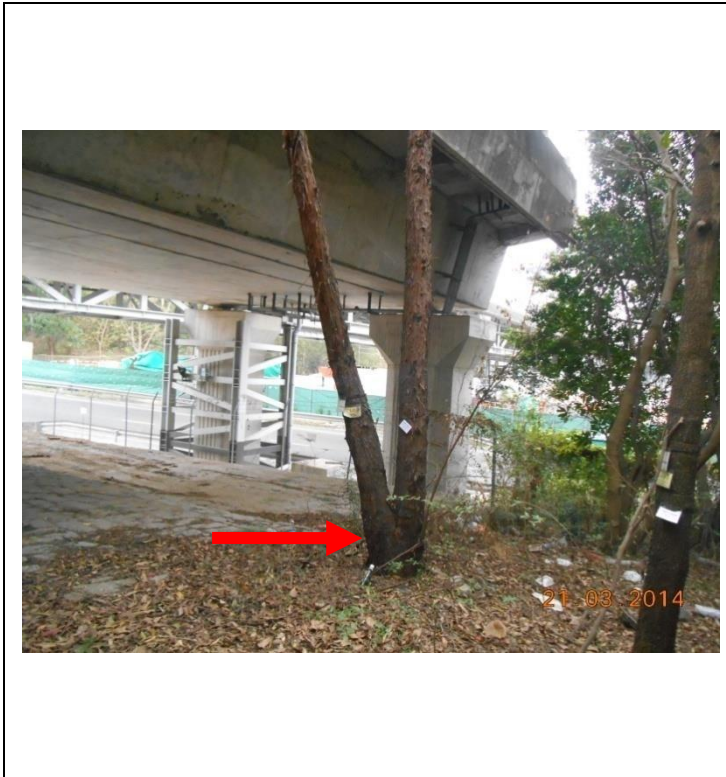
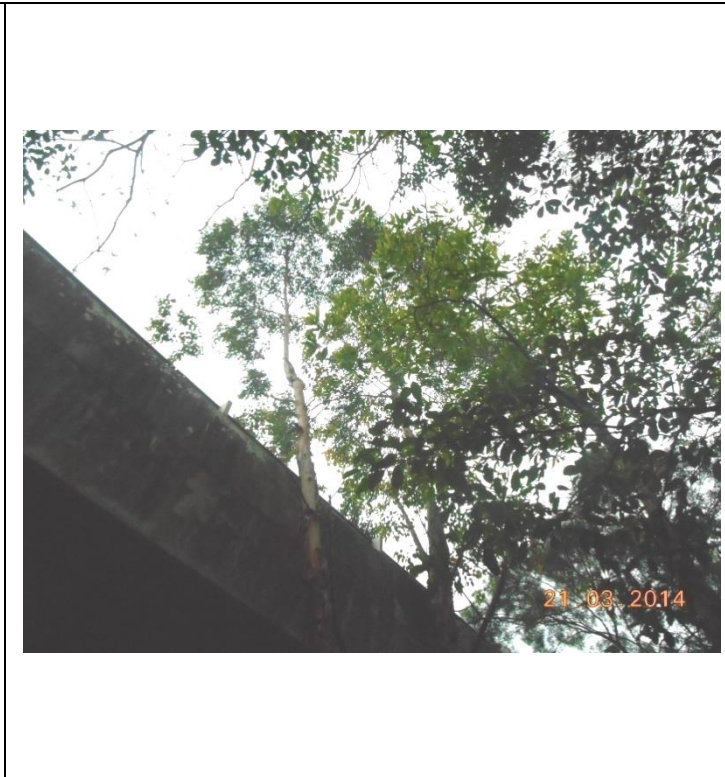
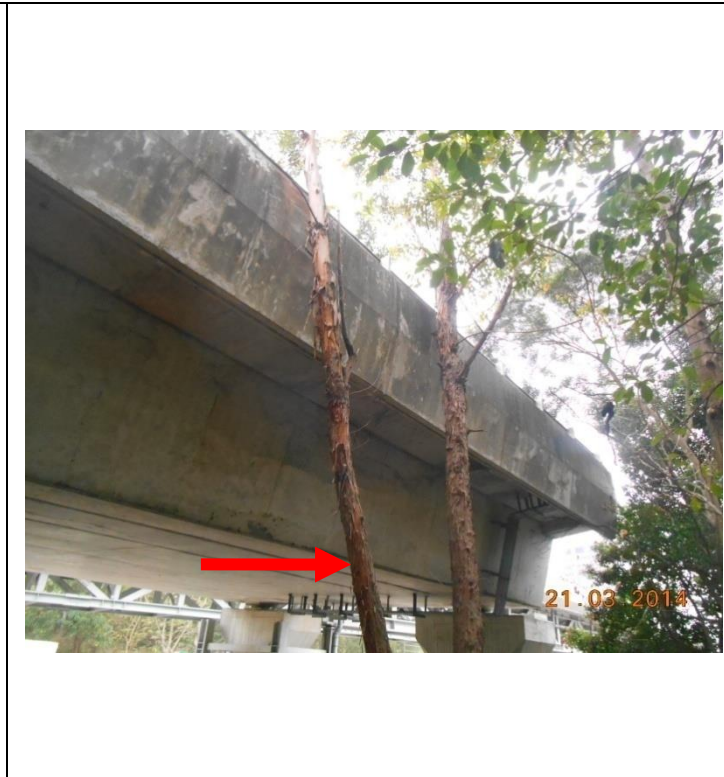
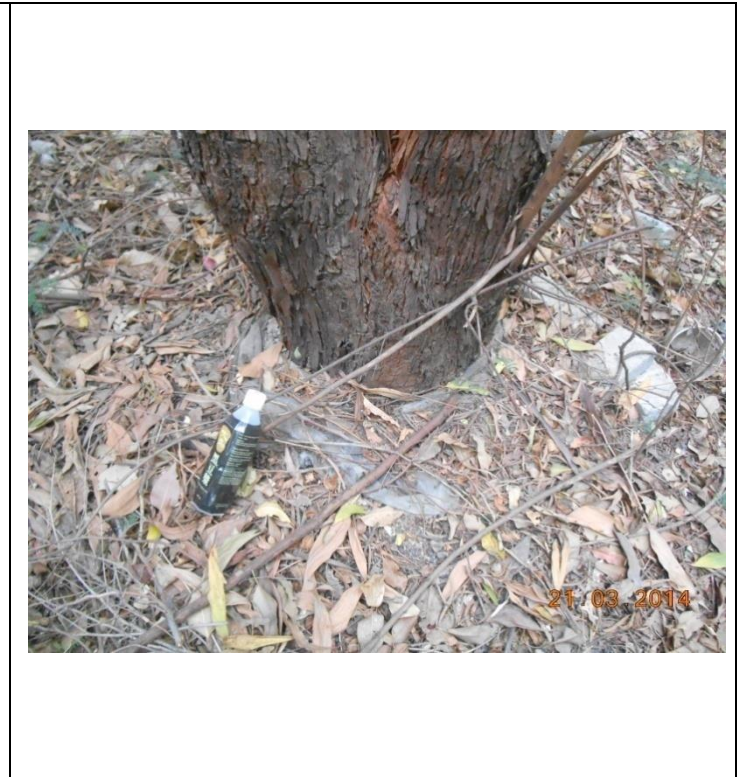
| YMT/T3091- 1-Fell<br>Scientific Name: <i>Eucalyptu scamaldulensis</i> | YMT/T3091-2 | YMT/T3091-3<br>Co-dominant trunk | YMT/T3091-4 |

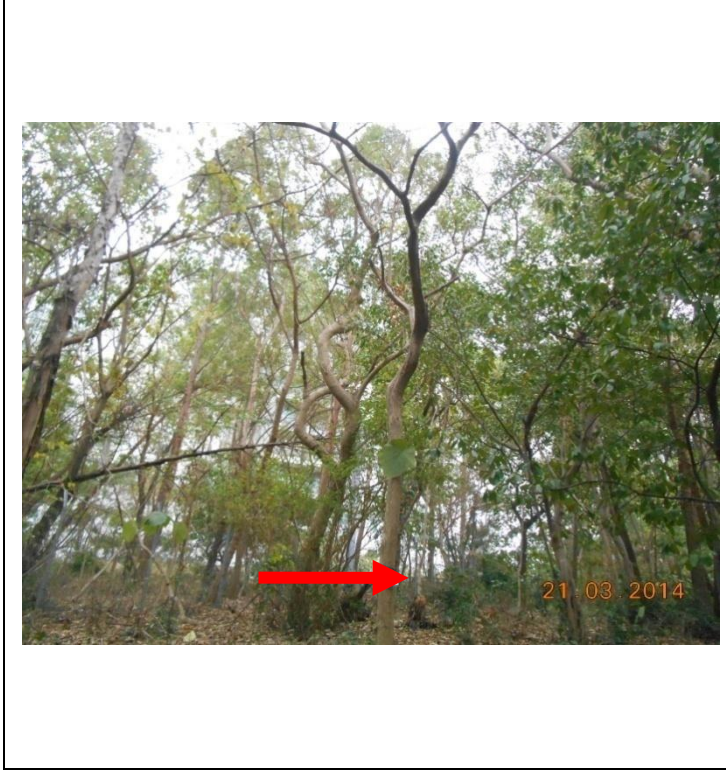
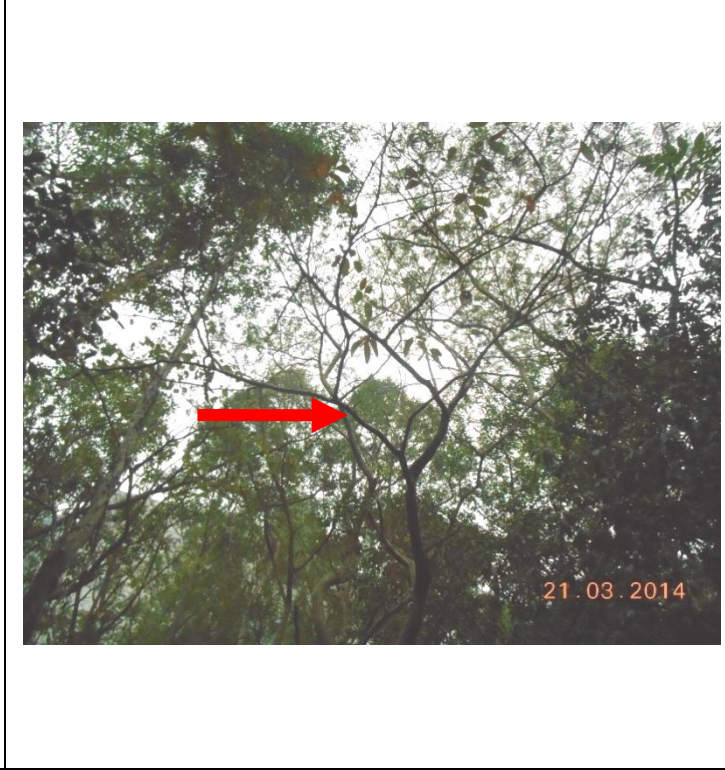
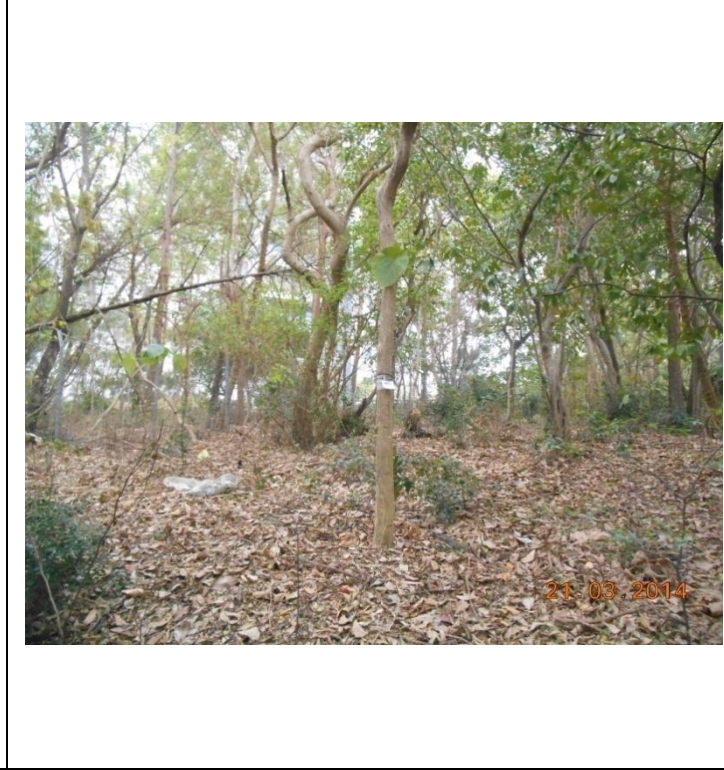
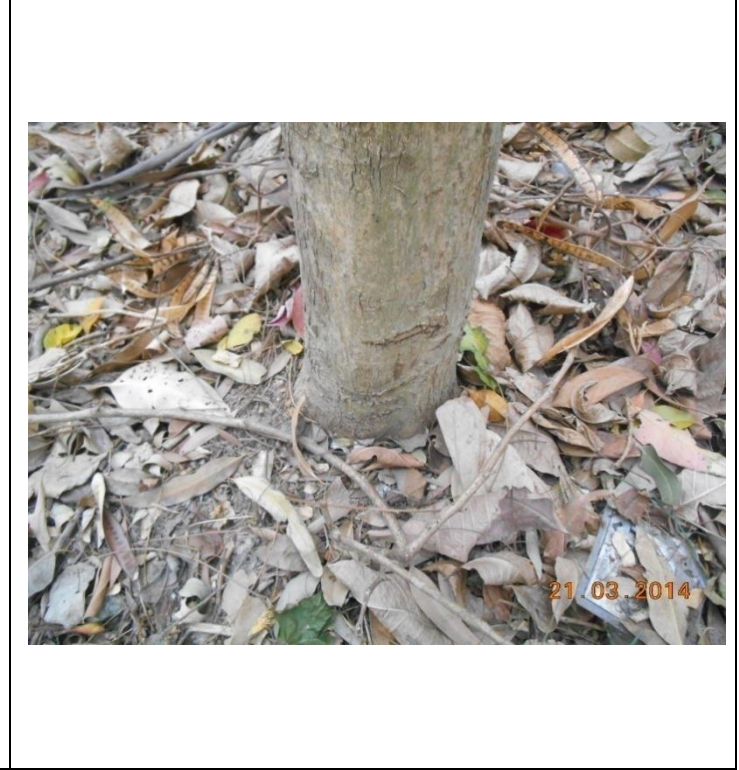
| YMT/T3092- 1-Fell<br>Scientific Name: <i>Lagerstroemia speciosa</i> | YMT/T3092-2<br>Dead branches | YMT/T3092-3 | YMT/T3092-4 |

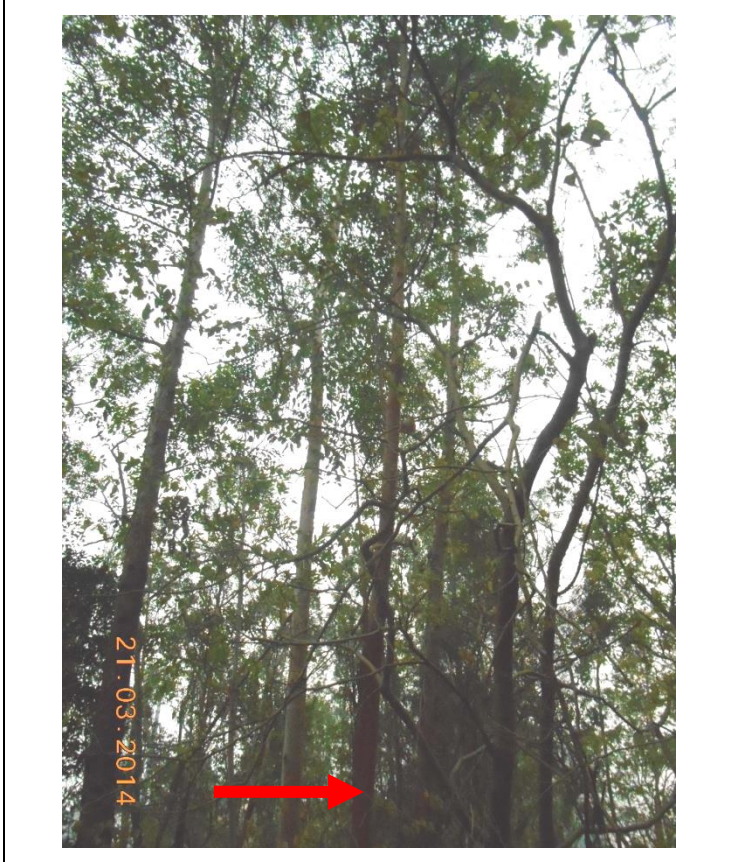
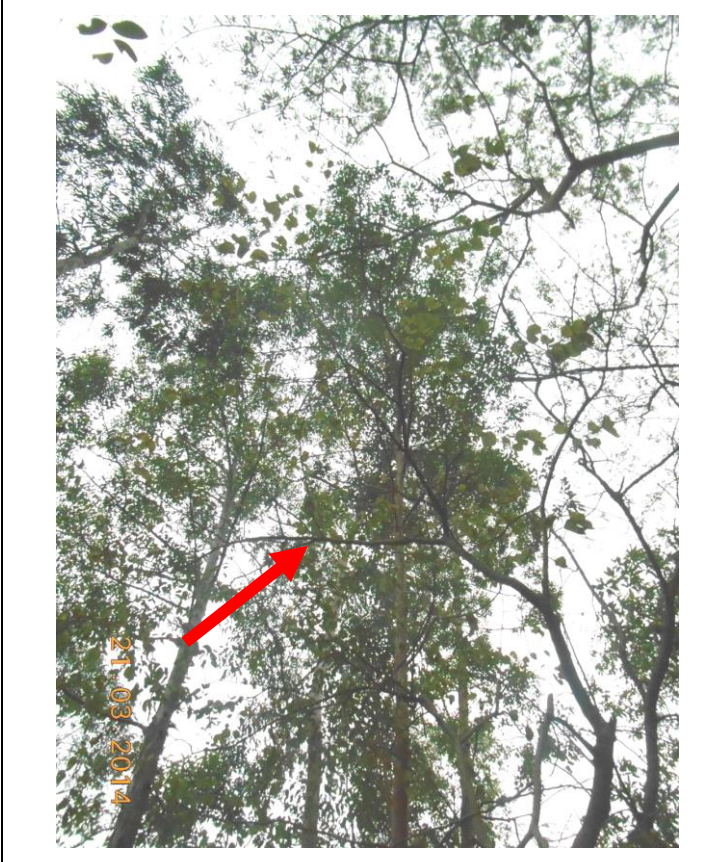
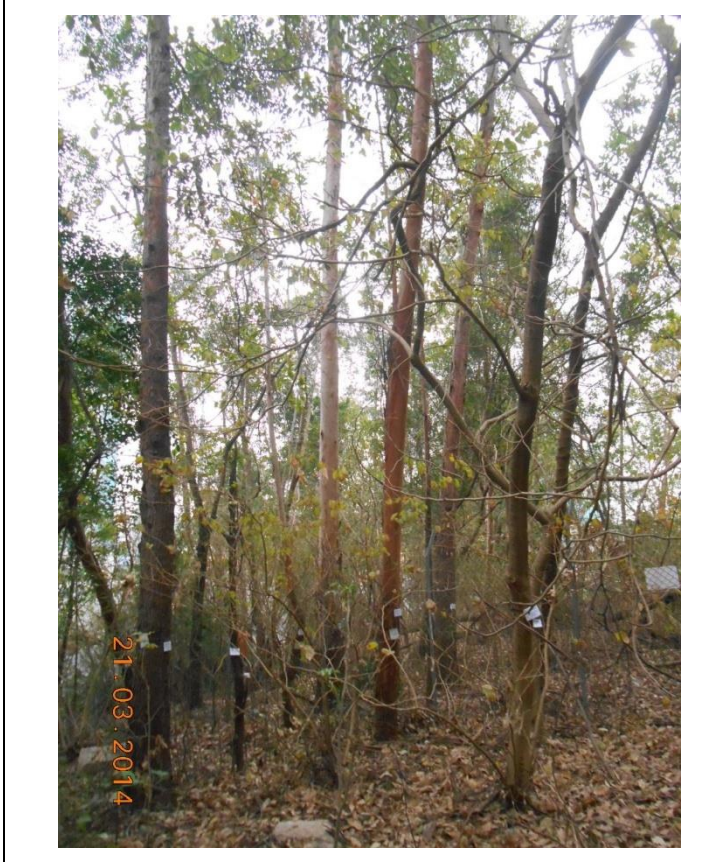
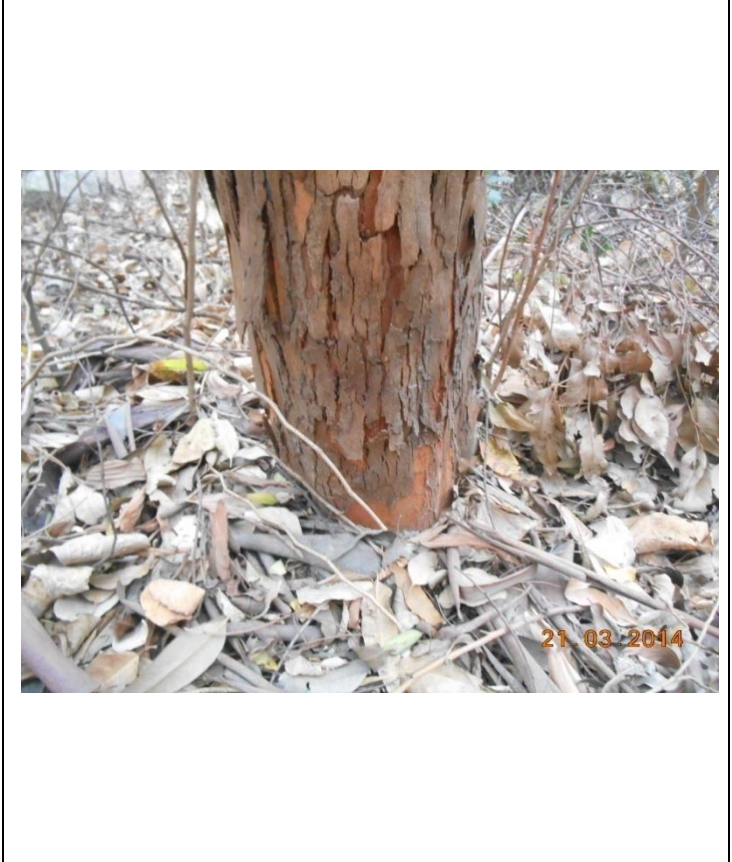
| YMT/T3096- 1-Retain<br>Scientific Name: <i>Eucalyptus camaldulensis</i> | YMT/T3096-2<br>Dead branches | YMT/T3096-3 | YMT/T3096-4 |

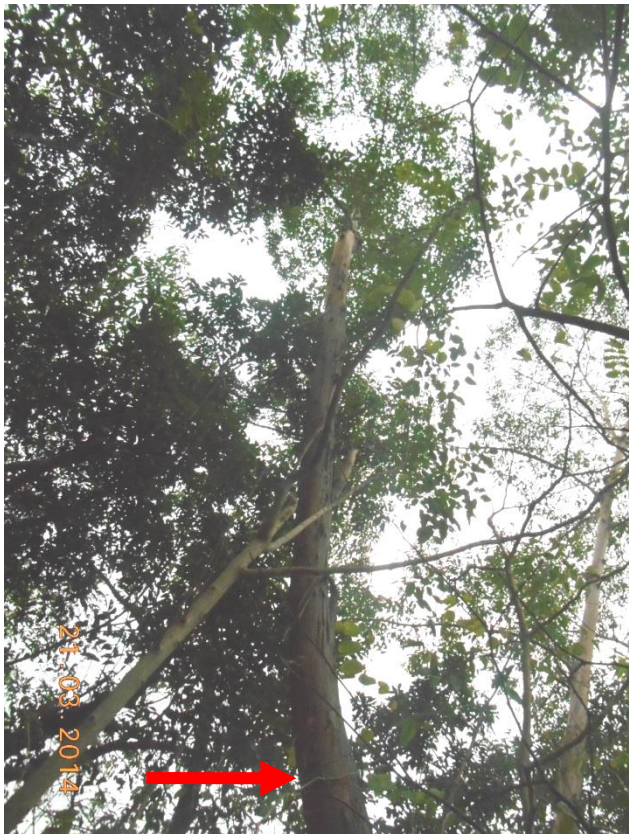
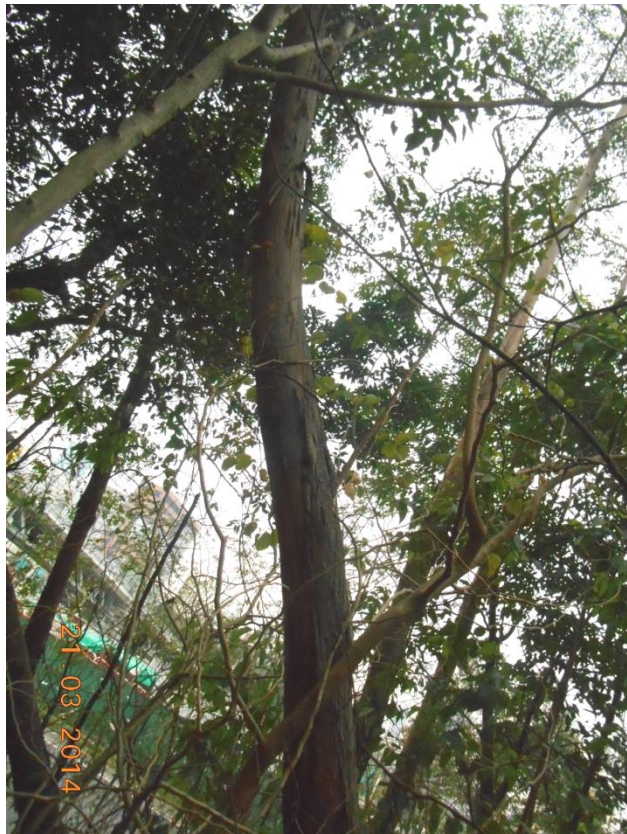
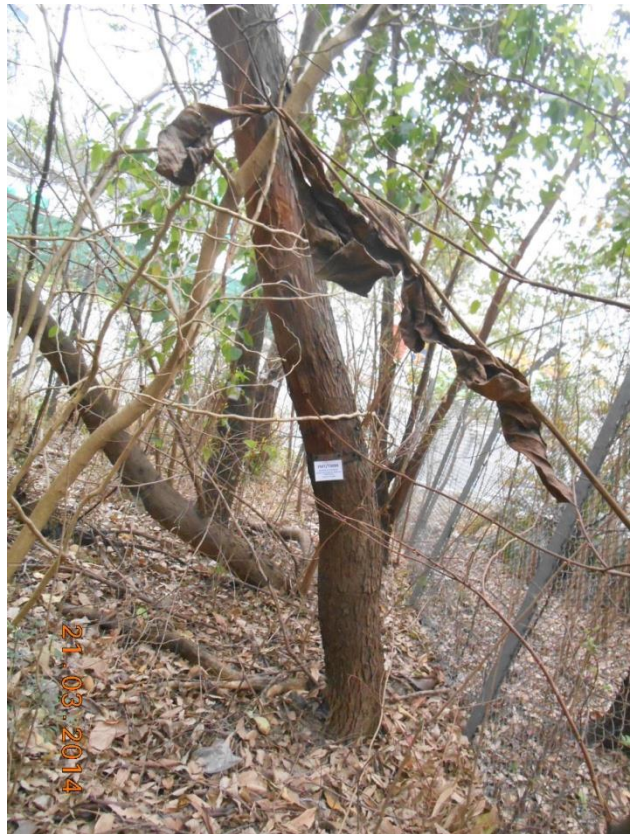
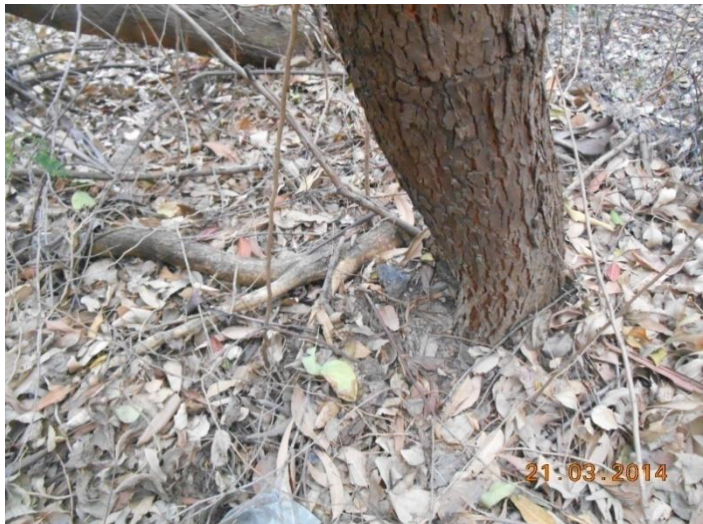
| YMT/T3099- 1-Retain<br>Scientific Name: <i>Eucalyptus camaldulensis</i> | YMT/T3099-2<br>Leaning | YMT/T3099-3 | YMT/T3099-4 |

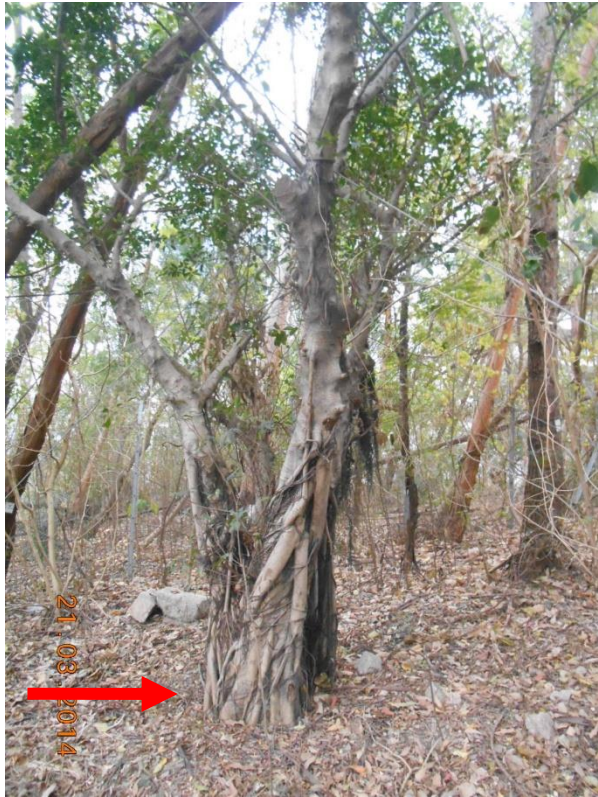
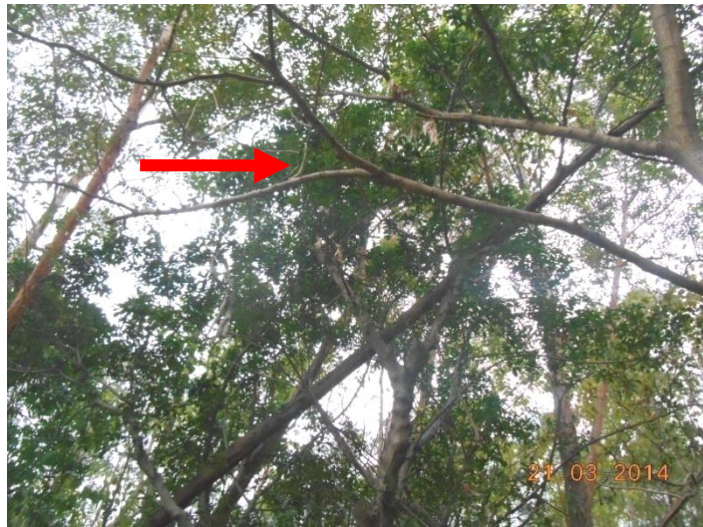
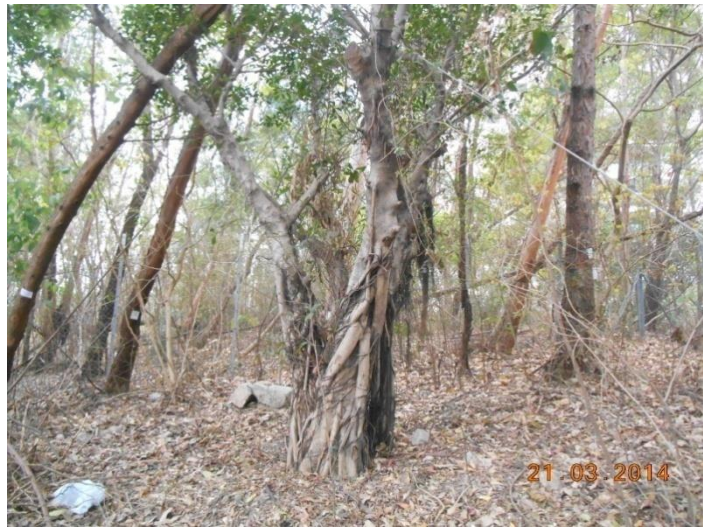
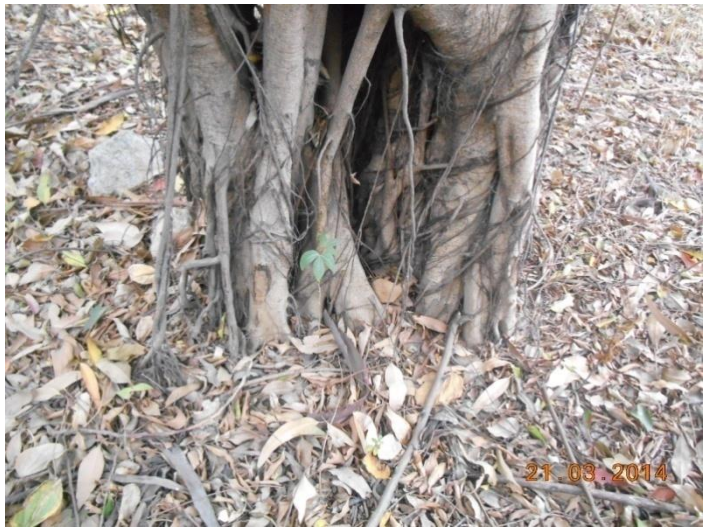
| YMT/T3100- 1-Retain<br>Scientific Name: <i>Ficus microcarpa</i> | YMT/T3100-2<br>Dead branches | YMT/T3100-3 | YMT/T3100-4 |
