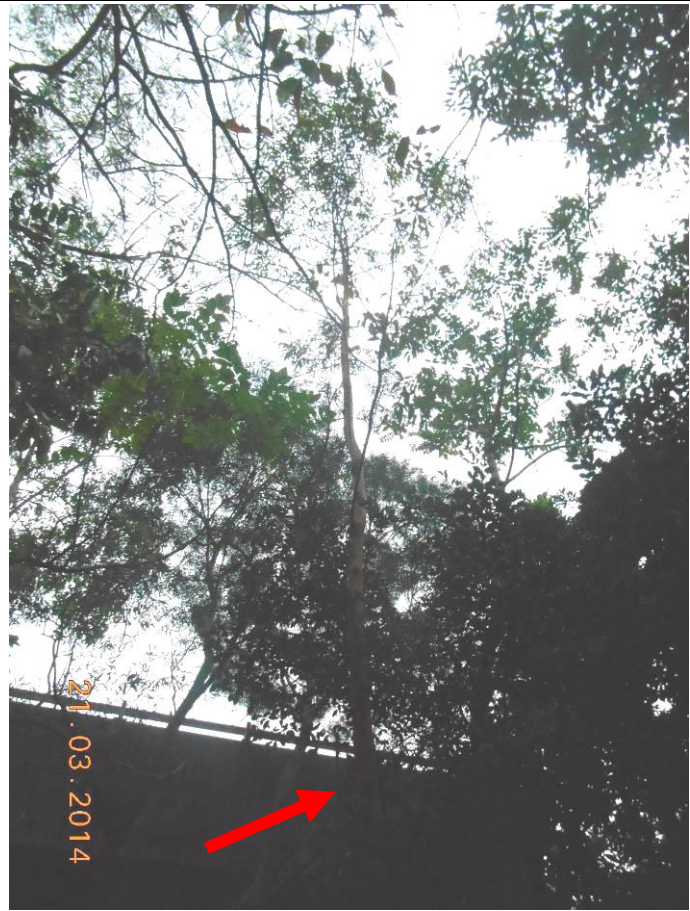
| YMT/ T3104- 1- Fell<br>Scientific Name: <i>Eucalyptus camaldulensis</i> | YMT/ T3104- 2 | YMT/ T3104- 3<br>Dead branches | YMT/ T3104- 4 |

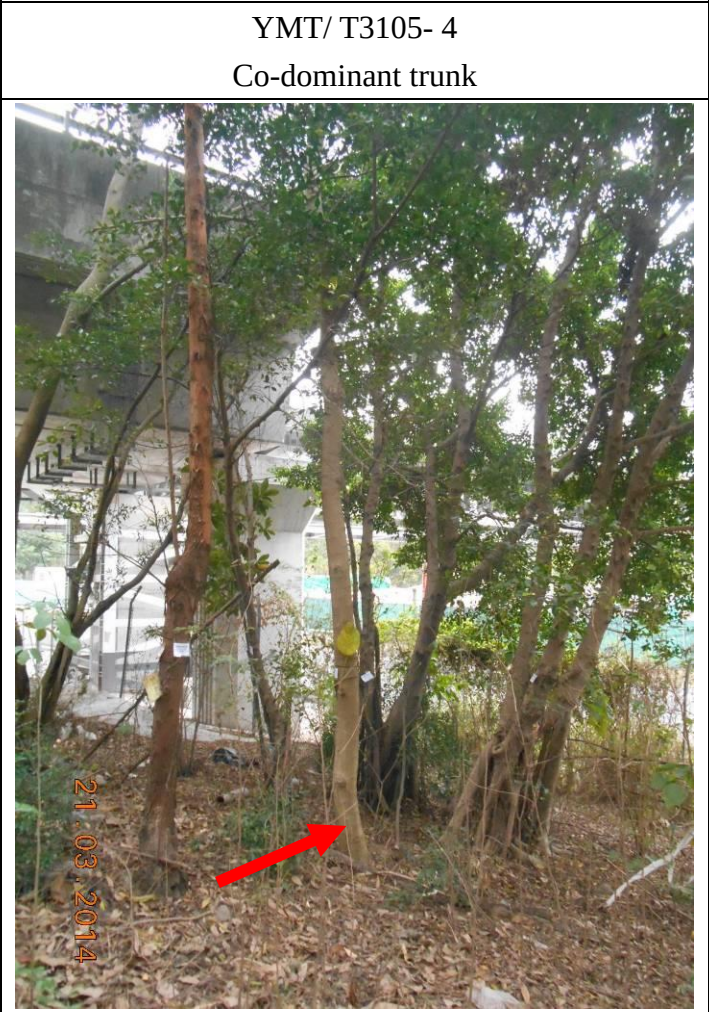
| YMT/ T3105- 1- Fell<br>Scientific Name: <i>Acacia confusa</i> | YMT/ T3105- 2 | YMT/ T3105- 3 | YMT/ T3105- 4<br>Co-dominant trunk |

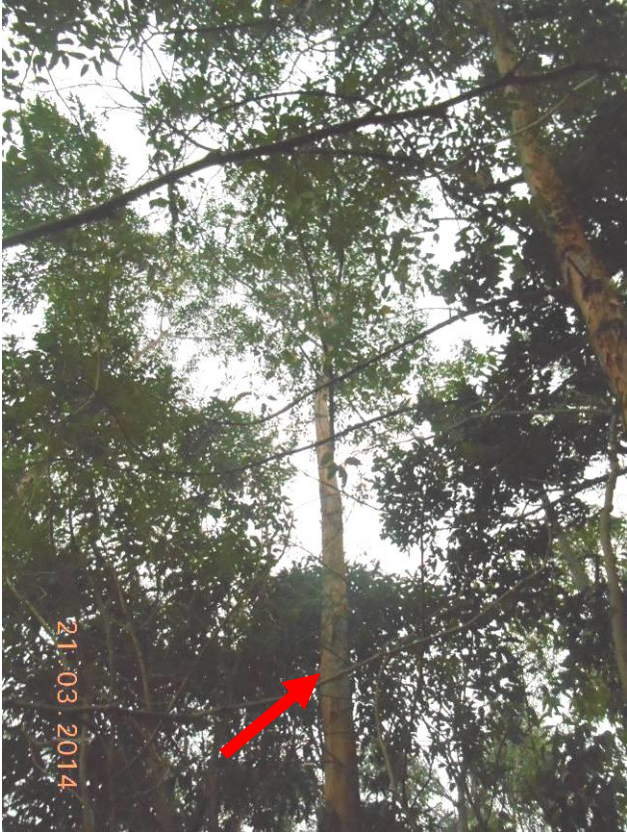
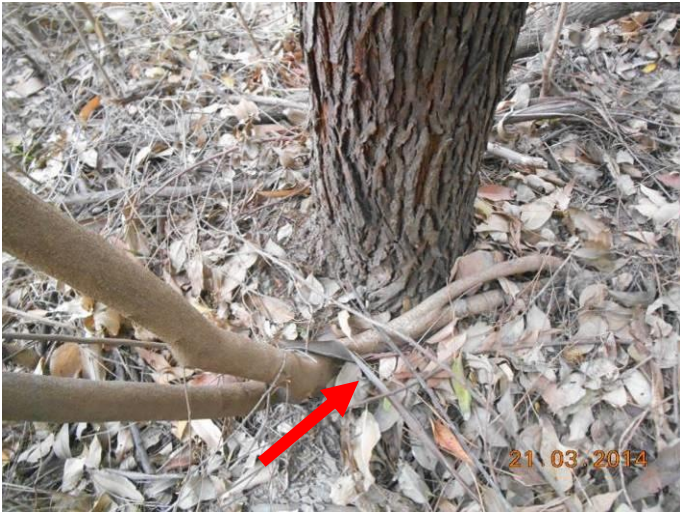
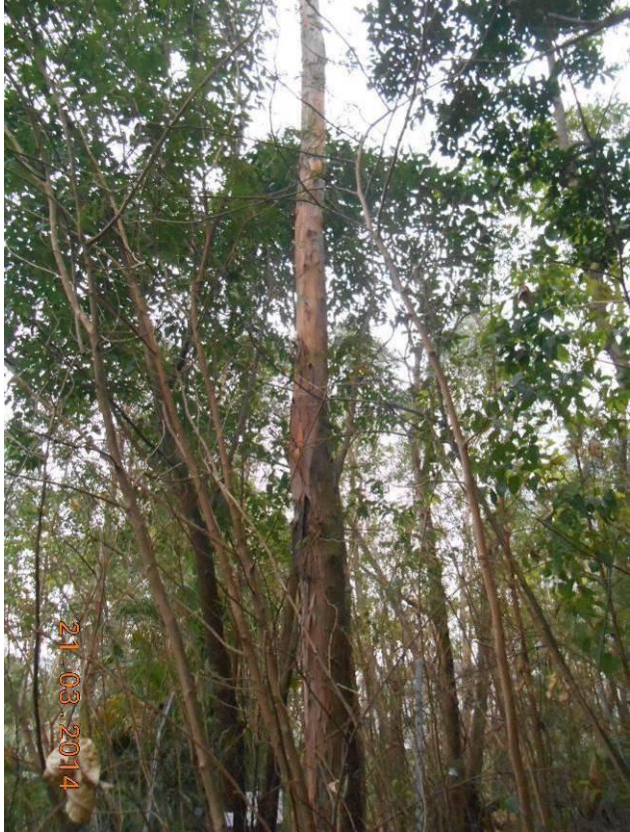
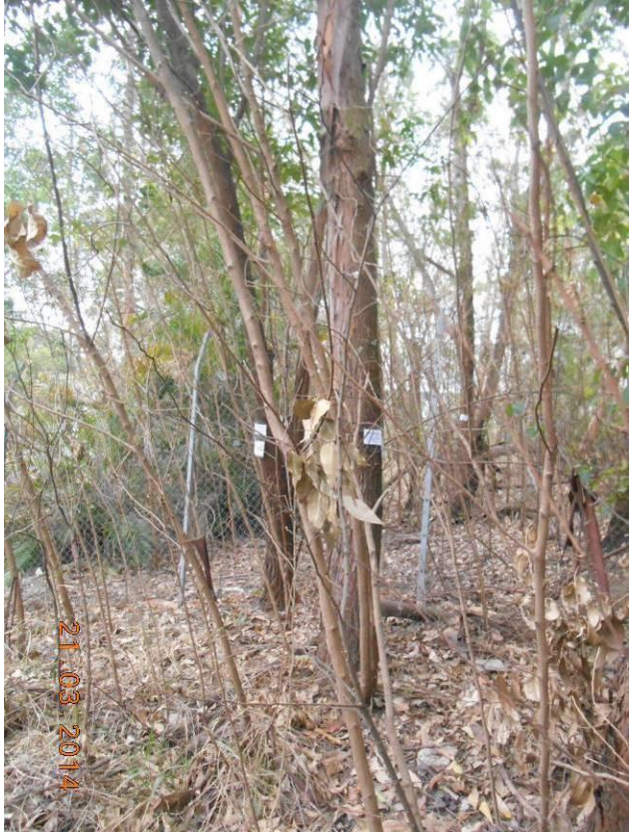
| YMT/ T3113- 1- Retain<br>Scientific Name: <i>Eucalyptus campanulata</i> | YMT/ T3113- 2<br>Exposed root | YMT/ T3113- 3 | YMT/ T3113- 4 |

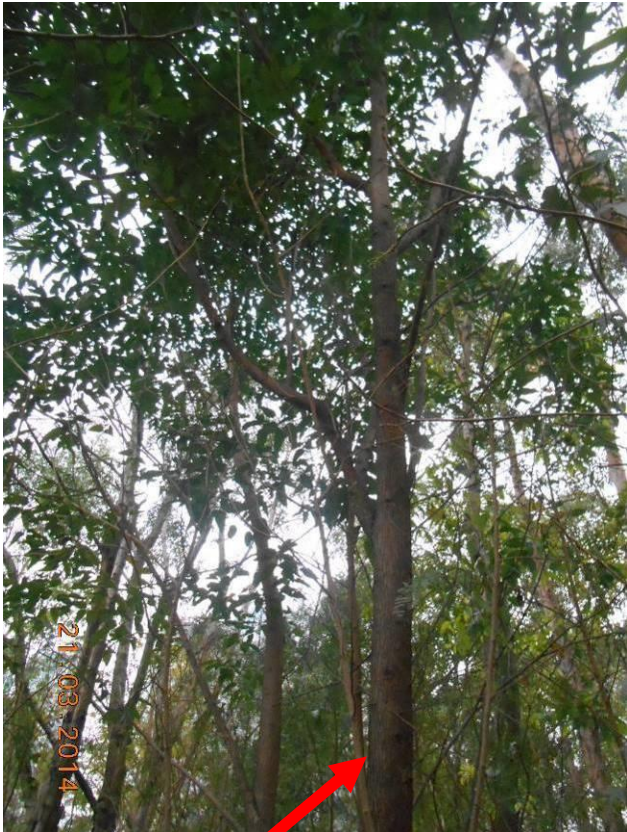
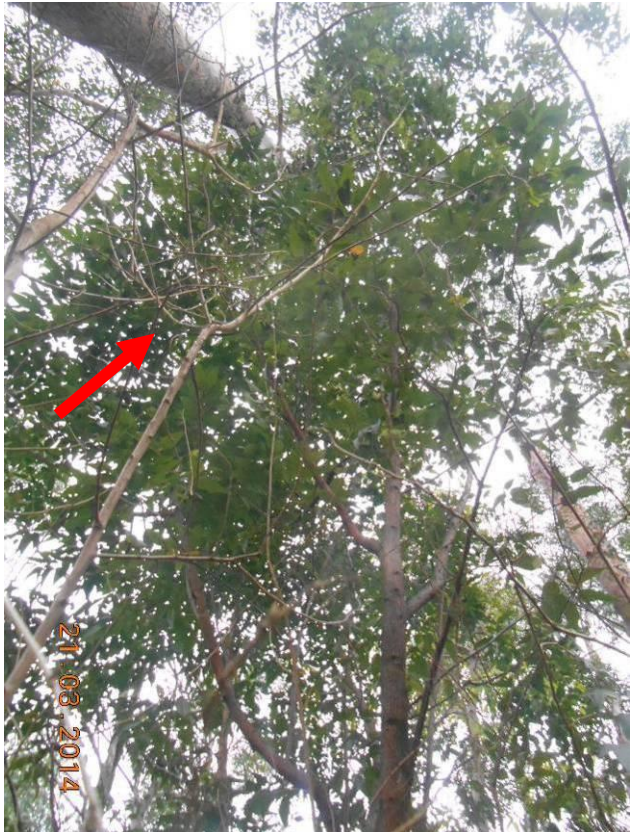
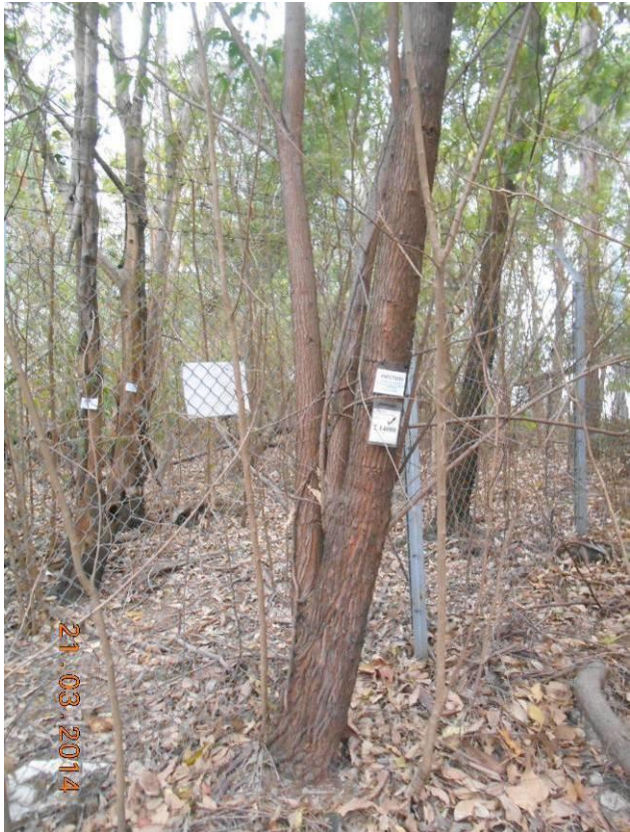
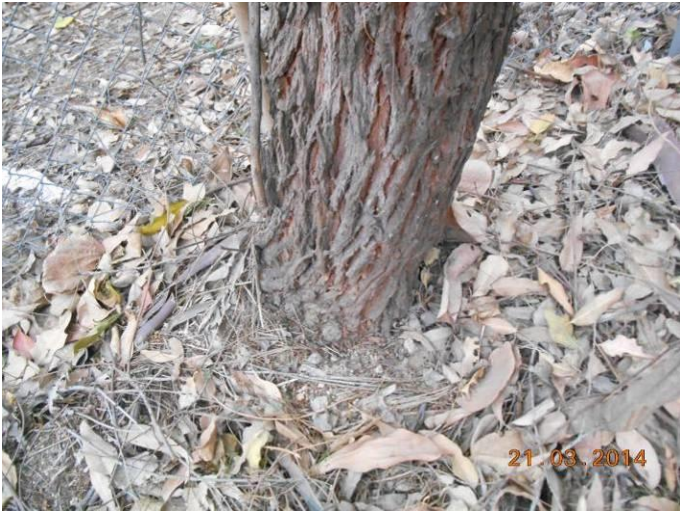
| YMT/ T3114- 1- Retain<br>Scientific Name: <i>Eucalyptus campanulata</i> | YMT/ T3114- 2<br>Dead branches | YMT/ T3114- 3 | YMT/ T3114- 4 |

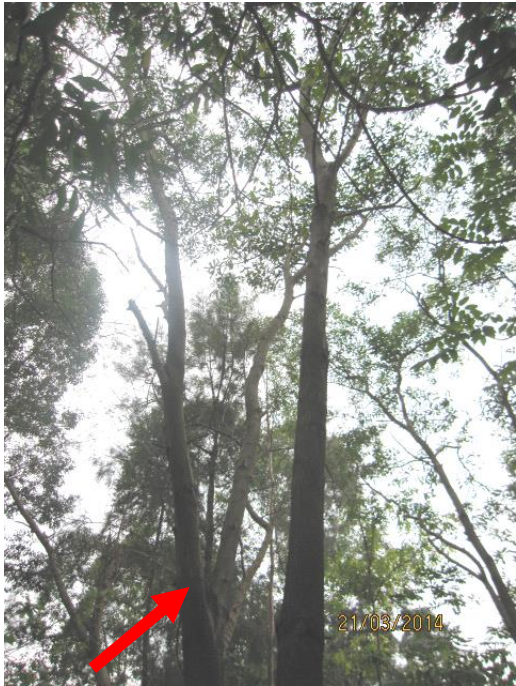
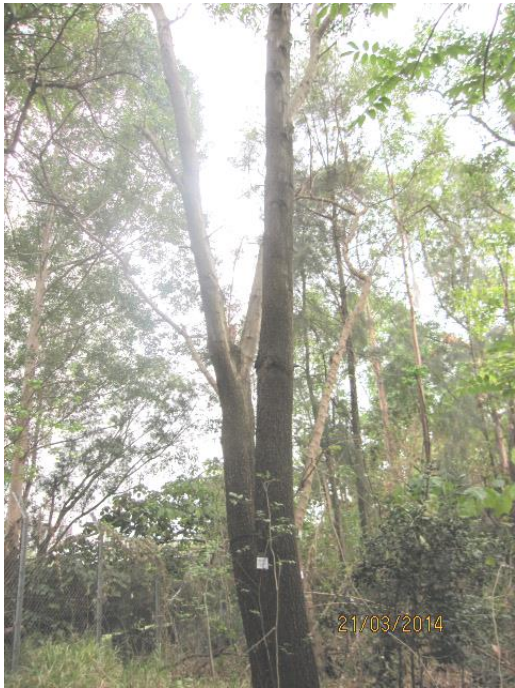
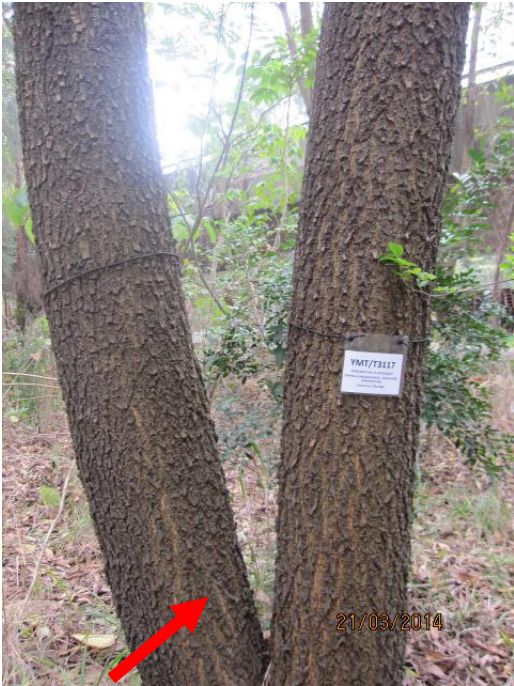
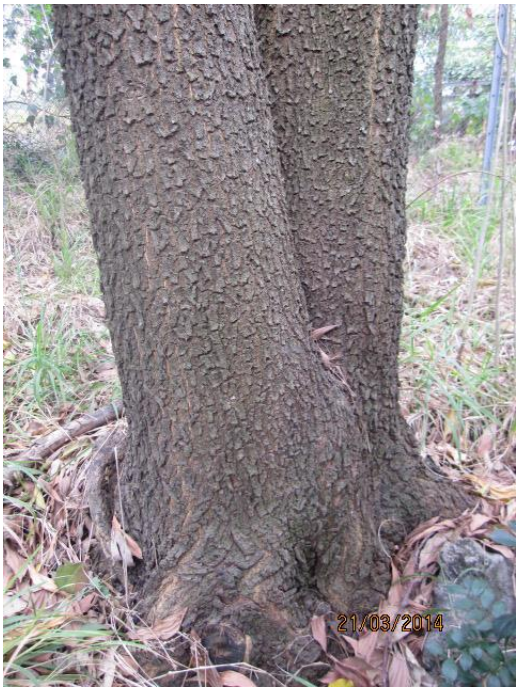
| YMT/ T3117 – 1- Retain<br>Scientific Name: <i>Acacia mangium</i> | YMT/ T3117 - 2 | YMT/ T3117 – 3<br>Co-dominant trunk | YMT/ T3117 - 4 |

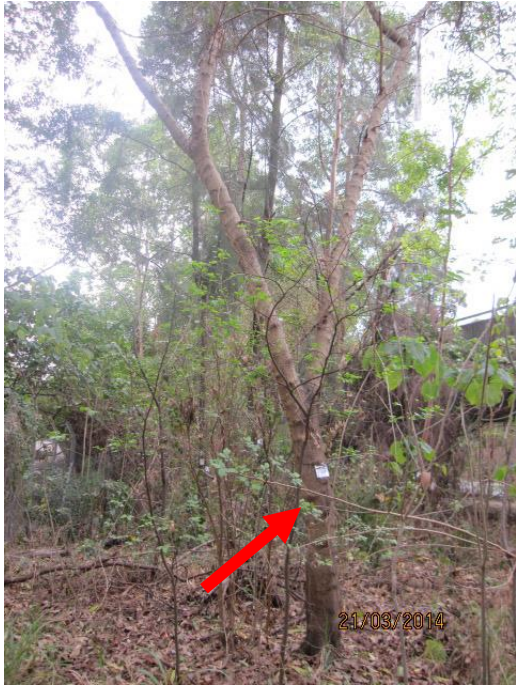
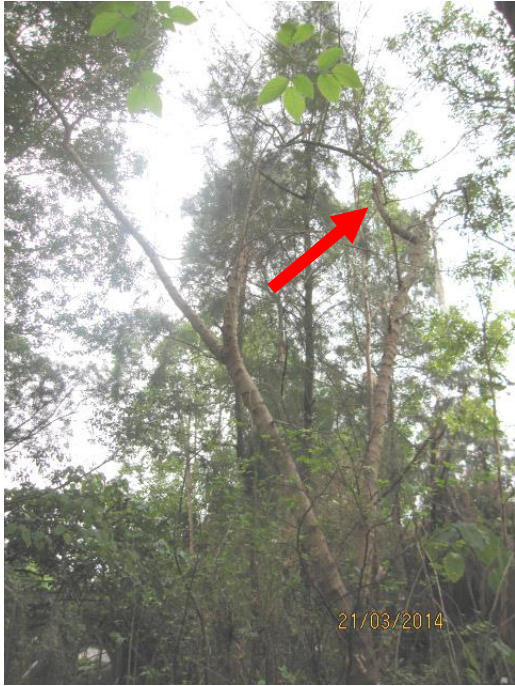
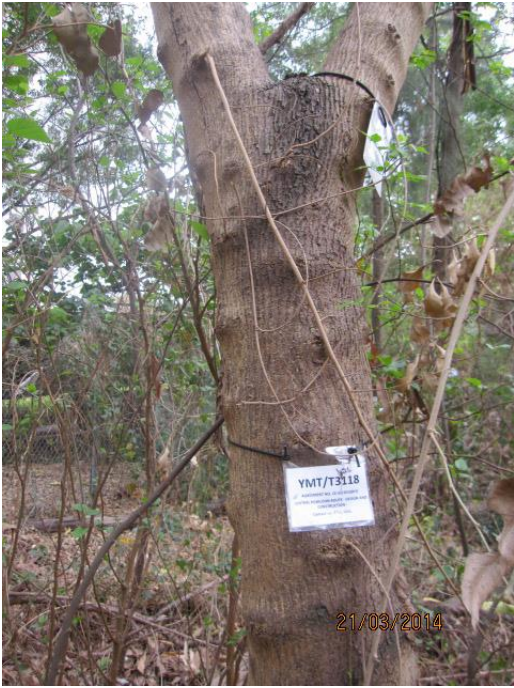
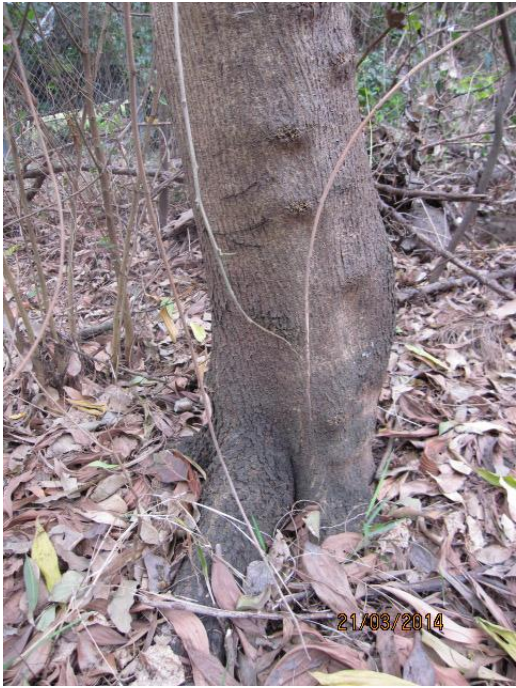
| YMT/ T3118 – 1- Retain<br>Scientific Name: <i>Leucaena leucocephala</i> | YMT/ T3118 – 2<br>Dead branches | YMT/ T3118 - 3 | YMT/ T3118 - 4 |

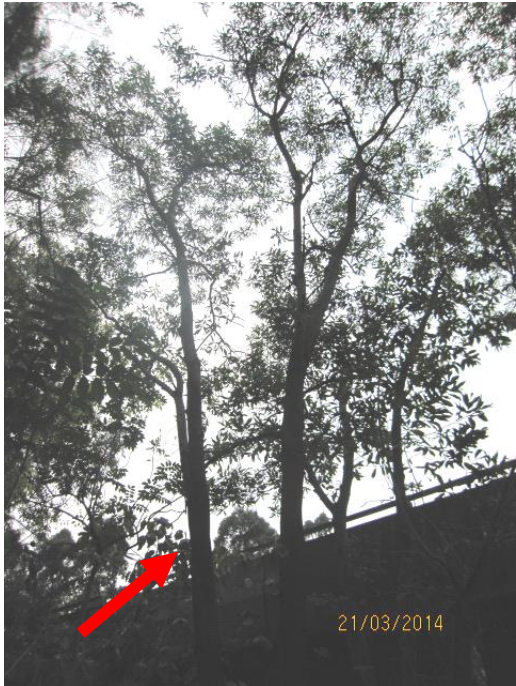
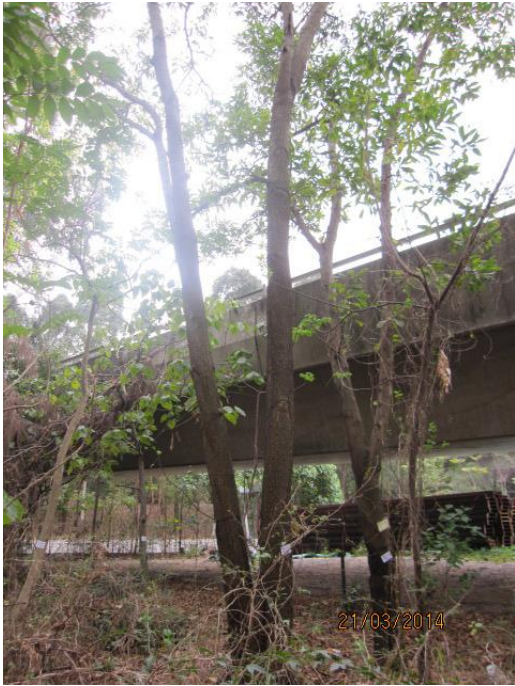
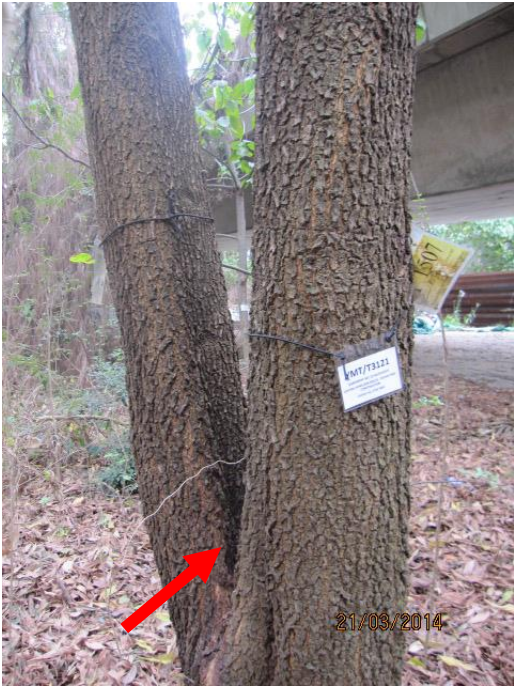
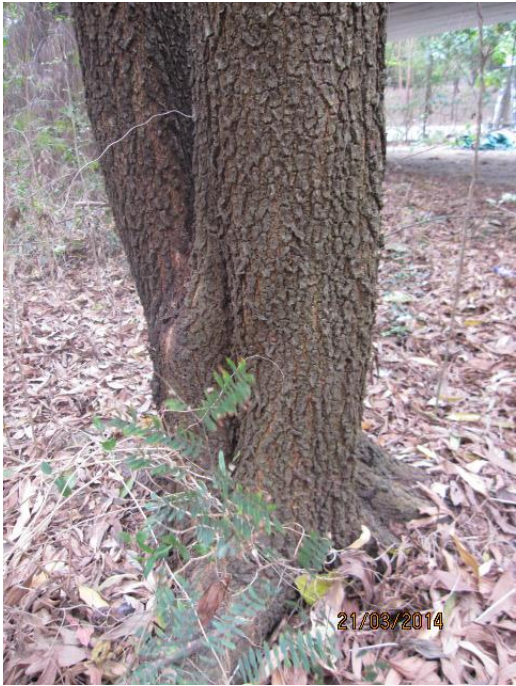
| YMT/ T3121 -1- Fell<br>Scientific Name: <i>Acacia mangium</i> | YMT/ T3121 - 2 | YMT/ T3121 – 3<br>Co-dominant trunk | YMT/ T3121 - 4 |

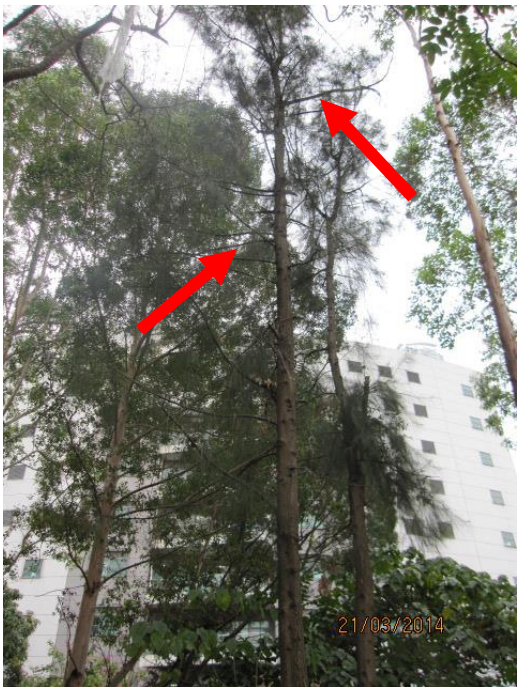
| YMT/ T3123 – 1- Fell<br>Scientific Name: <i>Casuarina equisetifolia</i> | YMT/ T3123 – 2<br>Dead branches | YMT/ T3123 - 3 | YMT/ T3123 - 4 |

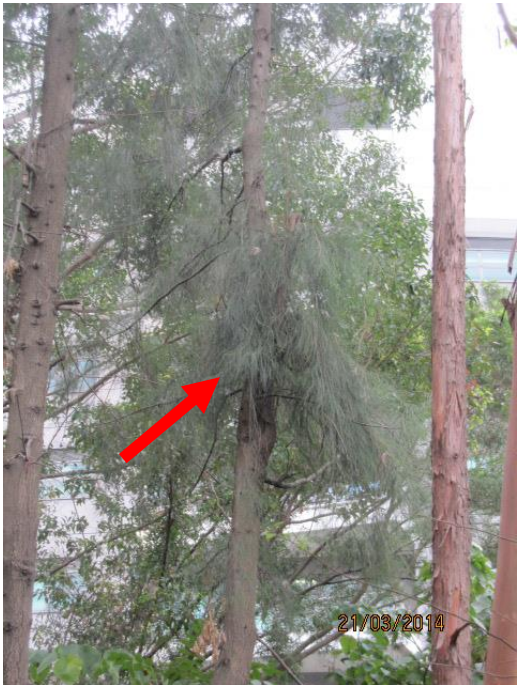
| YMT/ T3124 – 1- Fell<br>Scientific Name: <i>Casuarina equisetifolia</i> | YMT/ T3124 – 2<br>Dead branches | YMT/ T3124 - 3 | YMT/ T3124 - 4 |

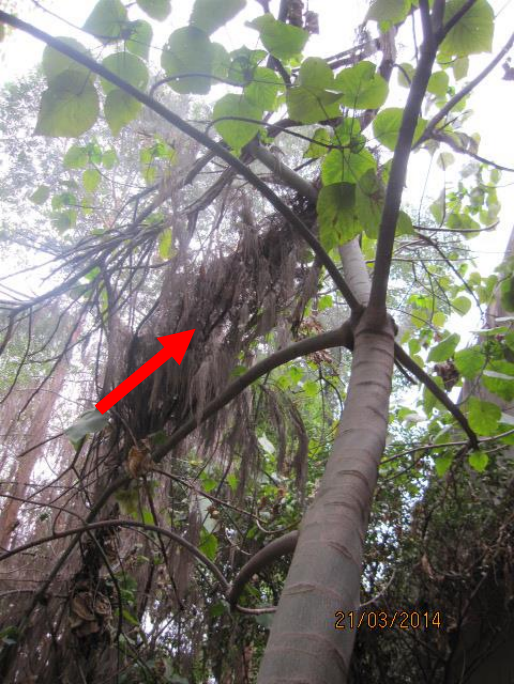
| YMT/ T3127 – 1- Fell<br>Scientific Name: <i>Macaranga tanarius var. tomentosa</i> | YMT/ T3127 – 2<br>Climber | YMT/ T3127 - 3 | YMT/ T3127 - 4 |

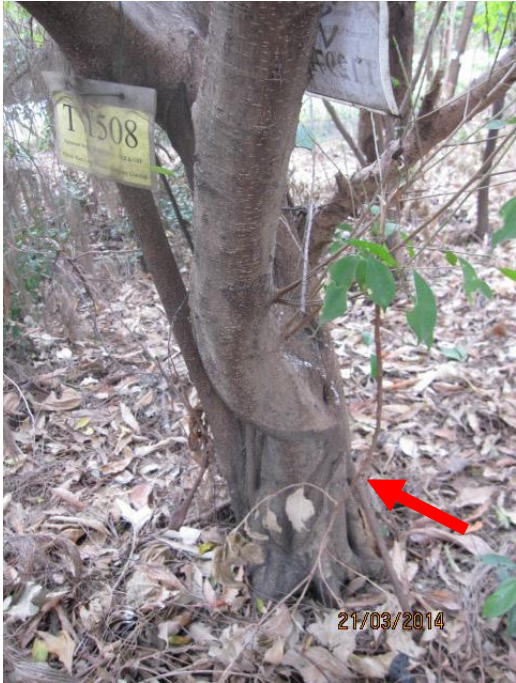
| YMT/ T3128 – 1-Fell<br>Scientific Name: <i>Ficus microcarpa</i> | YMT/ T3128 - 2 | YMT/ T3128 – 3<br>Epicormics | YMT/ T3128 - 4 |

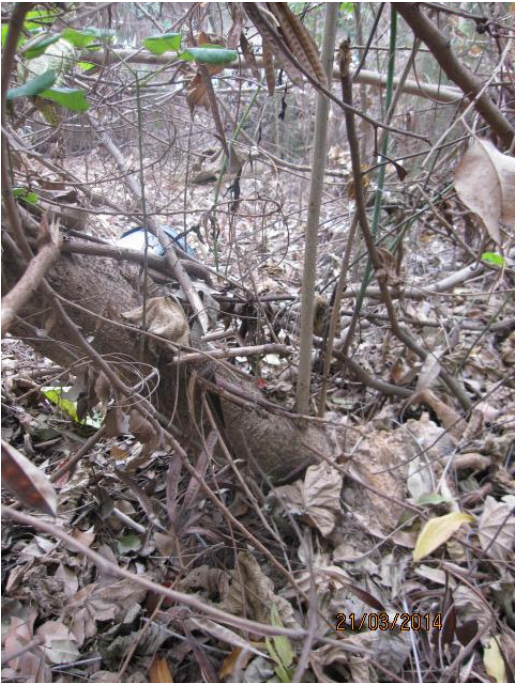
| YMT/ T3130 – 1-Retain<br>Scientific Name: <i>Spathodea campanulata</i> | YMT/ T3130 - 2 | YMT/ T3130 - 3 | YMT/ T3130 – 4<br>Leaning |

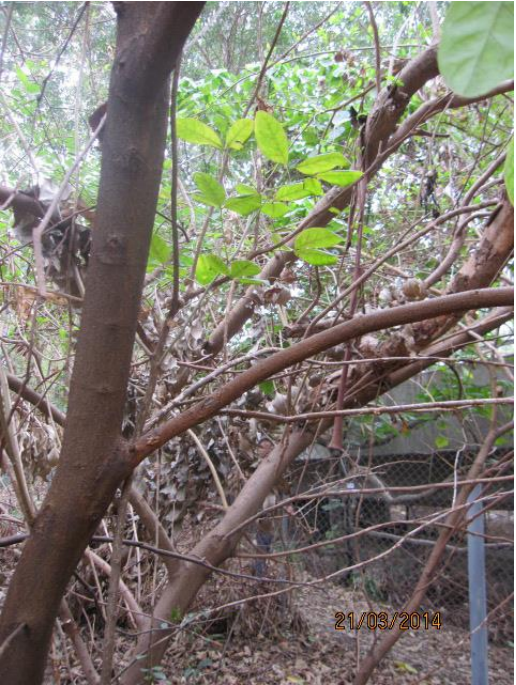
| YMT/ T3131 – 1- Retain<br>Scientific Name: <i>Morus alba</i> | YMT/ T3131 – 2<br>Dead branches | YMT/ T3131 - 3 | YMT/ T3131 - 4 |

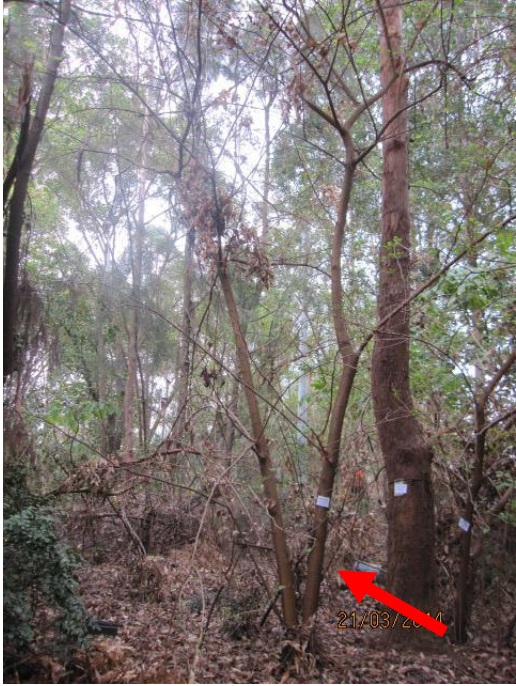
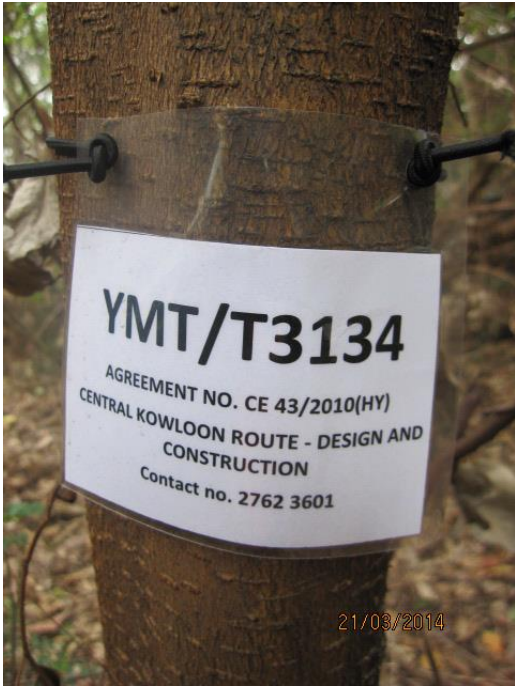
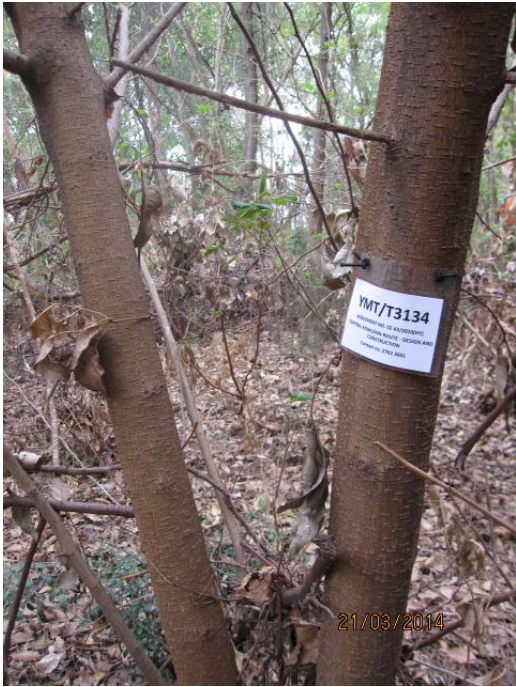
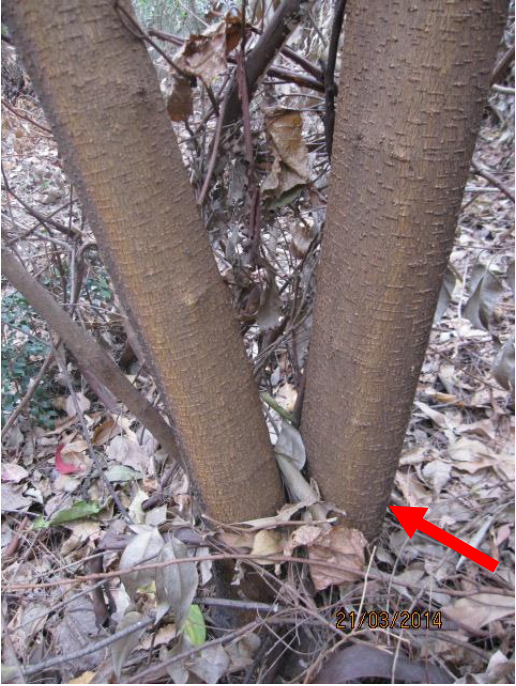
| YMT/ T3134- 1- Retain<br>Scientific Name: <i>Morus alba</i> | YMT/ T3134- 2 | YMT/ T3134- 3 | YMT/ T3134- 4<br>Co-dominant trunk |

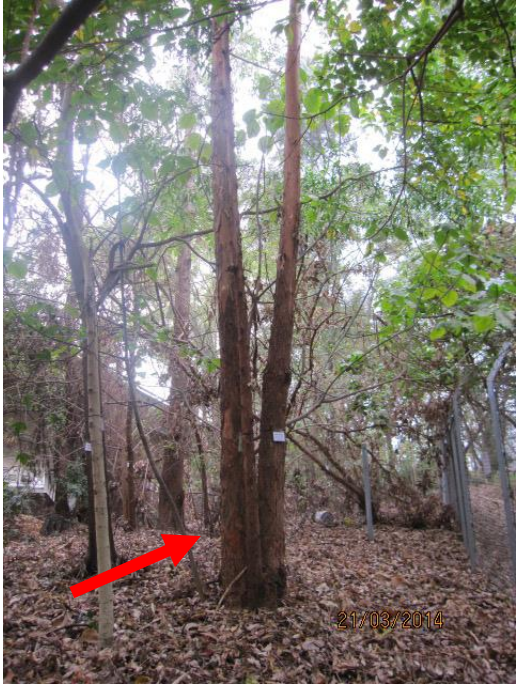
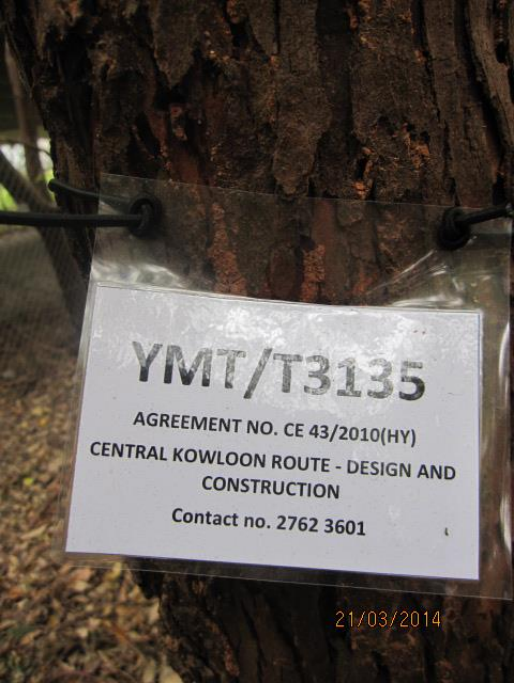
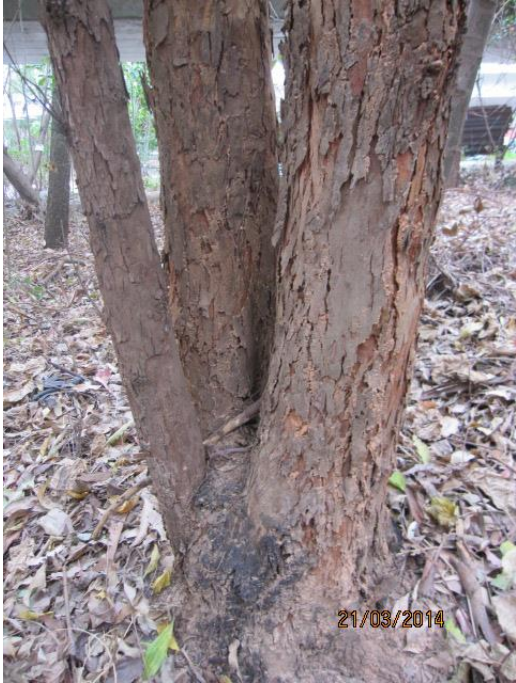
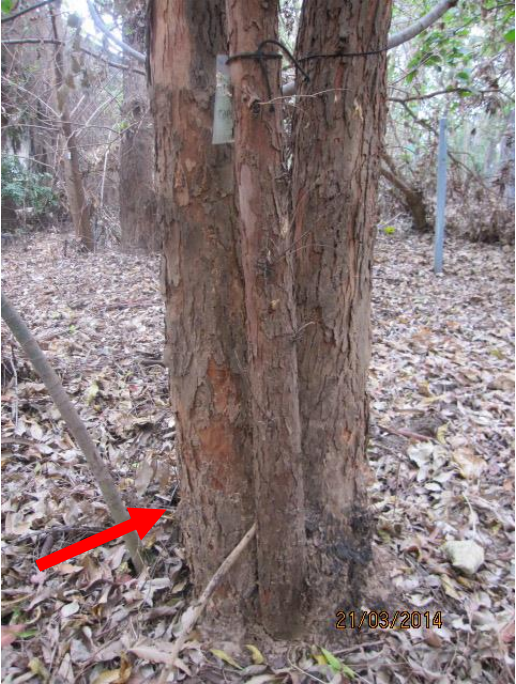
| YMT/ T3135- 1- Retain<br>Scientific Name: <i>Eucalyptus camaldulensis</i> | YMT/ T3135- 2 | YMT/ T3135- 3 | YMT/ T3135- 4<br>Co-dominant trunk |

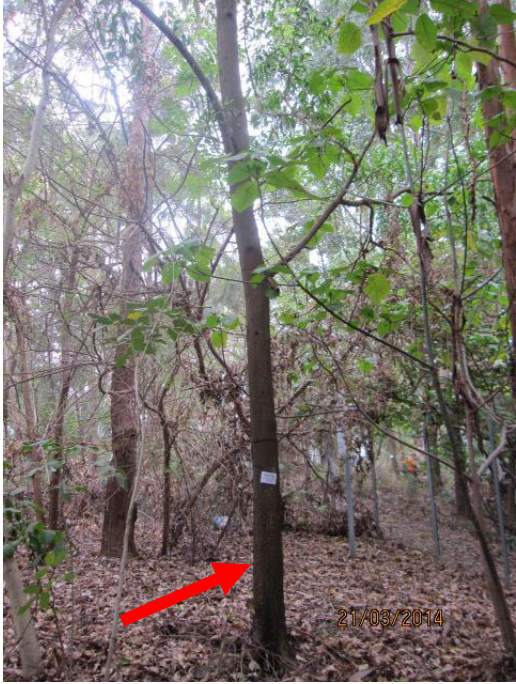
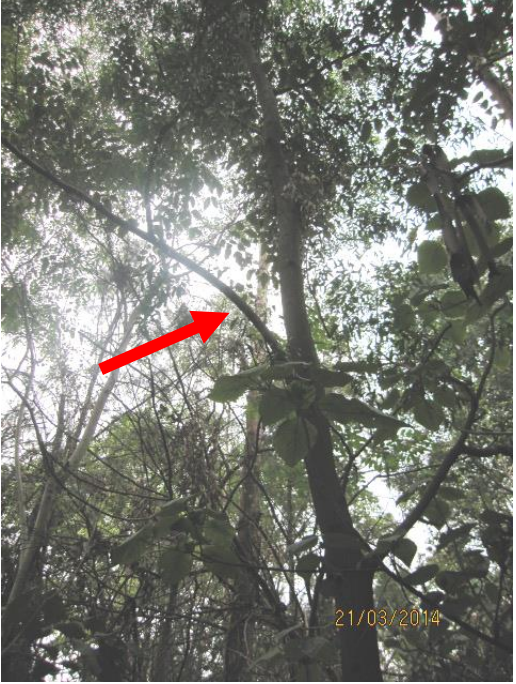
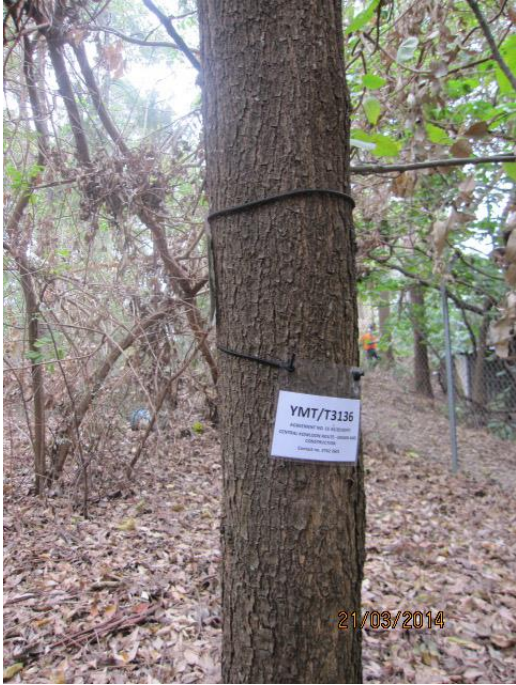
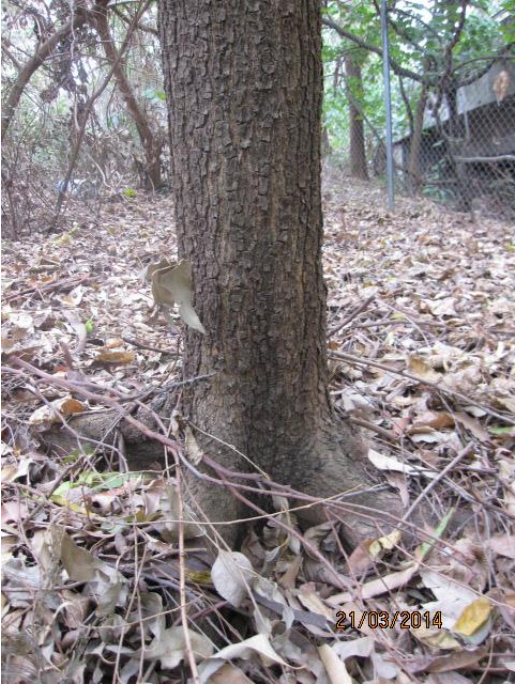
| YMT/ T3136- 1- Retain<br>Scientific Name: <i>Acacia mangium</i> | YMT/ T3136- 2<br>Dead branches | YMT/ T3136- 3 | YMT/ T3136- 4 |

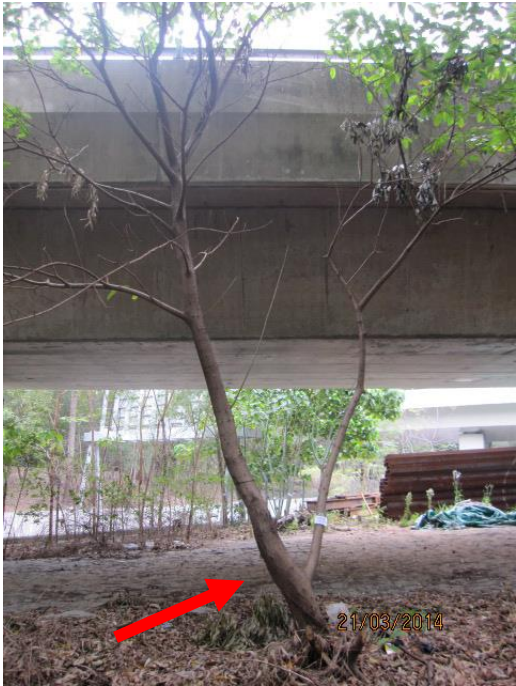
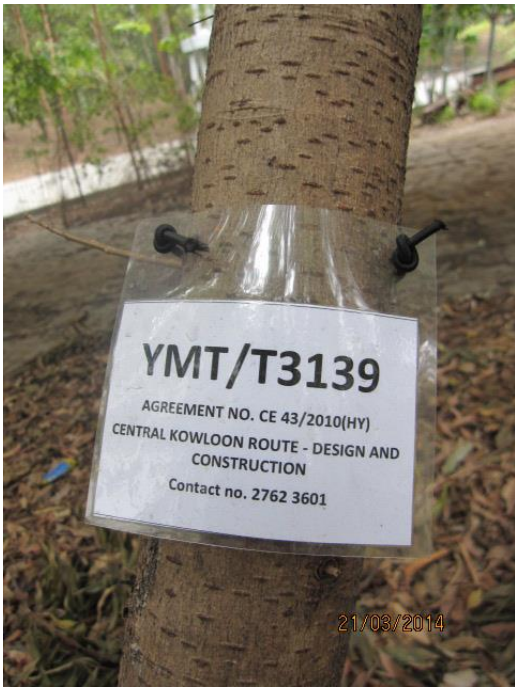
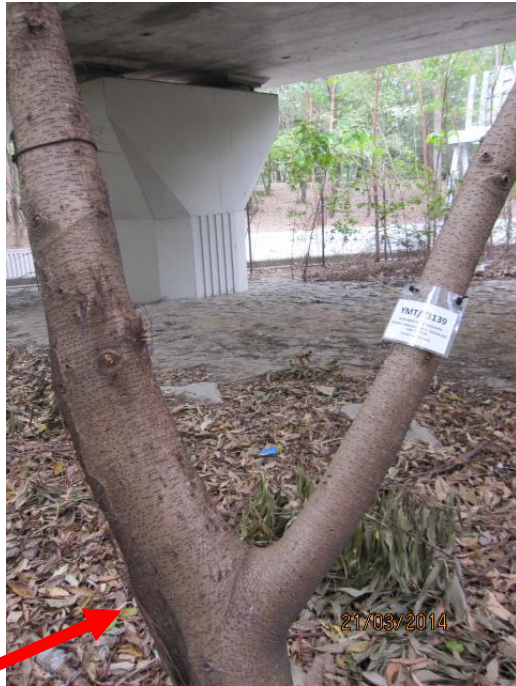
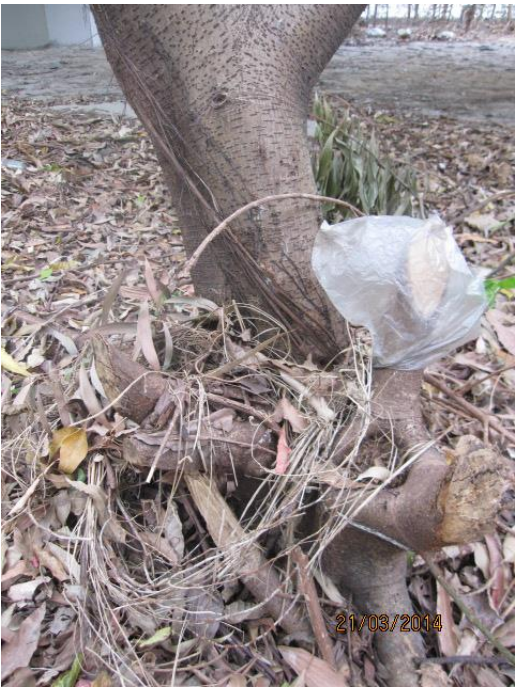
| YMT/ T3139- 1- Retain<br>Scientific Name: <i>Ficus virens</i> | YMT/ T3139- 2 | YMT/ T3139- 3<br>Co-dominant trunk | YMT/ T3139- 4 |

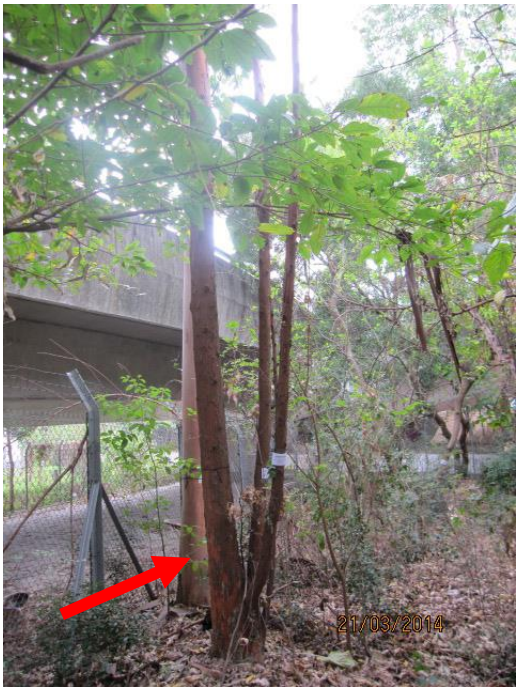
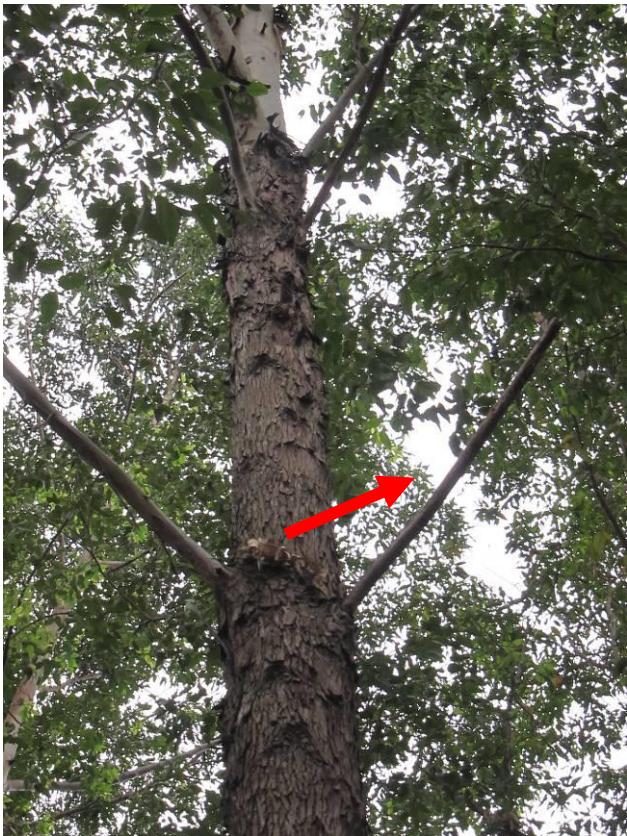
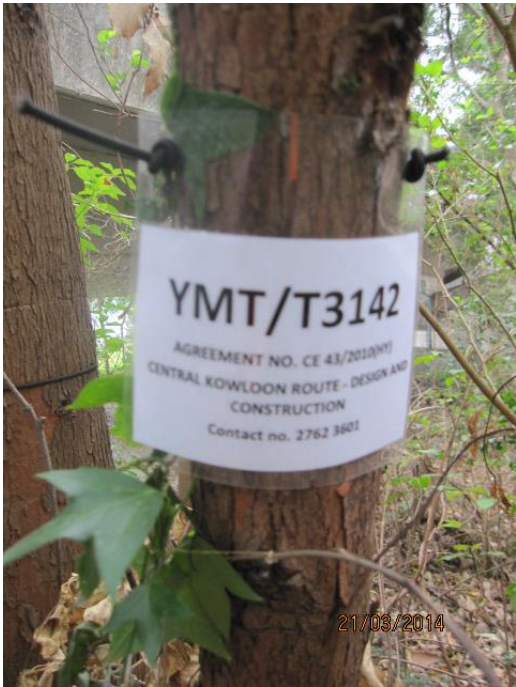
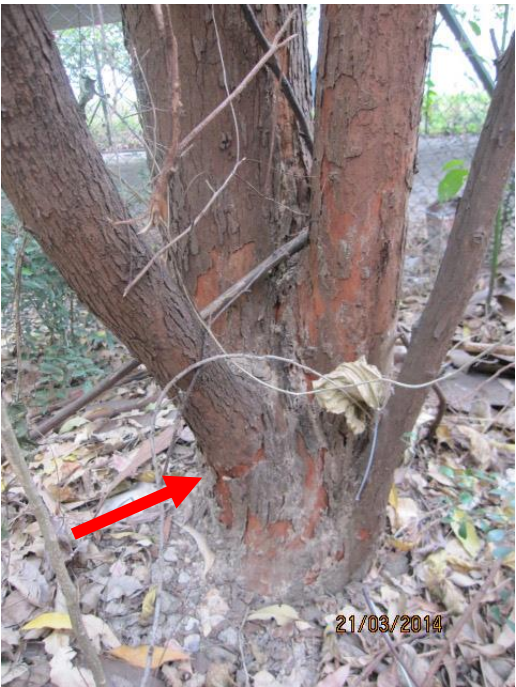
| YMT/ T3142- 1- Retain<br>Scientific Name: <i>Eucalyptus camaldulensis</i> | YMT/ T3142- 2<br>Dead branches | YMT/ T3142- 3 | YMT/ T3142- 4<br>Co-dominant trunk |

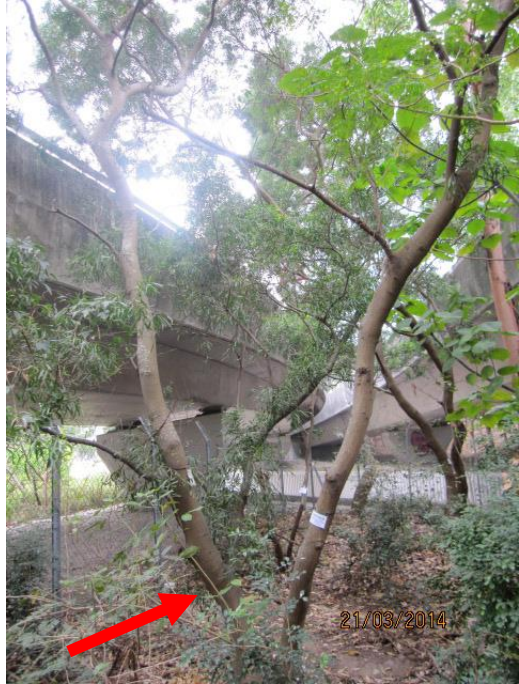
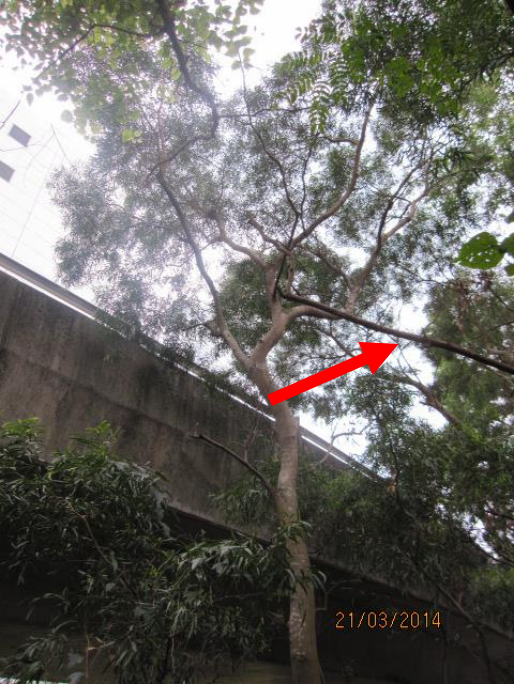
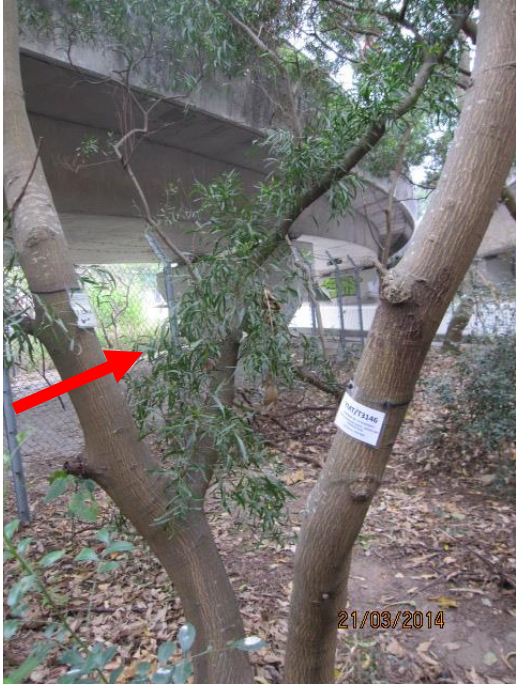
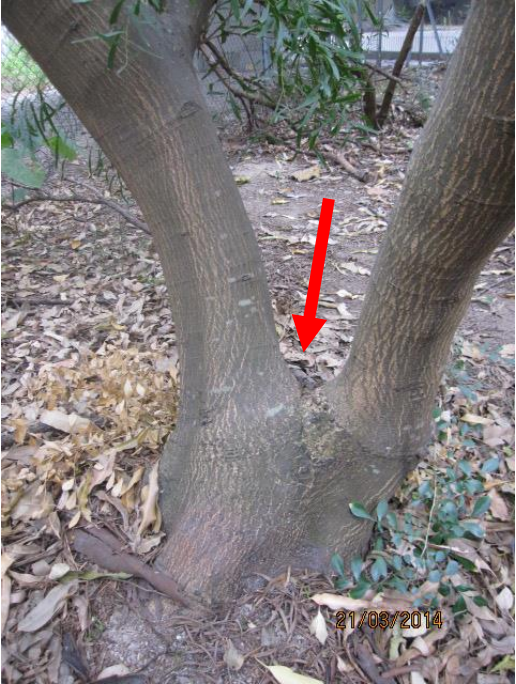
| YMT/ T3146- 1- Retain<br>Scientific Name: <i>Acacia confusa</i> | YMT/ T3146- 2<br>Dead branches | YMT/ T3146- 3<br>Epicormics | YMT/ T3146- 4<br>Co-dominant trunk |

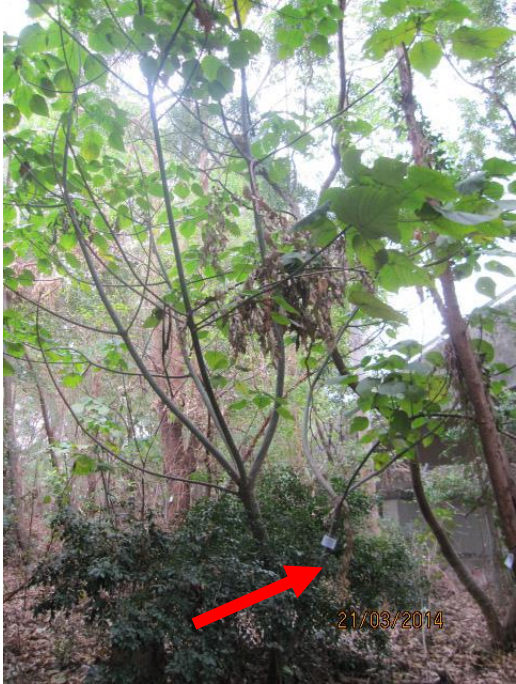
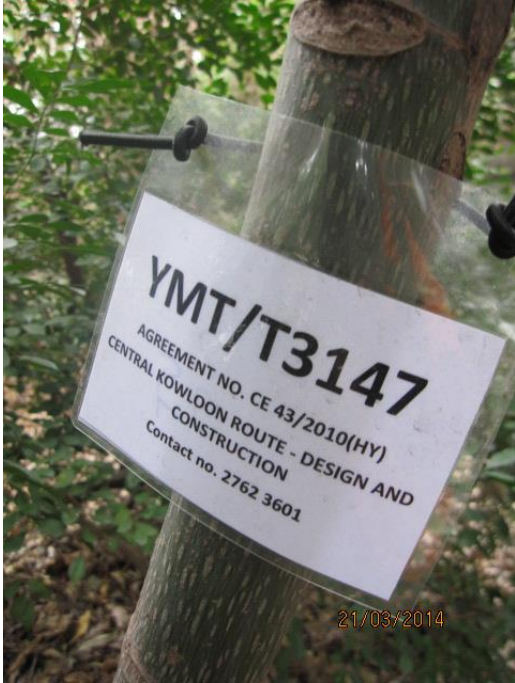
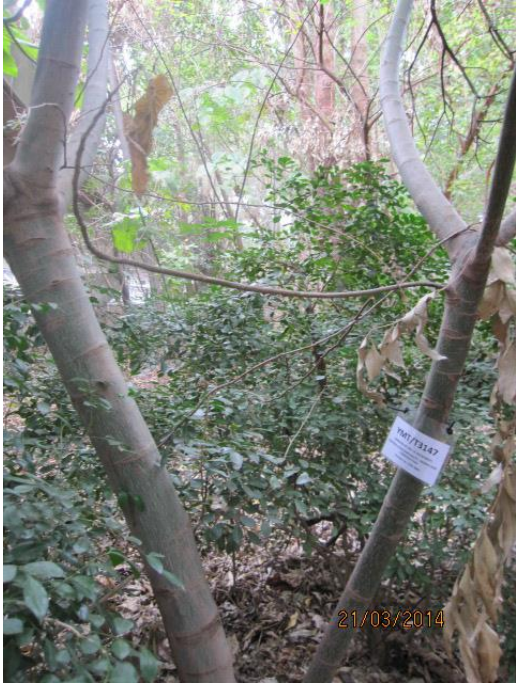
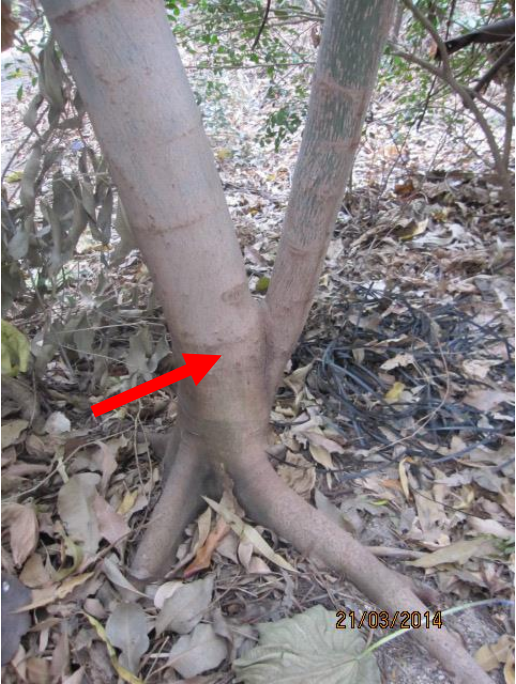
| YMT/ T3147- 1- Retain<br>Scientific Name: <i>Macaranga tanarius var. tomentosa</i> | YMT/ T3147- 2 | YMT/ T3147- 3 | YMT/ T3147- 4<br>Cross branches |
