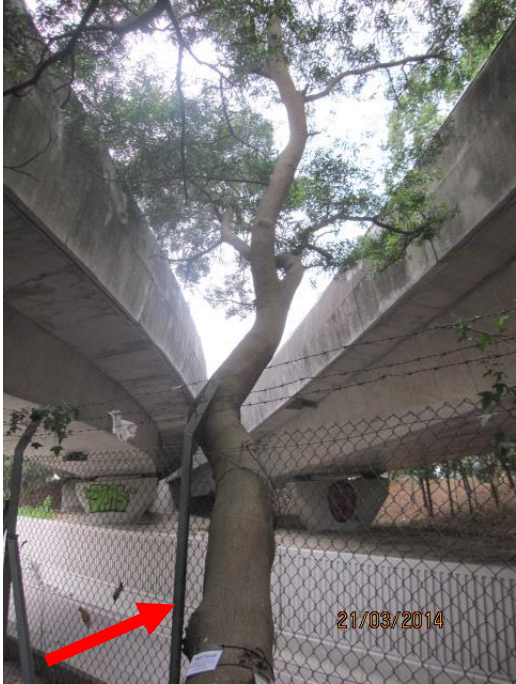
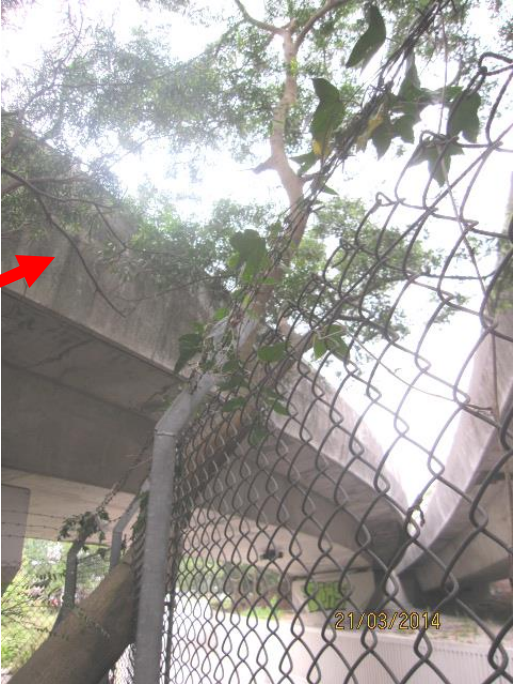
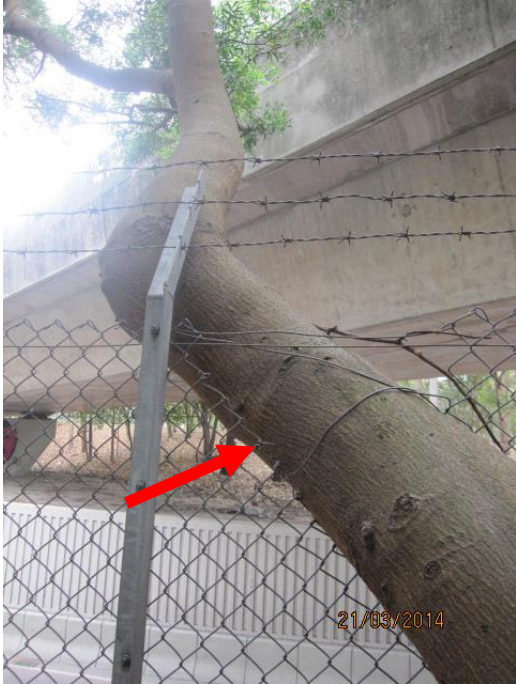
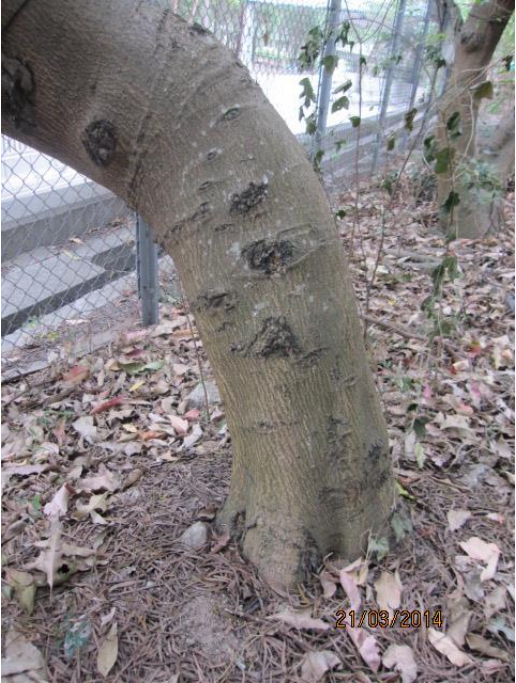
| YMT/ T3149- 1- Retain<br>Scientific Name: <i>Acacia confusa</i> | YMT/ T3149- 2<br>Dead branches | YMT/ T3149- 3<br>lying on fence | YMT/ T3149- 4<br>Leaning |

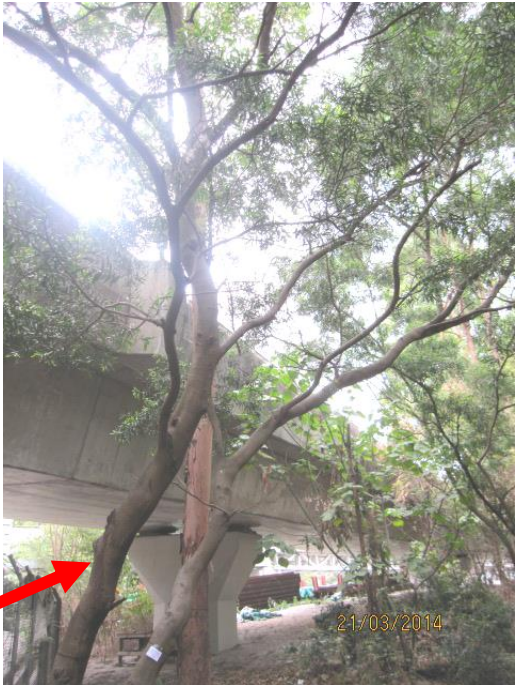
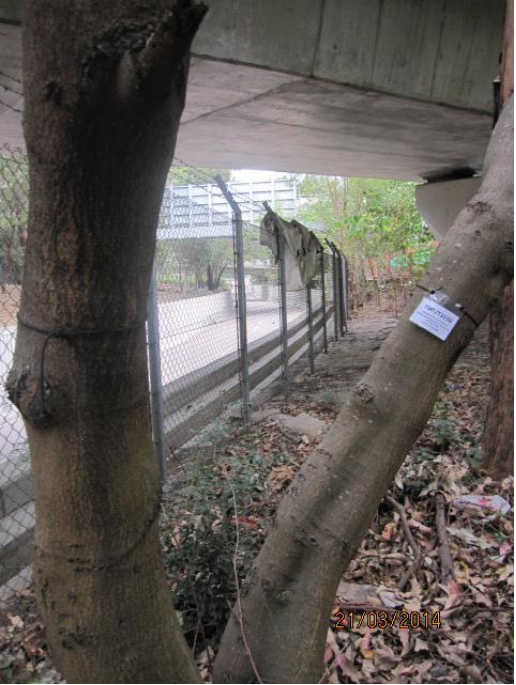
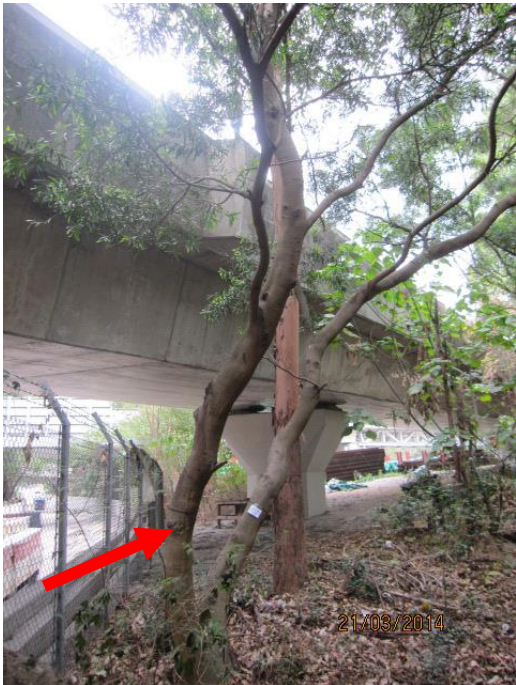
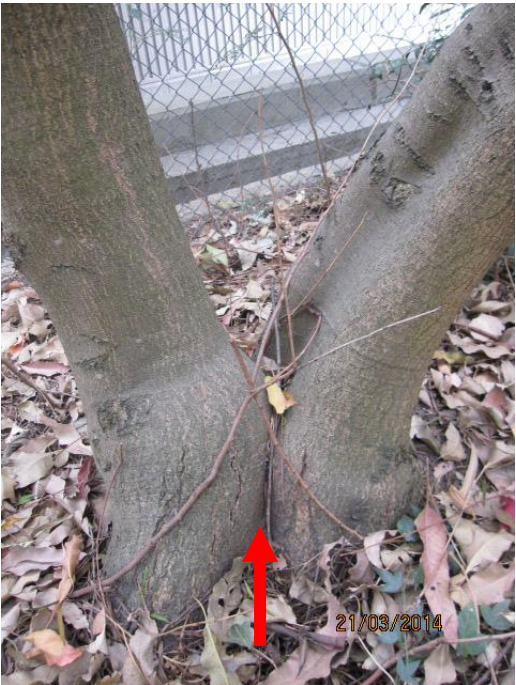
| YMT/ T3150- 1- Retain<br>Scientific Name: <i>Acacia confusa</i> | YMT/ T3150- 2<br>Co-dominant trunk | YMT/ T3150- 3<br>Leaning | YMT/ T3150- 4<br>Included bark |

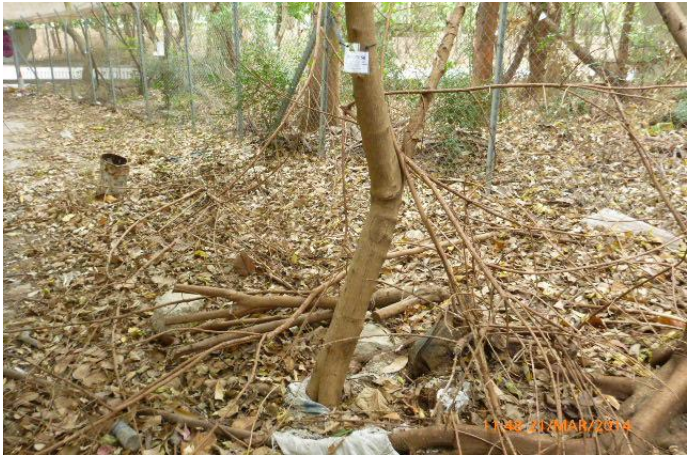
| YMT/ T3157- 1- Retain<br>Scientific Name: <i>Melia azedarach</i> | YMT/ T3157- 2 | YMT/ T3157- 3 | YMT/ T3157- 4<br>Co-dominant trunks |

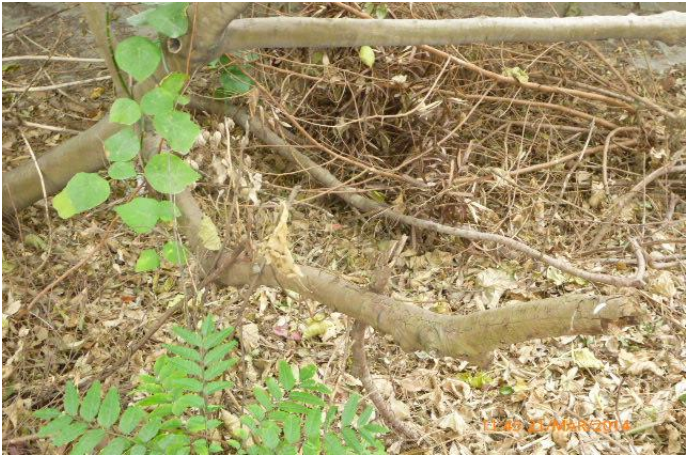
| YMT/ T3161- 1- Retain<br>Scientific Name: <i>Leucaena leucocephala</i> | YMT/ T3161- 2 | YMT/ T3161- 3 | YMT/ T3161- 4<br>Co-dominant trunk |

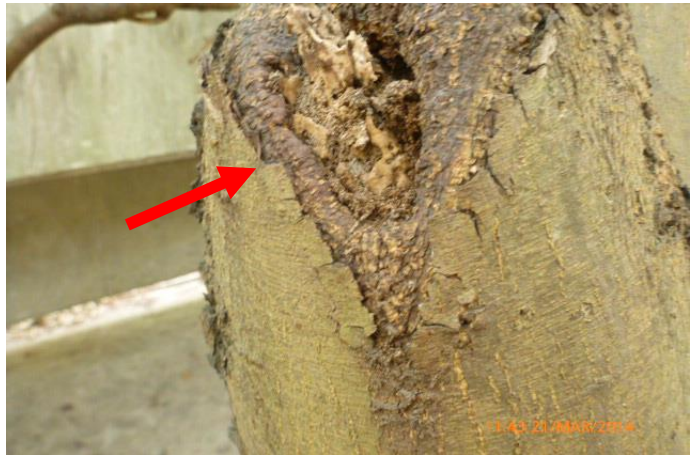
| YMT/ T3162- 1- Retain<br>Scientific Name: <i>Macaranga tanarius var. tomentosa</i> | YMT/ T3162- 2 | YMT/ T3162- 3<br>Wound | YMT/ T3162- 4 |

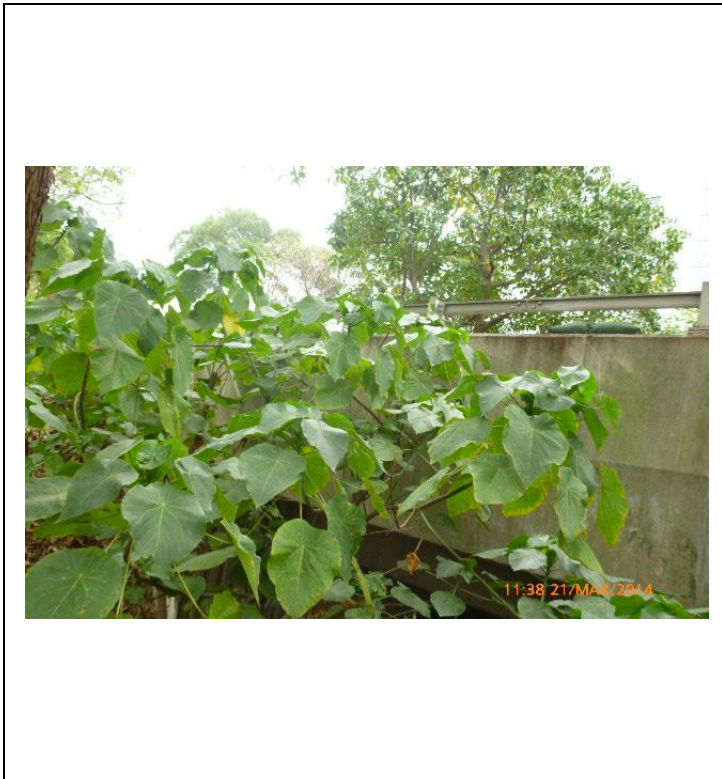
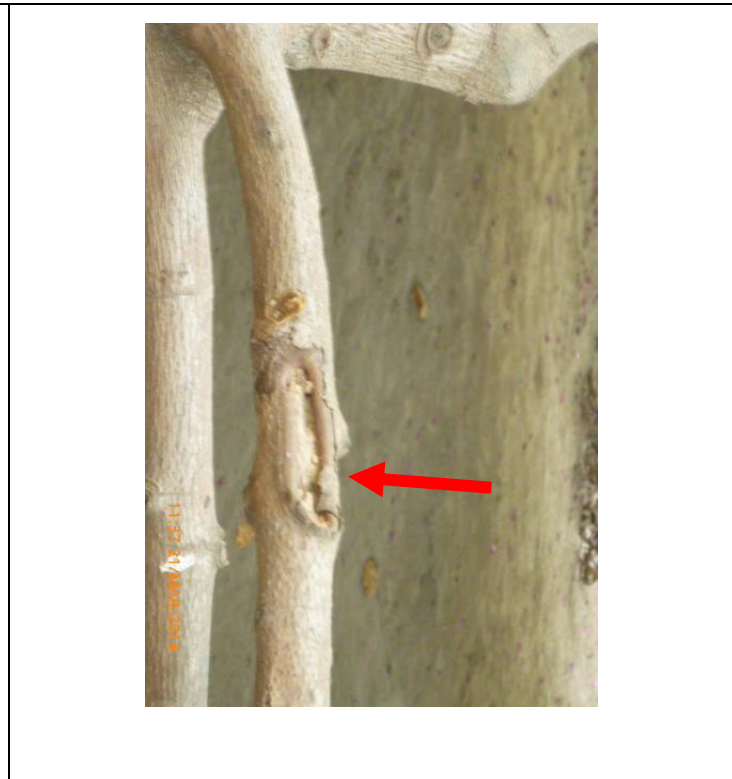
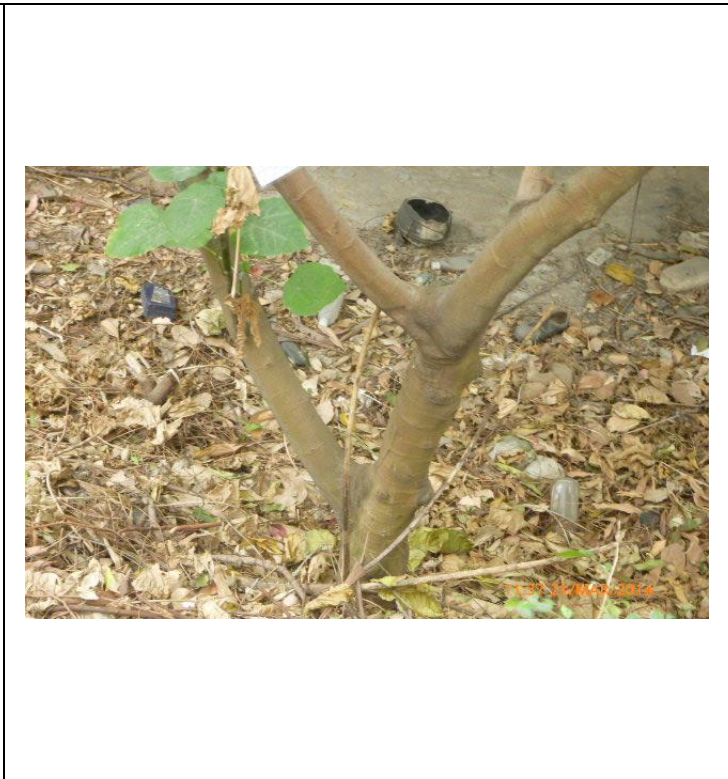
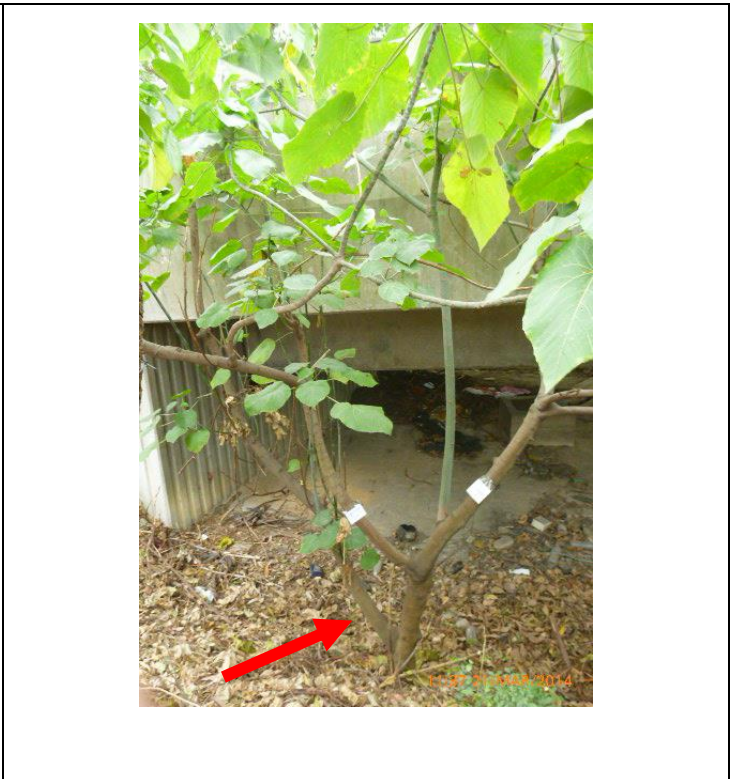
| YMT/ T3167- 1- Retain<br>Scientific Name: <i>Macaranga tanarius var. tomentosa</i> | YMT/ T3167- 2<br>Wound | YMT/ T3167- 3 | YMT/ T3167- 4 |

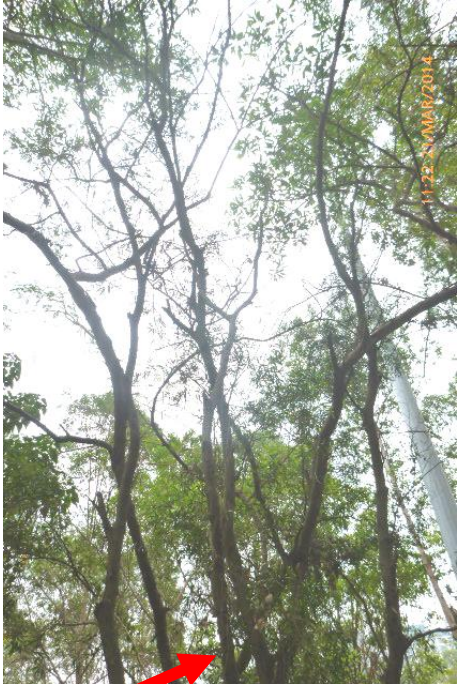
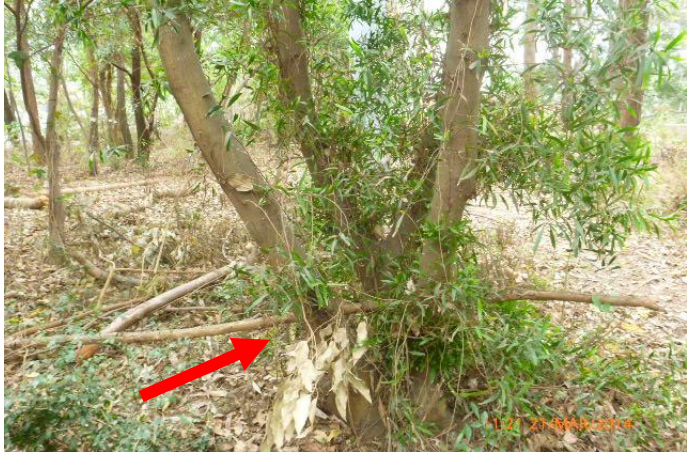
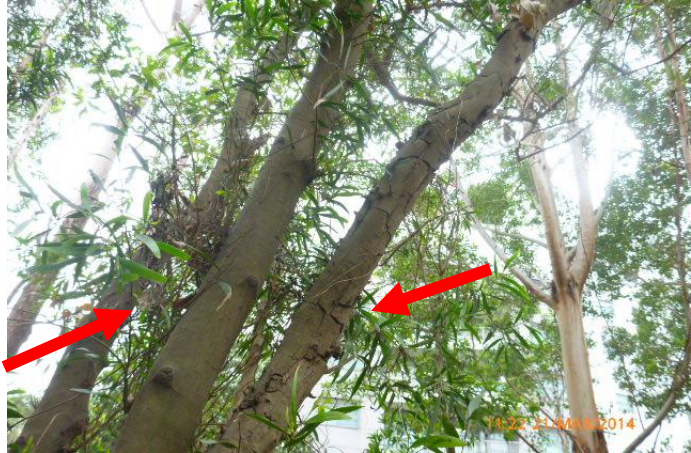
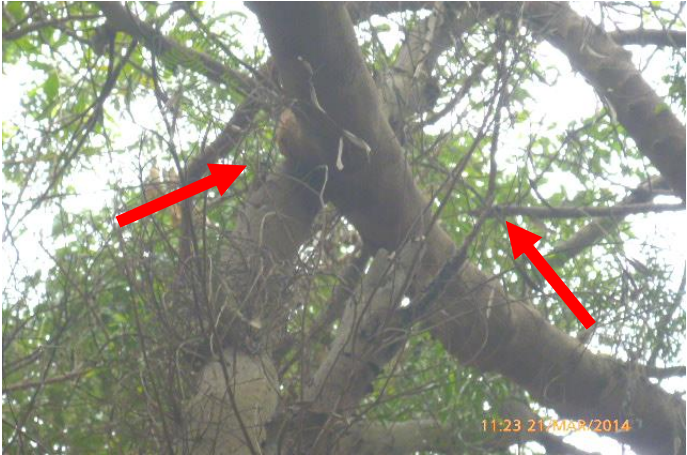
| YMT/ T3169- 1- Retain<br>Scientific Name: <i>Acacia confusa</i> | YMT/ T3169- 2<br>Co-dominant trunk | YMT/ T3169- 3<br>Epicormics | YMT/ T3169- 4<br>Cross branches & dead branches |

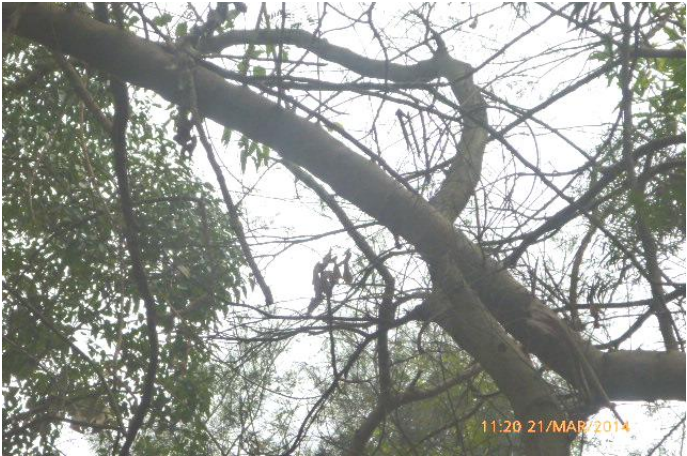
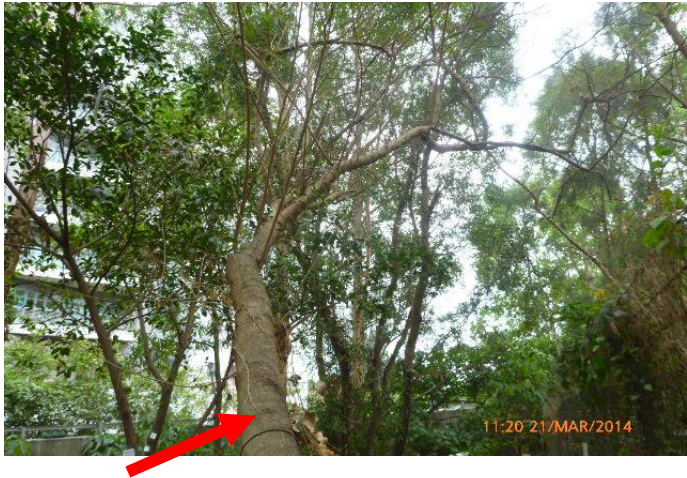
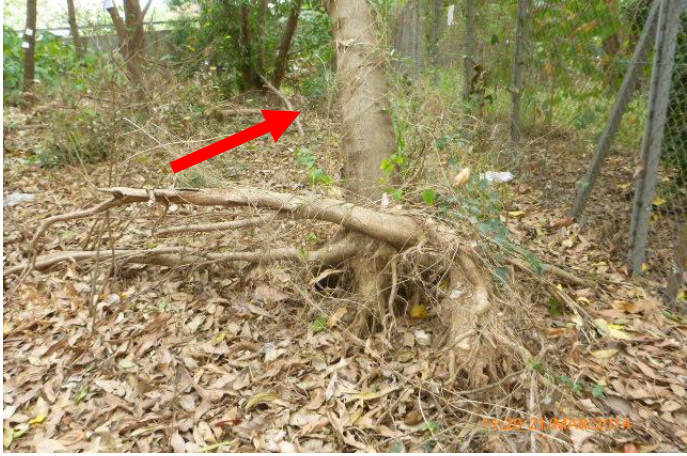
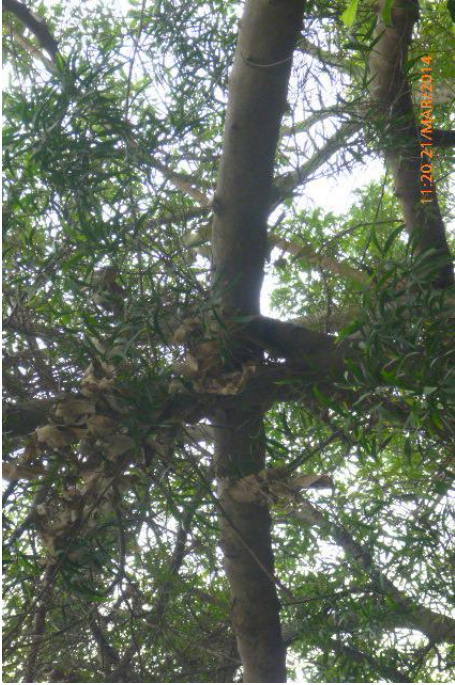
| YMT/ T3171- 1- Retain<br>Scientific Name: <i>Leucaena leucocephala</i> | YMT/ T3171- 2<br>Dead branches | YMT/ T3171- 3<br>Leaning | YMT/ T3171- 4<br>Cross branches |

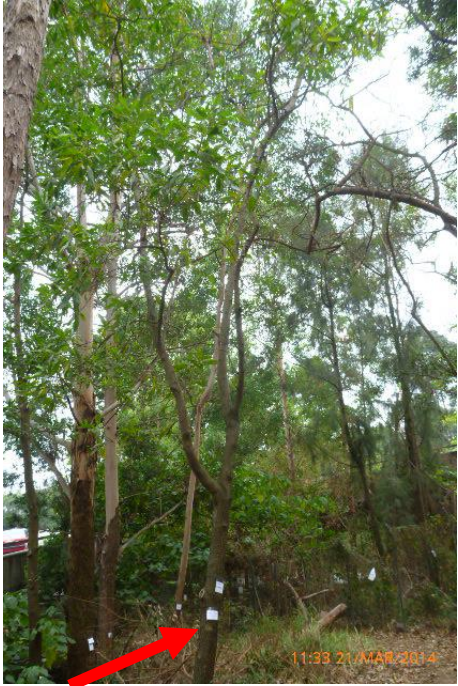
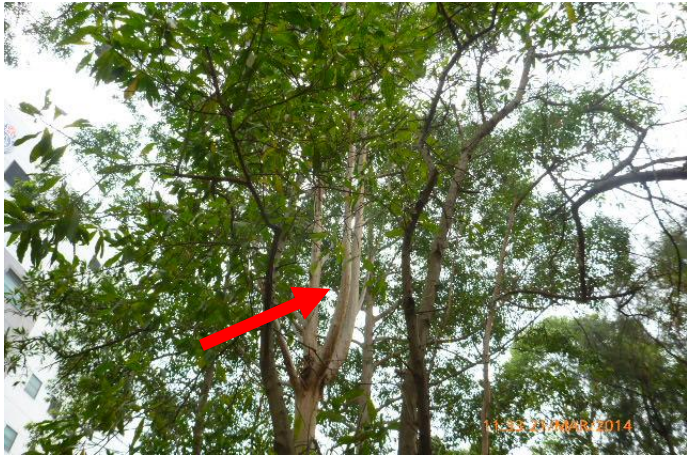
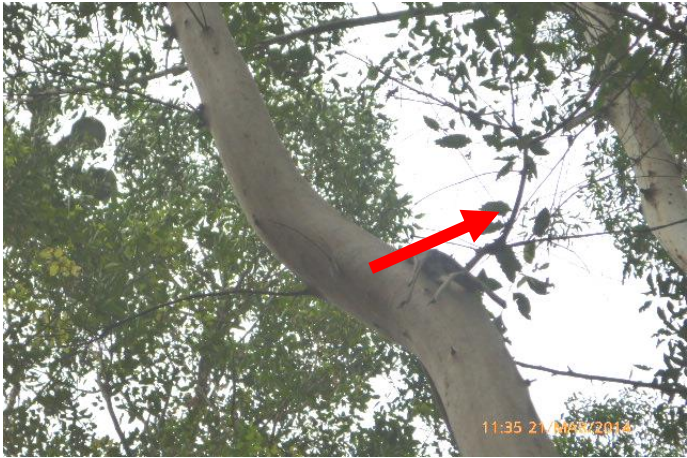
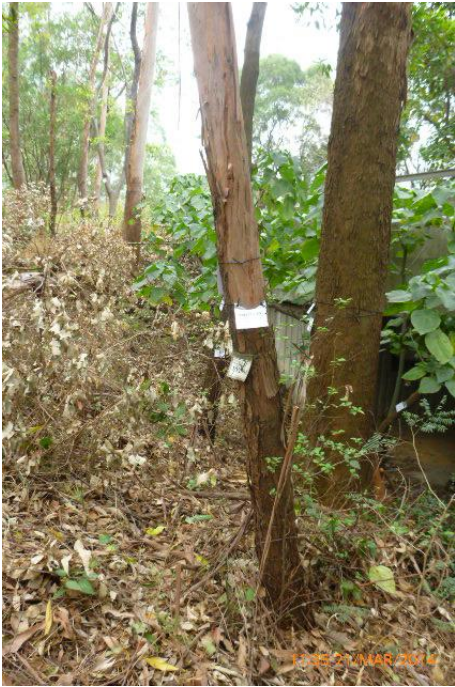
| YMT/ T3172- 1- Retain<br>Scientific Name: <i>Acacia mangium</i> | YMT/ T3172- 2<br>Dead branches | YMT/ T3172- 3<br>Epicormics | YMT/ T3172- 4 |

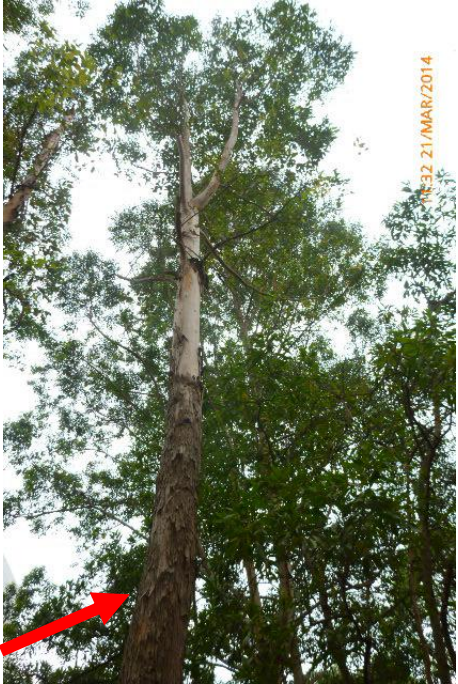
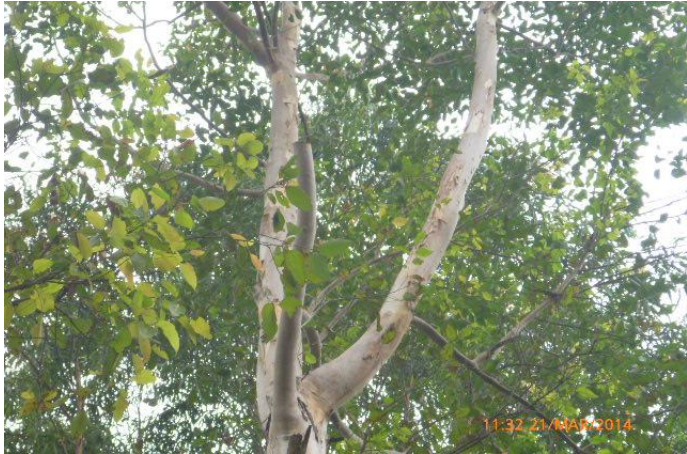
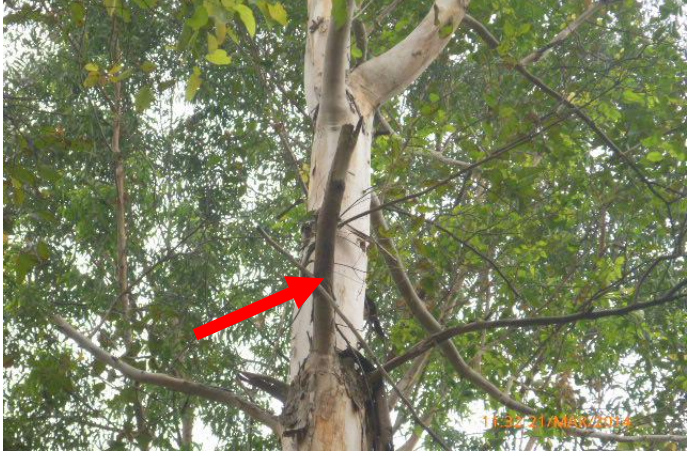
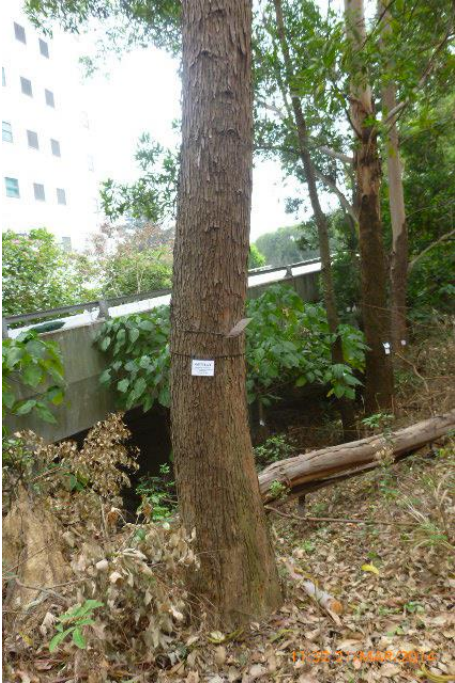
| YMT/ T3173- 1- Retain<br>Scientific Name: <i>Eucalyptus camaldulensis</i> | YMT/ T3173- 2 | YMT/ T3173- 3<br>Dead branches | YMT/ T3173- 4 |

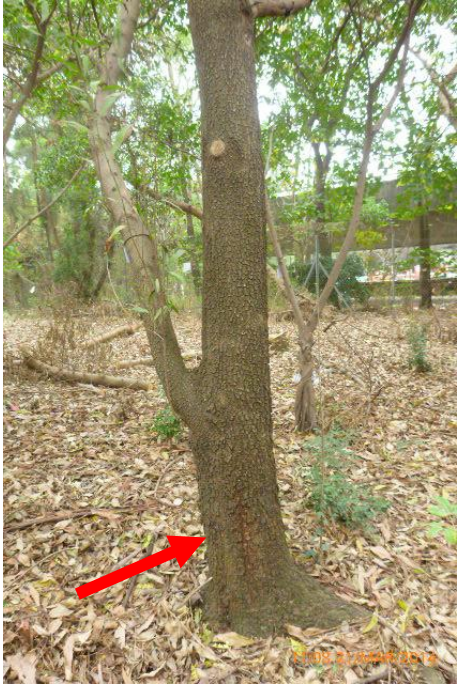
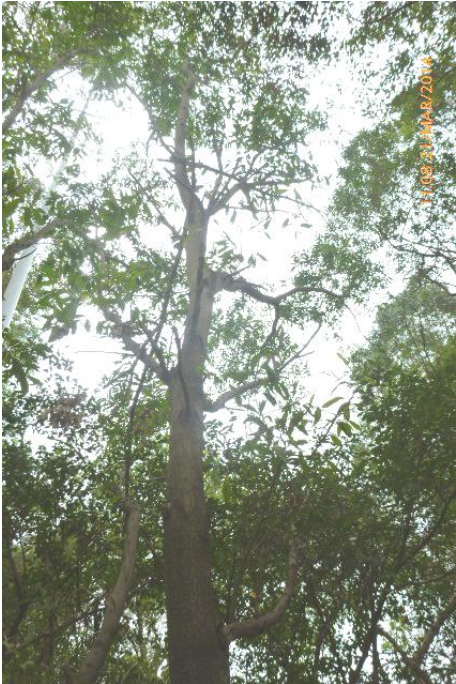
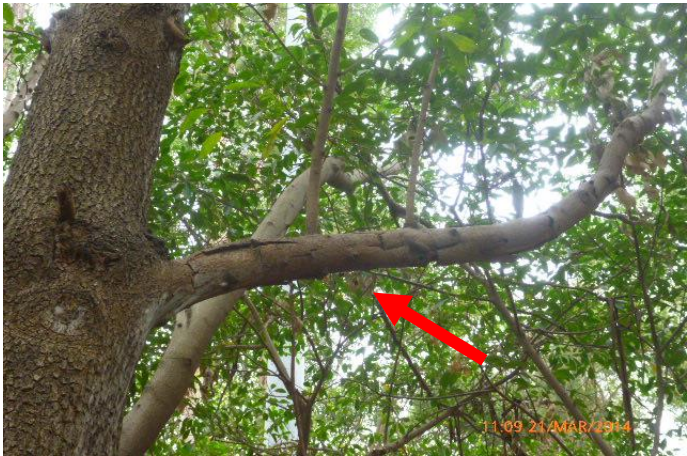
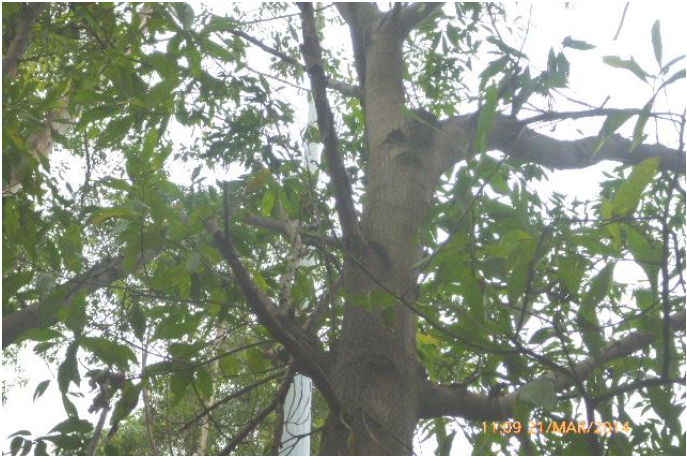
| YMT/ T3186- 1- Retain<br>Scientific Name: <i>Acacia mangium</i> | YMT/ T3186- 2 | YMT/ T3186- 3<br>Dead branches | YMT/ T3186- 4 |

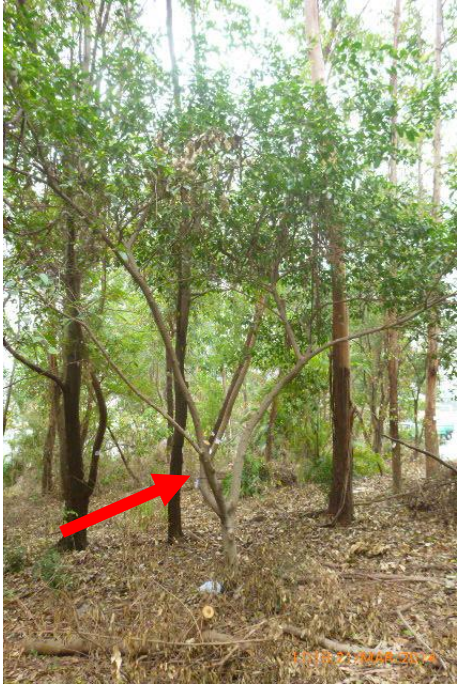
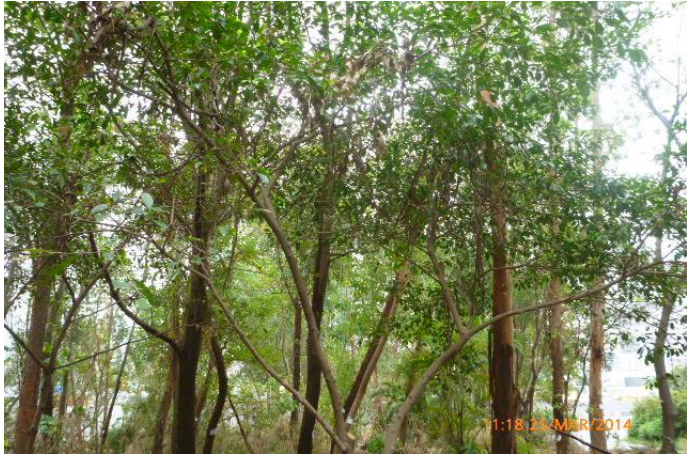
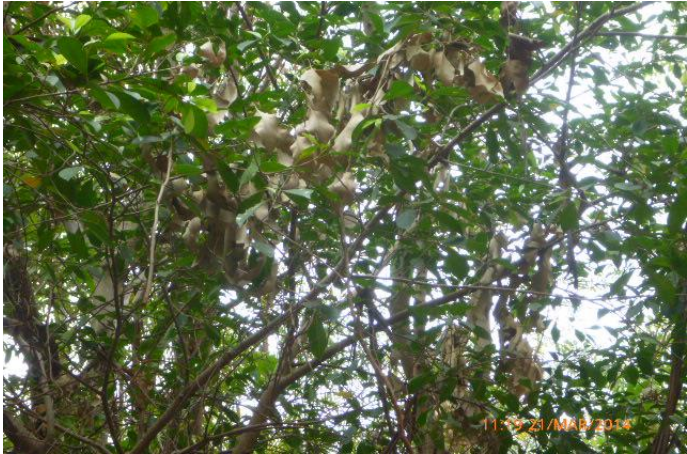
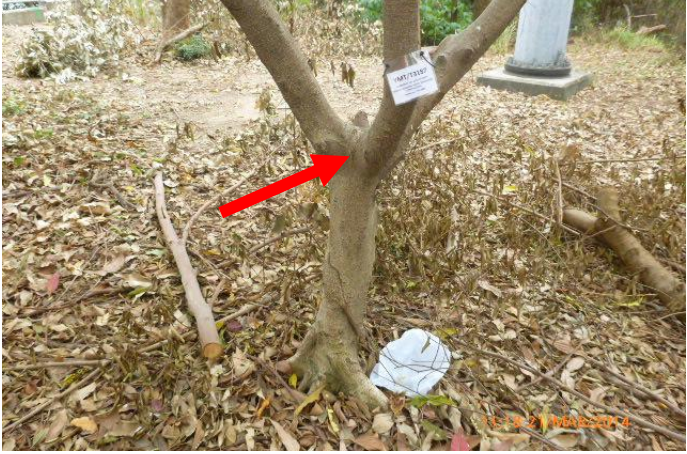
| YMT/ T3187- 1- Retain<br>Scientific Name: <i>Ficus microcarpa</i> | YMT/ T3187- 2 | YMT/ T3187- 3 | YMT/ T3187- 4<br>Co-dominant trunk |

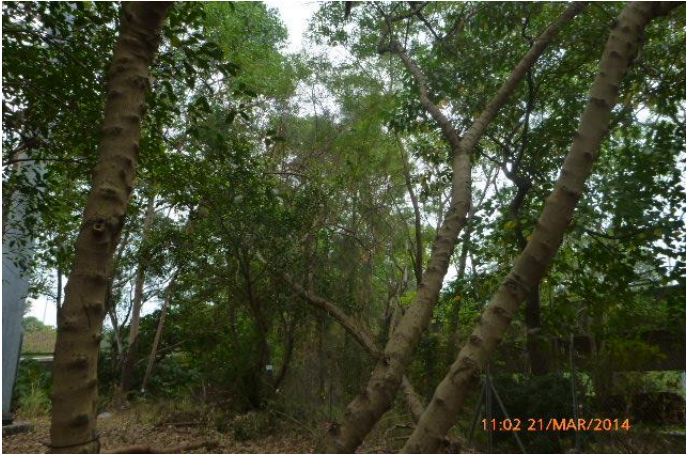
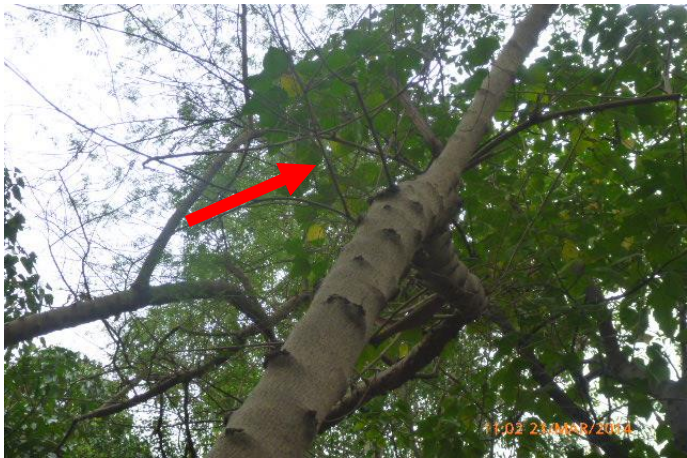
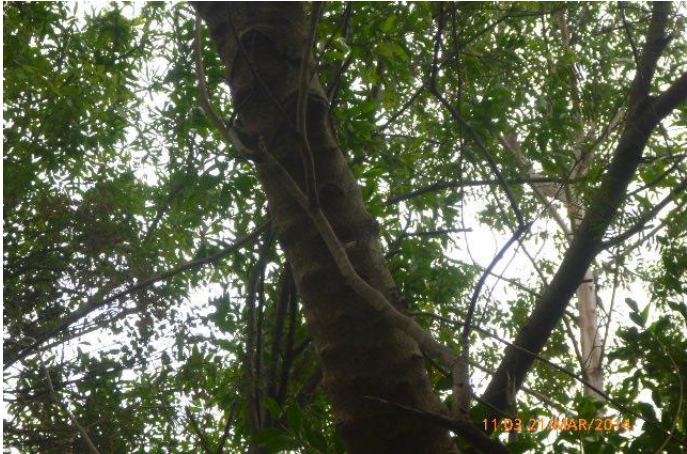
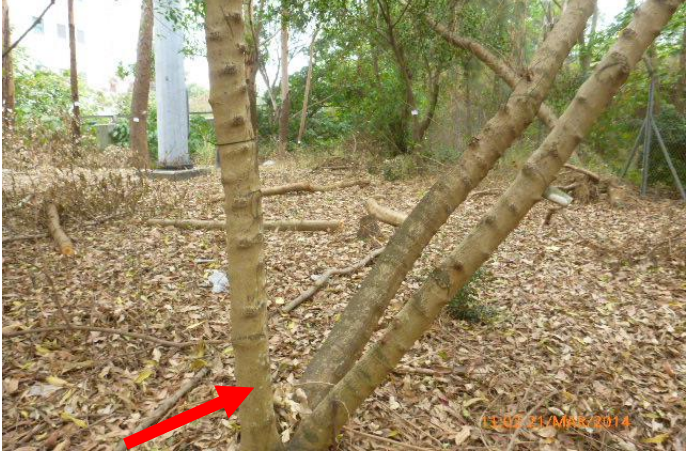
| YMT/ T3189- 1- Retain<br>Scientific Name: <i>Macaranga tanarius</i> var. <i>tomentosa</i> | YMT/ T3189- 2<br>Dead branches | YMT/ T3189- 3 | YMT/ T3189- 4<br>Co-dominant trunk |

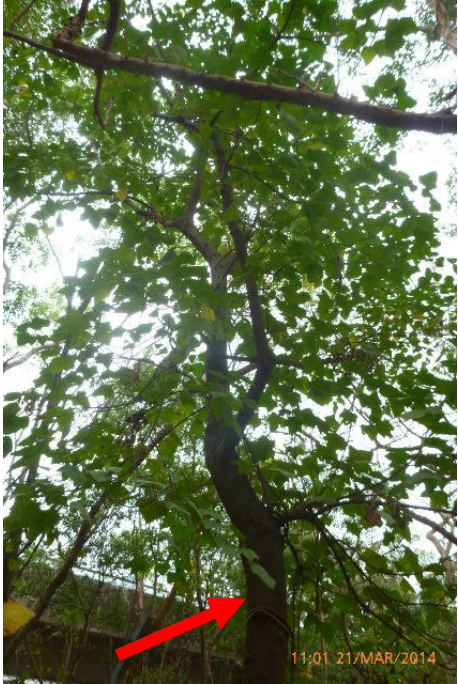
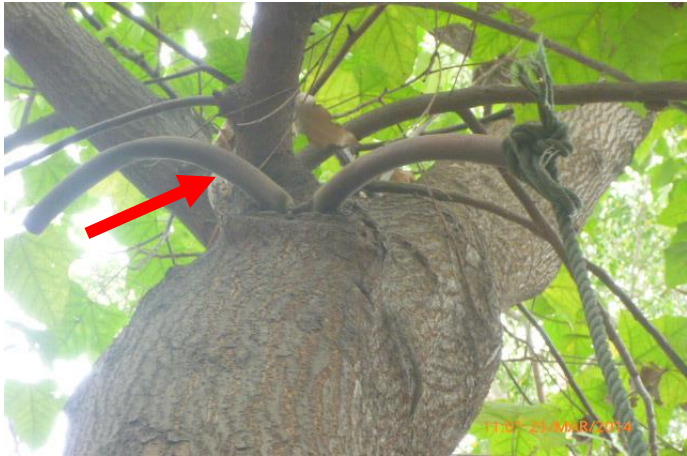
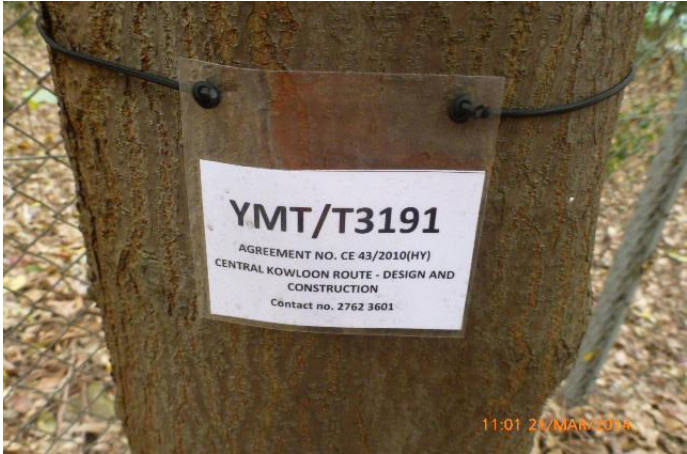
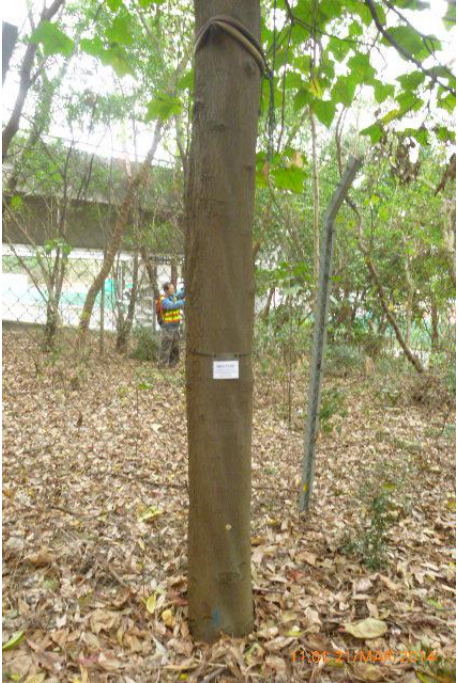
| YMT/ T3191- 1- Retain<br>Scientific Name: <i>Aleurites moluccana</i> | YMT/ T3191- 2<br>Epicormics | YMT/ T3191- 3 | YMT/ T3191- 4 |

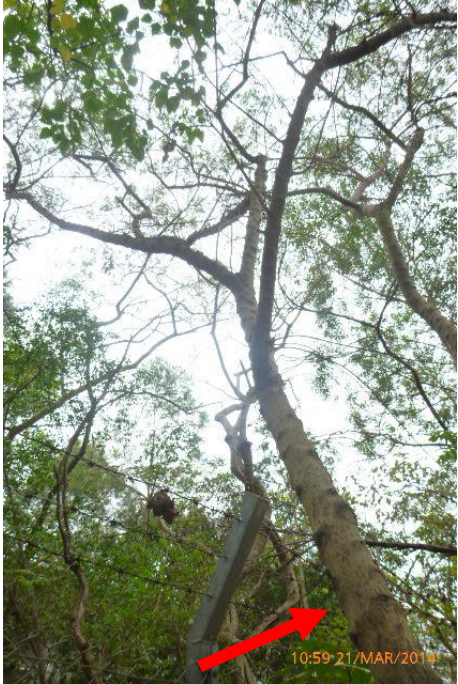
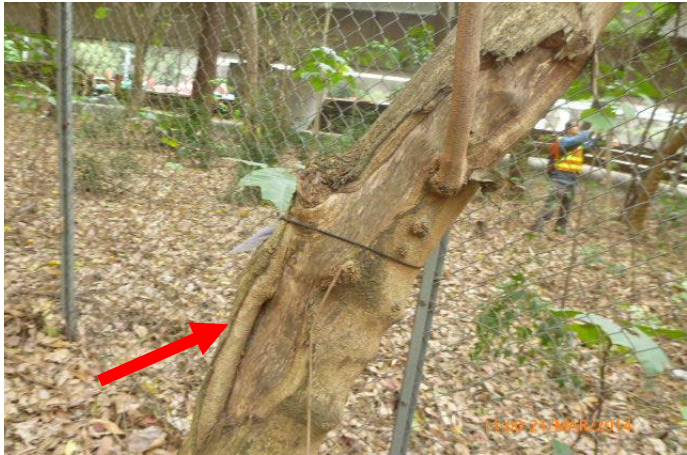
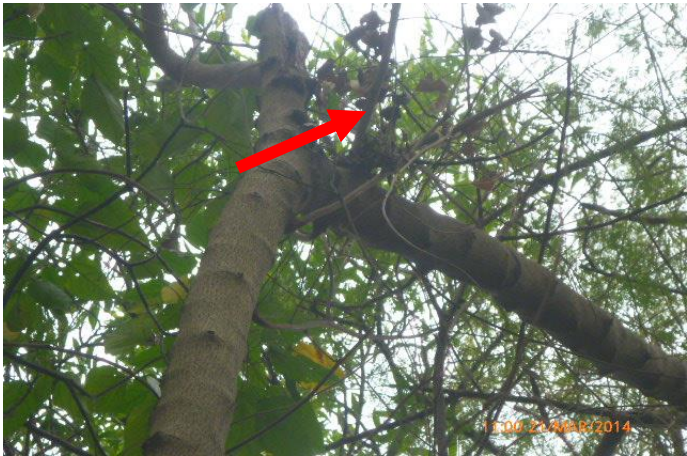
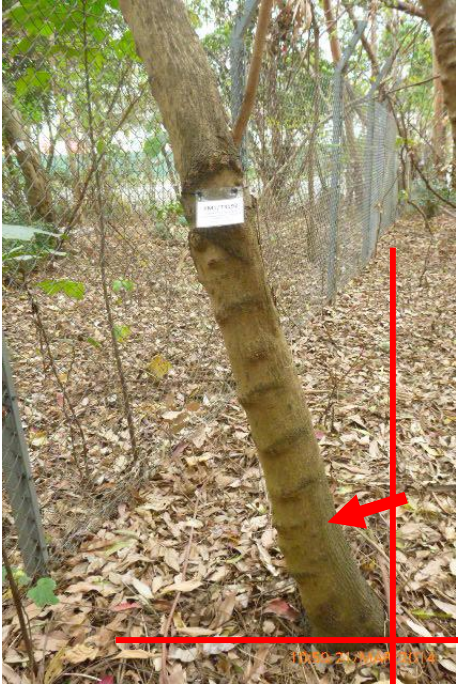
| YMT/ T3192- 1- Retain<br>Scientific Name: <i>Leucaena leucocephala</i> | YMT/ T3192- 2<br>Wound on trunk | YMT/ T3192- 3<br>Dead branches | YMT/ T3192- 4<br>Leaning |

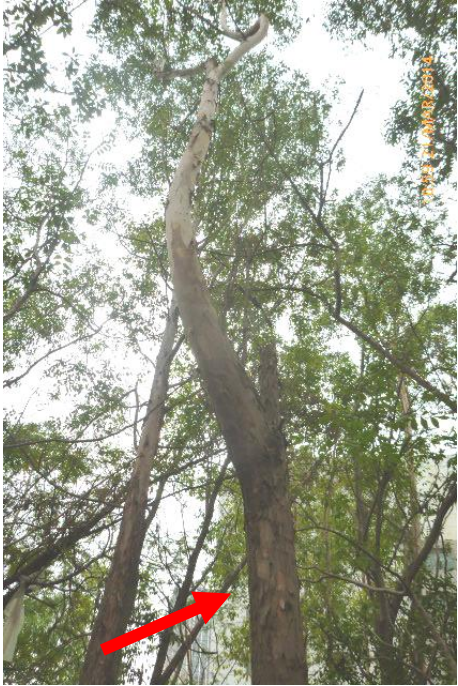
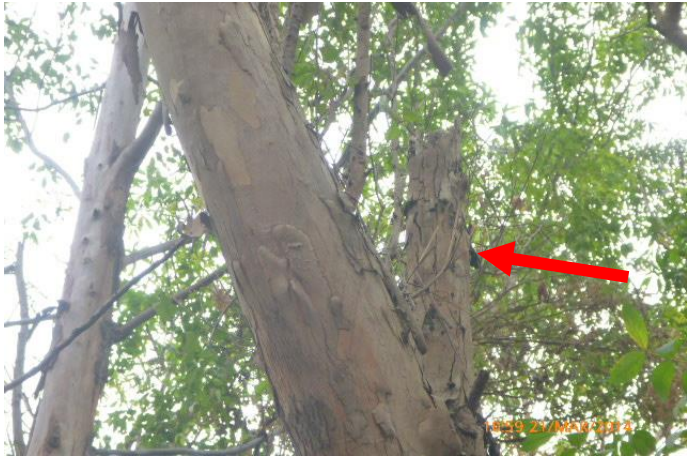
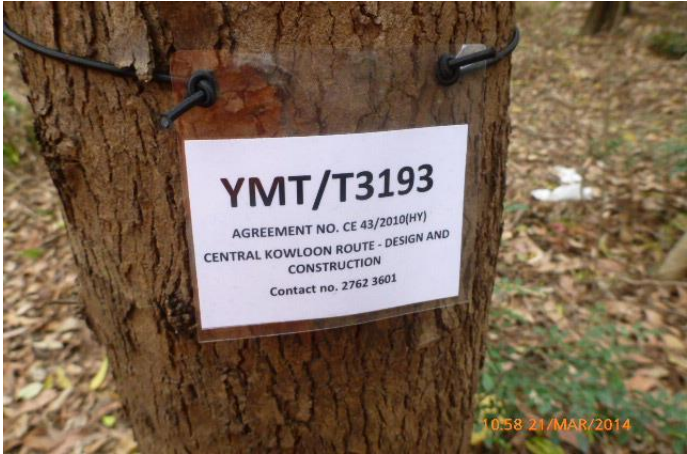
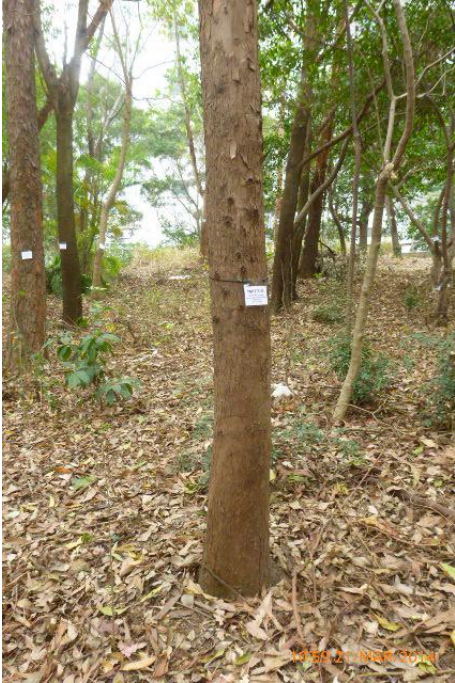
| YMT/ T3193- 1- Retain<br>Scientific Name: <i>Eucalyptus camaldulensis</i> | YMT/ T3193- 2<br>Broken branches | YMT/ T3193- 3 | YMT/ T3193- 4 |

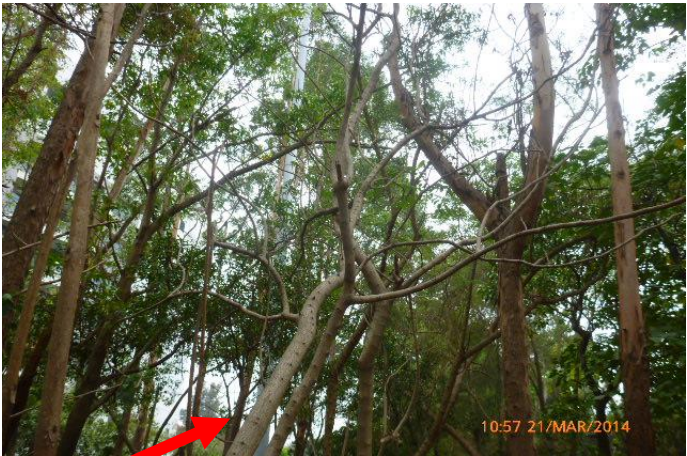
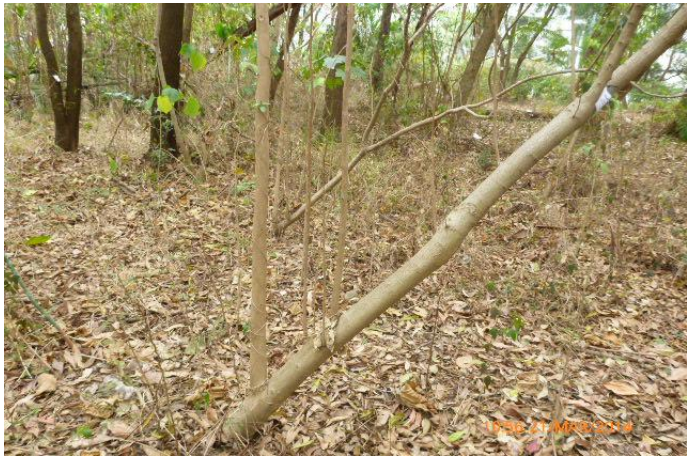
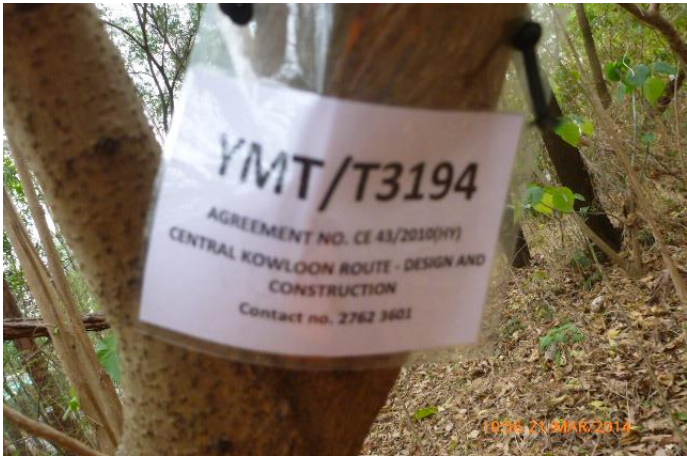
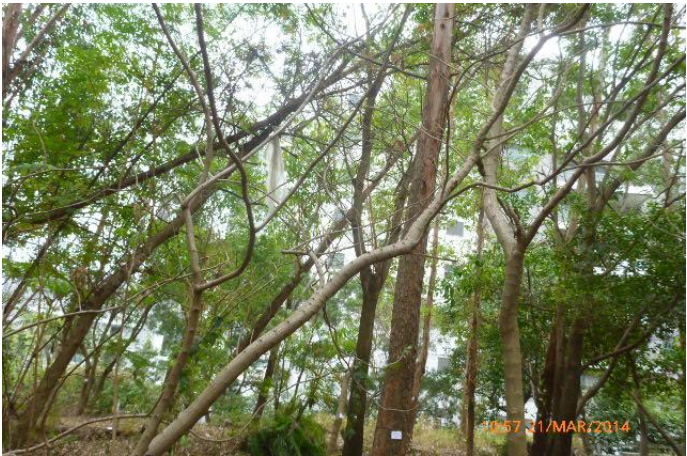
| YMT/ T3194- 1- Retain<br>Scientific Name: <i>Spathodea campanulata</i> | YMT/ T3194- 2<br>Leaning | YMT/ T3194- 3 | YMT/ T3194- 4 |

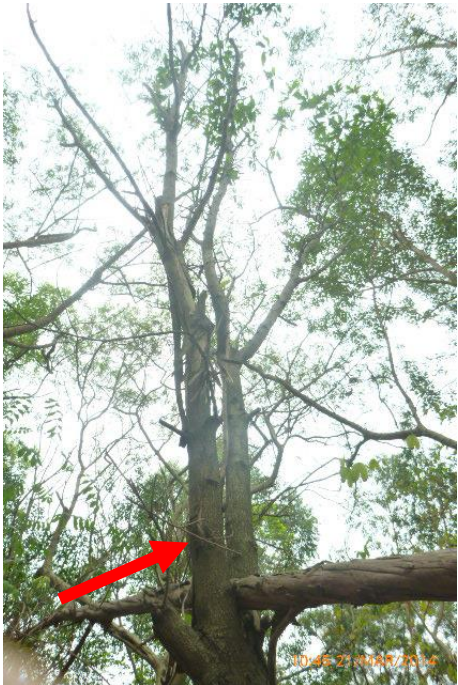
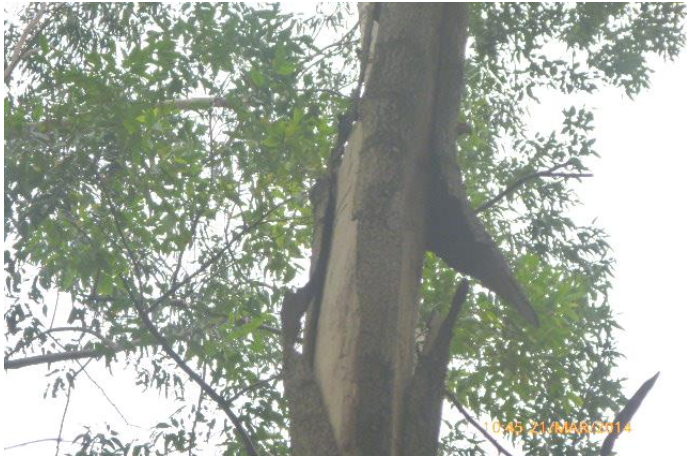
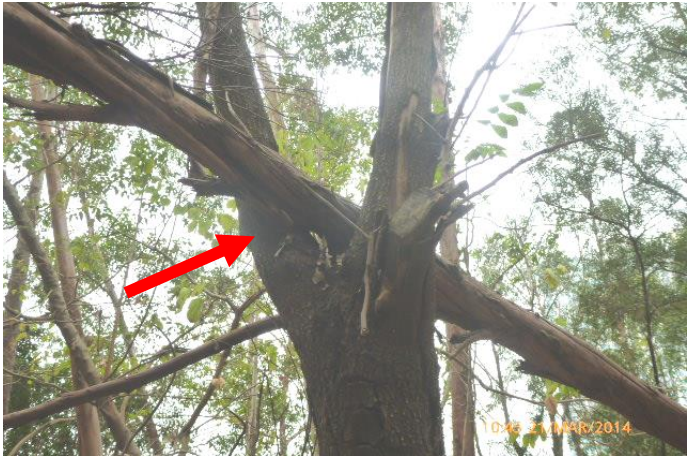
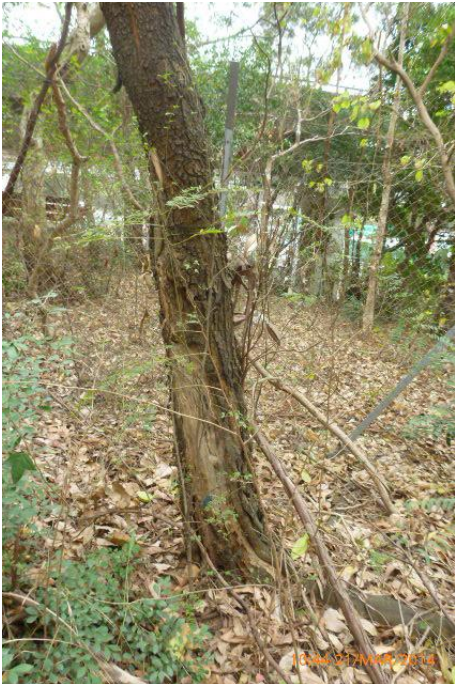
| YMT/ T3196- 1- Retain<br>Scientific Name: <i>Acacia mangium</i> | YMT/ T3196- 2 | YMT/ T3196- 3<br>Cross branches | YMT/ T3196- 4 |

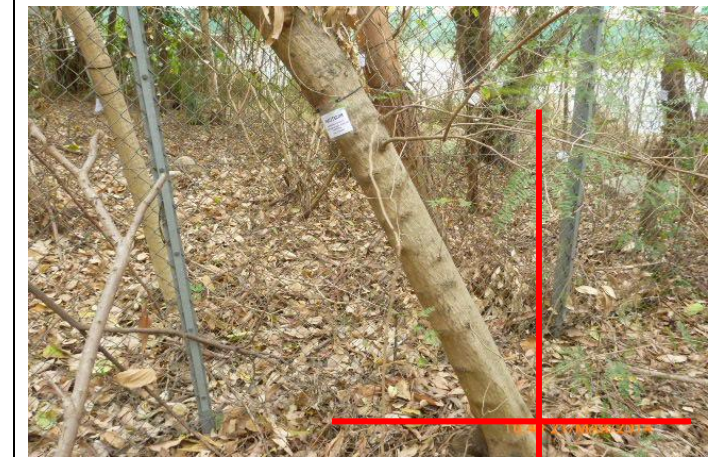
| YMT/ T3208- 1- Retain<br>Scientific Name: <i>Leucaena leucocephala</i> | YMT/ T3208- 2<br>Leaning | YMT/ T3208- 3<br>Exposed root | YMT/ T3208- 4 |

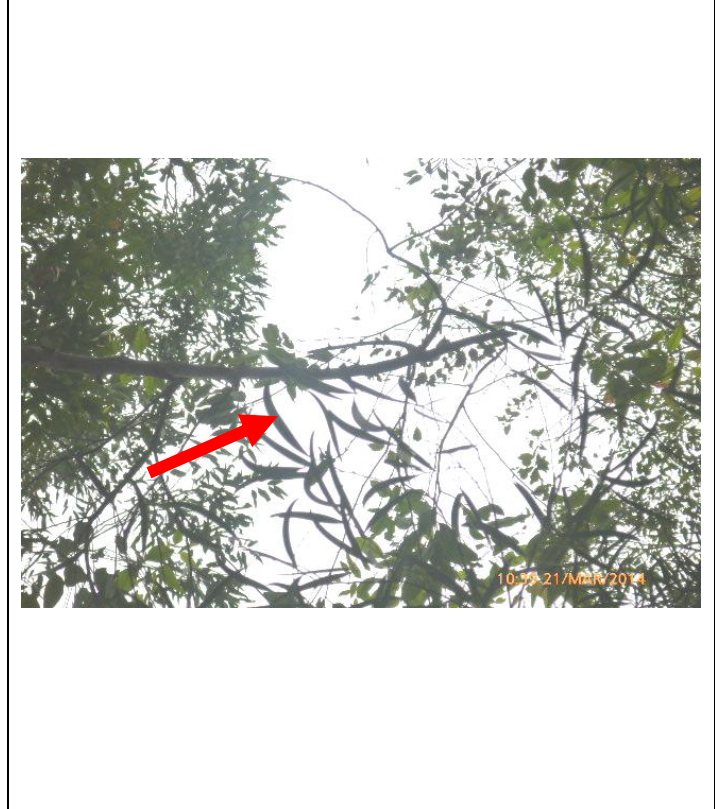
| YMT/ T3210- 1- Retain<br>Scientific Name: <i>Eucalyptus camaldulensis</i> | YMT/ T3210- 2 | YMT/ T3210- 3<br>Dead branches | YMT/ T3210- 4 |

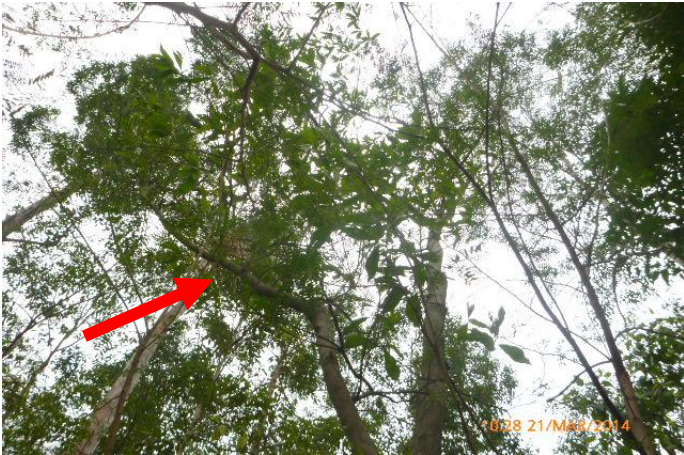
| YMT/ T3229- 1- Retain<br>Scientific Name: <i>Acacia mangium</i> | YMT/ T3229- 2<br>Cross branches | YMT/ T3229- 3<br>Dead branches | |
