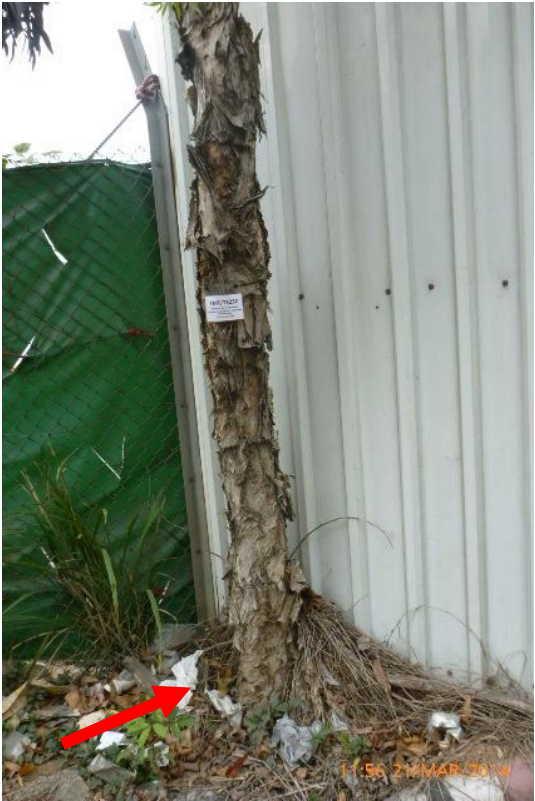
| YMT/ T3232- 1-Retain<br><i>Melaleuca cajuputi subsp. cumingiana</i> | YMT/ T3232- 2 | YMT/ T3232- 3 | YMT/ T3232- 4<br>Growth restricted |

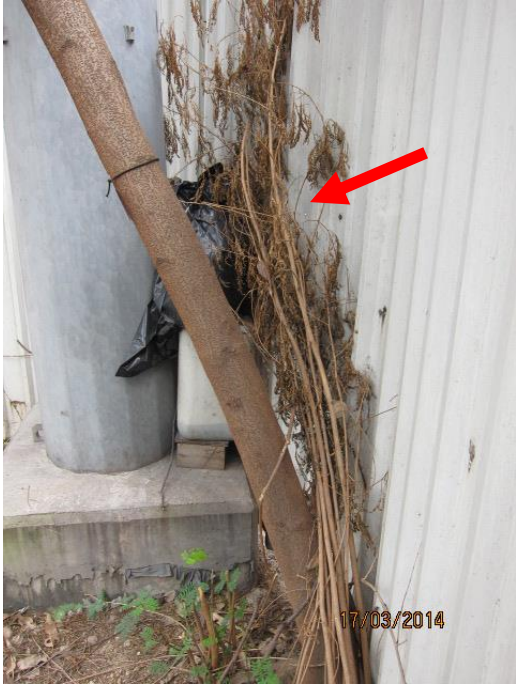
| YMT/ T3233- 1- Retain<br>Scientific Name: <i>Leucaena leucocephala</i> | YMT/ T3233- 2 | YMT/ T3233- 3<br>Climber | YMT/ T3233- 4<br>Growth restricted |

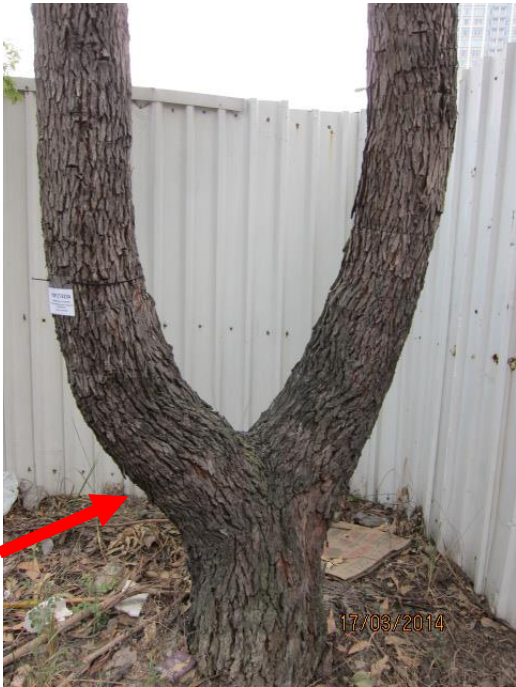
| YMT/ T3234- 1- Retain<br>Scientific Name: <i>Eucalyptus robusta</i> | YMT/ T3234- 2 | YMT/ T3234- 3<br>Co-dominant trunk | YMT/ T3234- 4 |

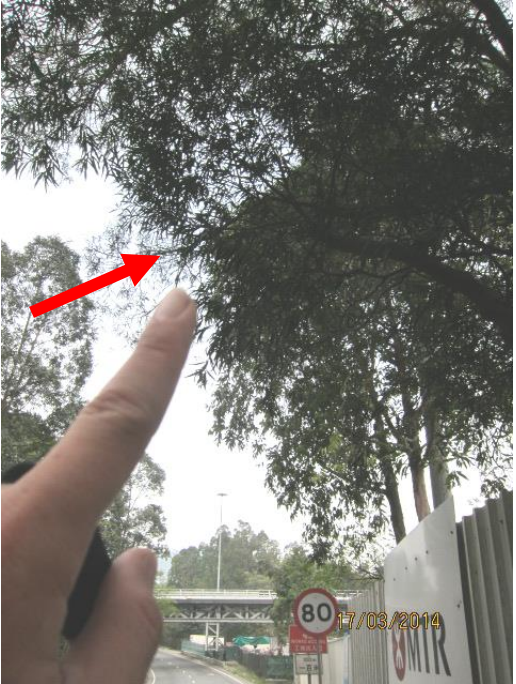
| YMT/ T3235- 1- Retain<br>Scientific Name: <i>Acacia confusa</i> | YMT/ T3235- 2<br>Dead branches | YMT/ T3235- 3<br>lying on fence | YMT/ T3235- 4 |

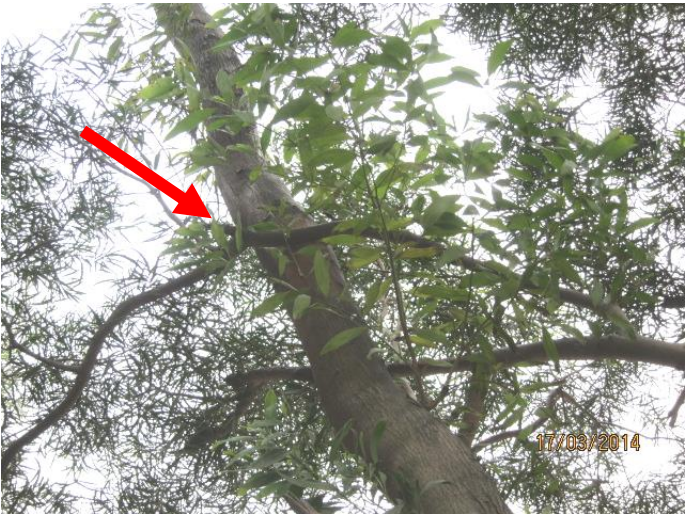
| YMT/ T3236- 1- Retain<br>Scientific Name: <i>Acacia mangium</i> | YMT/ T3236- 2<br>Cross branches | YMT/ T3236- 3<br>Dead branches | YMT/ T3236- 4<br>Leaning |

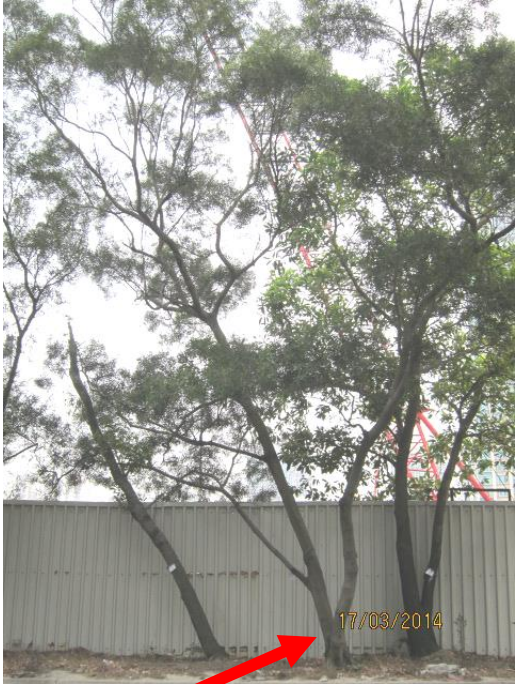
| YMT/ T3237- 1- Retain<br>Scientific Name: <i>Acacia confusa</i> | YMT/ T3237- 2 | YMT/ T3237- 3<br>Dead branches | YMT/ T3237- 4 |

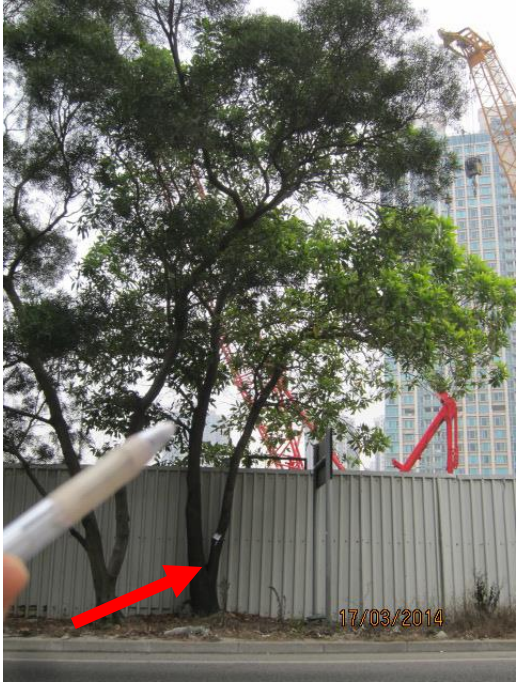
| YMT/ T3238- 1- Retain<br>Scientific Name: <i>Acacia mangium</i> | YMT/ T3238- 2<br>Dead branches | YMT/ T3238- 3 | YMT/ T3238- 4<br>Gross branches |

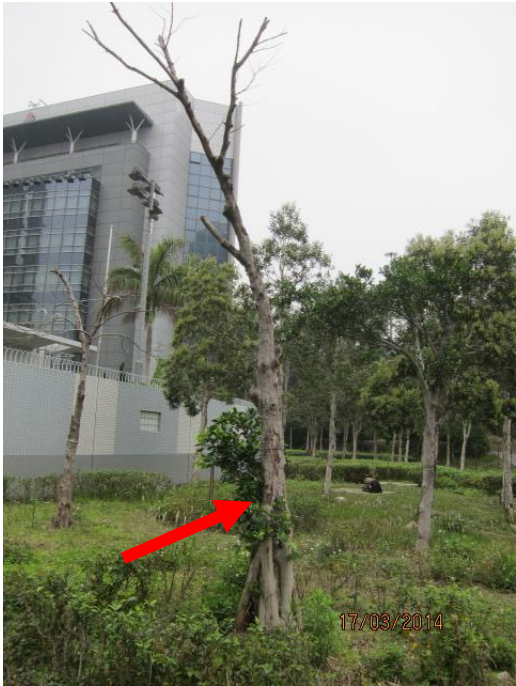
| YMT/ T3249- 1-Retain<br>Scientific Name: <i>Ficus microcarpa</i> | YMT/ T3249- 2 | YMT/ T3249- 3 | YMT/ T3249- 4 |

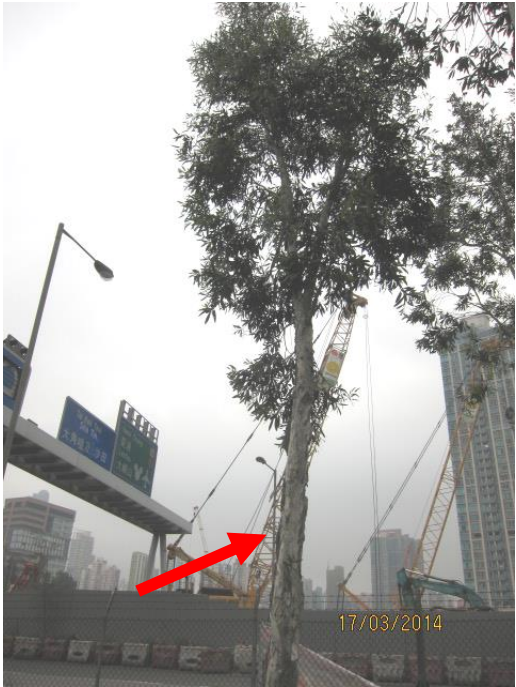
| YMT/ T3250- 1-Retain<br><i>Melaleuca cajuputi subsp. cumingiana</i> | YMT/ T3250- 2 | YMT/ T3250- 3 | YMT/ T3250- 4 |

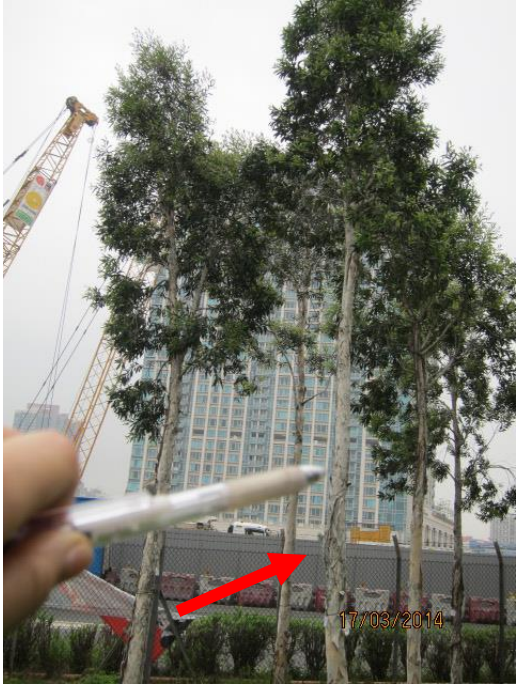
| YMT/ T3251- 1-Retain<br><i>Melaleuca cajuputi subsp. cumingiana</i> | YMT/ T3251- 2 | YMT/ T3251- 3 | YMT/ T3251- 4 |

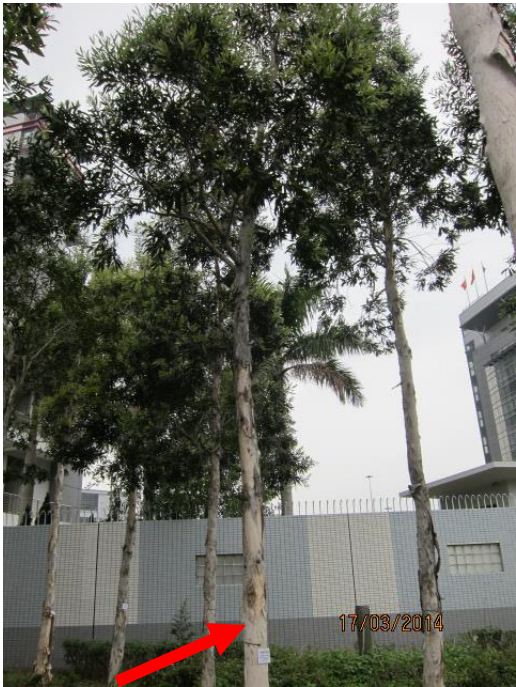
| YMT/ T3258- 1-Retain<br><i>Melaleuca cajuputi subsp. cumingiana</i> | YMT/ T3258- 2 | YMT/ T3258- 3 | YMT/ T3258- 4 |

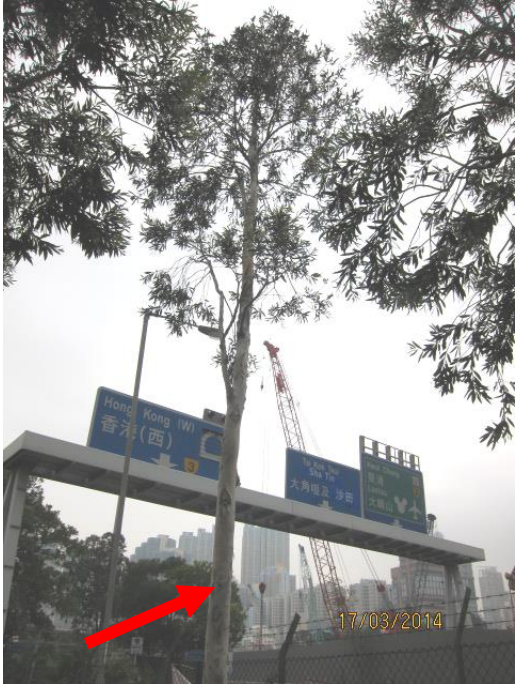
| YMT/ T3259- 1-Retain<br><i>Melaleuca cajuputi subsp. cumingiana</i> | YMT/ T3259- 2 | YMT/ T3259- 3 | YMT/ T3259- 4 |

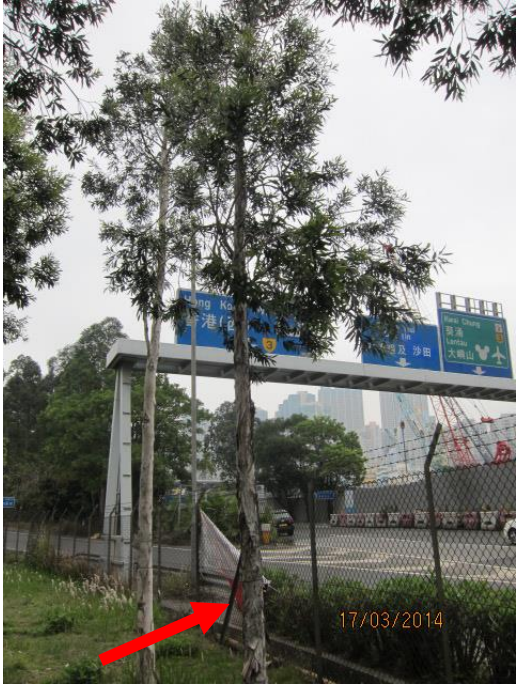
| YMT/ T3260- 1-Retain<br><i>Melaleuca cajuputi subsp. cumingiana</i> | YMT/ T3260- 2 | YMT/ T3260- 3 | YMT/ T3260- 4 |

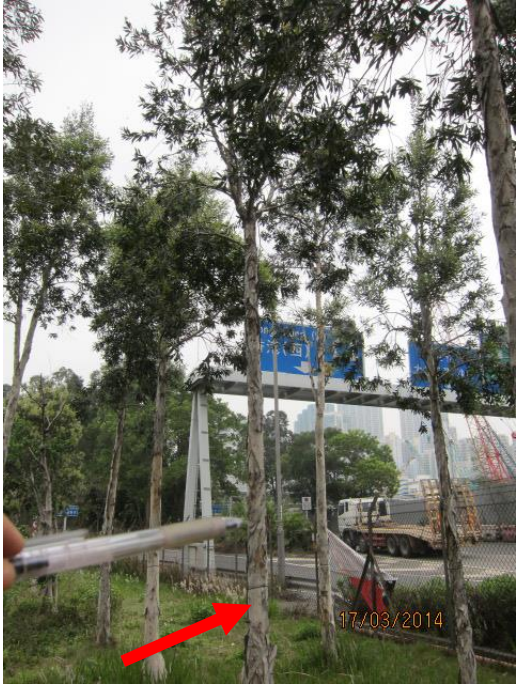
| YMT/ T3261- 1-Retain<br><i>Melaleuca cajuputi subsp. cumingiana</i> | YMT/ T3261- 2 | YMT/ T3261- 3 | YMT/ T3261- 4 |

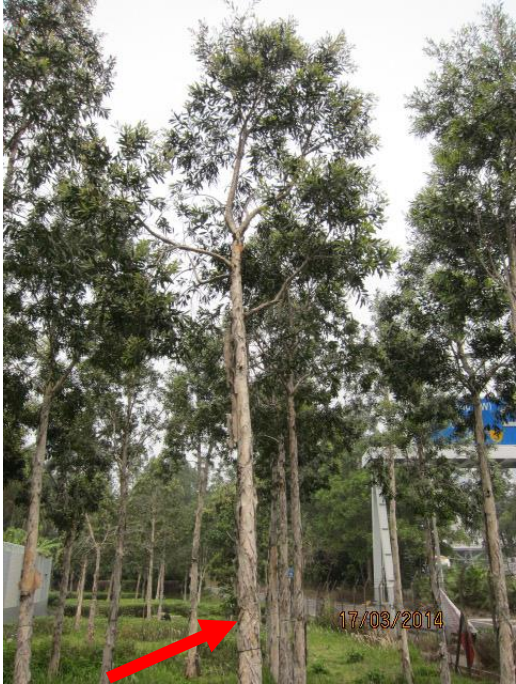
| YMT/ T3265- 1-Retain<br><i>Melaleuca cajuputi subsp. cumingiana</i> | YMT/ T3265- 2 | YMT/ T3265- 3 | YMT/ T3265- 4 |

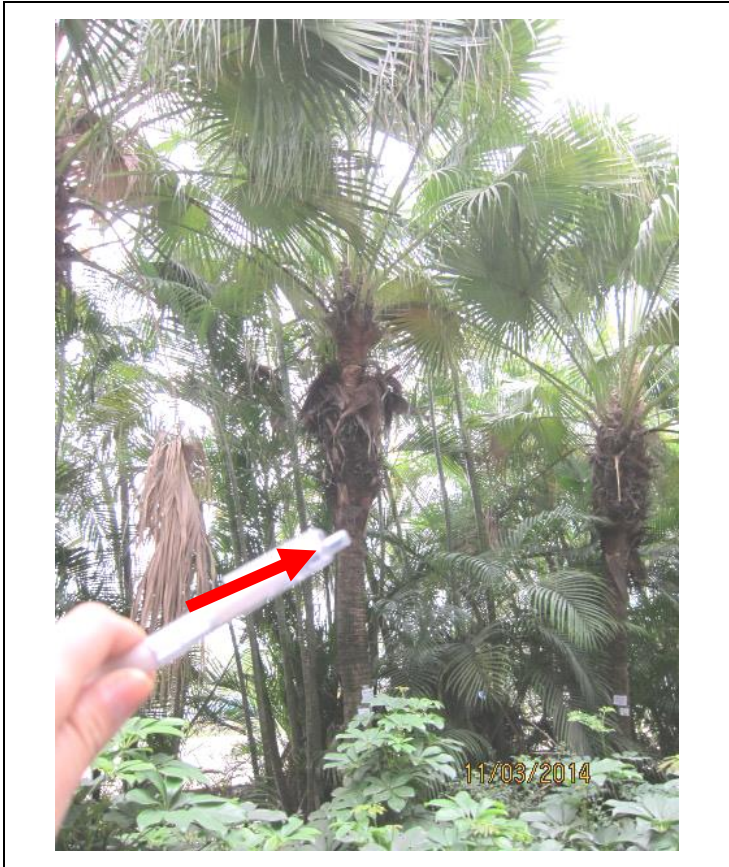
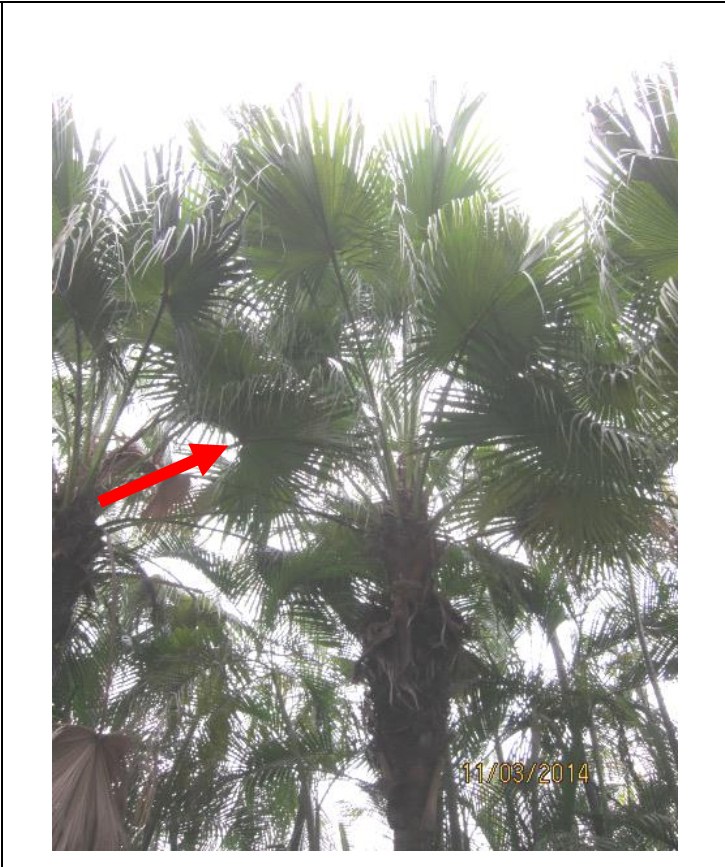
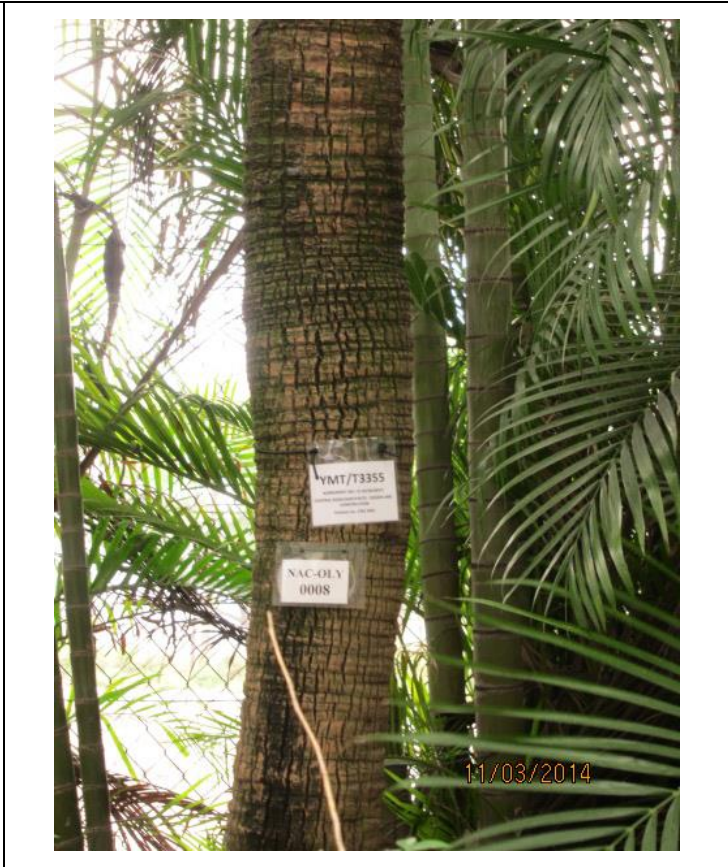
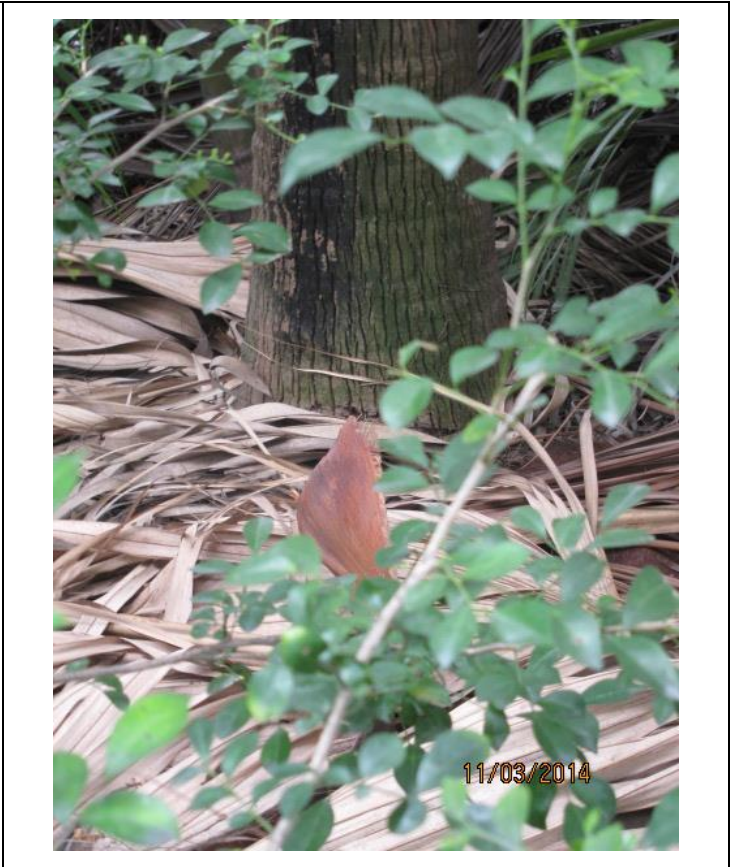
| YMT/T3355-1-Retain<br>Scientific Name: <i>Livistona chinensis</i> | YMT/T3355-2<br>Crown suppressed | YMT/T3355-3 | YMT/T3355-4 |

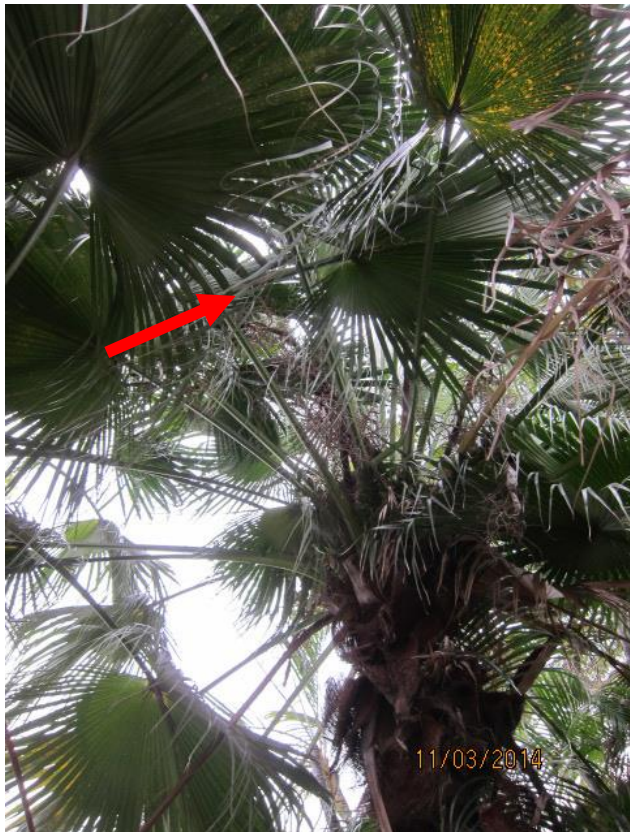
| <p>YMT/T3360-1-Retain<br/>Scientific Name: <i>Livistona chinensis</i></p> | <p>YMT/T3360-2<br/>Crown suppressed</p> | <p>YMT/T3360-3</p> | <p>YMT/T3360-4</p> |

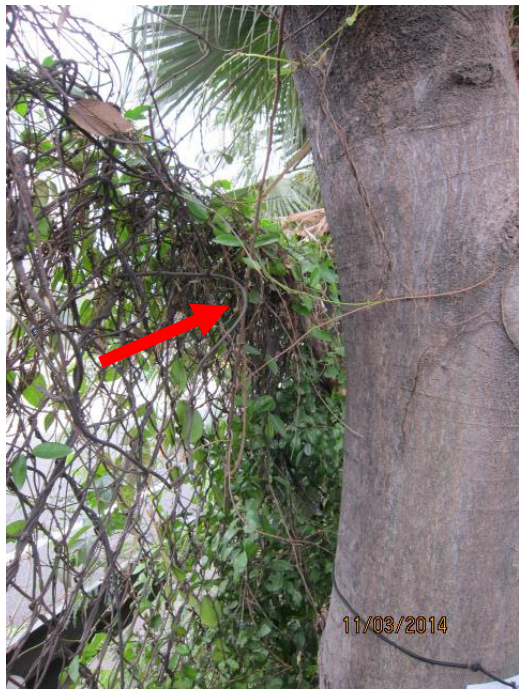
| YMT/T3363-1-Retain<br>Scientific Name: <i>Celtis sinensis</i> | YMT/T3363-2 | YMT/T3363-3Climber | YMT/T3363-4 |

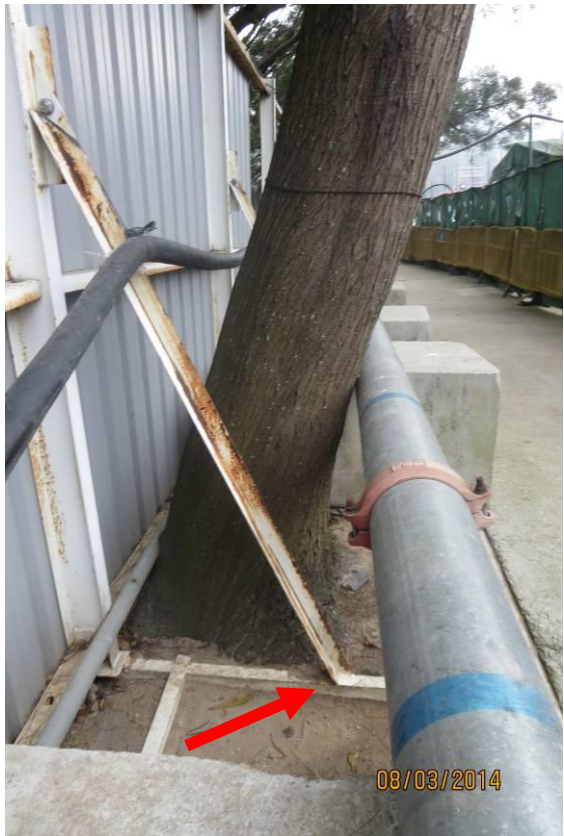
| YMT/T3364-1-Fell<br>Scientific Name: <i>Melia azedarach</i> | YMT/T3364-2 | YMT/T3364-3 | YMT/T3364-4<br>Growth restricted |

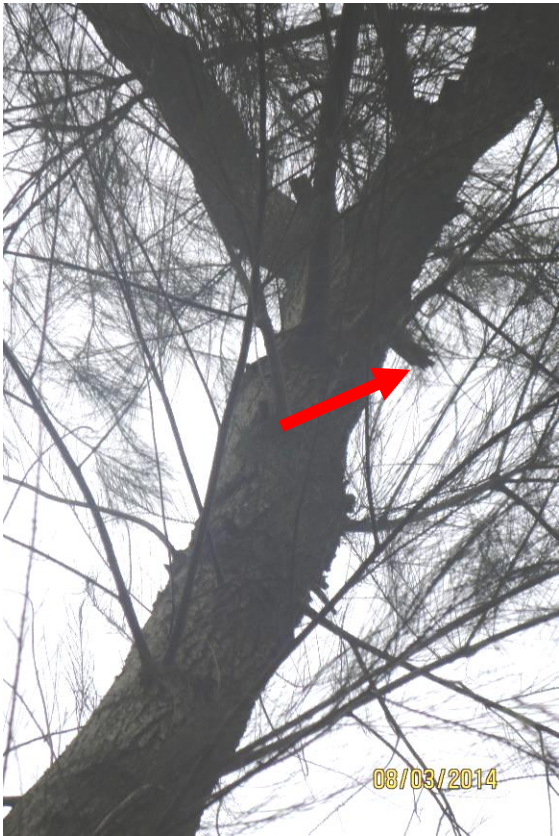
| YMT/T3366-1-Fell<br>Scientific Name: <i>Casuarina equisetifolia</i> | YMT/T3366-2 | YMT/T3366-3<br>Dead branches | YMT/T3366-4 |

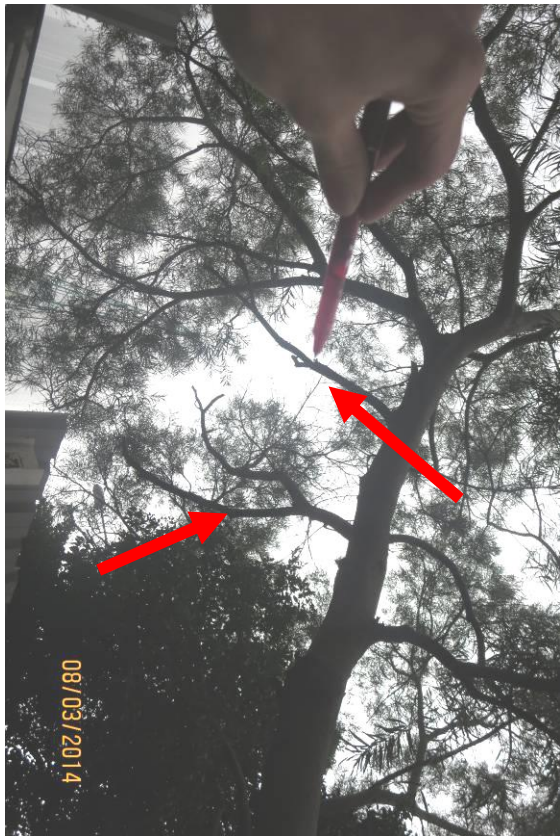
| YMT/T3367-1-Fell<br>Scientific Name: <i>Acacia confusa</i> | YMT/T3367-2<br>Dead branches | YMT/T3367-3<br>Included bark | YMT/T3367-4 |

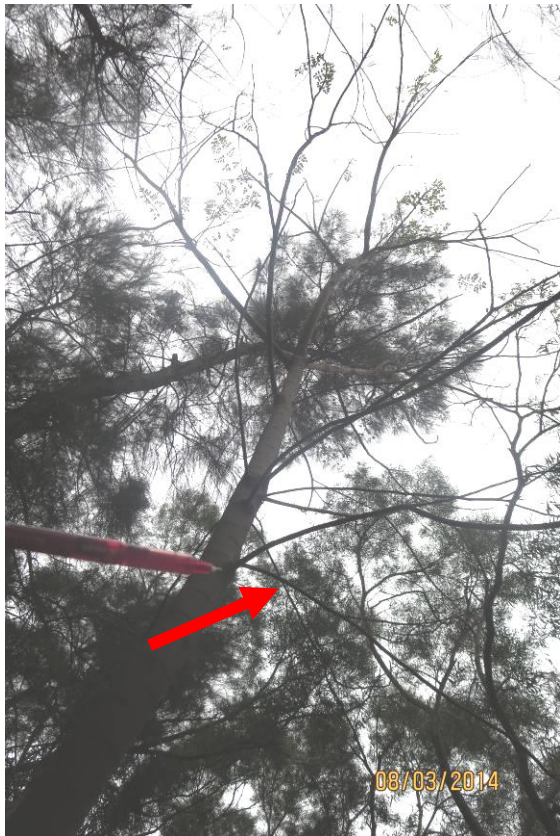
| YMT/T3369-1-Fell<br>Scientific Name: <i>Melia azedarach</i> | YMT/T3369-2<br>Dead branches | YMT/T3369-3 | YMT/T3369-4 |

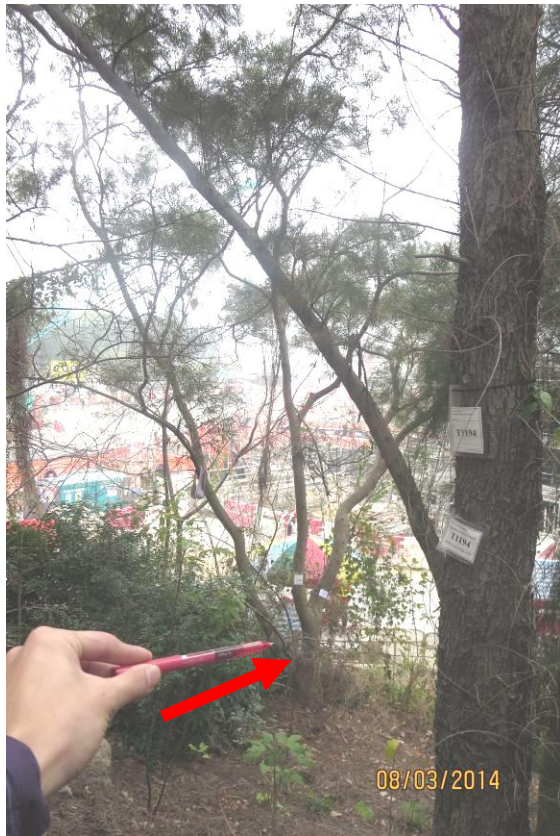
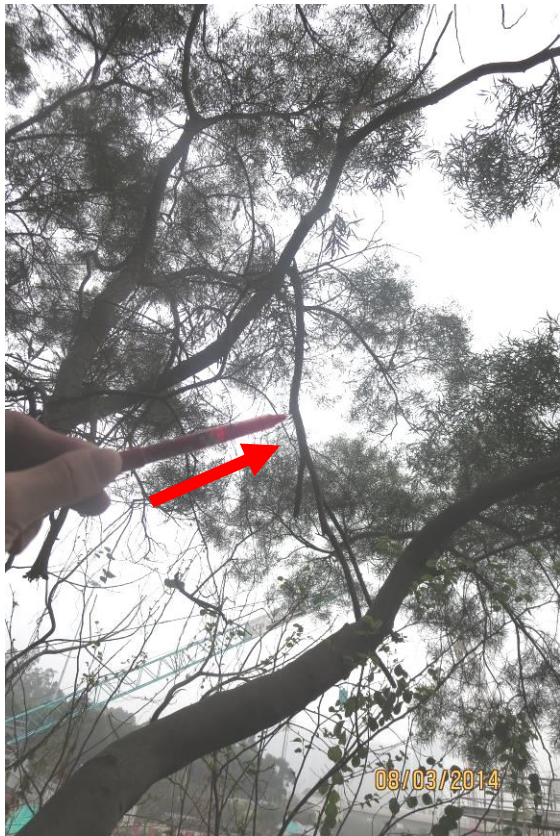
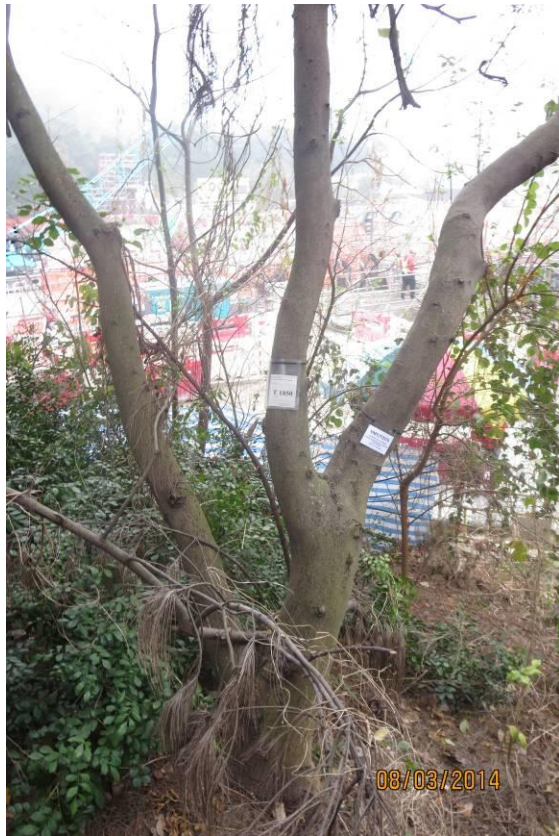
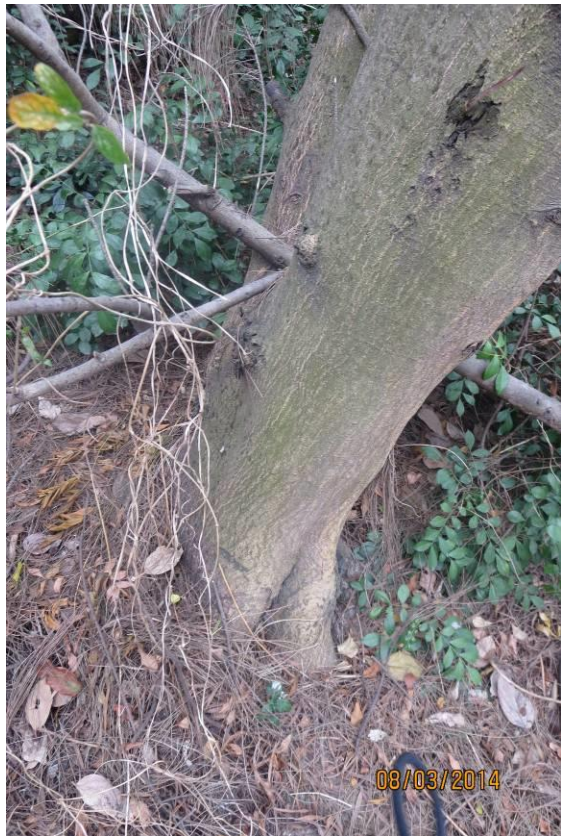
| YMT/T3370-1-Fell<br>Scientific Name: <i>Acacia confusa</i> | YMT/T3370-2<br>Dead branches | YMT/T3370-3 | YMT/T3370-4 |

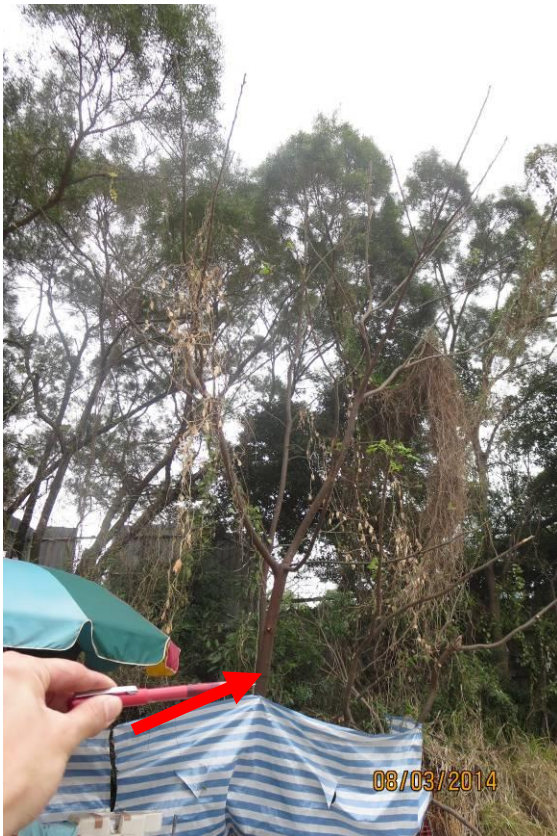
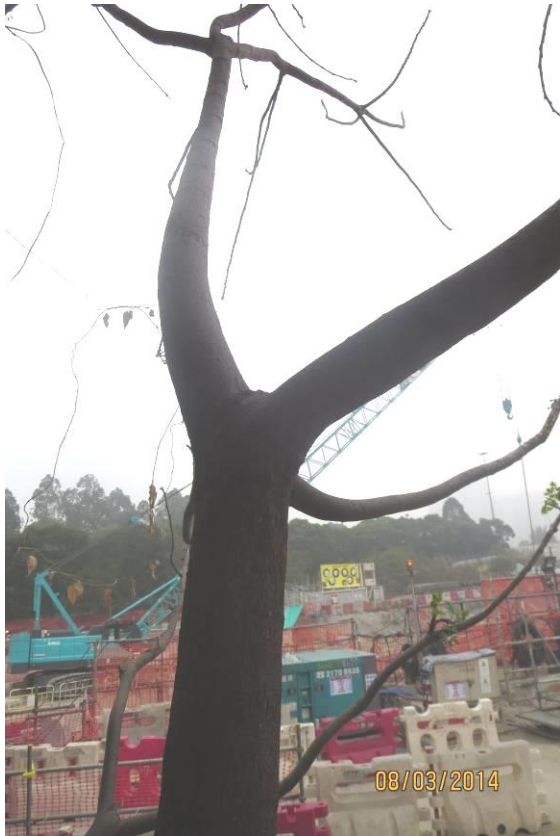
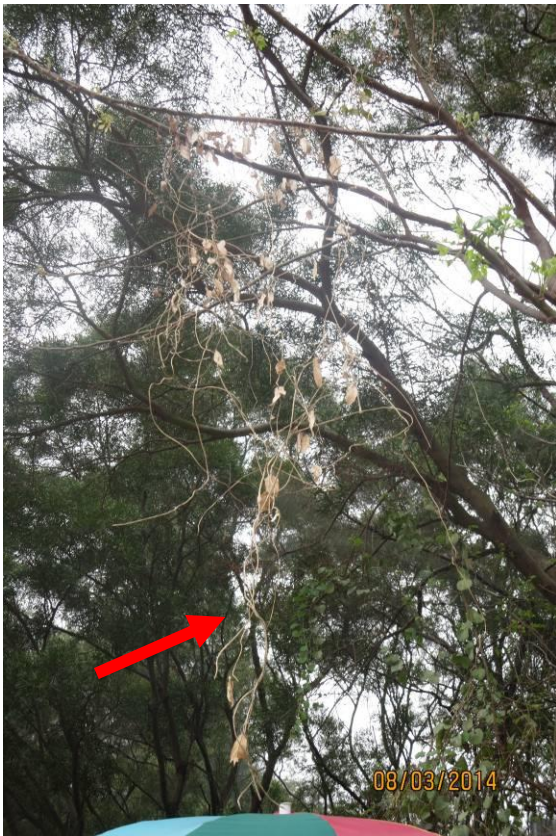
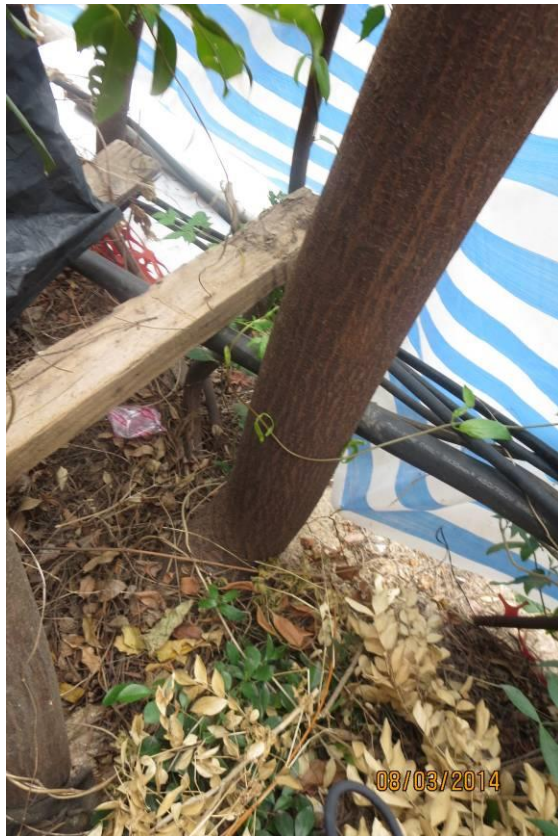
| YMT/T3371-1-Fell<br>Scientific Name: <i>Melia azedarach</i> | YMT/T3371-2 | YMT/T3371-3<br>Climber | YMT/T3371-4 |

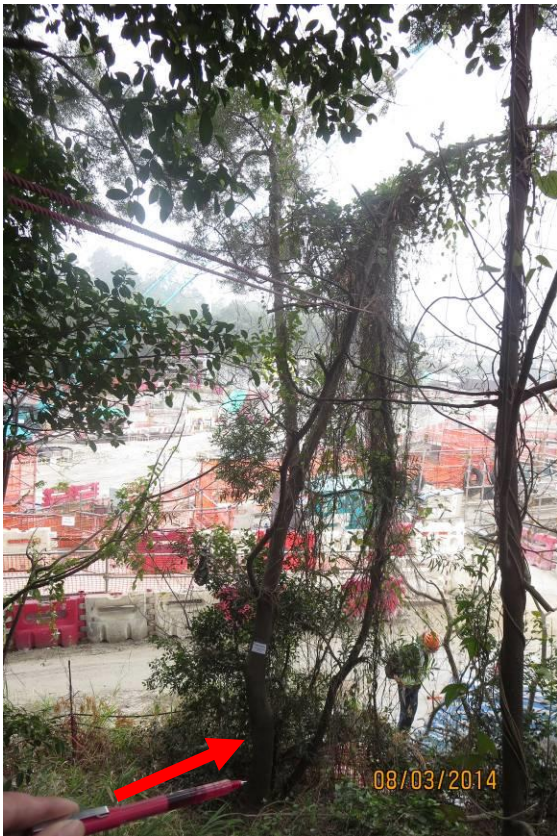
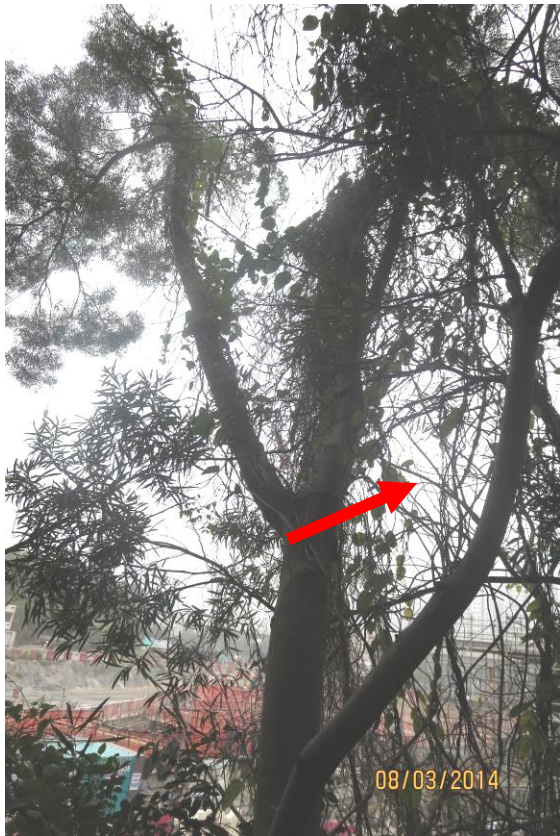
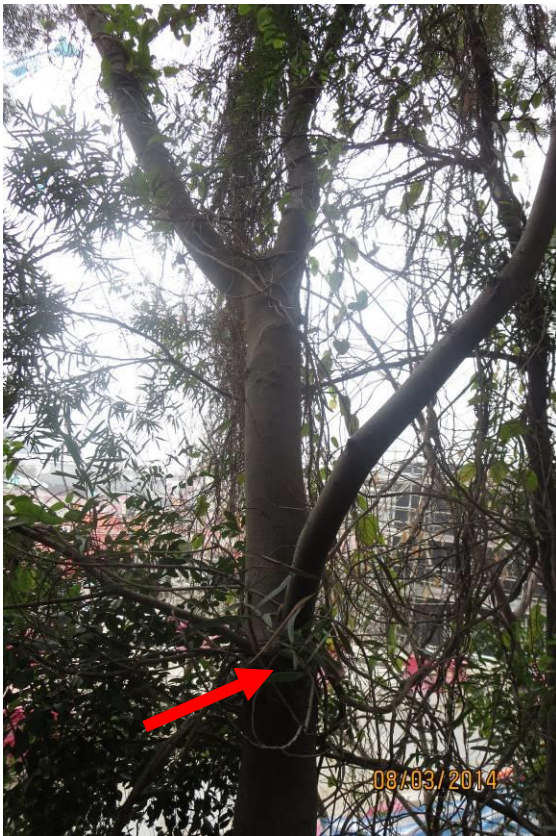
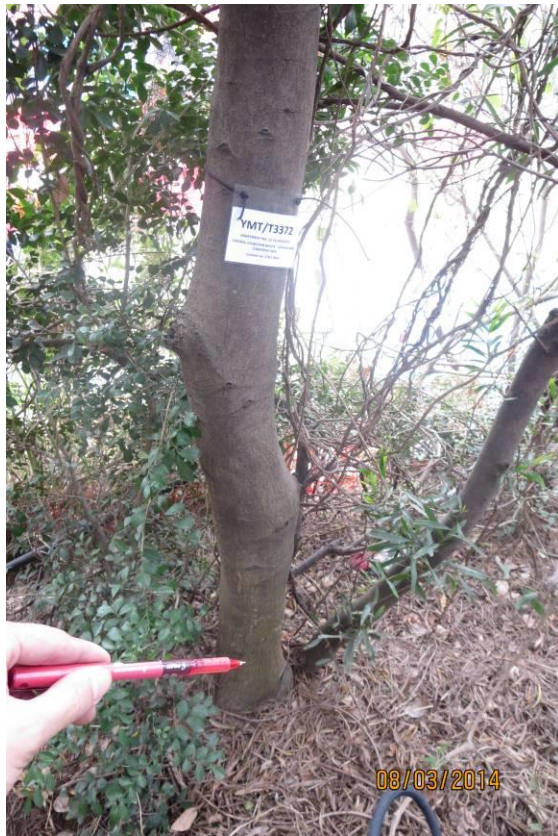
| YMT/T3372-1-Fell<br>Scientific Name: <i>Acacia confusa</i> | YMT/T3372-2<br>Dead branches | YMT/T3372-3<br>Climber | YMT/T3372-4 |

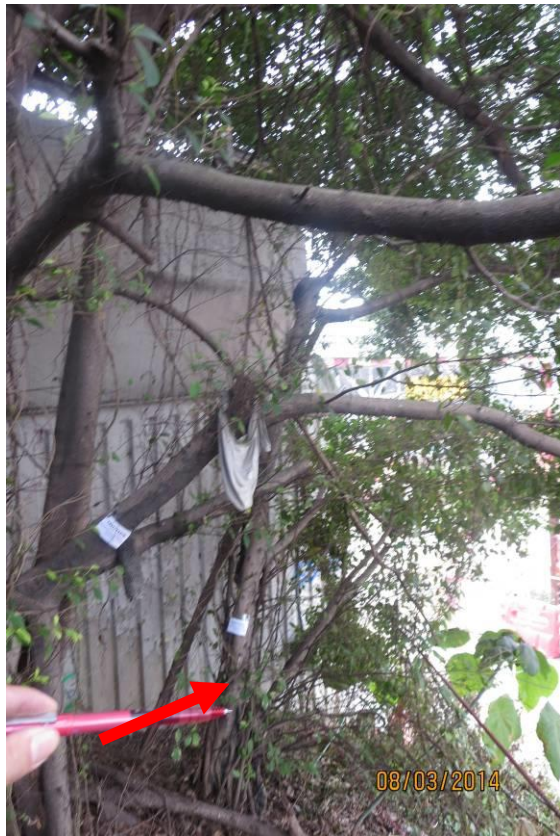
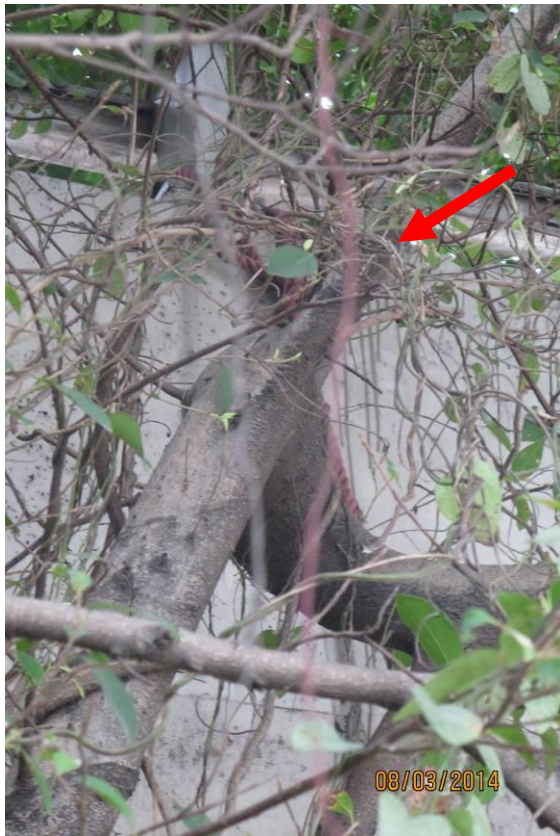
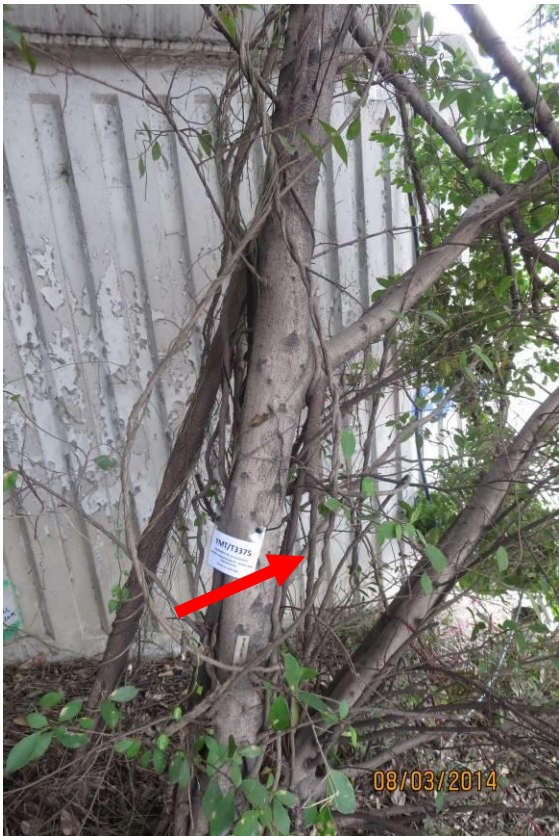
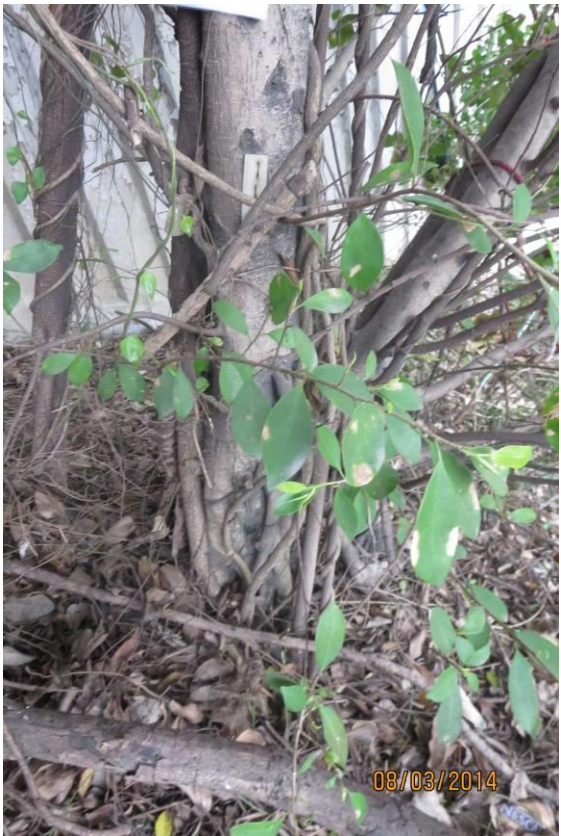
| YMT/T3375-1-Fell<br>Scientific Name: <i>Ficus microcarpa</i> | YMT/T3375-2<br>Dead branches | YMT/T3375-3<br>Climber | YMT/T3375-4 |

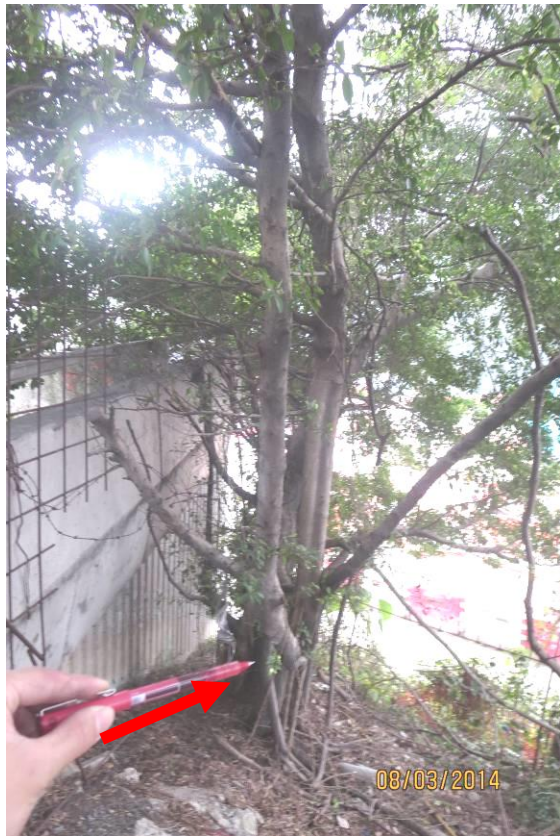
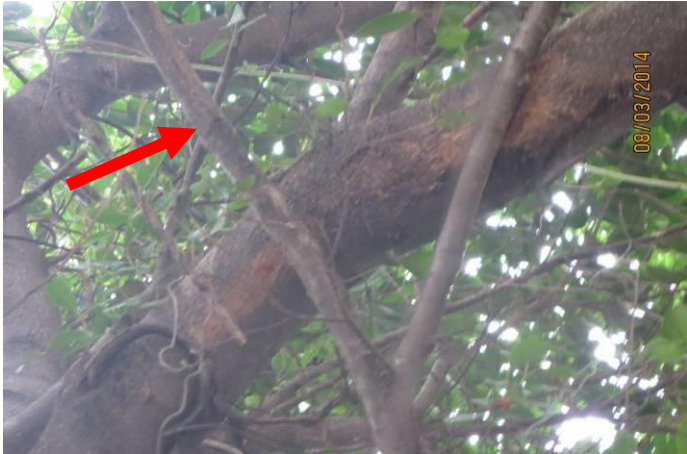
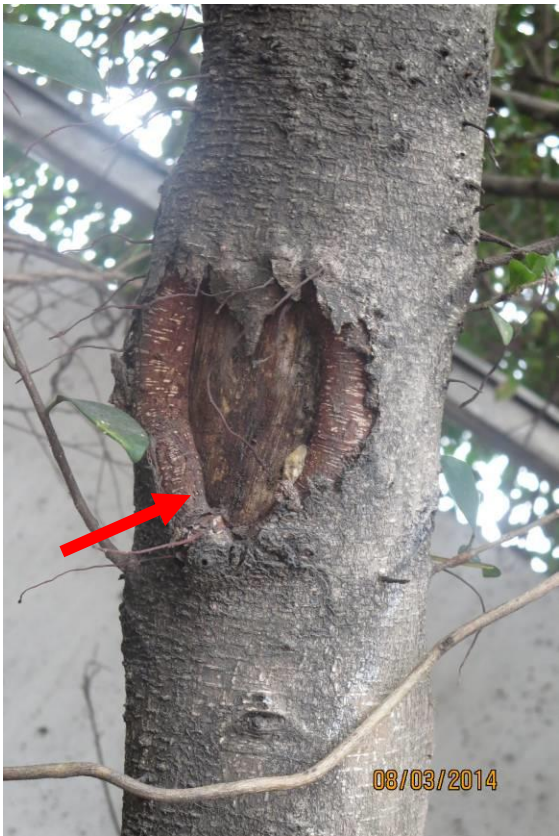
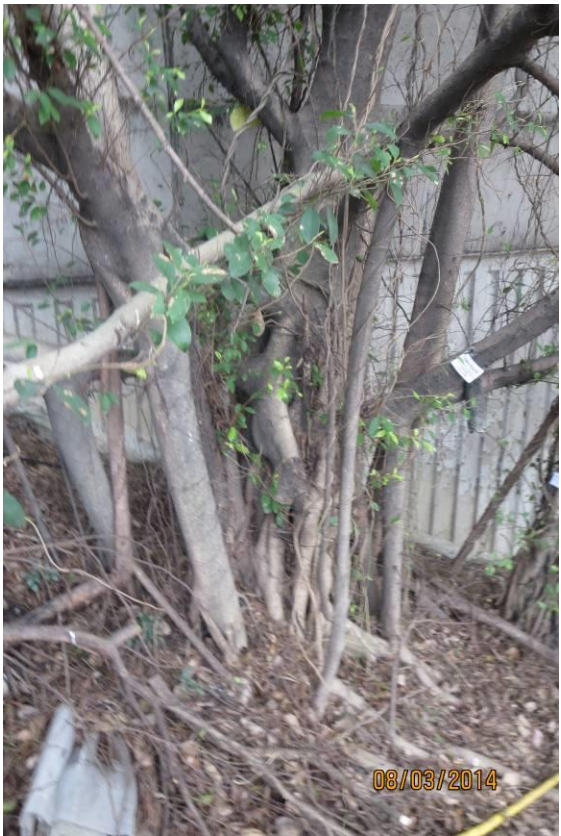
| YMT/T3376-1-Fell<br>Scientific Name: <i>Ficus microcarpa</i> | YMT/T3376-2<br>Cross branches | YMT/T3376-3<br>Wound on trunk | YMT/T3376-4 |

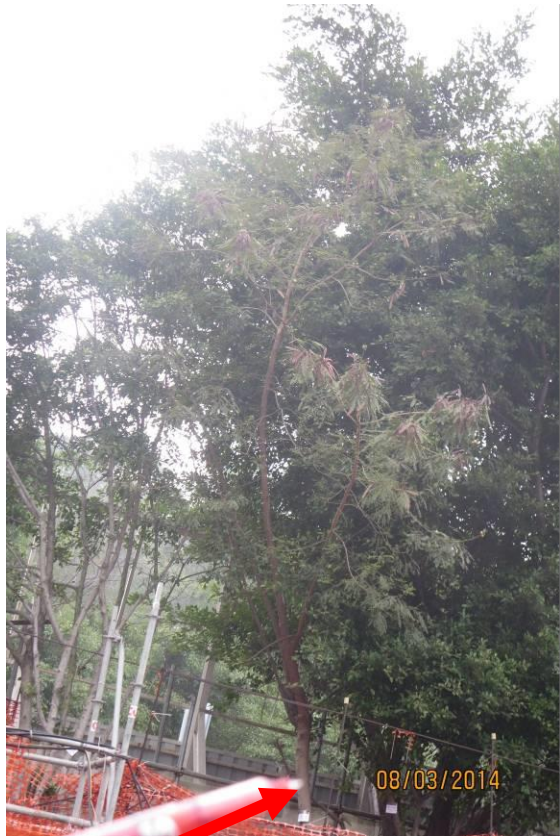
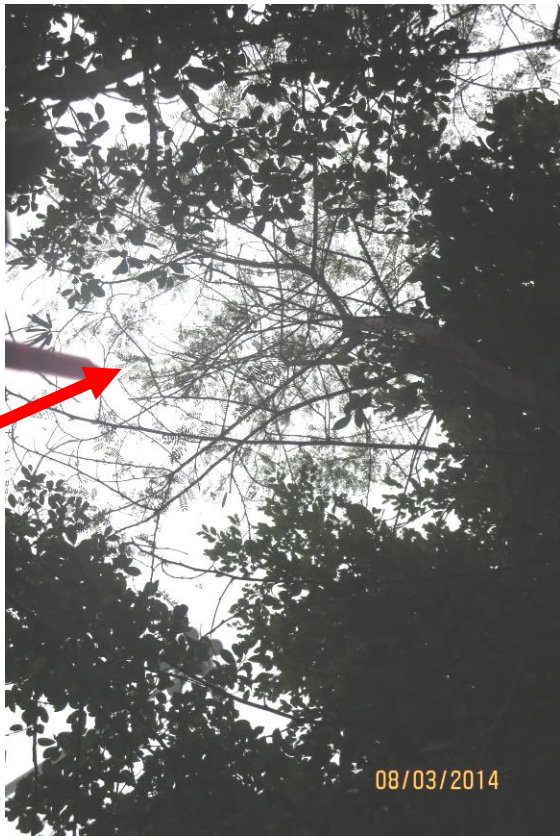
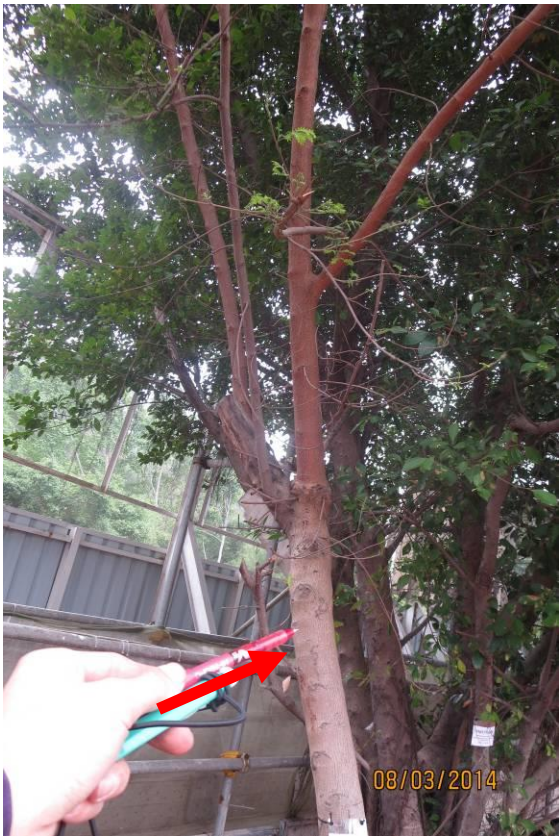
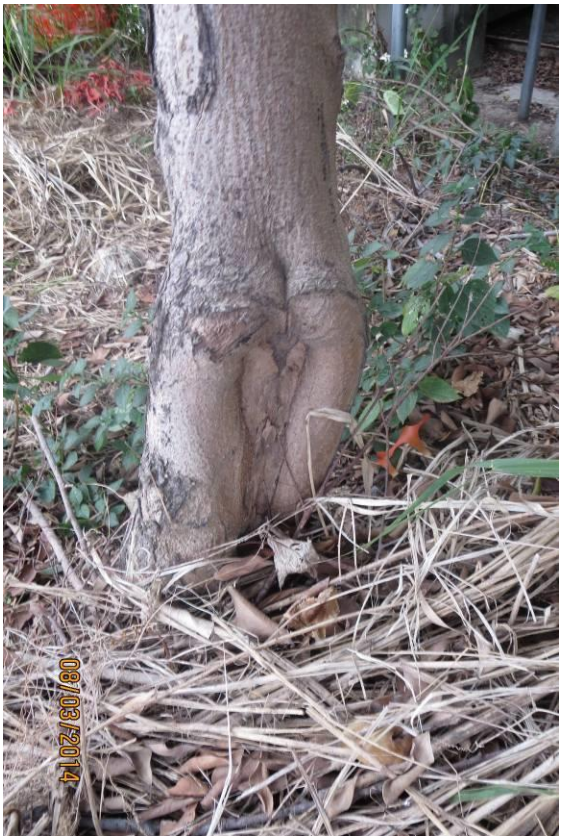
| YMT/T3378-1-Fell<br>Scientific Name: <i>Leucaena leucocephala</i> | YMT/T3378-2<br>Dead branches | YMT/T3378-3 | YMT/T3378-4 |
