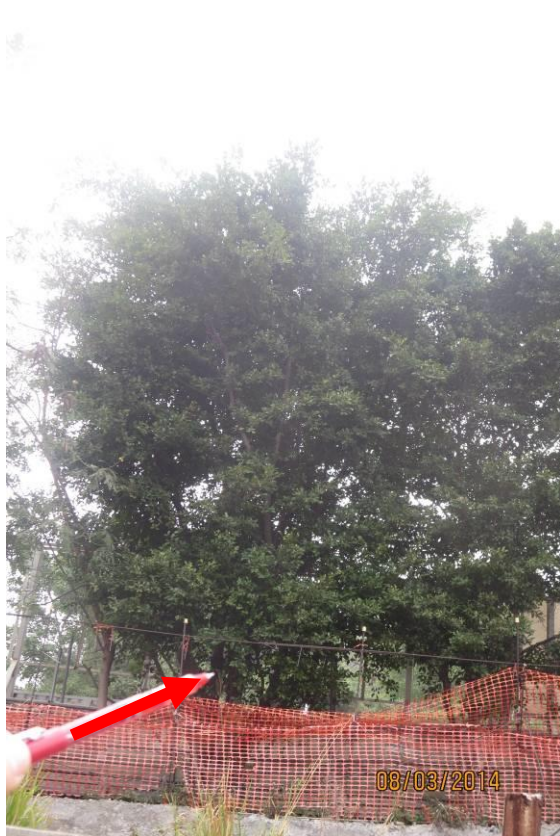
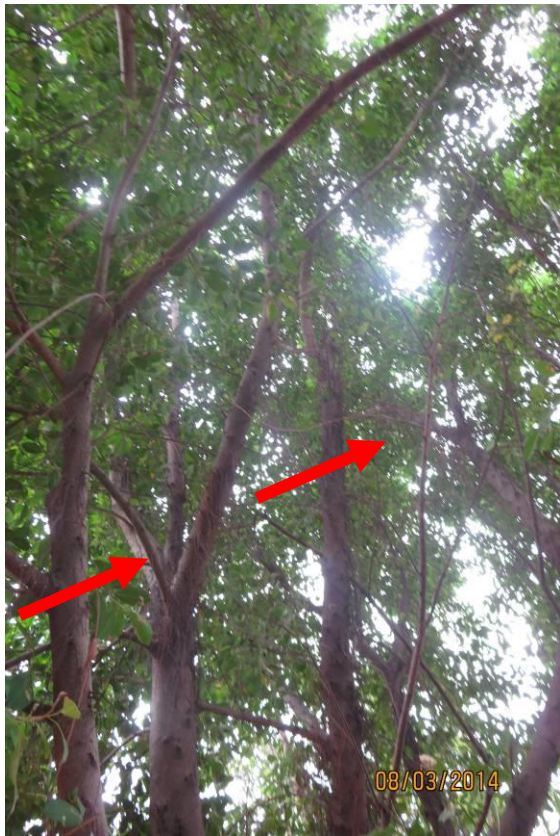
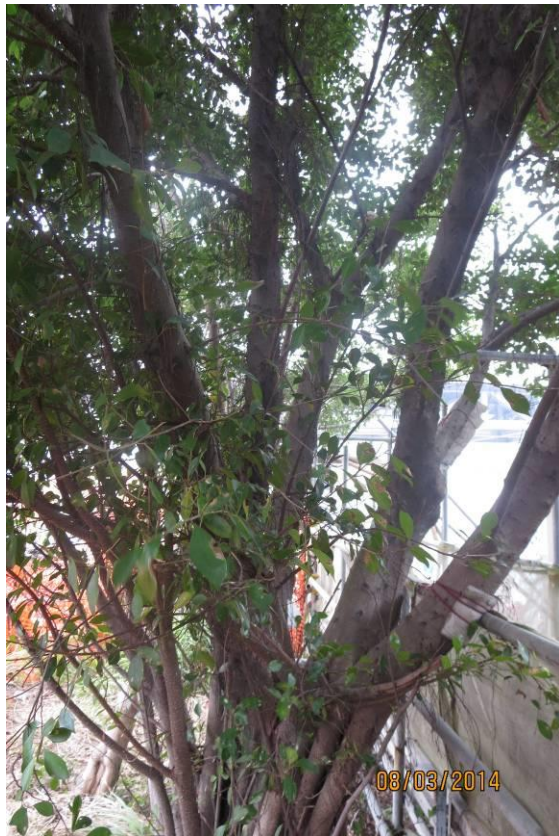
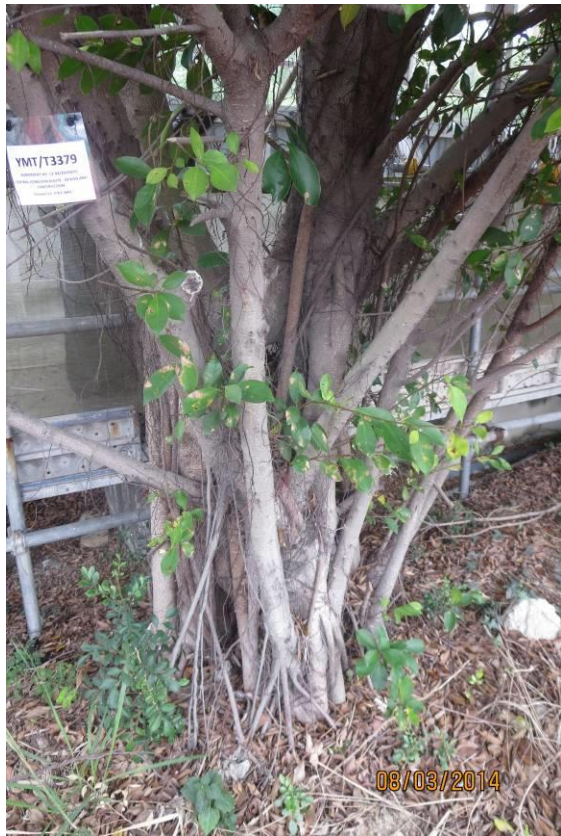
| YMT/T3379-1-Fell<br>Scientific Name: <i>Ficus microcarpa</i> | YMT/T3379-2<br>Dead branches | YMT/T3379-3 | YMT/T3379-4 |

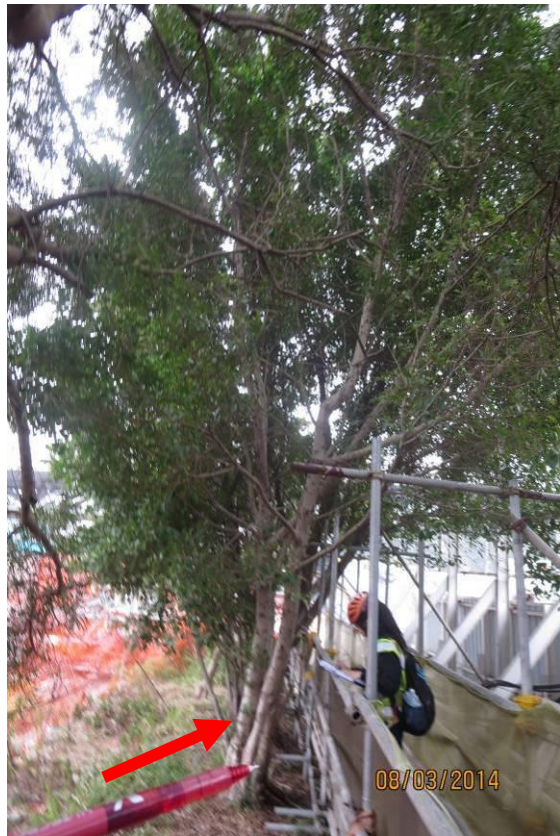
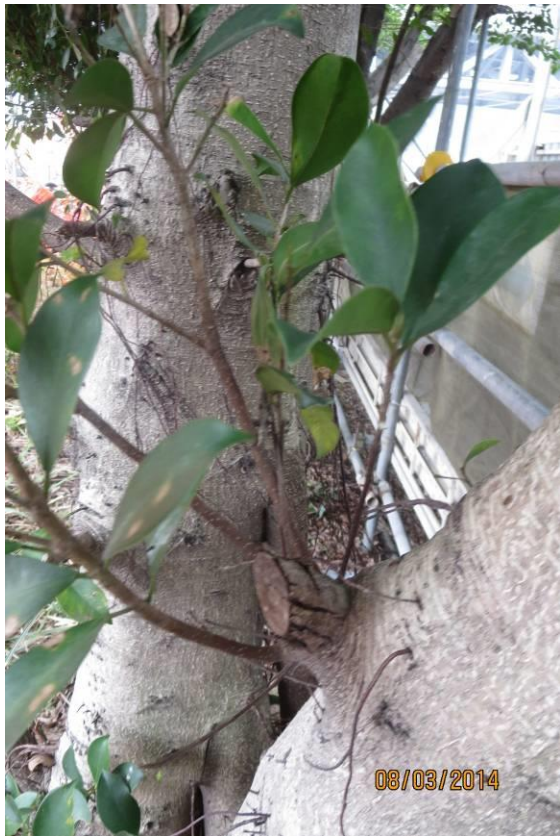
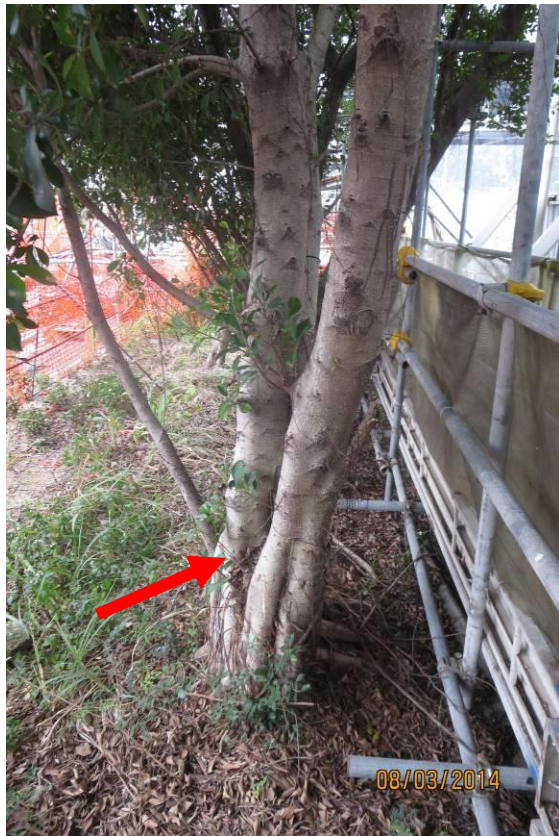
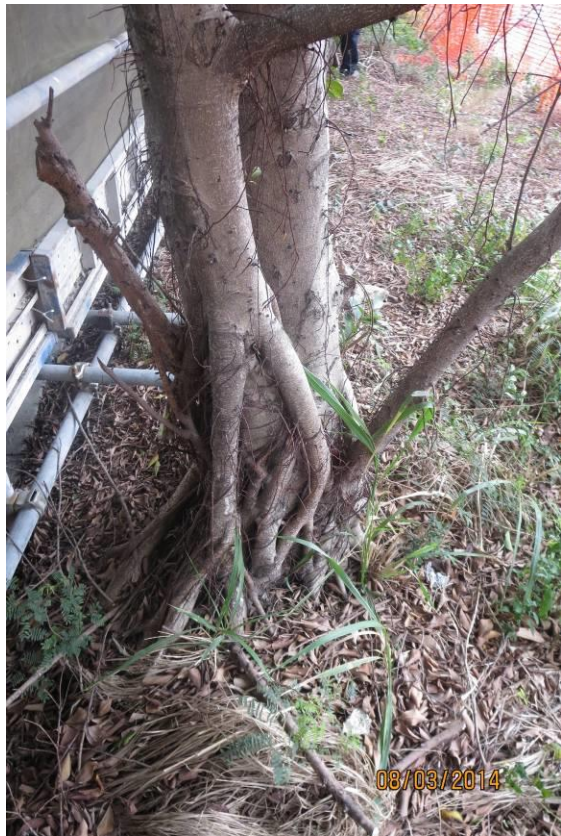
| YMT/T3380-1-Fell<br>Scientific Name: <i>Ficus microcarpa</i> | YMT/T3380-2 | YMT/T3380-3<br>Co-dominant trunk | YMT/T3380-4 |

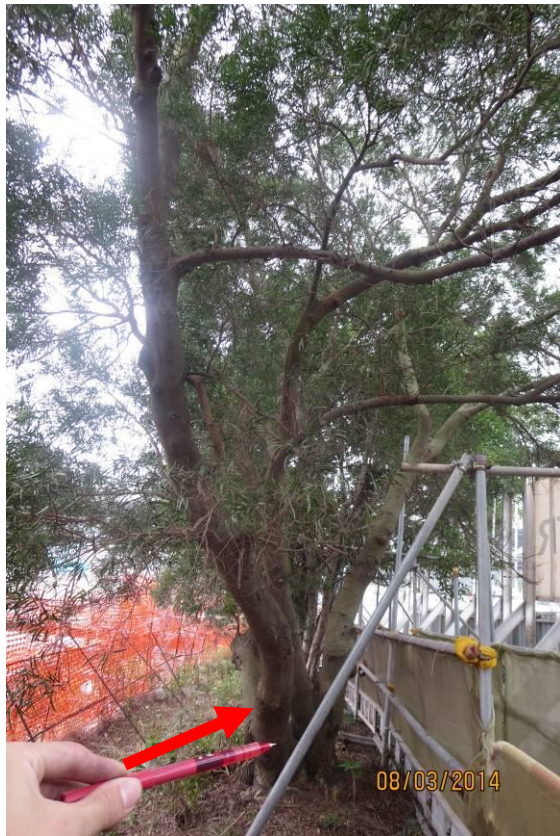
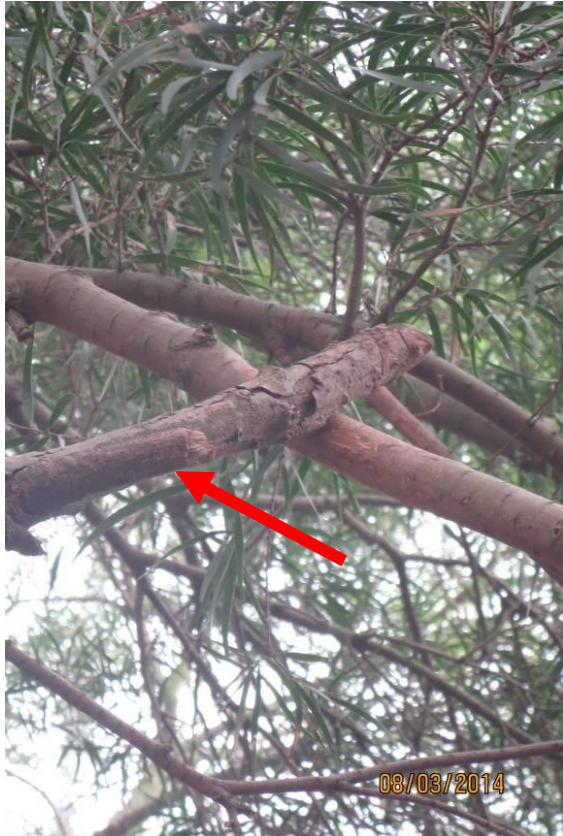
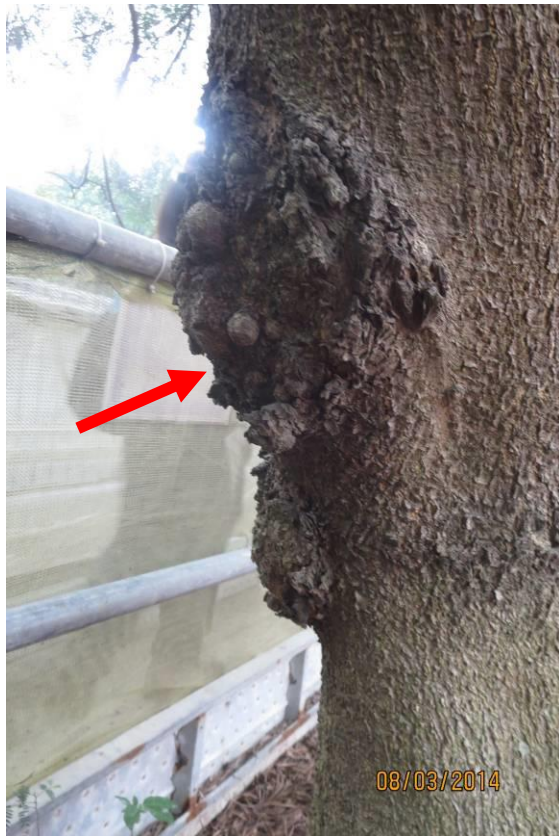
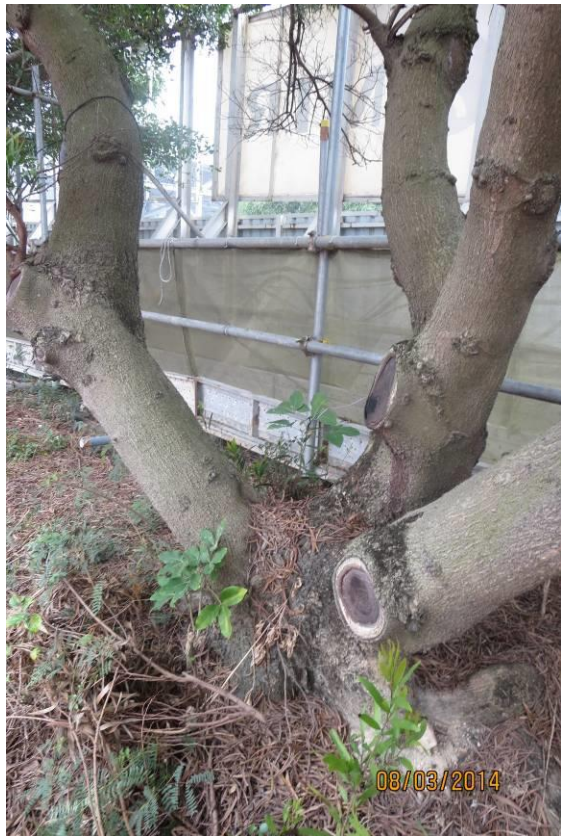
| YMT/T3381-1-Fell<br>Scientific Name: <i>Acacia confusa</i> | YMT/T3381-2<br>Dead branches | YMT/T3381-3<br>bulge on trunk | YMT/T3381-4 |

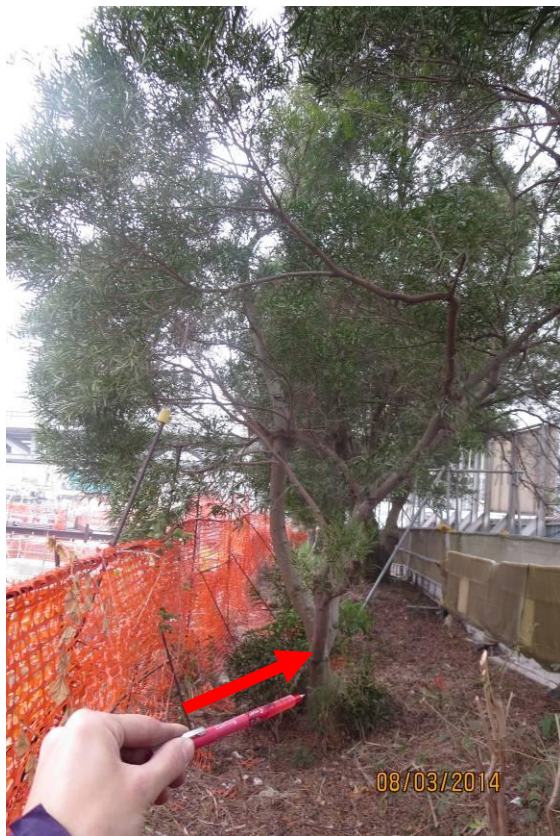
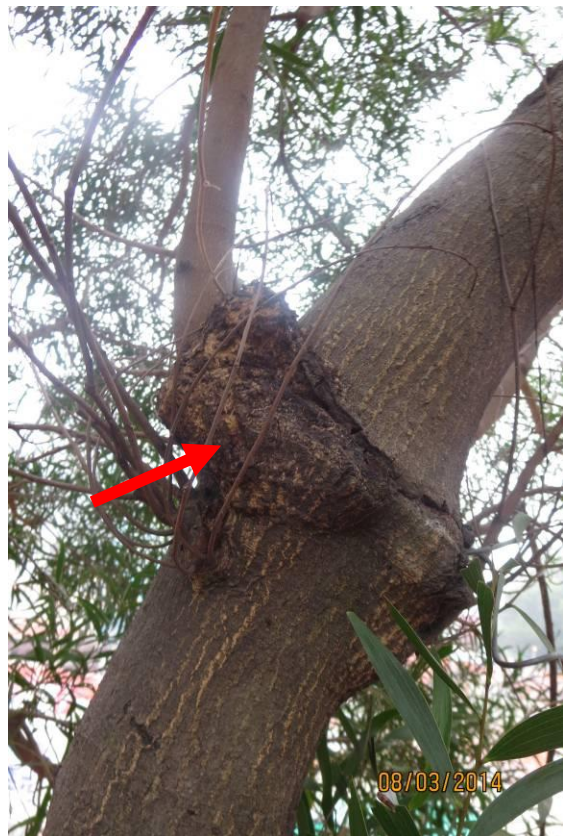
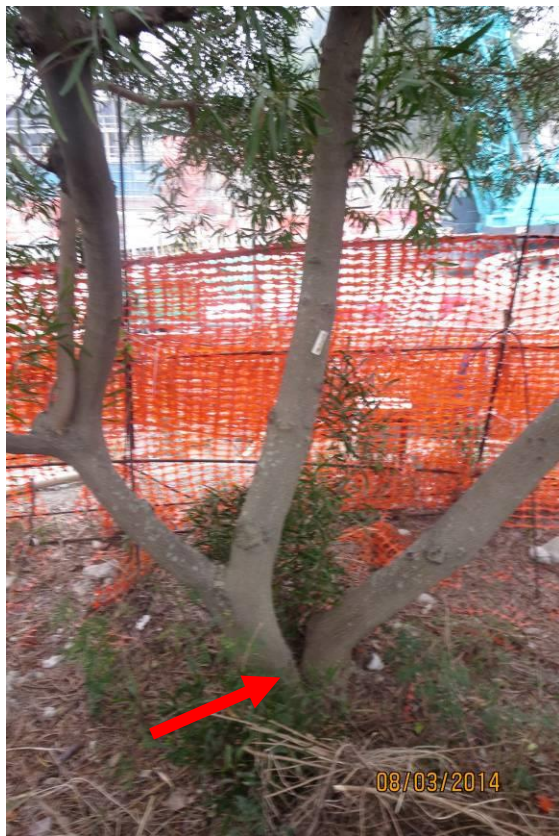
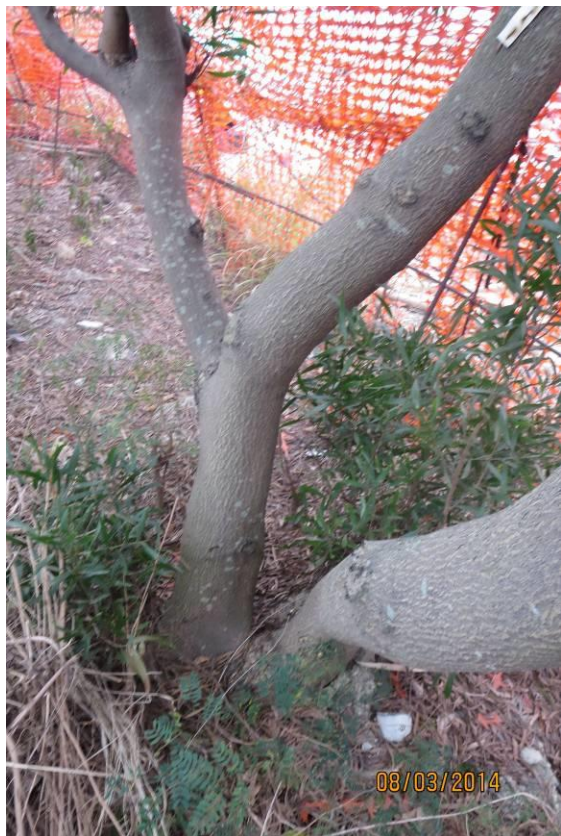
| YMT/T3382-1-Fell<br>Scientific Name: <i>Acacia confusa</i> | YMT/T3382-2<br>bulge on trunk | YMT/T3382-3<br>Co-dominant trunk | YMT/T3382-4 |

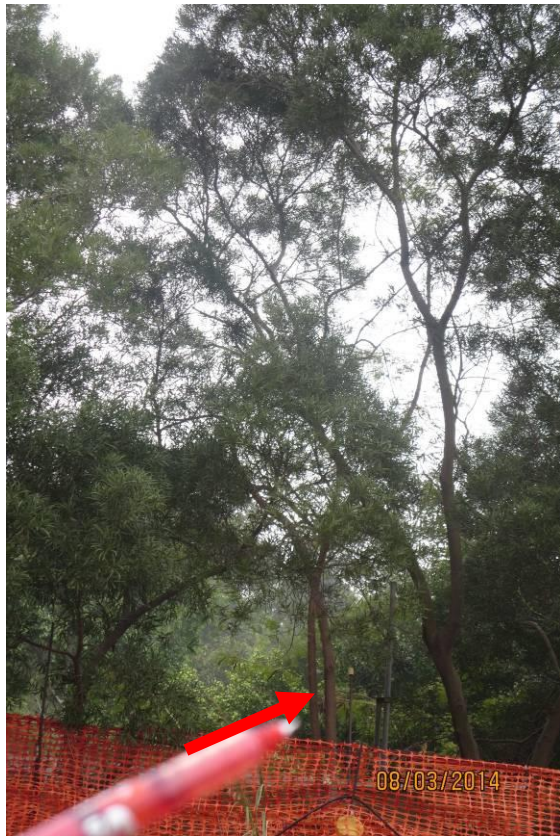
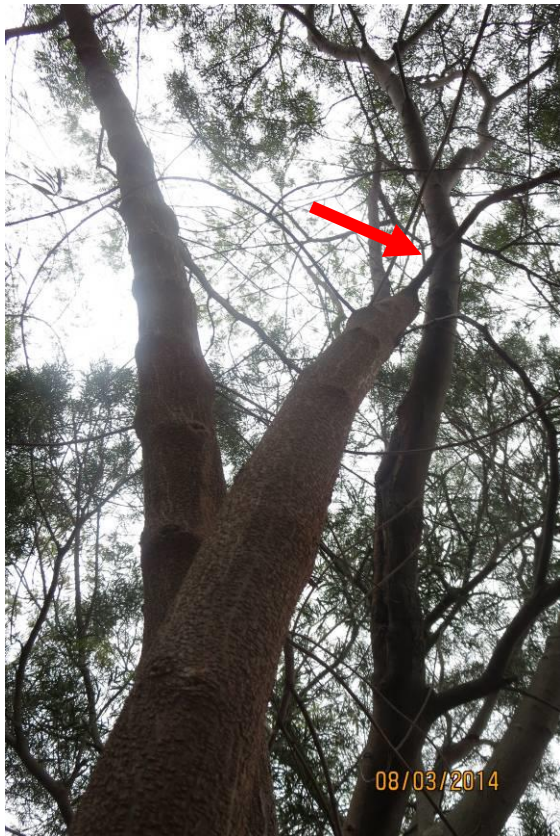
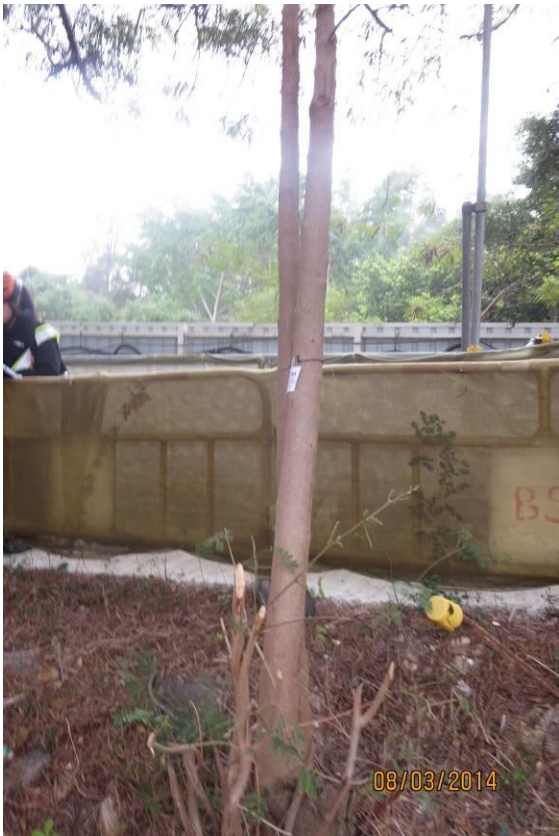
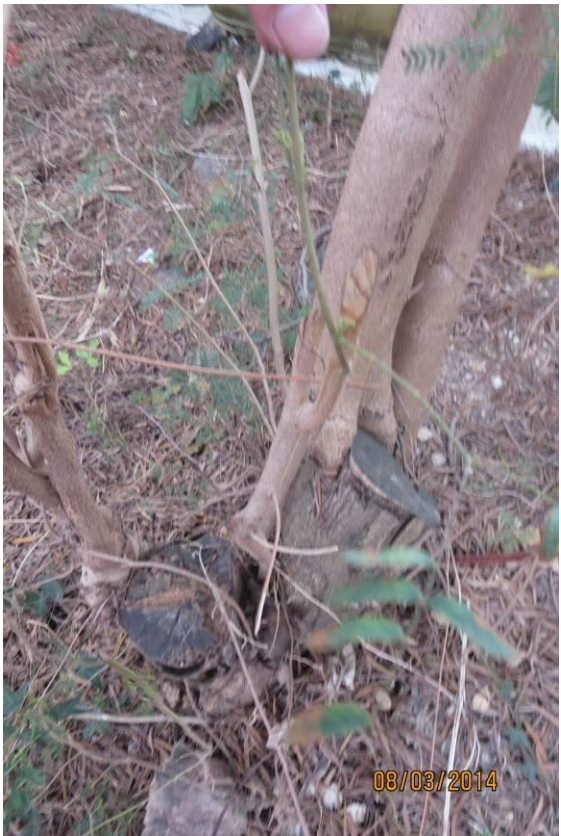
| YMT/T3383-1-Fell<br>Scientific Name: <i>Leucaena leucocephala</i> | YMT/T3383-2<br>Cross branches | YMT/T3383-3 | YMT/T3383-4 |

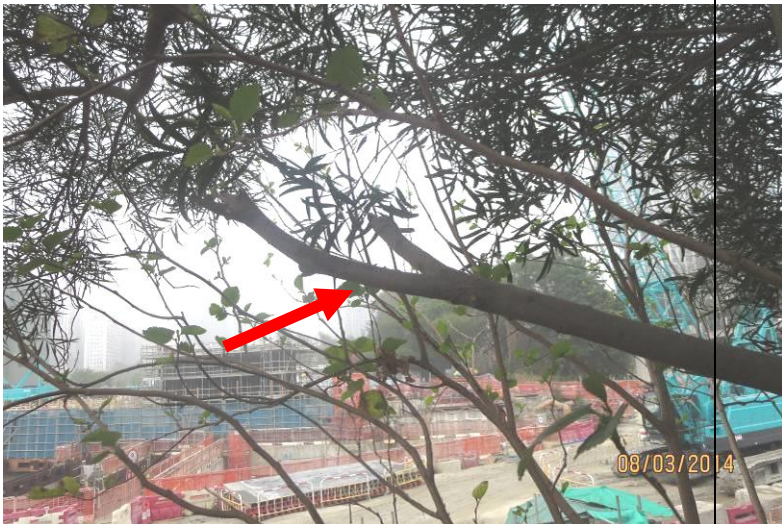
| YMT/T3384-1-Fell<br>Scientific Name: <i>Acacia confusa</i> | YMT/T3384-2<br>Dead branches | YMT/T3384-3<br>Broken branches | YMT/T3384-4<br>Co-dominant trunk |

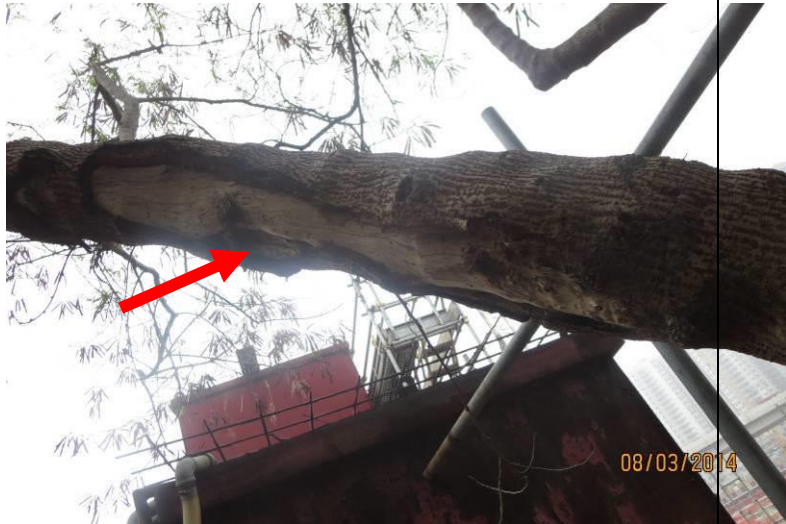
| YMT/T3385-1-Fell<br>Scientific Name: <i>Acacia confusa</i> | YMT/T3385-2<br>Dead branches | YMT/T3385-3<br>mechanical damage | YMT/T3385-4 |

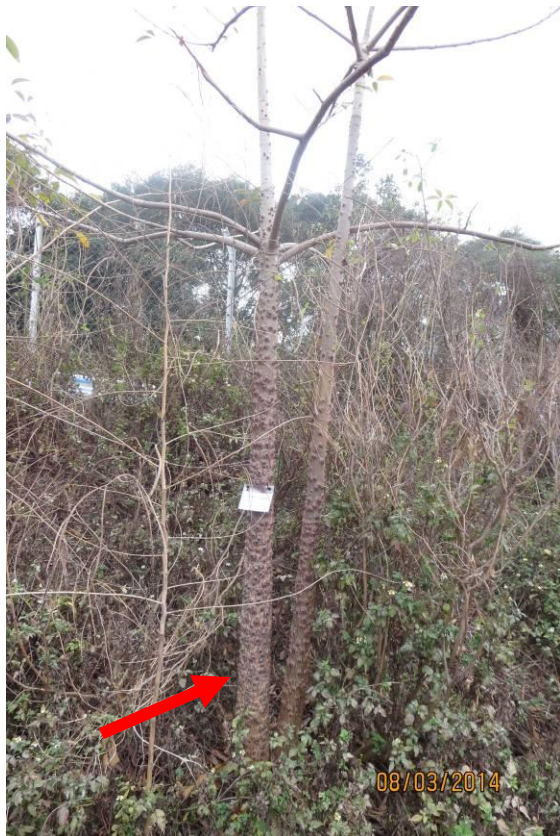
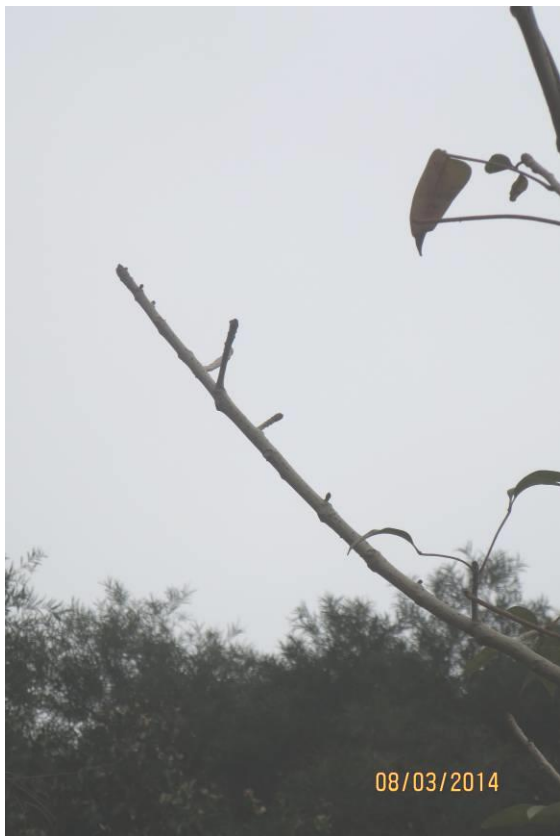
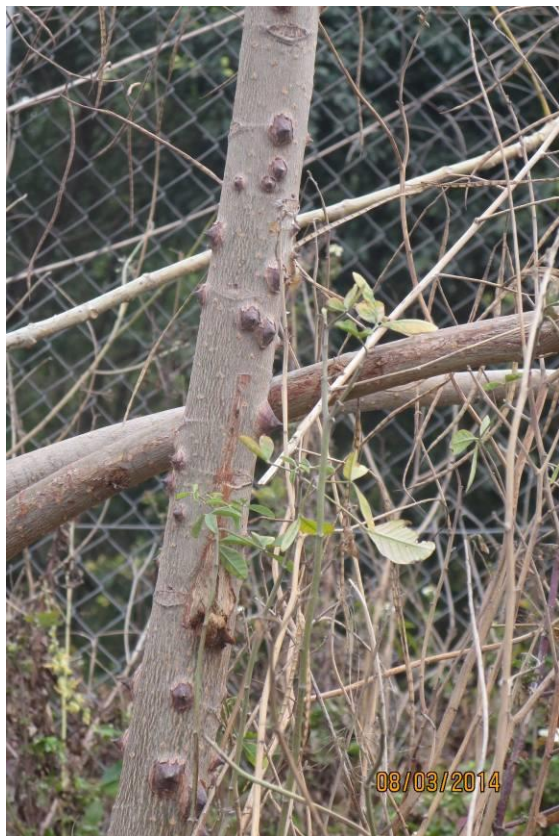
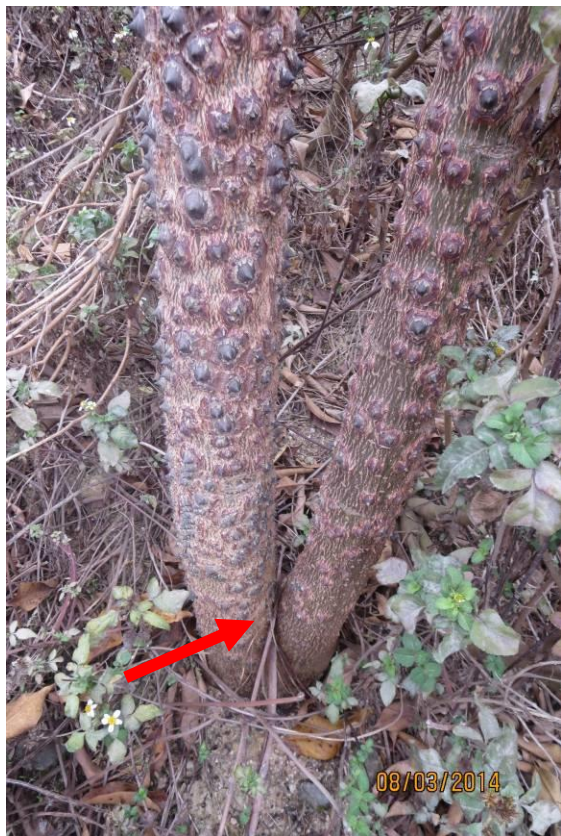
| YMT/T3388-1- Retain<br>Scientific Name: <i>Bombax ceiba</i> | YMT/T3388-2 | YMT/T3388-3 | YMT/T3388-4<br>Included bark |

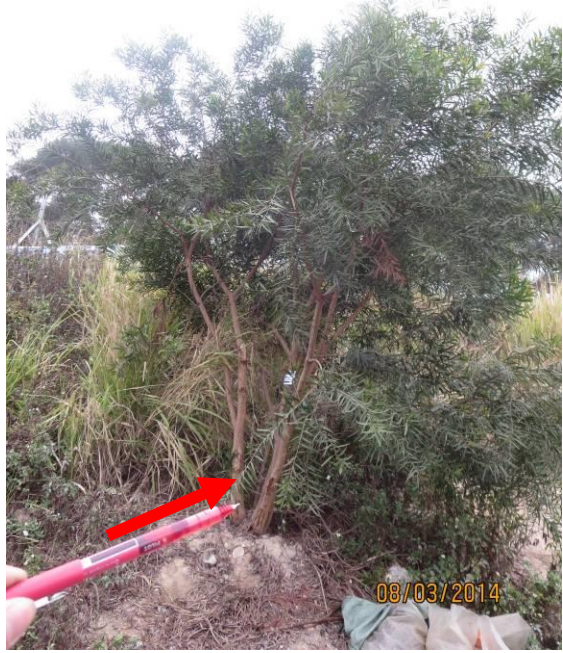
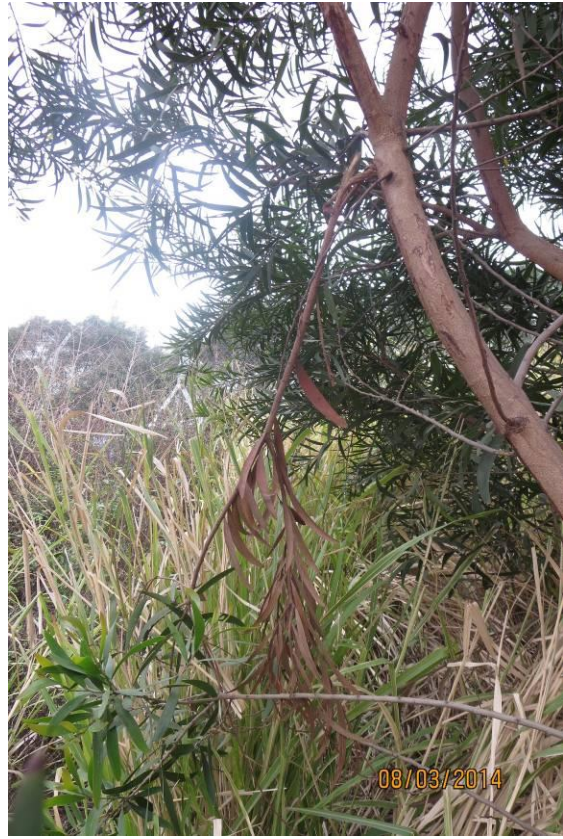
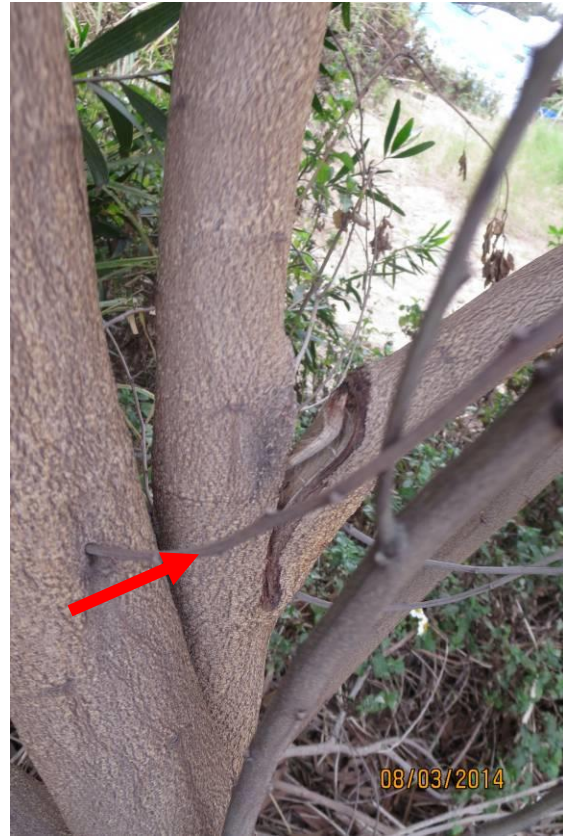
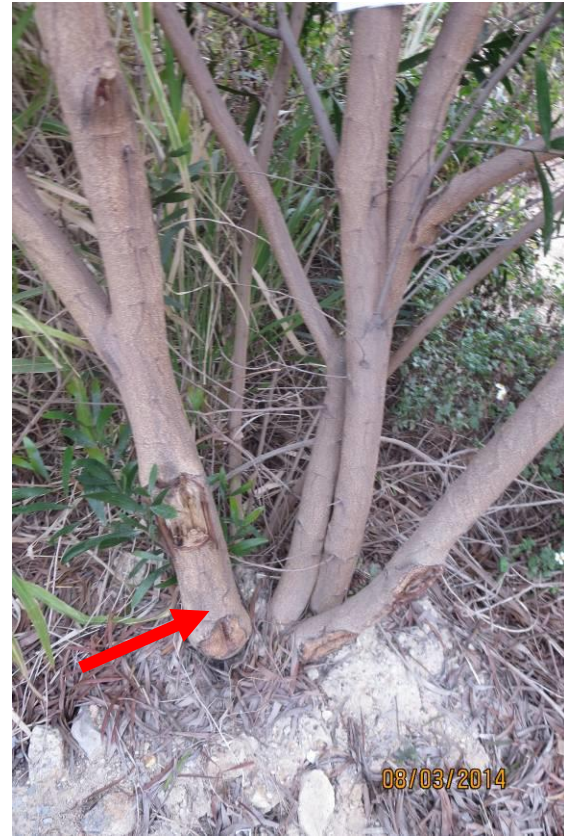
| <p>YMT/T3389-1- Retain<br/>Scientific Name: <i>Acacia confusa</i></p> | <p>YMT/T3389-2</p> | <p>YMT/T3389-3<br/>Dieback</p> | <p>YMT/T3389-4<br/>Co-dominant trunk</p> |

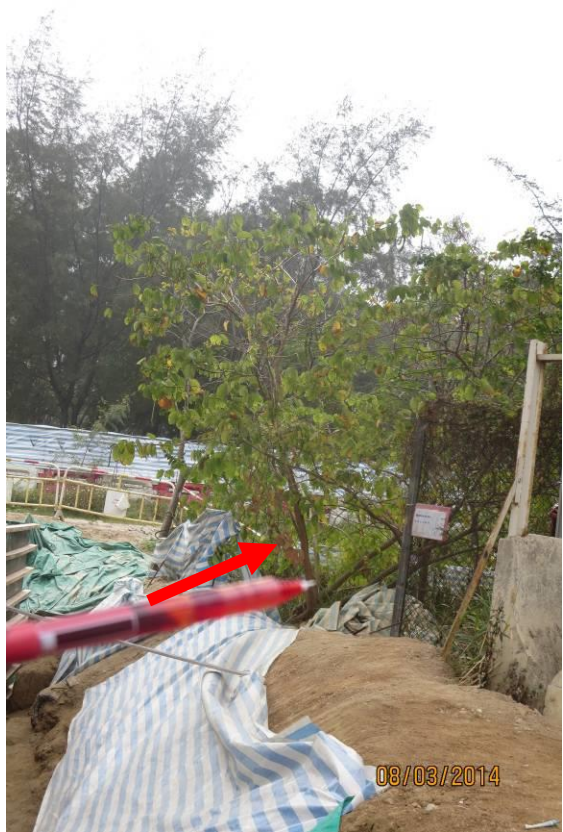
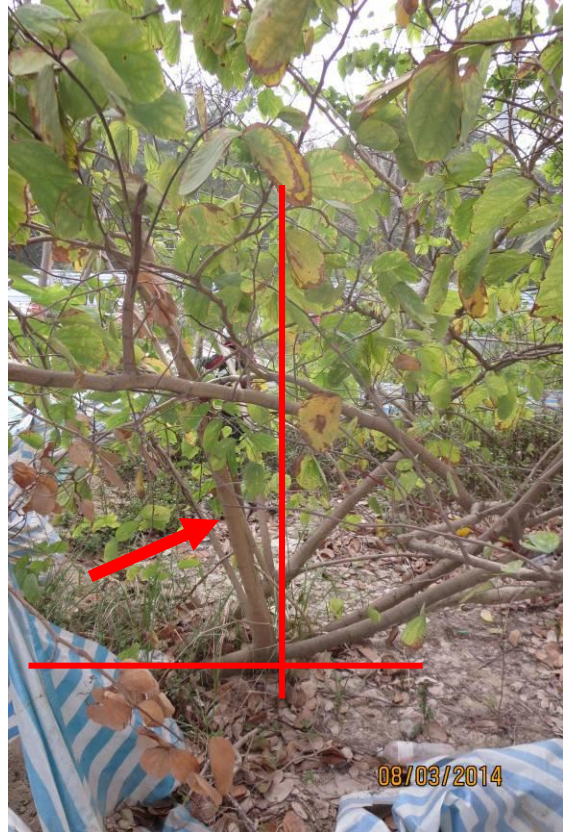
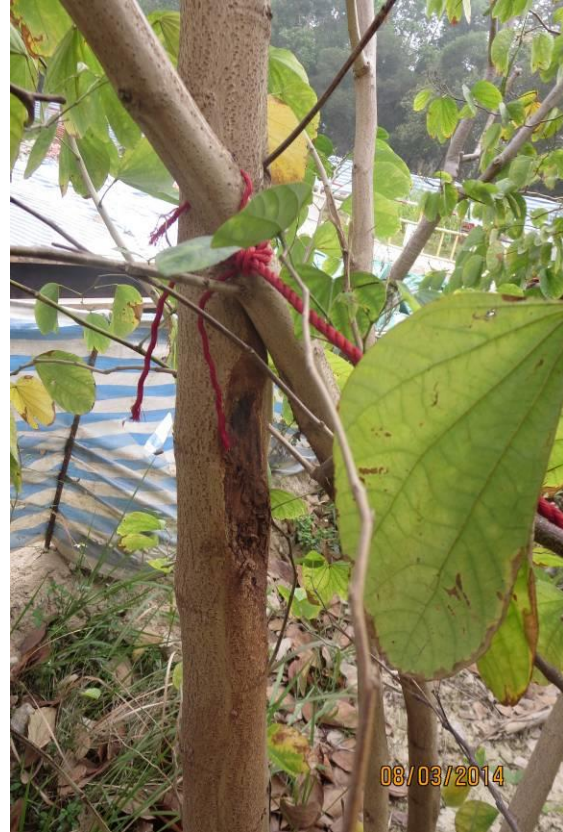
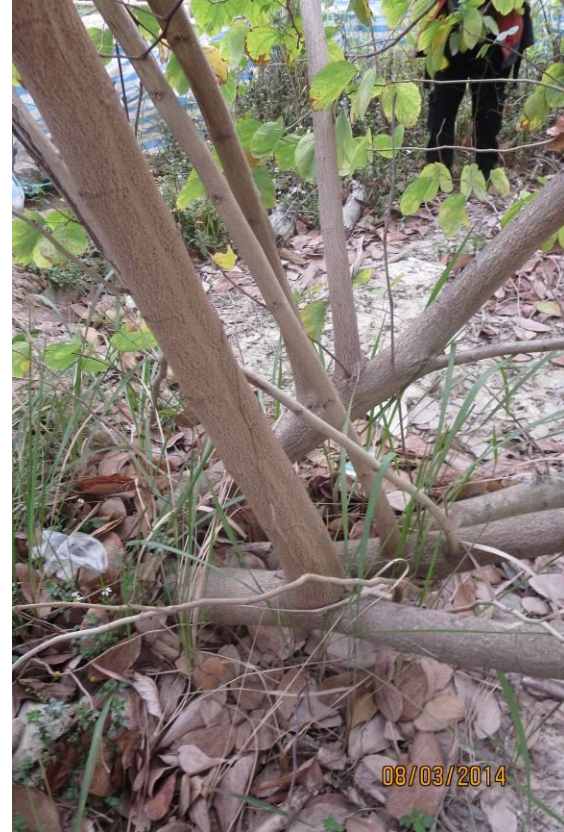
| <p>YMT/T3390-1-Retain<br/>Scientific Name: <i>Bauhinia x blakeana</i></p> | <p>YMT/T3390-2<br/>Leaning</p> | <p>YMT/T3390-3</p> | <p>YMT/T3390-4</p> |

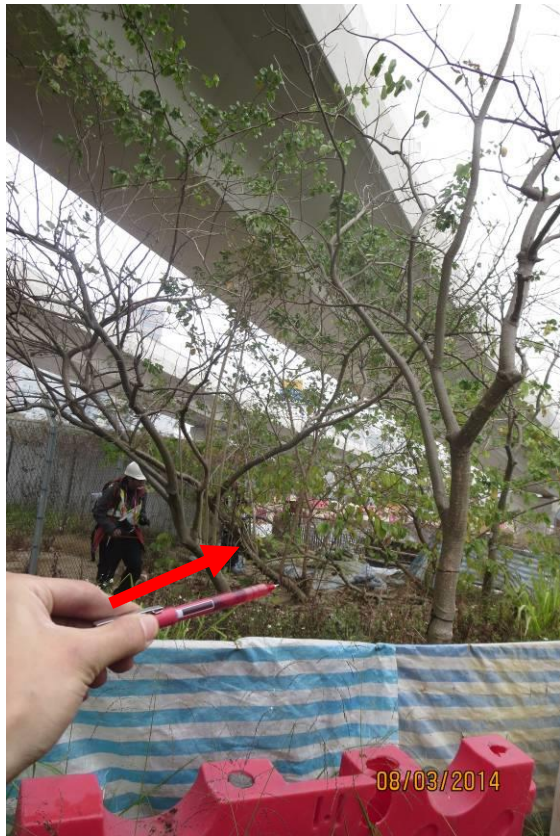
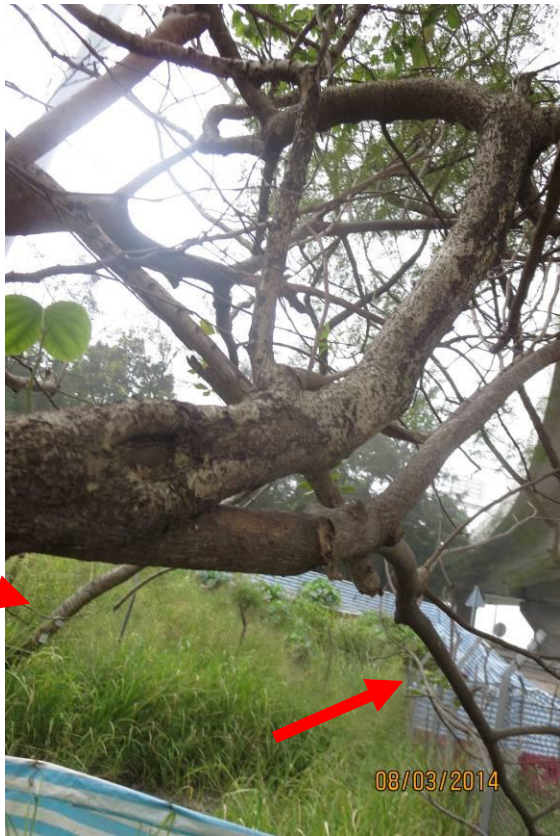
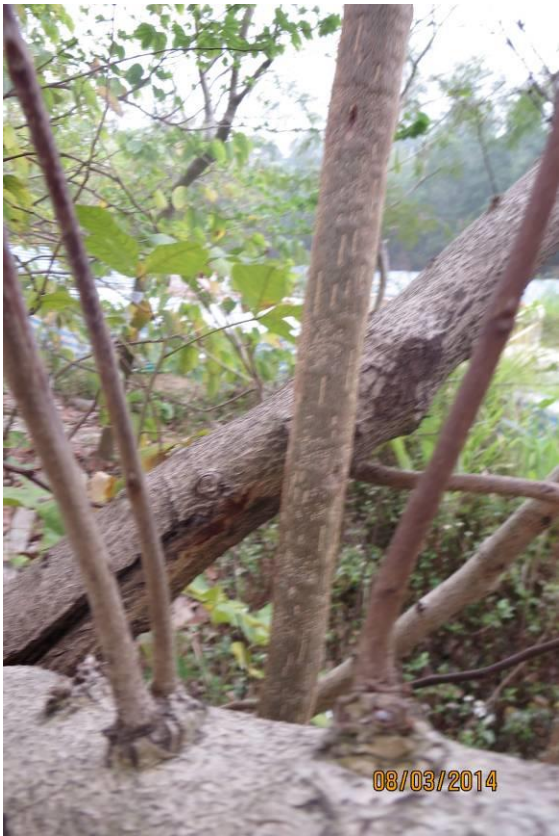
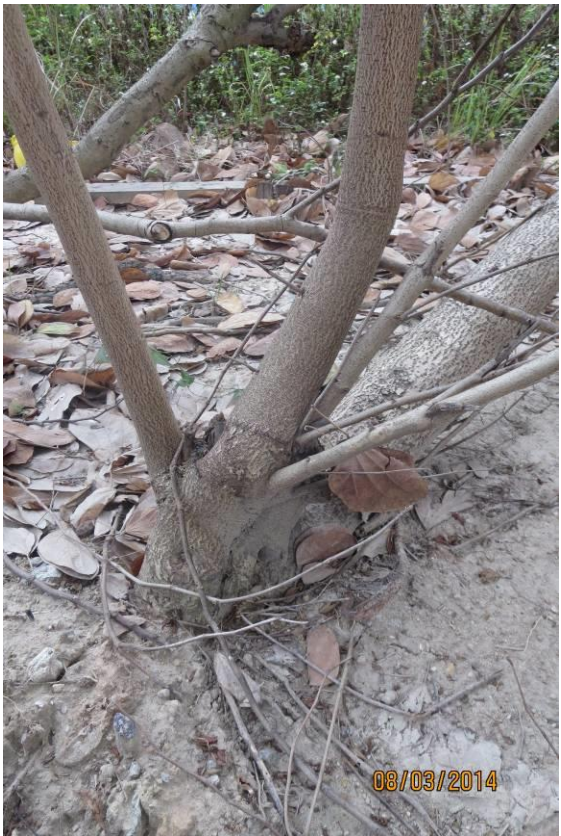
| YMT/T3391-1-Retain<br>Scientific Name: <i>Bauhinia x blakeana</i> | YMT/T3391-2<br>Dead branches | YMT/T3391-3 | YMT/T3391-4 |

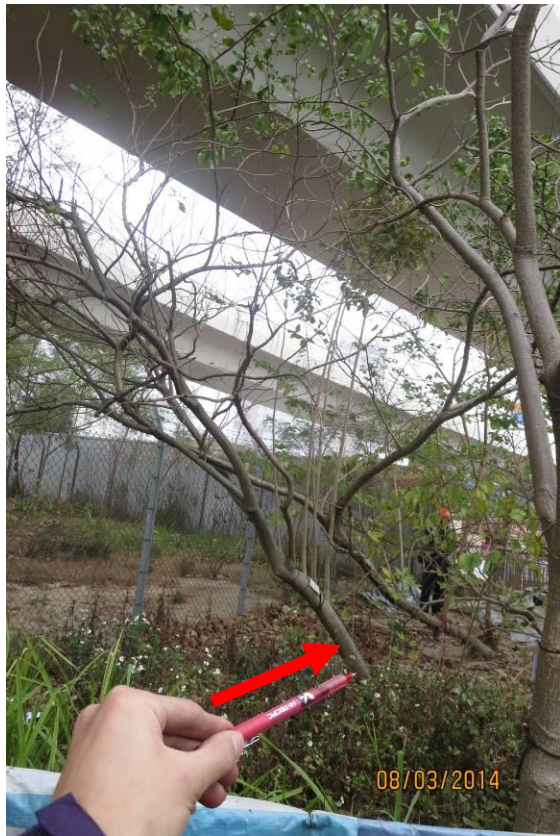
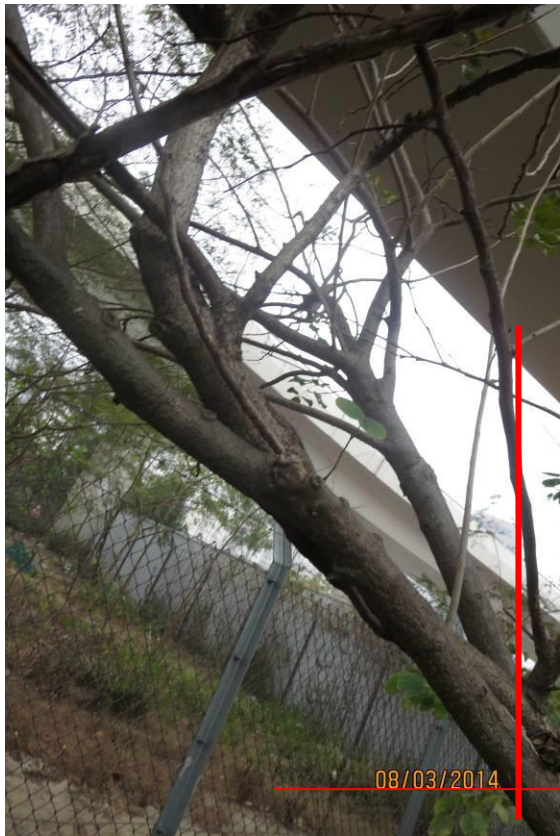
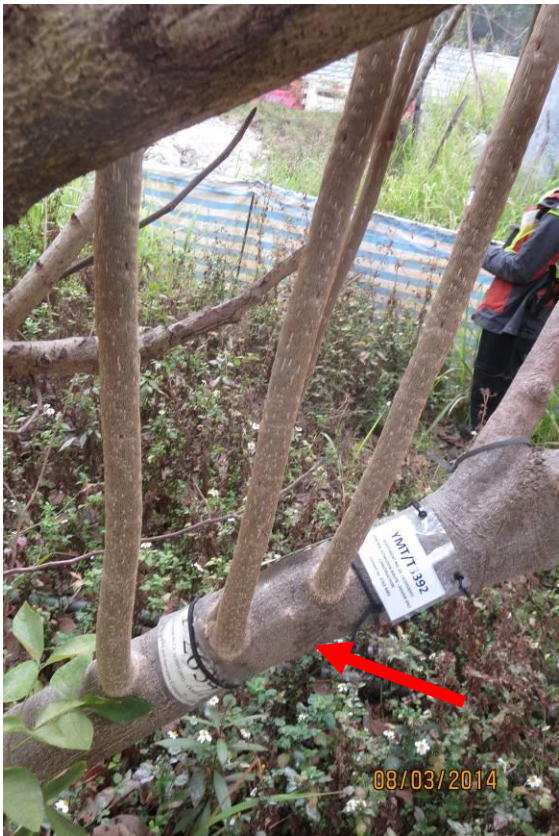
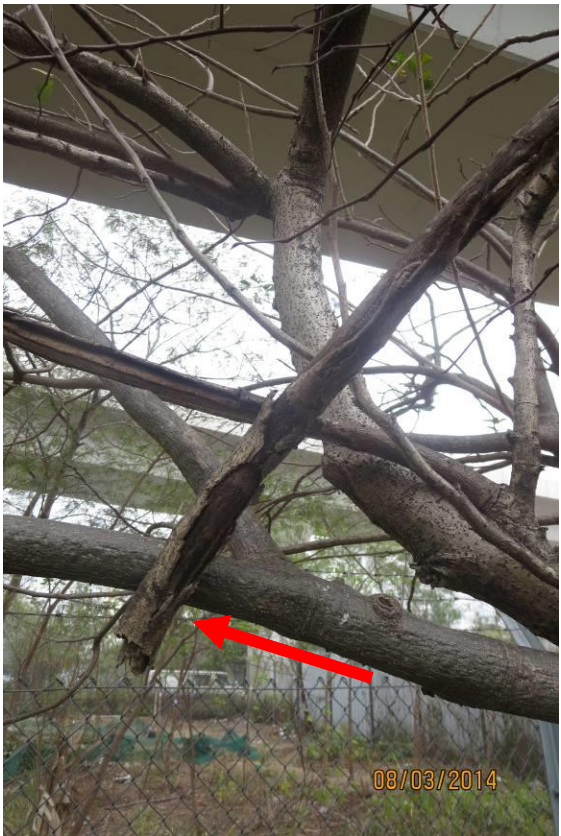
| YMT/T3392-1-Retain<br>Scientific Name: <i>Bauhinia x blakeana</i> | YMT/T3392-2<br>Leaning | YMT/T3392-3<br>Epicormics | YMT/T3392-4<br>Dead branches |

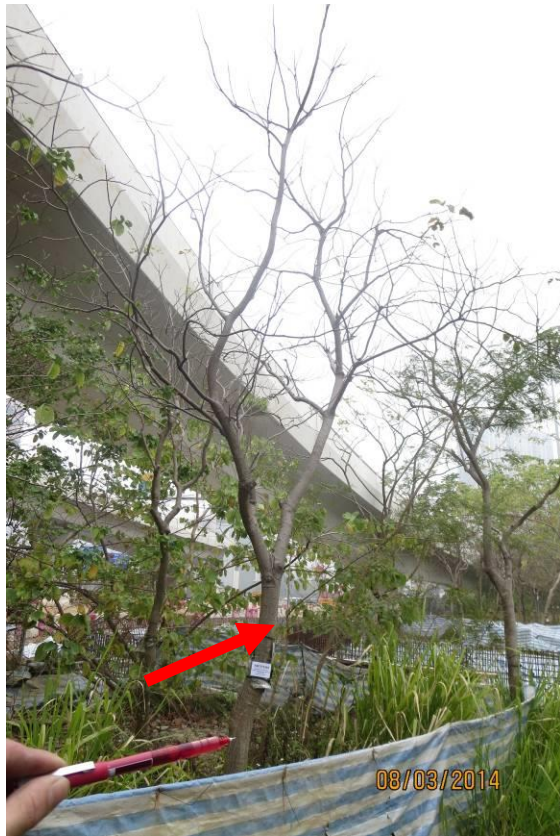
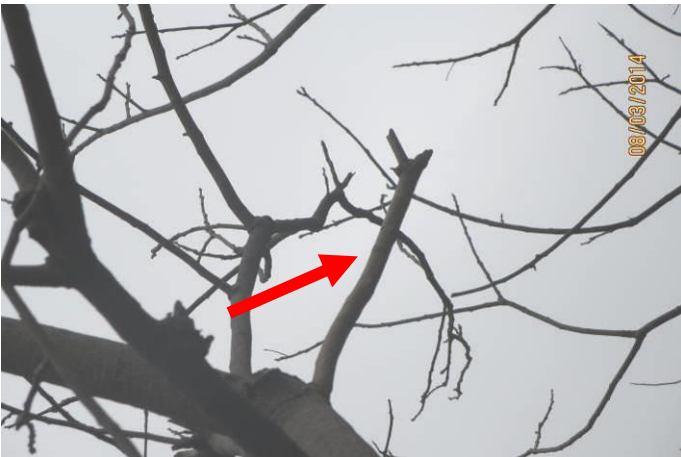
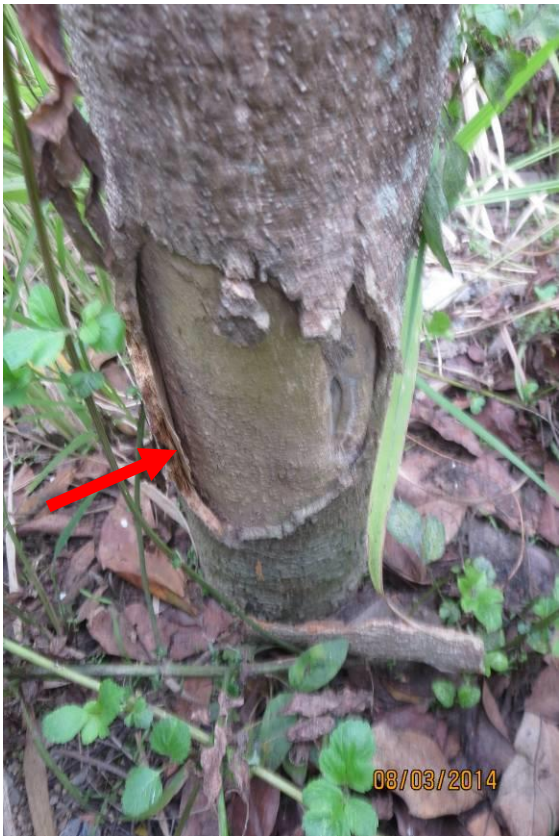
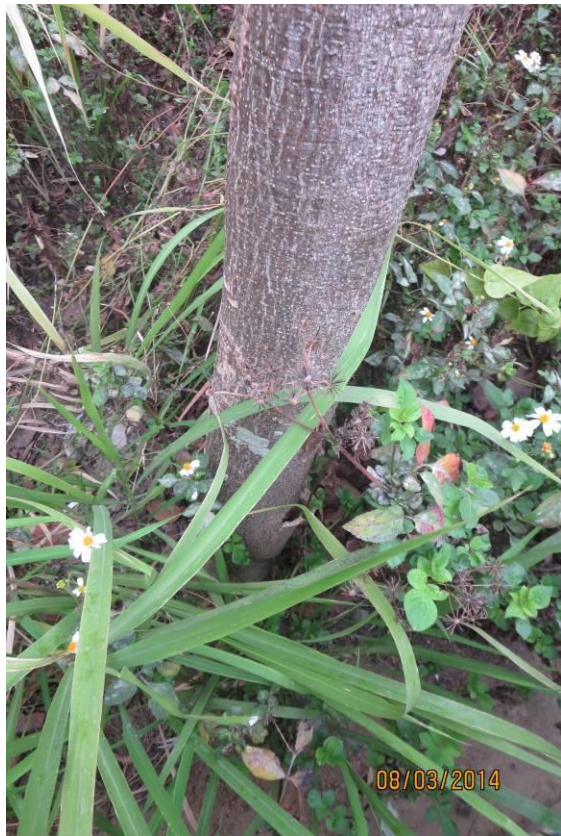
| YMT/T3394-1-Retain<br>Scientific Name: <i>Melia azedarach</i> | YMT/T3394-2<br>Dead branches | YMT/T3394-3<br>Wound | YMT/T3394-4 |

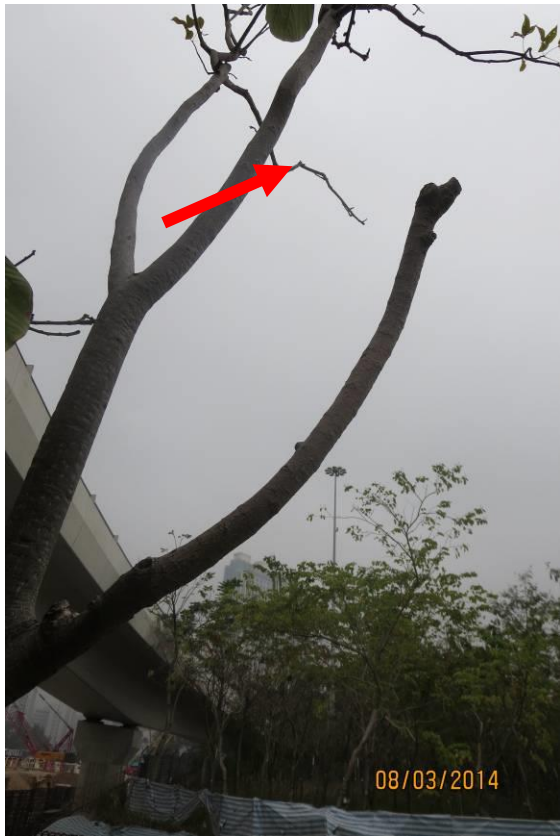
| YMT/T3397-1-Retain<br>Scientific Name: <i>Melia azedarach</i> | YMT/T3397-2 | YMT/T3397-3 | YMT/T3397-4 |

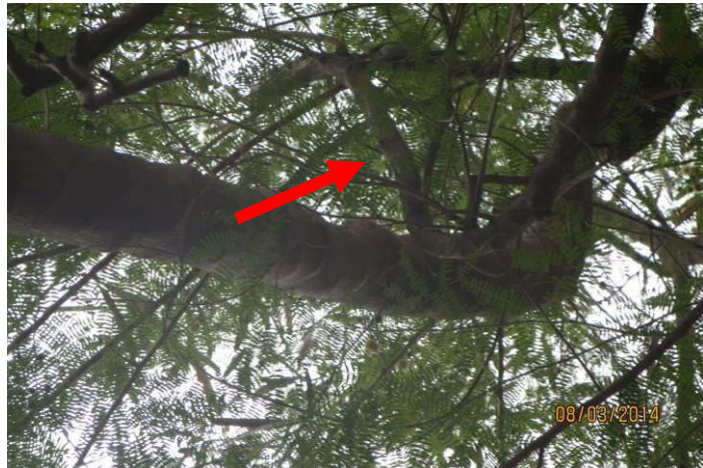
| YMT/T3398-1-Retain<br>Scientific Name: <i>Leucaena leucocephala</i> | YMT/T3398-2<br>Dead branches | YMT/T3398-3<br>Leaning | YMT/T3398-4 |

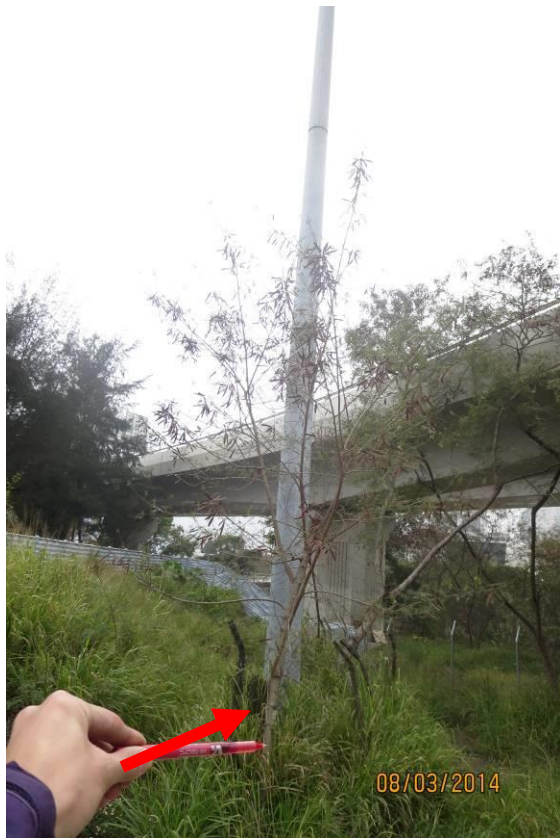
| YMT/T3399-1-Retain<br>Scientific Name: <i>Leucaena leucocephala</i> | YMT/T3399-2<br>Topped | YMT/T3399-3 | YMT/T3399-4 |
