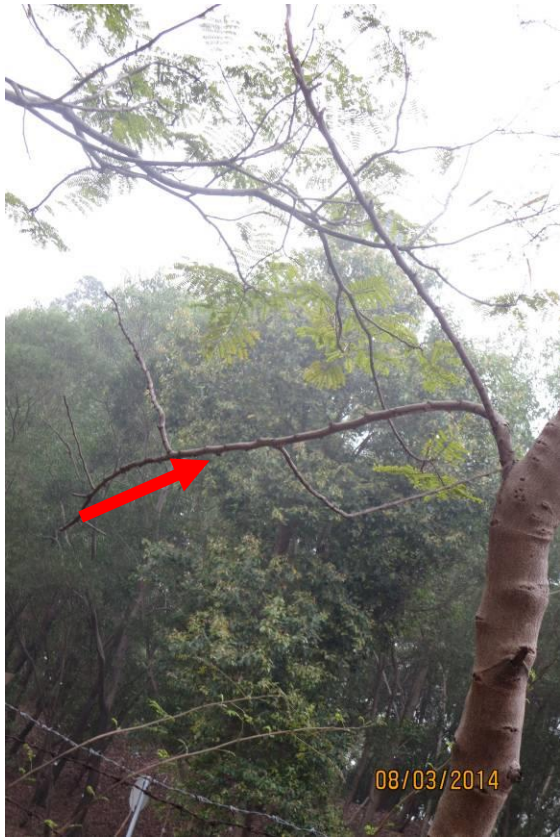
| YMT/T3400-1-Fell<br>Scientific Name: <i>Leucaena leucocephala</i> | YMT/T3400-2<br>Dead branches | YMT/T3400-3<br>fence included | YMT/T3400-4 |

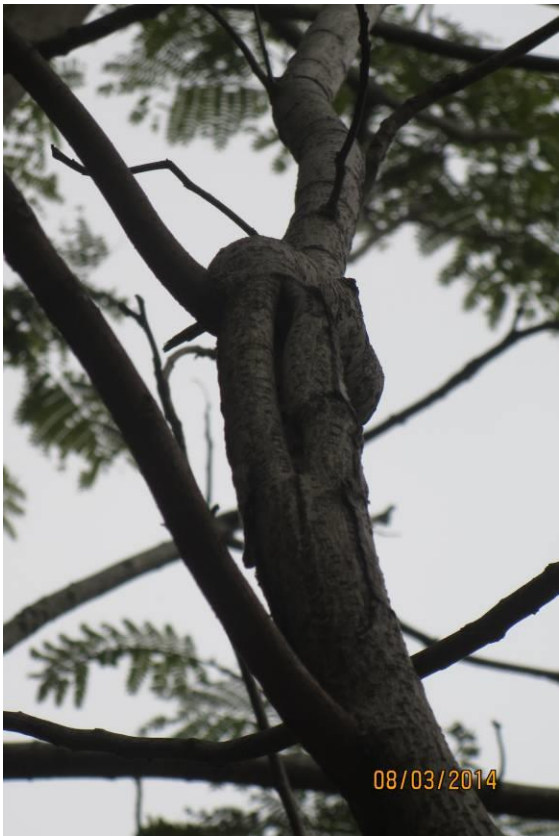
| YMT/T3402-1-Fell<br>Scientific Name: <i>Leucaena leucocephala</i> | YMT/T3402-2<br>Dead branches | YMT/T3402-3 | YMT/T3402-4 |

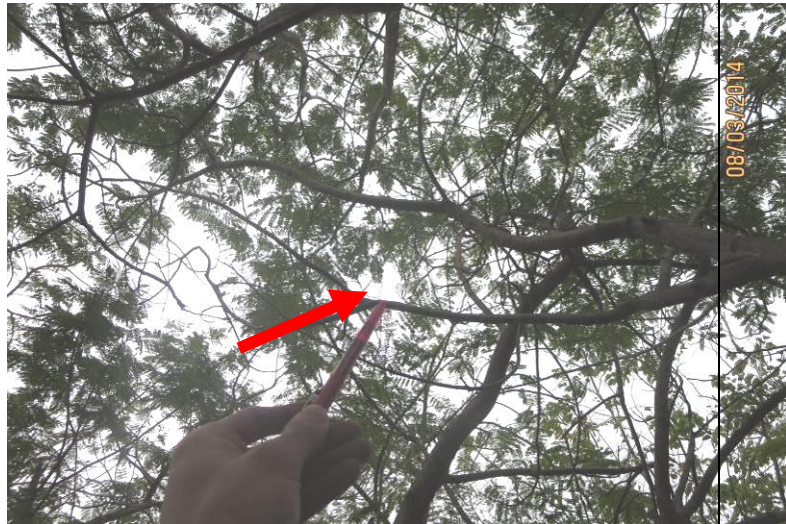
| YMT/T3403-1-Fell<br>Scientific Name: <i>Leucaena leucocephala</i> | YMT/T3403-2 | YMT/T3403-3 | YMT/T3403-4 |

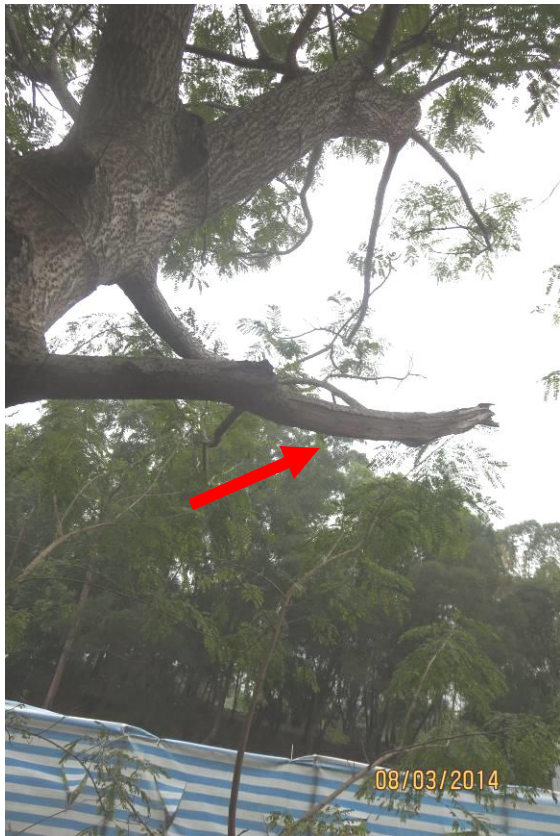
| YMT/T3404-1-Fell<br>Scientific Name: <i>Leucaena leucocephala</i> | YMT/T3404-2<br>Broken branches | YMT/T3404-3 | YMT/T3404-4 |

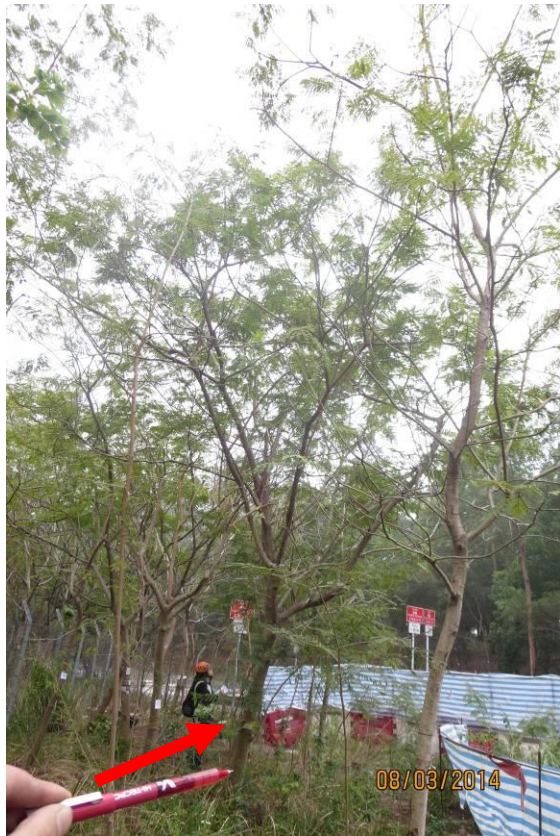
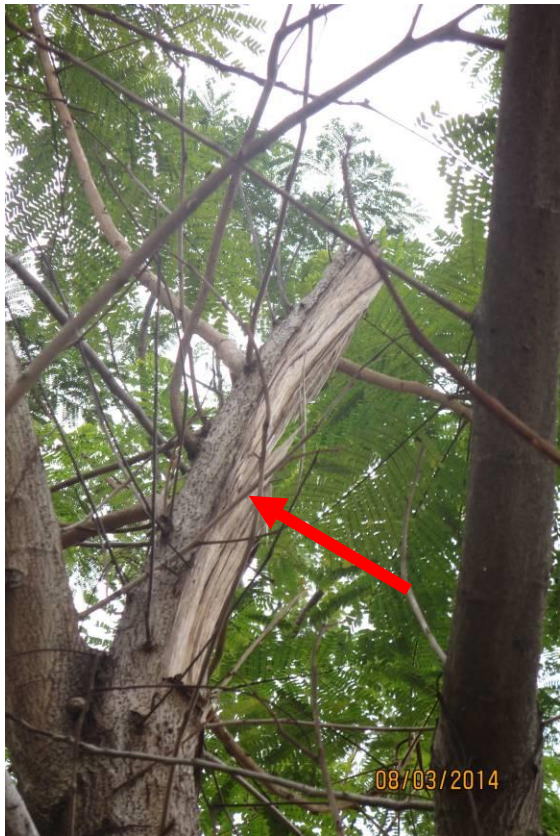
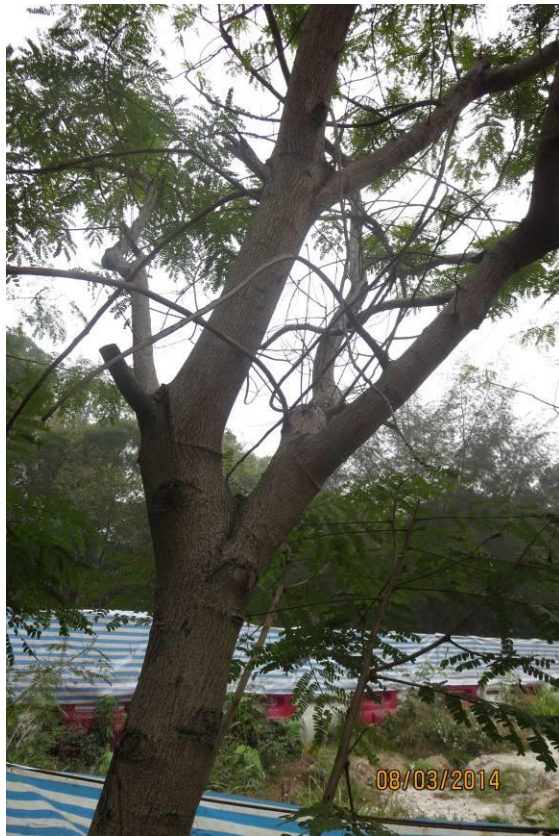
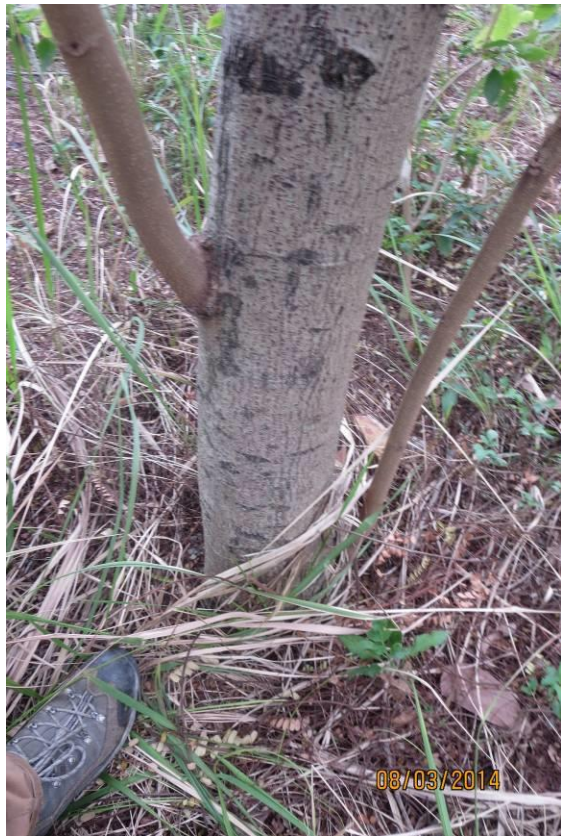
| YMT/T3406-1-Fell<br>Scientific Name: <i>Leucaena leucocephala</i> | YMT/T3406-2<br>Broken branches | YMT/T3406-3 | YMT/T3406-4 |

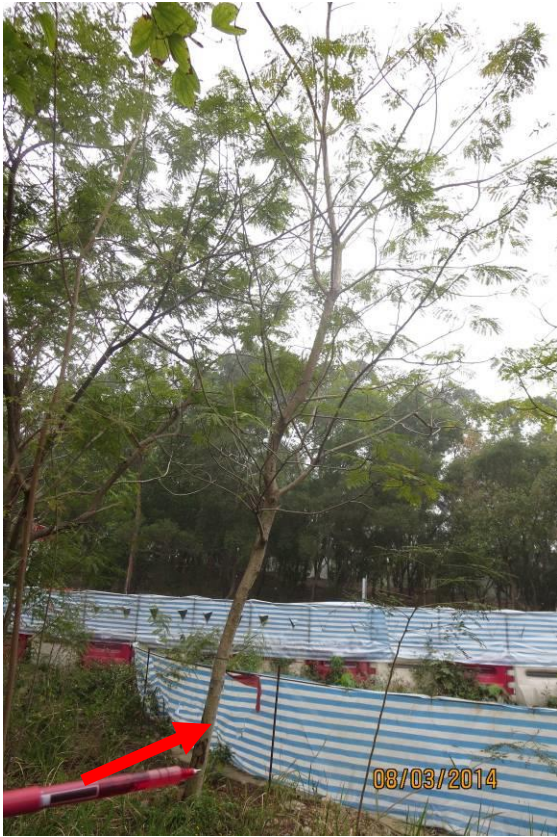
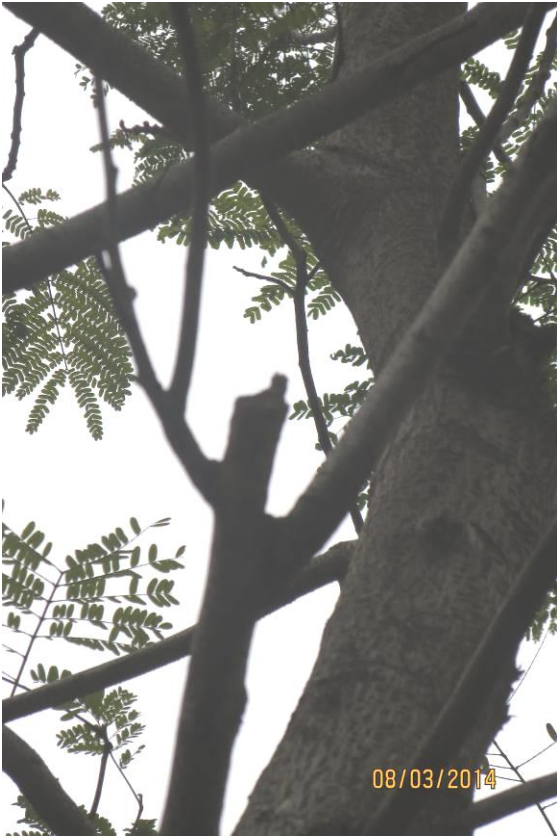
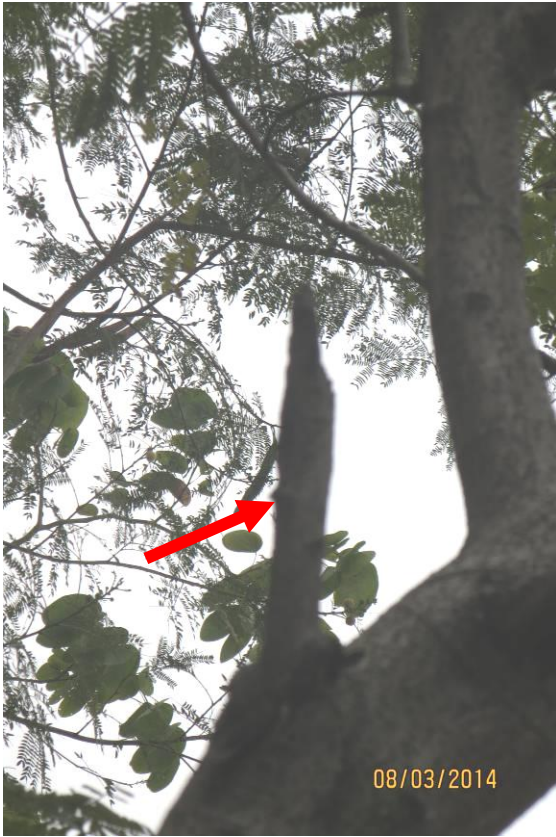
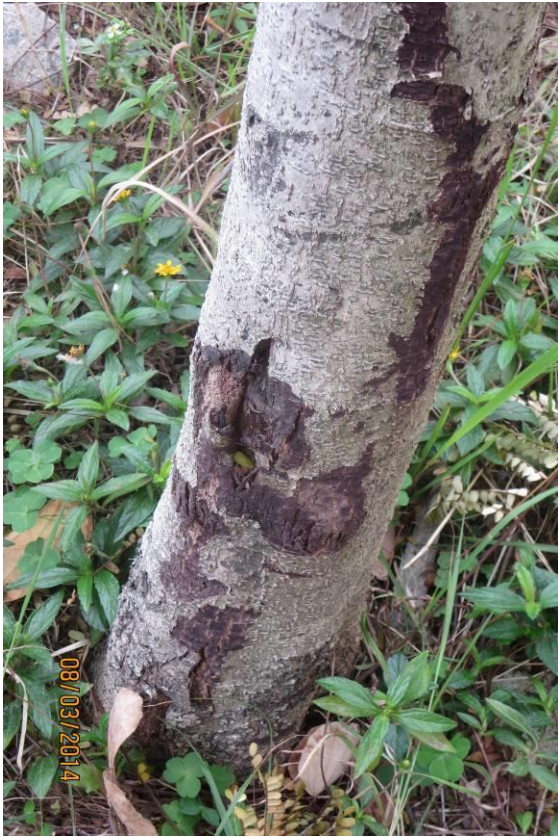
| YMT/T3407-1-Fell<br>Scientific Name: <i>Leucaena leucocephala</i> | YMT/T3407-2 | YMT/T3407-3<br>Dead branches | YMT/T3407-4 |

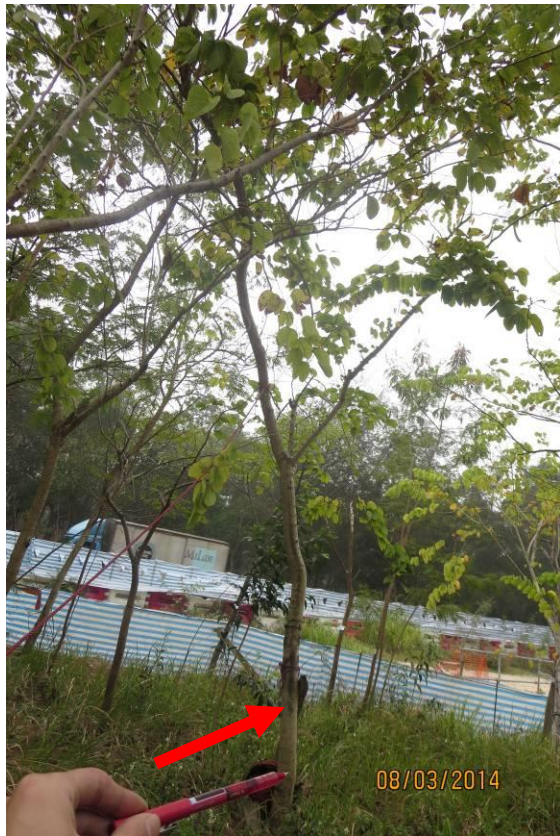
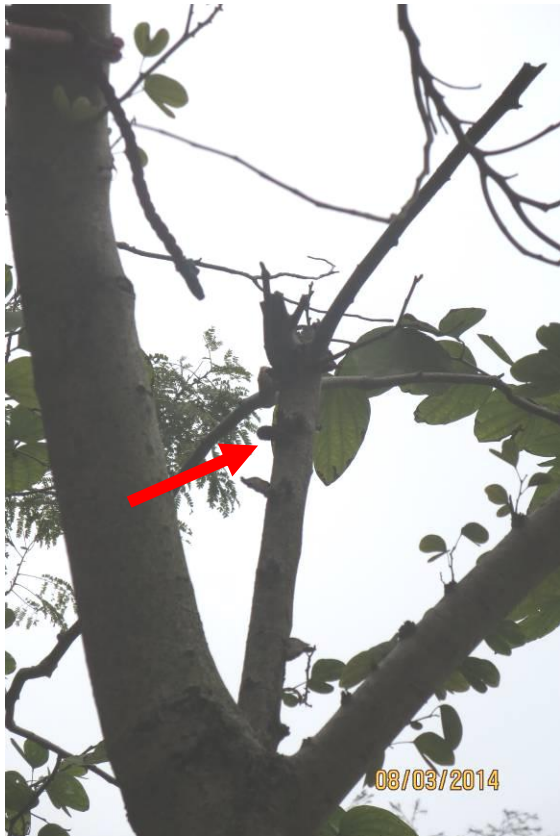
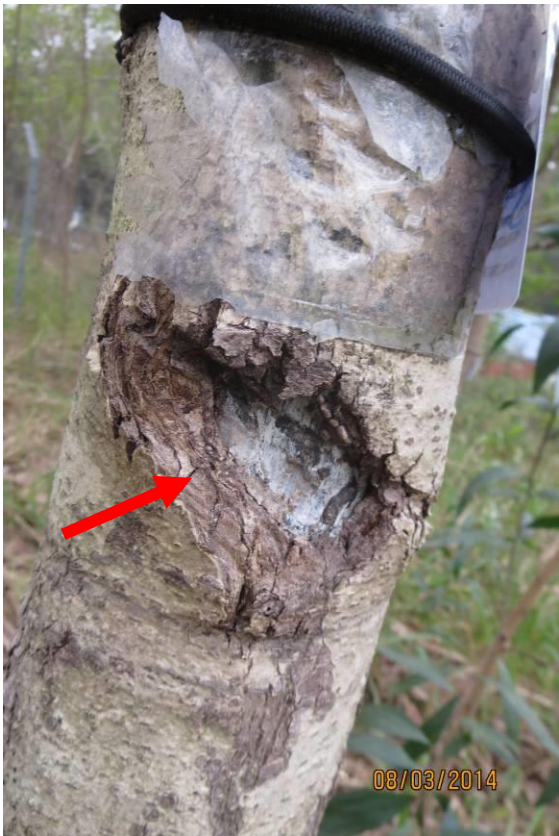
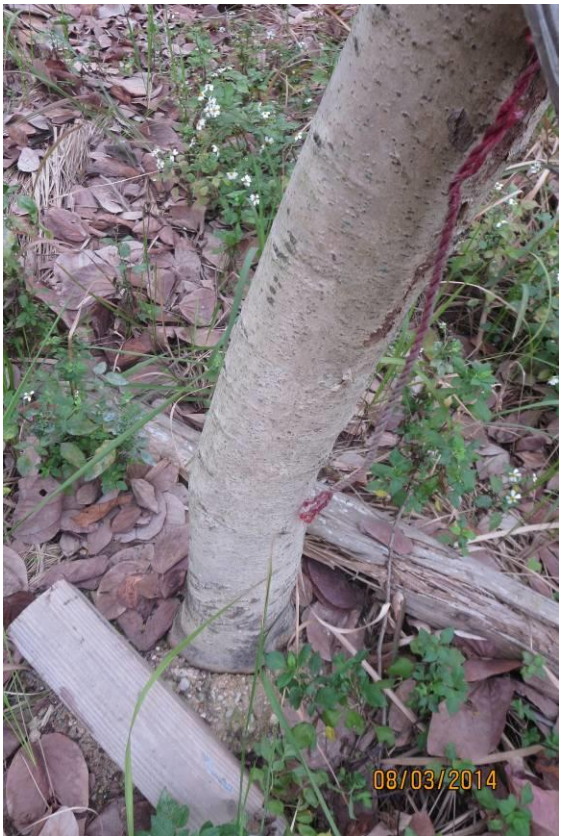
| YMT/T3410-1-Retain<br>Scientific Name: <i>Bauhinia x blakeana</i> | YMT/T3410-2 | YMT/T3410-3<br>Wound | YMT/T3410-4 |

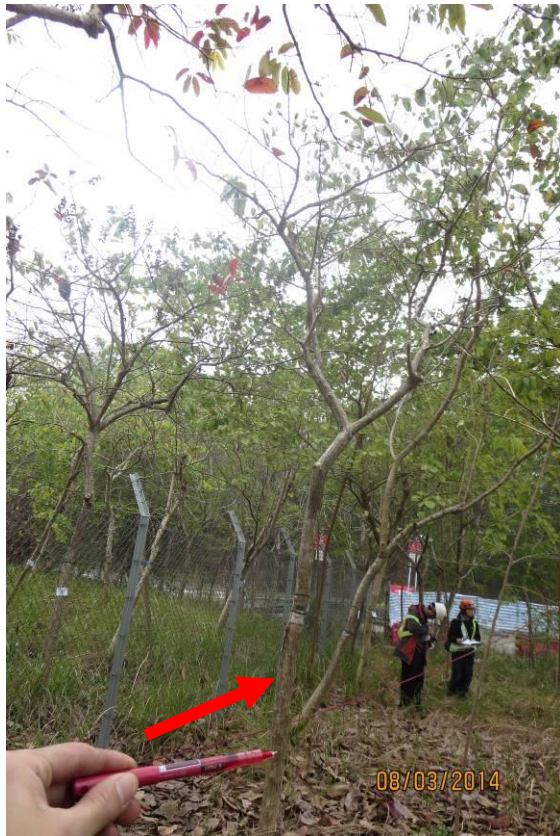
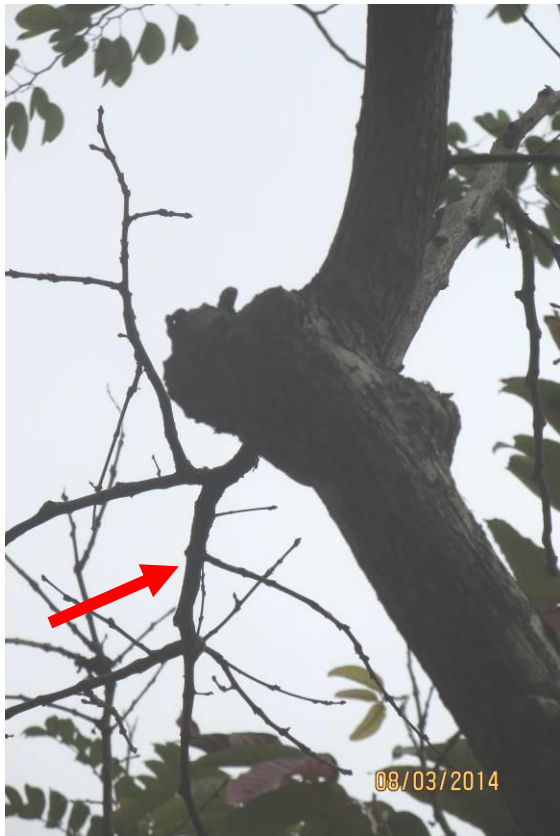
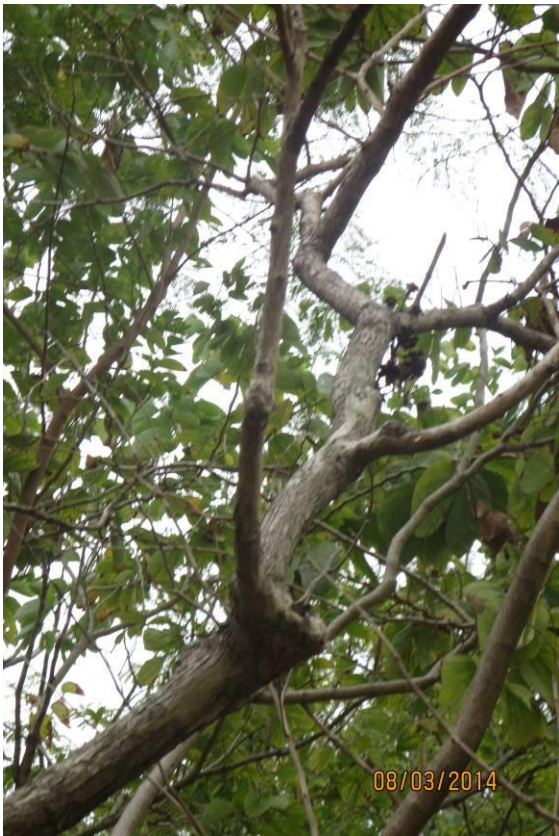
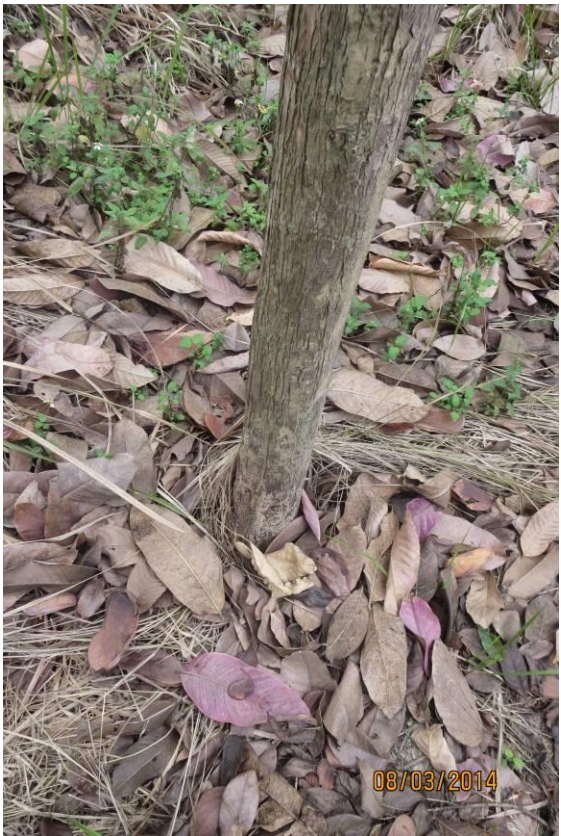
| YMT/T3411-1-Retain<br>Scientific Name: <i>Lagerstroemia speciosa</i> | YMT/T3411-2<br>Dead branches | YMT/T3411-3 | YMT/T3411-4 |

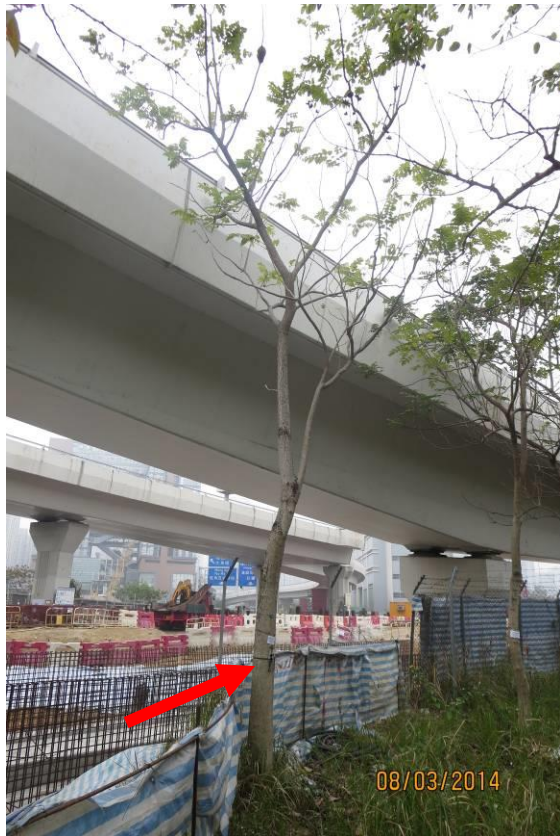
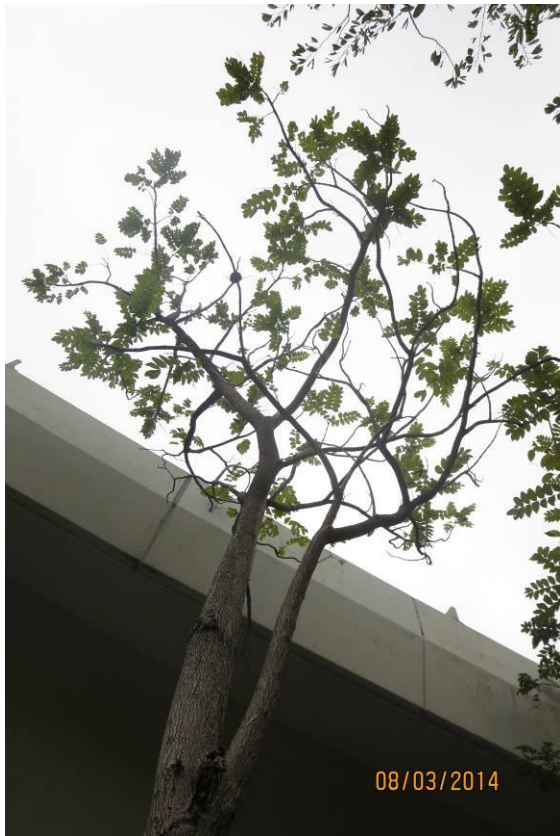
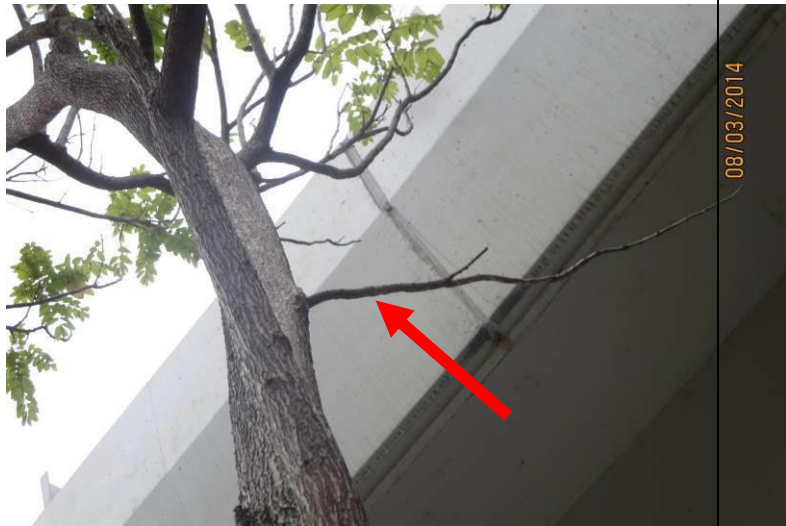
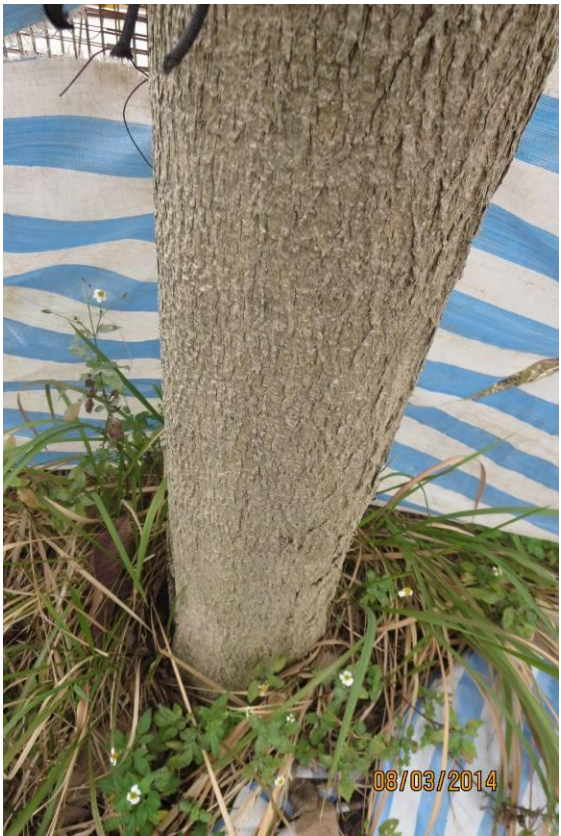
| YMT/T3415-1-Retain<br>Scientific Name: <i>Spathodea campanulata</i> | YMT/T3415-2 | YMT/T3415-3<br>Dead branches | YMT/T3415-4 |

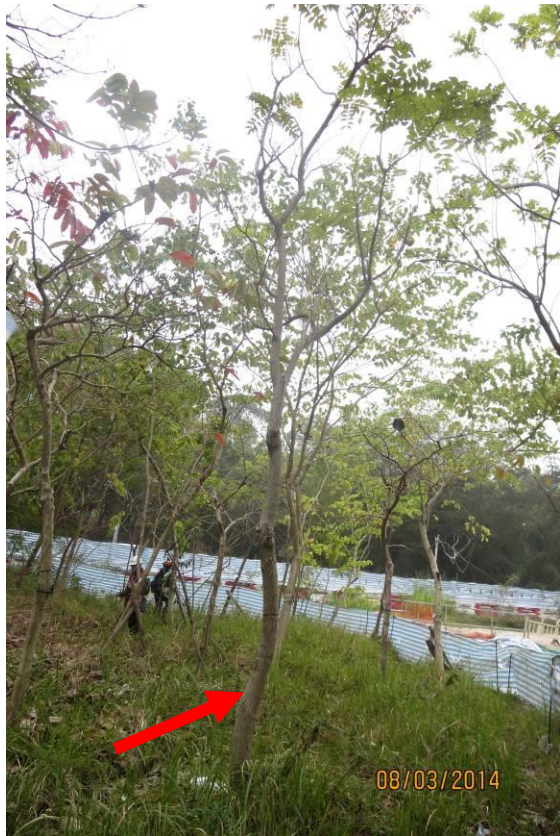
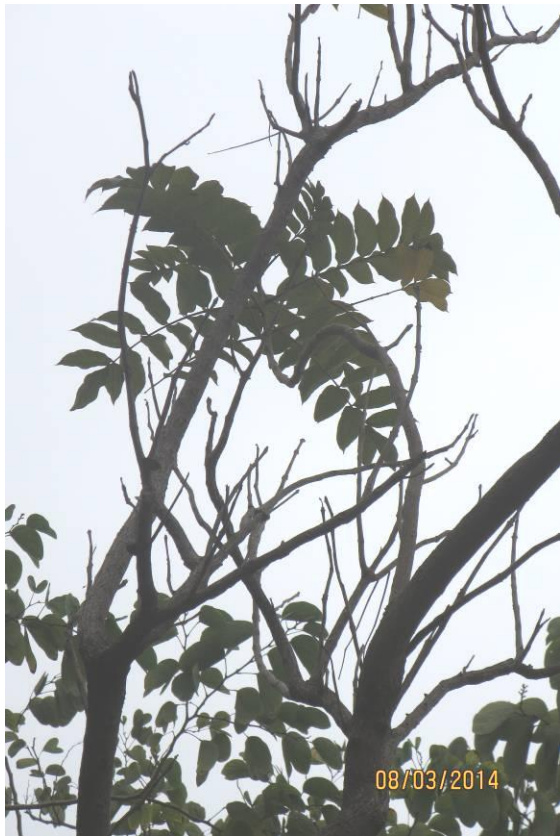
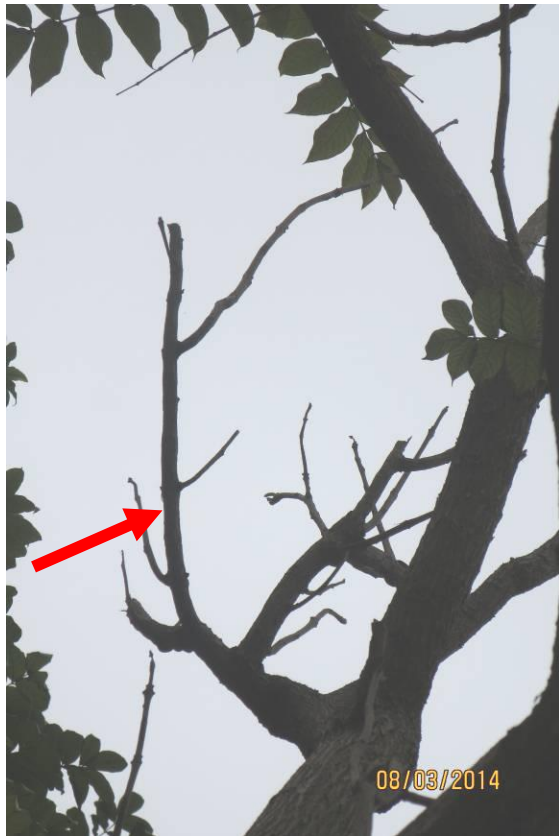
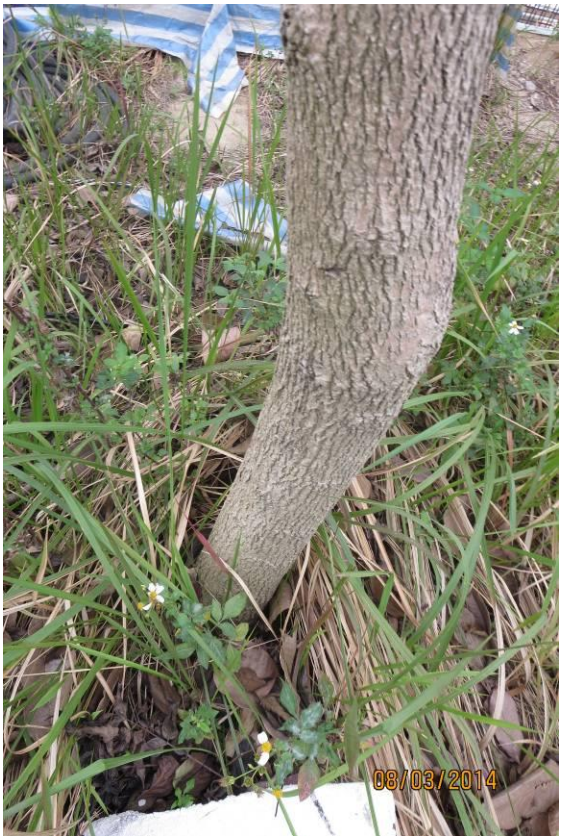
| YMT/T3416-1-Retain<br>Scientific Name: <i>Spathodea campanulata</i> | YMT/T3416-2 | YMT/T3416-3<br>Dead branches | YMT/T3416-4 |

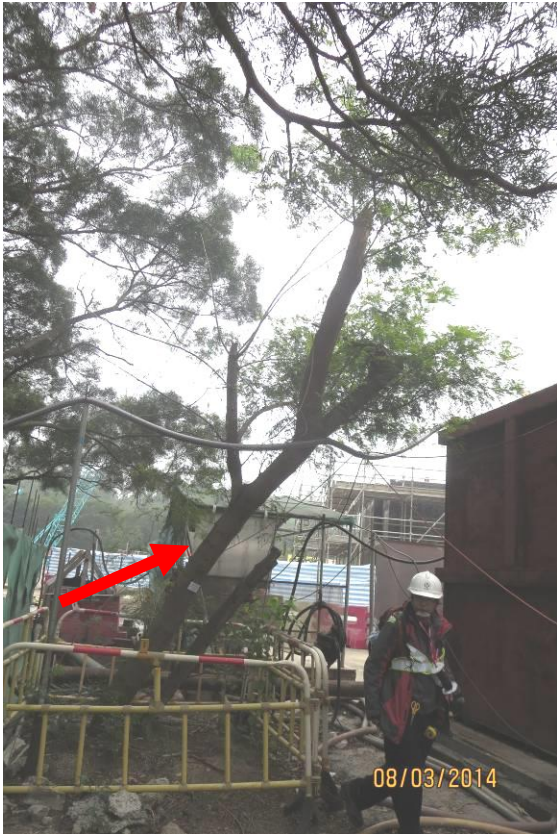
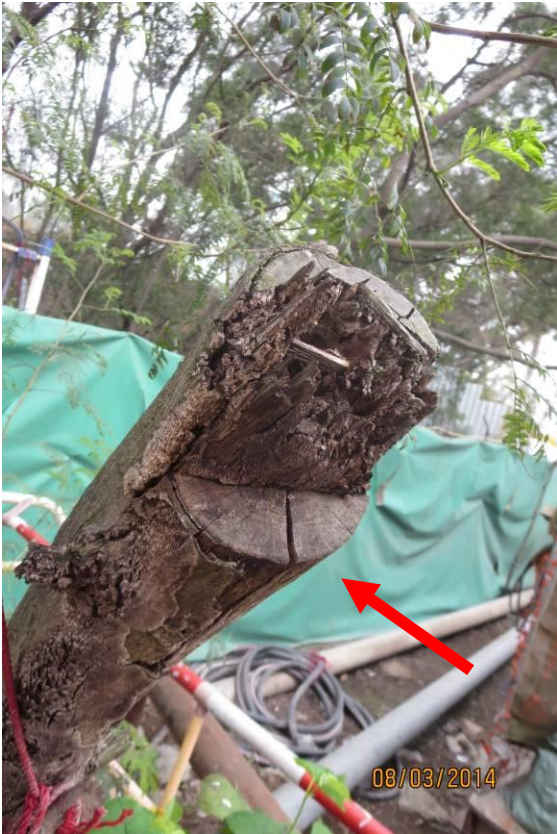
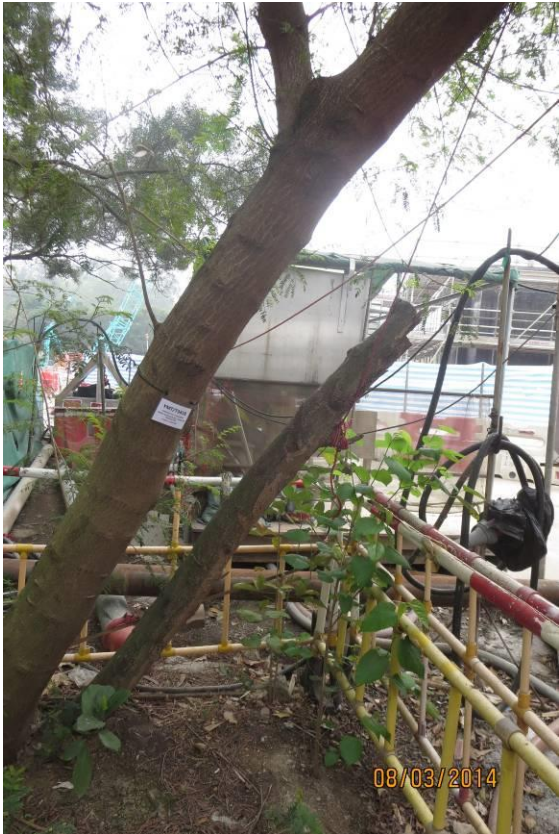
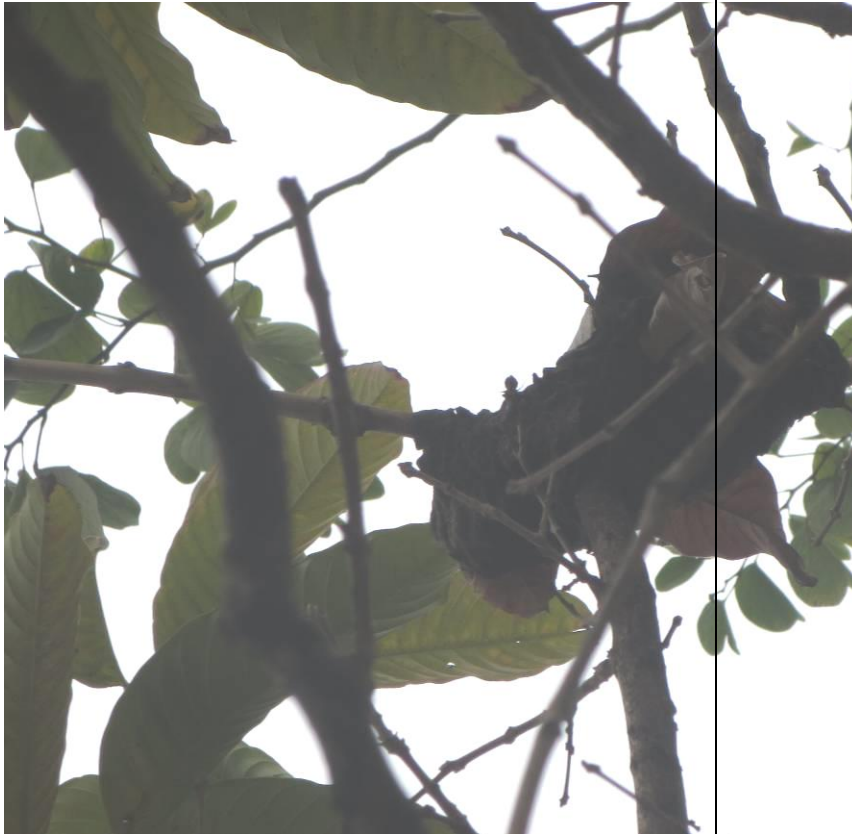
| YMT/T3418-1-Fell<br>Scientific Name: <i>Leucaena leucocephala</i> | YMT/T3418-2<br>Broken branches | YMT/T3418-3 | YMT/T3418-4<br>Dead branches |

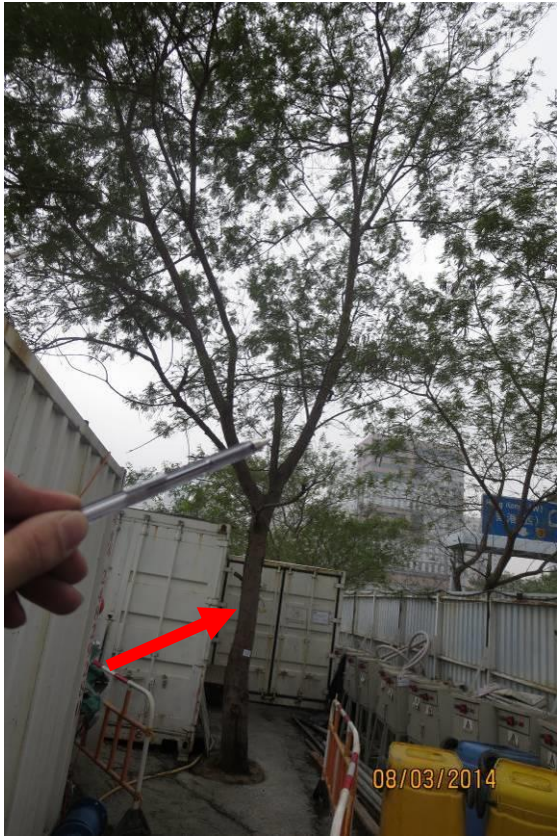
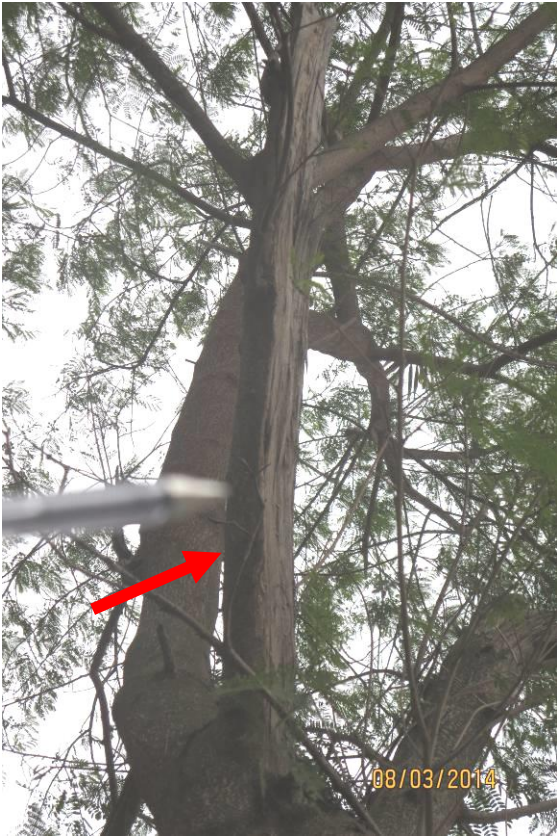
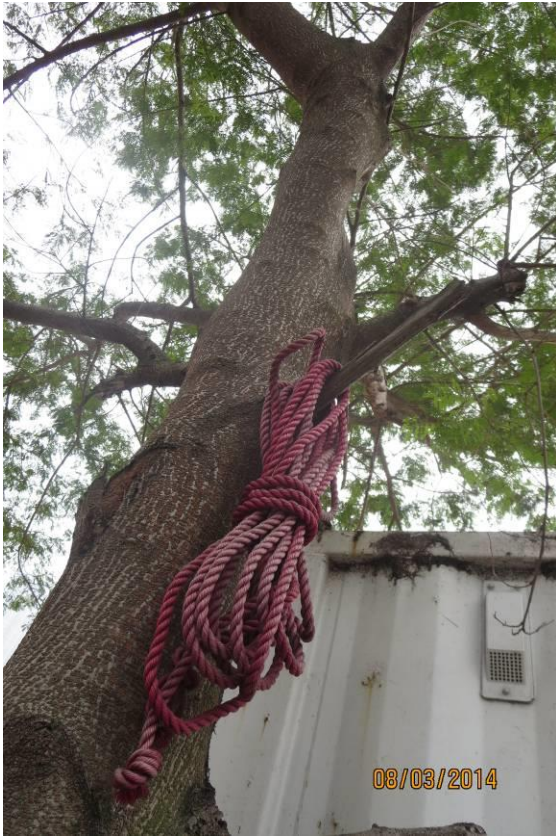
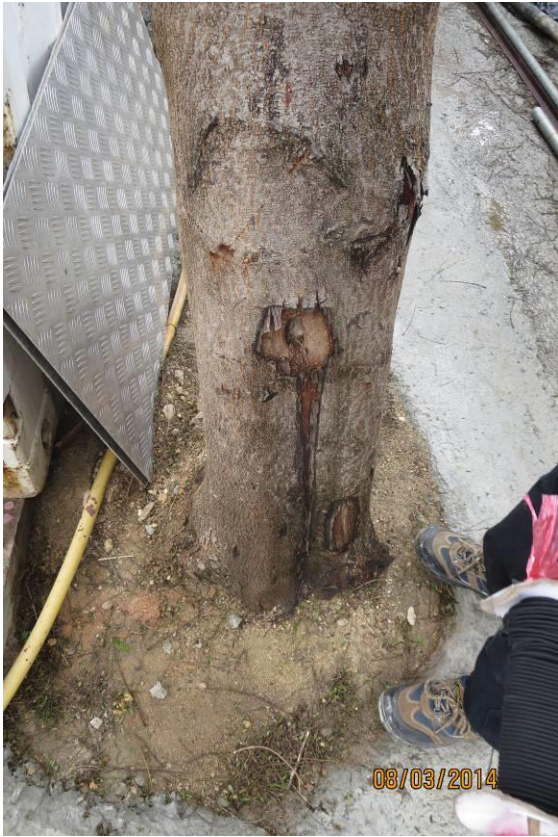
| YMT/T3419-1-Fell<br>Scientific Name: <i>Leucaena leucocephala</i> | YMT/T3419-2<br>Broken branches | YMT/T3419-3 | YMT/T3419-4 |

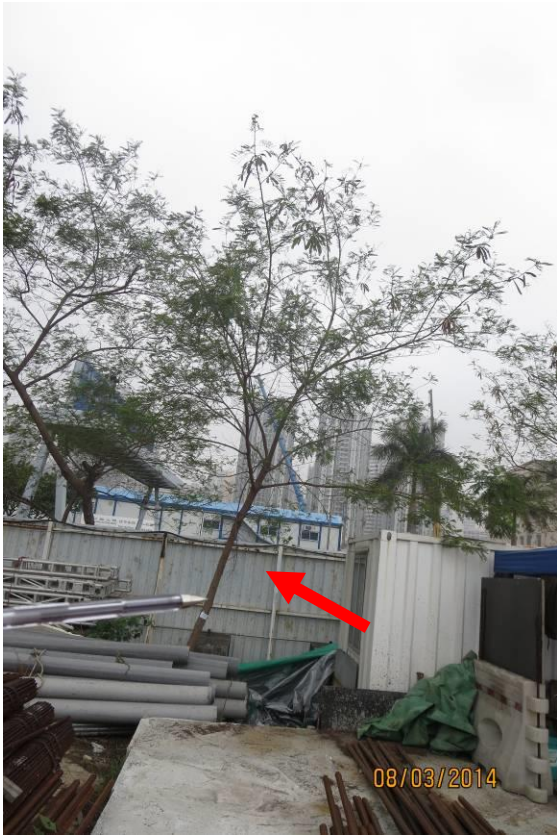
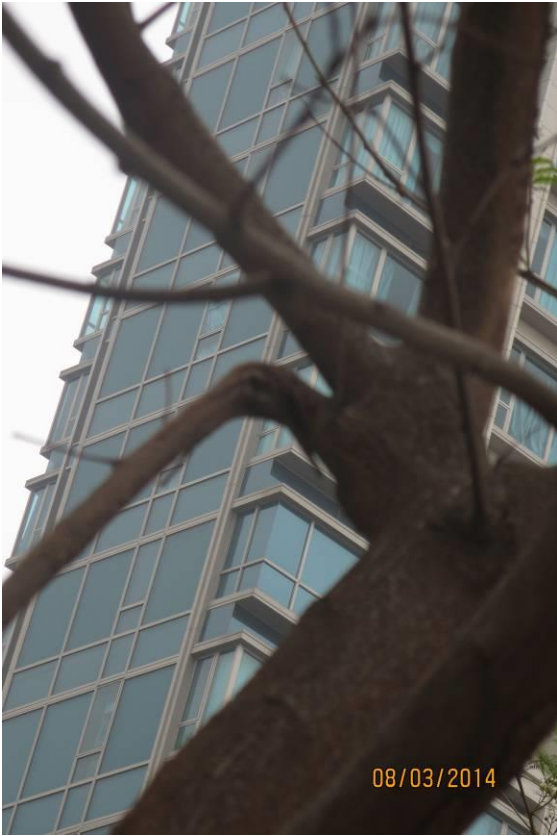
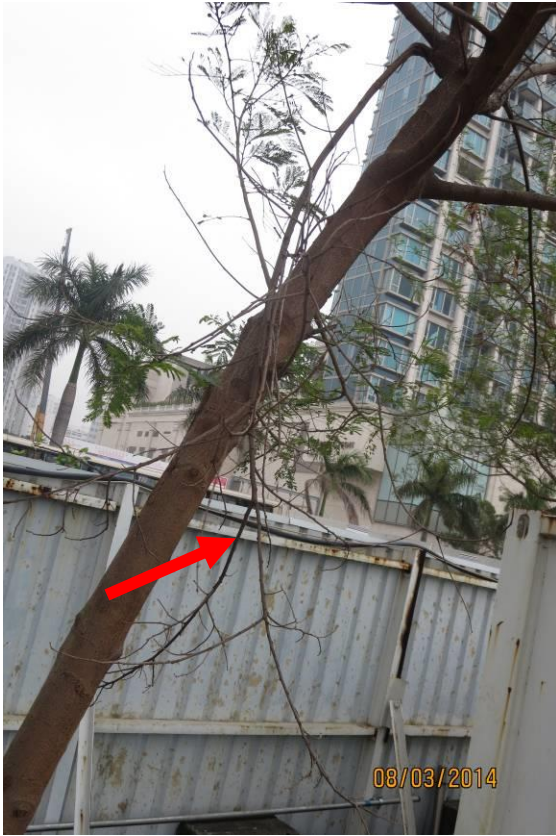
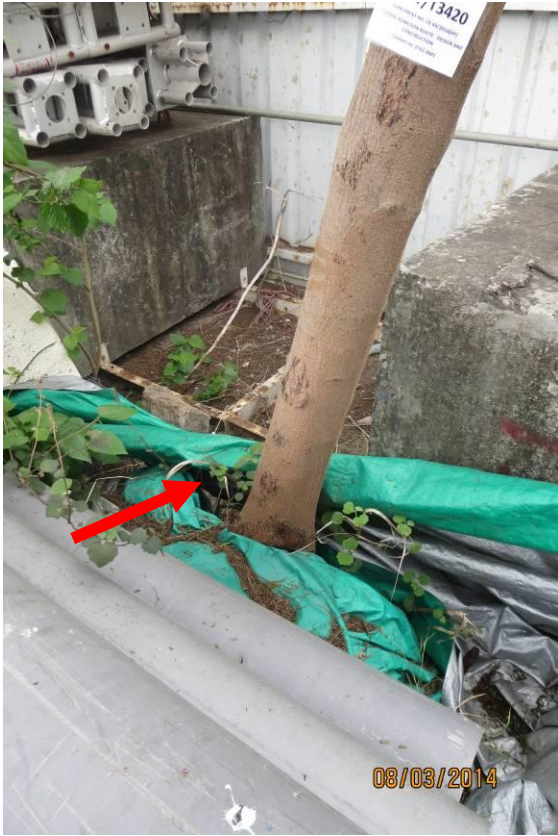
| YMT/T3420-1-Fell<br>Scientific Name: <i>Leucaena leucocephala</i> | YMT/T3420-2 | YMT/T3420-3<br>Dead branches | YMT/T3420-4<br>Leaning |

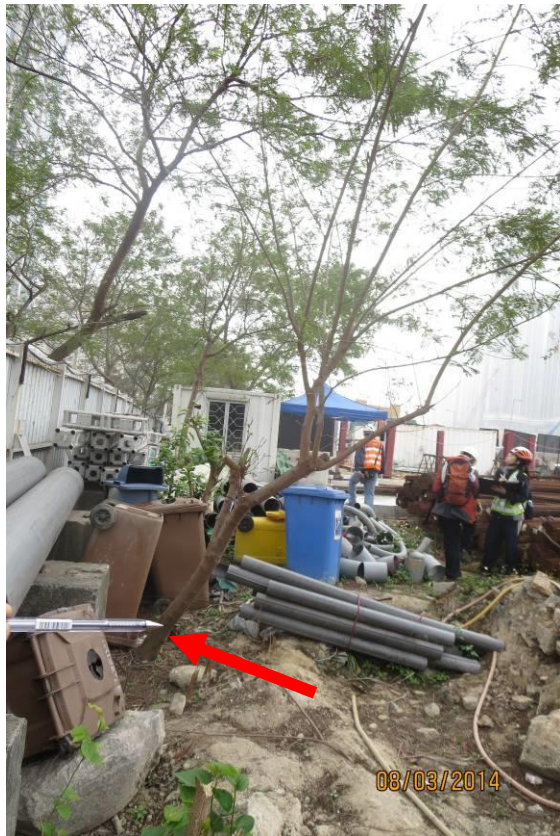
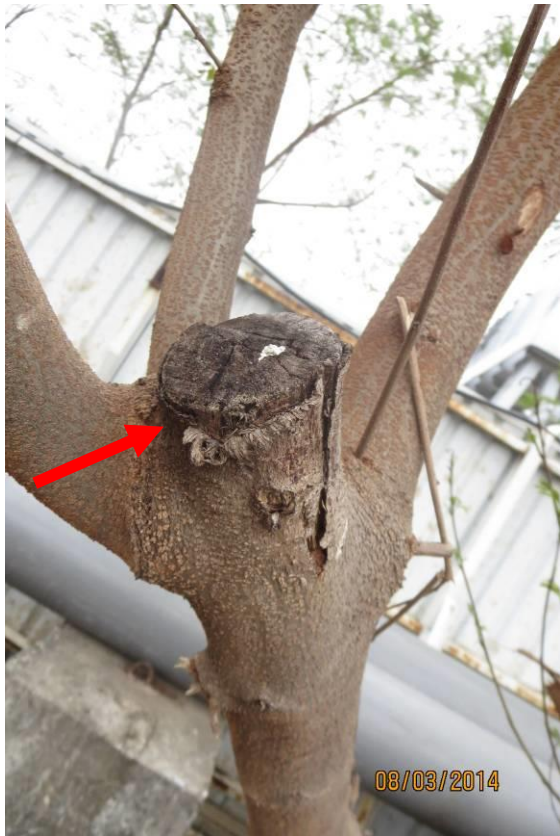
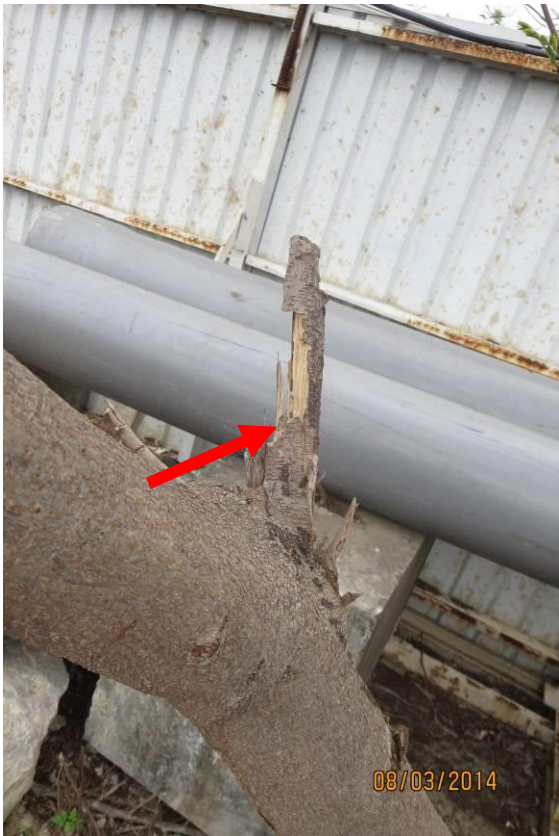
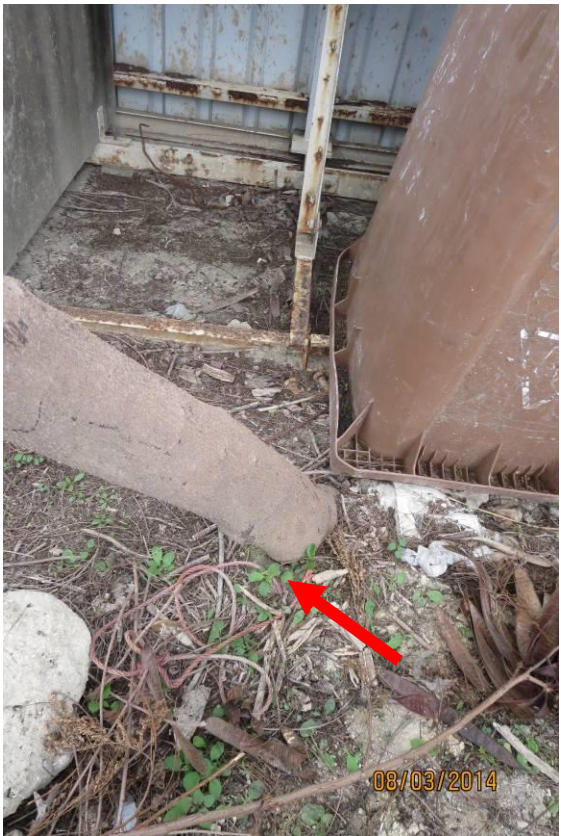
| YMT/T3421-1-Fell<br>Scientific Name: <i>Leucaena leucocephala</i> | YMT/T3421-2 | YMT/T3421-3<br>Dead branches | YMT/T3421-4<br>Leaning |

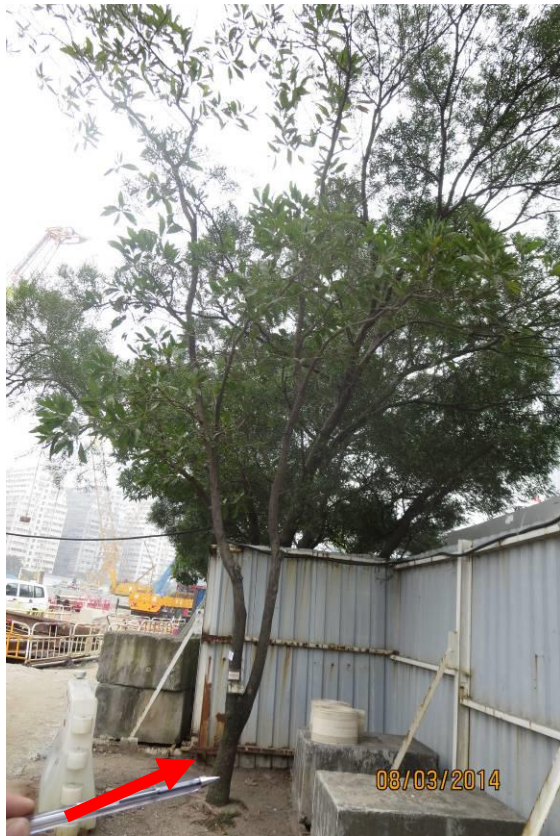
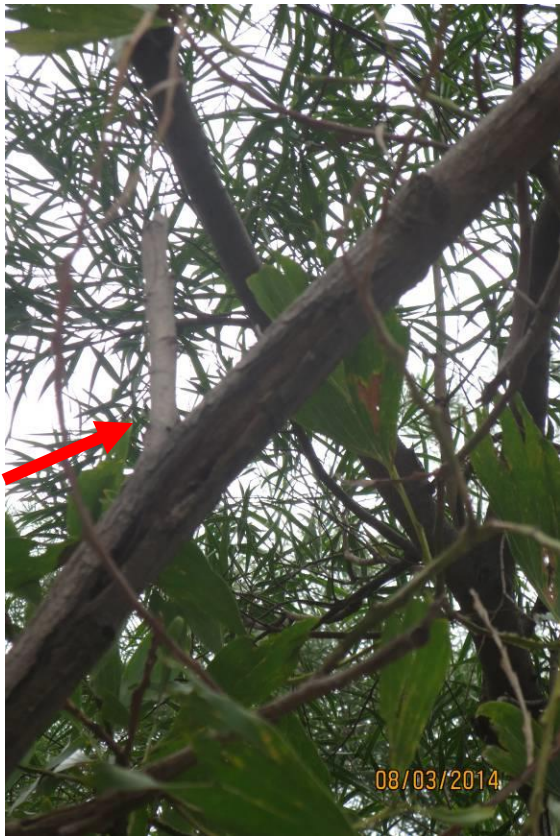
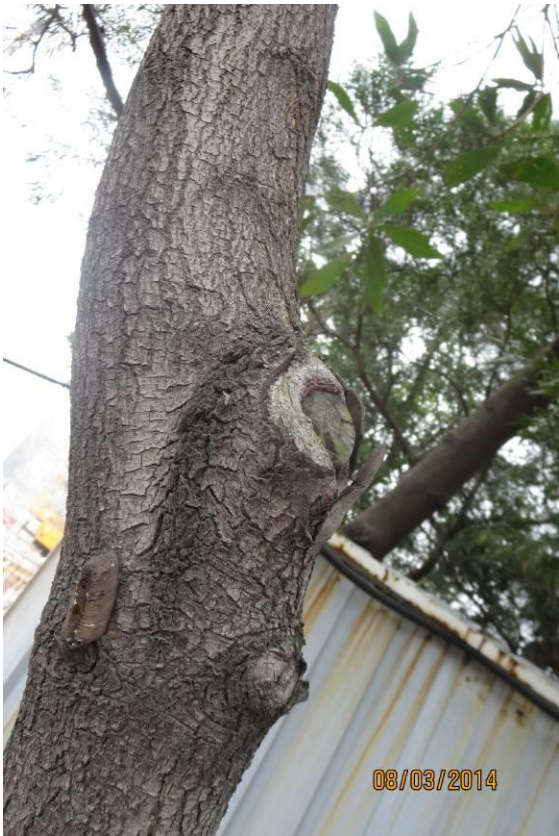
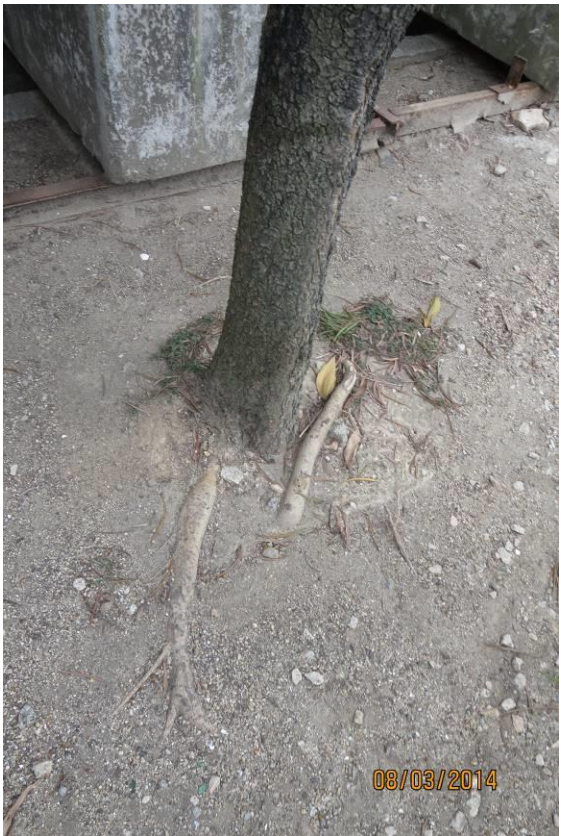
| YMT/T3422-1-Retain<br>Scientific Name: <i>Acacia mangium</i> | YMT/T3422-2<br>Dead branches | YMT/T3422-3 | YMT/T3422-4 |
