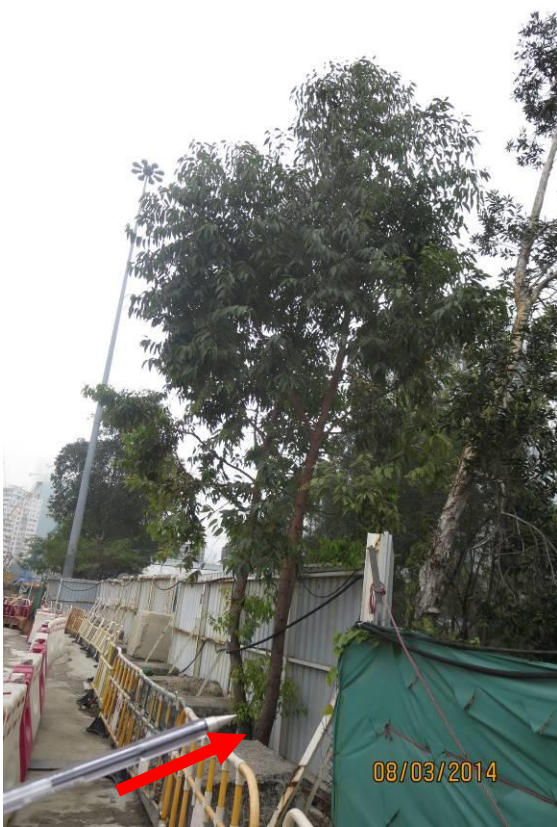
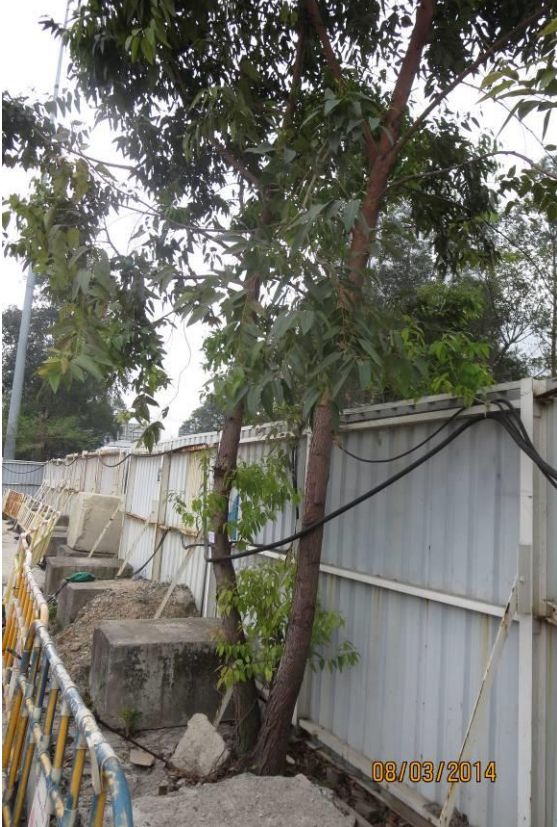
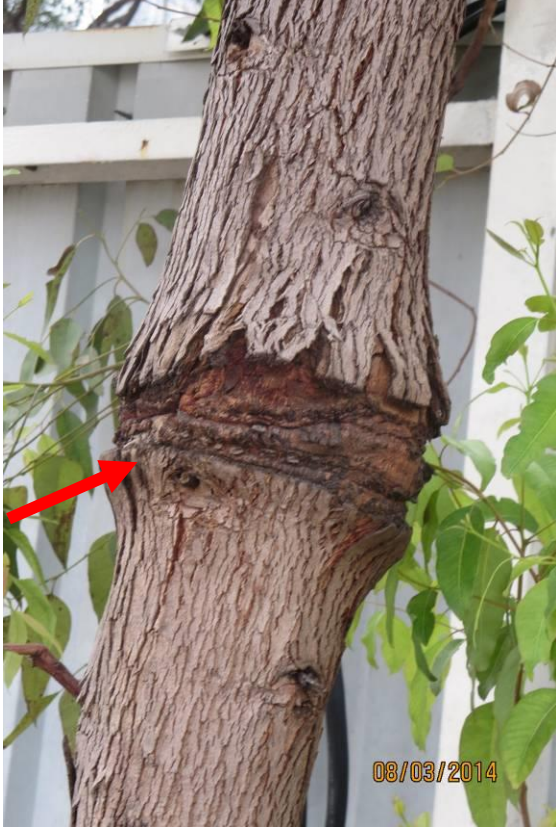
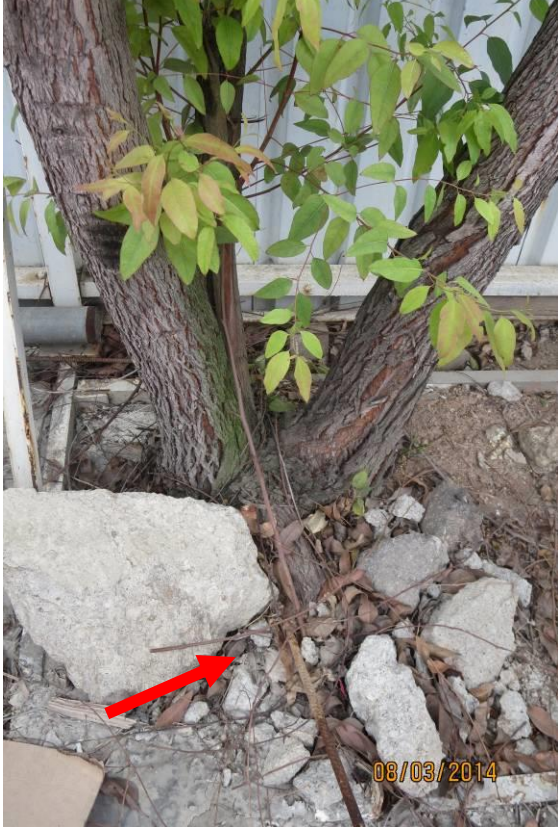
| <p>YMT/T3423-1-Retain<br/>Scientific Name: <i>Eucalyptus robusta</i></p> | <p>YMT/T3423-2</p> | <p>YMT/T3423-3<br/>Wound</p> | <p>YMT/T3423-4<br/>Co-dominant trunk, growth restricted</p> |

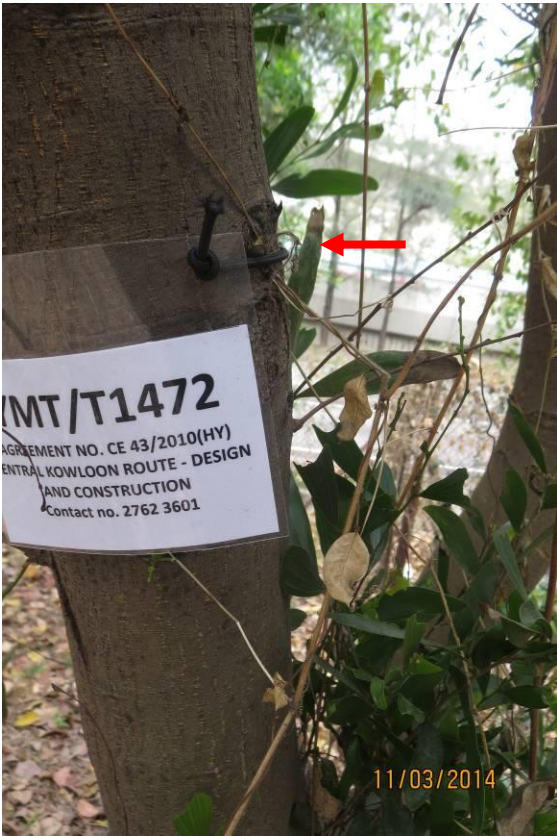
| YMT/T1472- 1-Affected by other project<br>Scientific Name: <i>Acacia confusa</i> | YMT/T1472- 2<br>Hanger | YMT/T1472- 3<br>Epicormics | YMT/T1472- 4 |

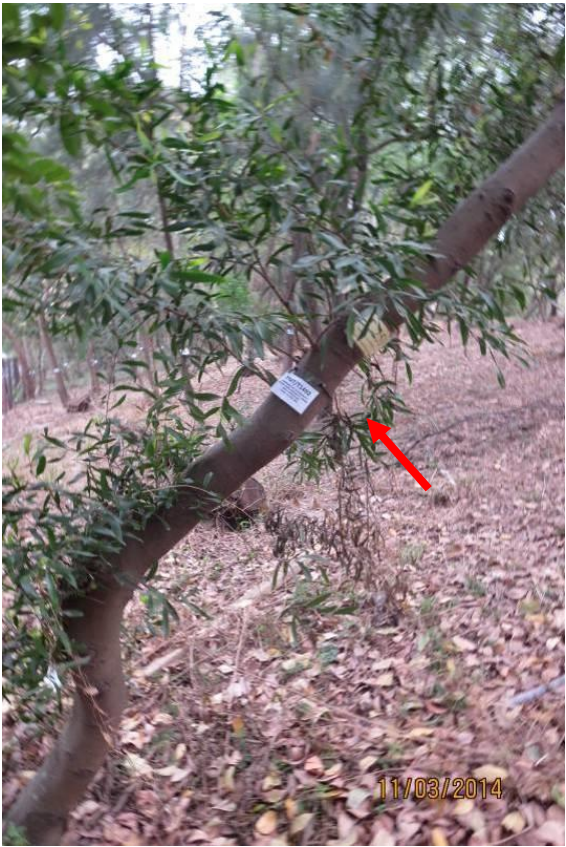
| YMT/T1492- 1-Fell<br>Scientific Name: <i>Acacia confusa</i> | YMT/T1492- 2 | YMT/T1492- 3<br>Lean at 45° | YMT/T1492- 4<br>Epicormics |

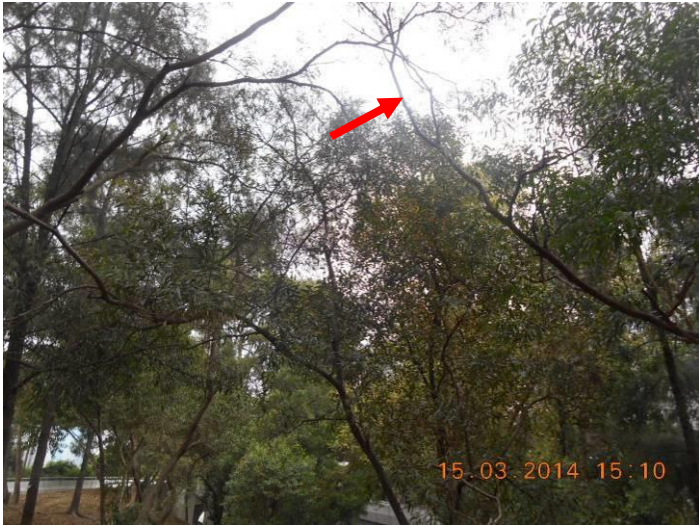
| YMT/T1497- 1-Fell<br>Scientific Name: <i>Casuarina equisetifolia</i> | YMT/T1497- 2<br>Topped | YMT/T1497- 3 | YMT/T1497- 4 |

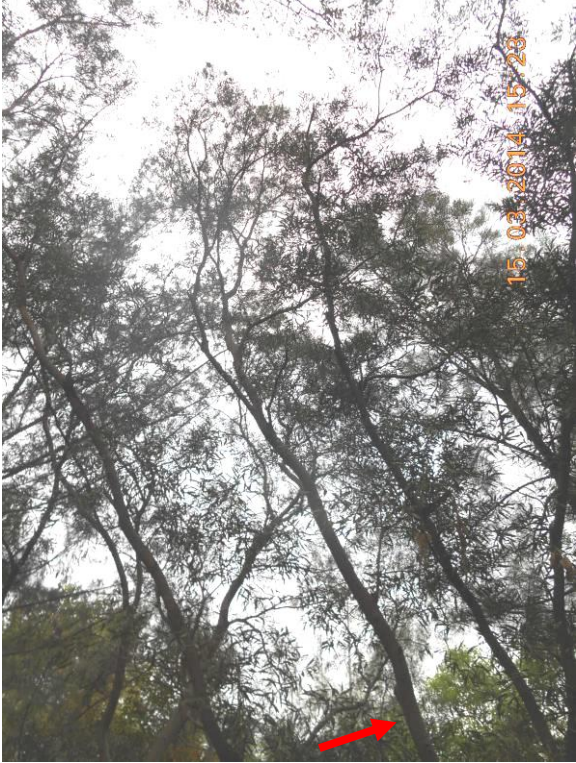
| YMT/T1498- 1-Fell<br>Scientific Name: <i>Acacia confusa</i> | YMT/T1498- 2<br>Dead branches | YMT/T1498- 3 | YMT/T1498- 4<br>Hanger |

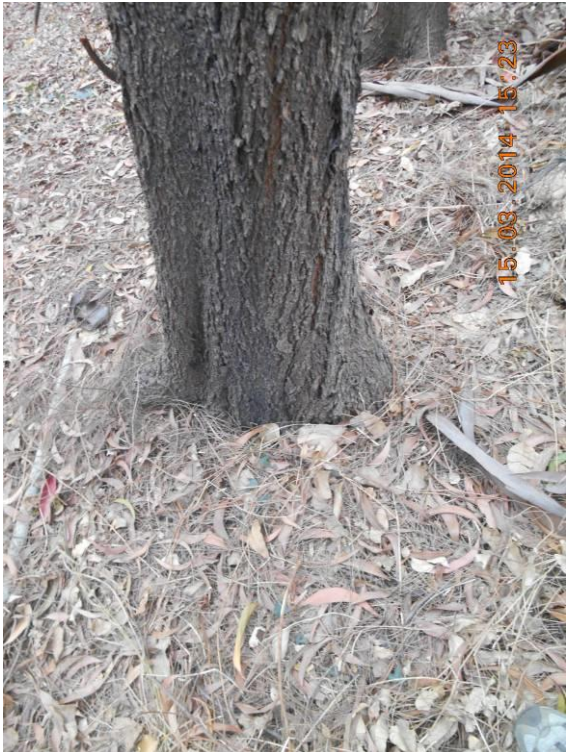
| YMT/T1506- 1-Affected by other project<br>Scientific Name: <i>Acacia confusa</i> | YMT/T1506- 2 | YMT/T1506- 3 | YMT/T1506- 4<br>Co-dominant trunks |

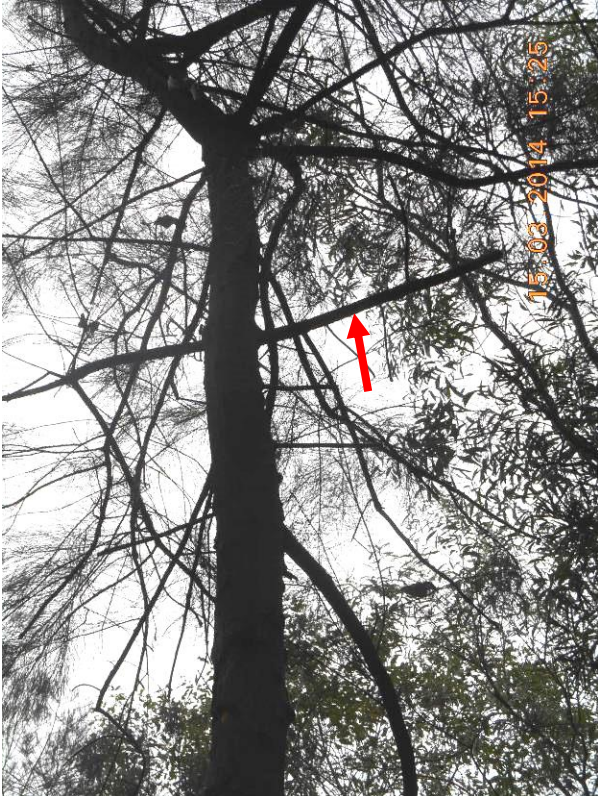
| YMT/T1508- 1-Fell<br>Scientific Name: <i>Casuarina equisetifolia</i> | YMT/T1508- 2<br>Dead branches | YMT/T1508- 3 | YMT/T1508- 4 |

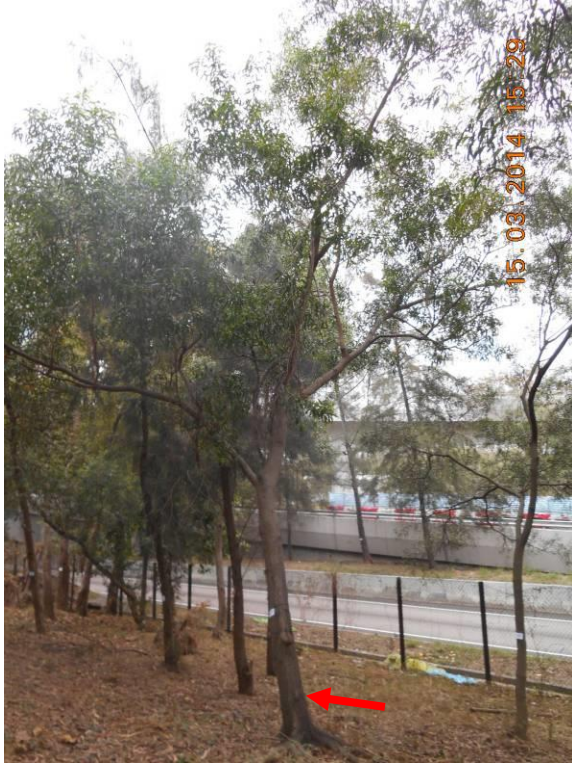
| YMT/T1510- 1-Fell<br>Scientific Name: <i>Acacia auriculiformis</i> | YMT/T1510- 2<br>Dead branches | YMT/T1510- 3 | YMT/T1510- 4<br>Exposed root |

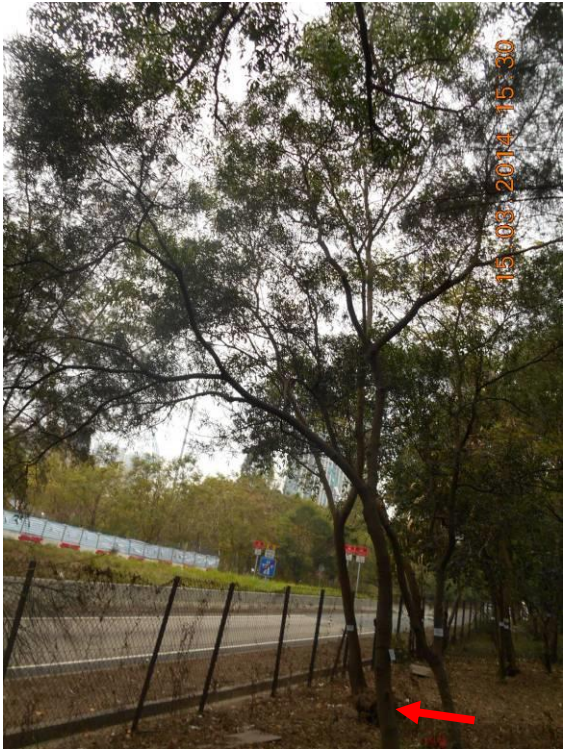
| YMT/T1511- 1-Fell<br>Scientific Name: <i>Acacia confusa</i> | YMT/T1511- 2 | YMT/T1511- 3 | YMT/T1511- 4 |

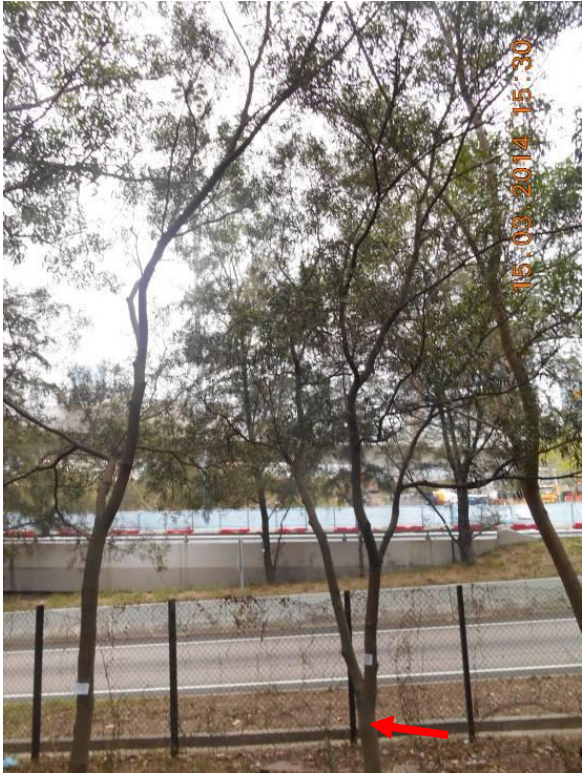
| YMT/T1512- 1-Fell<br>Scientific Name: <i>Acacia confusa</i> | YMT/T1512- 2 | YMT/T1512- 3 | YMT/T1512- 4 |
