**Legislative Council
Panel on Environmental Affairs**

**Electrical Incidents of
CLP Power Hong Kong Limited in 2024**

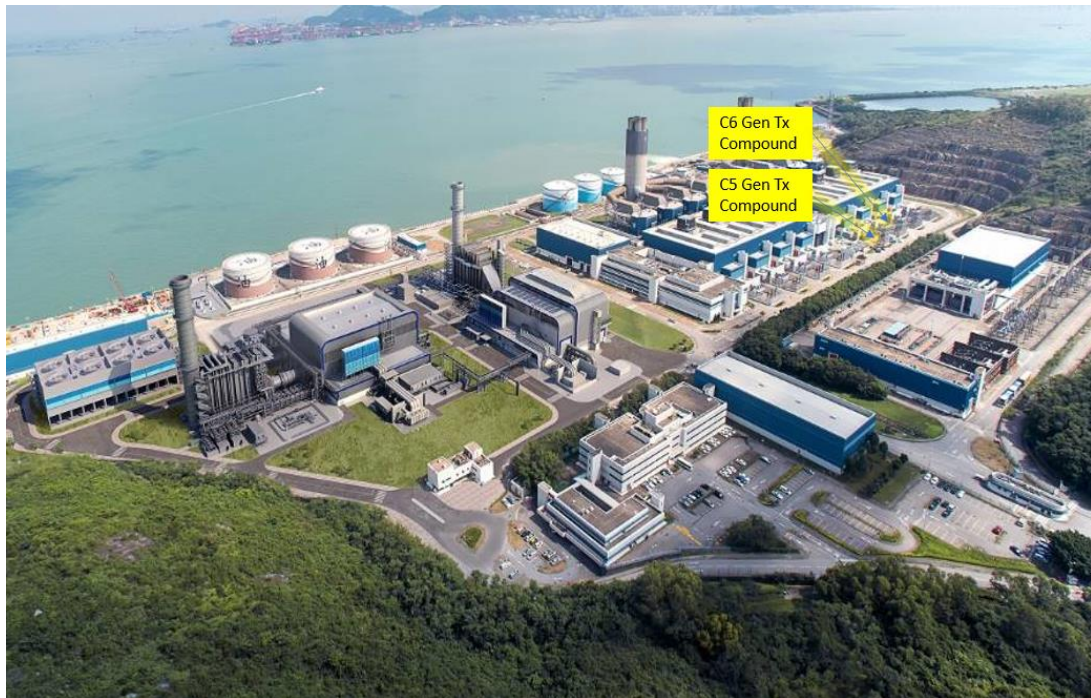
Figure 1 Layout of Black Point Power Station (BPPS)

The lightning protection system (LPS) was built at BPPS according to international standard. It includes 4 lightning masts at each open-air generator transformer compound to provide lightning protection to the equipment installed inside the transformer compounds. With the existing LPS in place, the residual risk of lightning strikes hitting our generation equipment is considered as low as reasonably practicable.

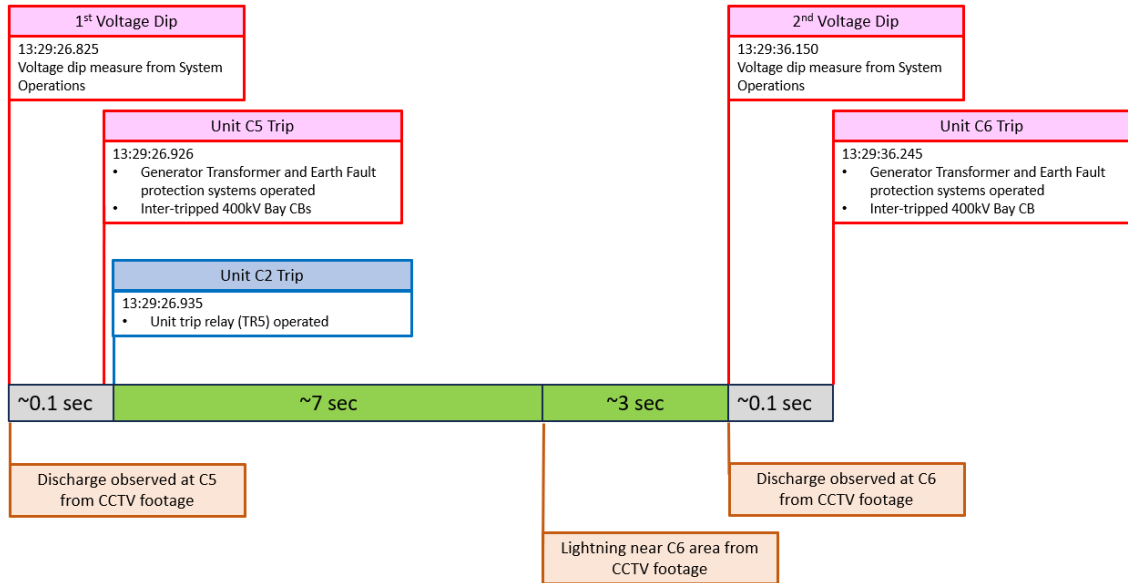
Figure 2 Timeline of Sequence of Events

- At 13:29:26 hours, discharge occurred at C5 generator transformer compound.
- At 13:29:33 hours, lightning observed at the vicinity of C6 generator transformer compound.
- At 13:29:36 hours, discharge occurred at C6 generator transformer compound.

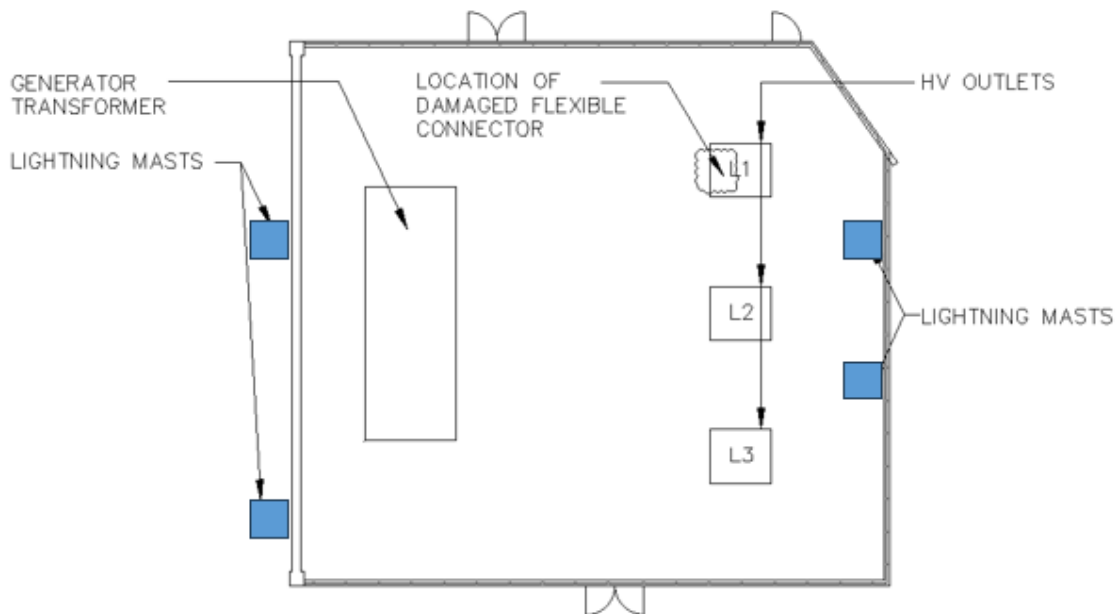
Figure 10 Layout of Electrical Equipment in a Generator Transformer Compound

Site inspections revealed that there was no damage to other equipment and installations inside the generator transformer compounds except some localized burn marks and metal loss at the flexible conductors of the generator transformers' HV outlet at unit C5 & C6 phase L1 respectively. Some metal patches could also be found at surrounding electrical components.
