**Electrical Incidents of CLP Power Hong Kong Limited  
in Tsing Yi in January 2024**

# Power Supply Interruption Incident at On Mei House, Tsing Yi On 7 January 2024

## INCIDENT INVESTIGATION REPORT

# **Nga Ying Chau Street Substation Voltage Dip Incident On 1 January 2024**

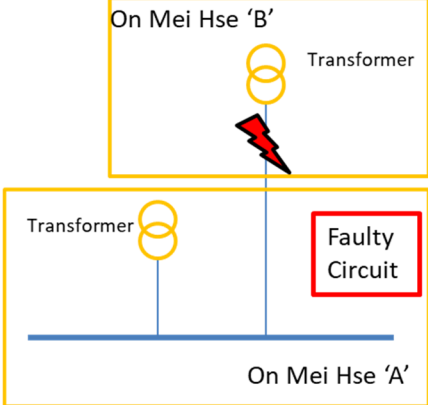
<p>The diagram shows a 11kV network. At the top, a yellow box labeled 'On Mei Hse 'B'' contains a transformer symbol and a lightning bolt icon. Below it, a larger yellow box labeled 'On Mei Hse 'A'' contains two transformer symbols connected to a horizontal blue line representing the busbar. A red box labeled 'Faulty Circuit' is connected to the busbar between the two transformers. A vertical line connects the transformer in the 'On Mei Hse 'B'' box to the busbar in the 'On Mei Hse 'A'' box.</p> <p>11kV Network diagram of the faulty circuit</p>
2

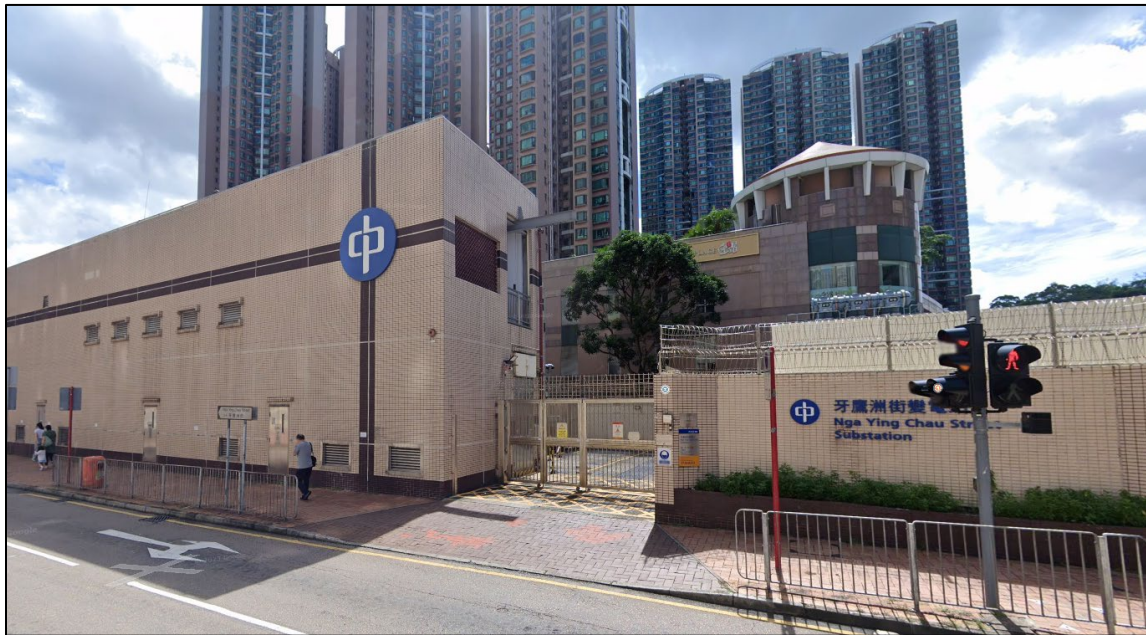
On 1 January 2024 at 15:13 hours, a voltage dip incident occurred which involved a power system component fault inside a CLP 132kV substation located at Nga Ying Chau Street (NGA) in Tsing Yi area. The CLP real-time operation system detected a fault on the 132kV cable circuit connecting a ring main unit (RMU) and a transformer inside the substation and the circuit was automatically isolated from the supply network immediately by CLP's protection system. There was no power interruption as the supply was maintained through auto-switching to CLP's alternative supply path. However, a voltage dip occurred, with L3 phase voltage dropped to 25% for about 0.08 second.

Witnesses reported seeing white smoke from the substation and hearing a loud sound at the scene. The white smoke had dissipated before CLP emergency response team arrived at around 15:40 hours, Fire Services Department (FSD), and Hong Kong Police Force (HKPF) were already at the scene. There was no sign of fire at scene.

Upon preliminary investigation, CLP emergency response team reported that an outdoor cable sealing end (CSE) at the L3 phase of the NGA RMU No. 1 connecting a transformer was broken, the faulty component was referred "132kV RMU L3 Phase CSE".

CLP took immediate action to commence repair work and fault investigation, at the same time enhanced preventive actions by inspecting all 132kV substations and conducting partial discharge testing on RMU CSEs in Tsing Yi in order to ensure power supply security in the area and prevent similar fault case.

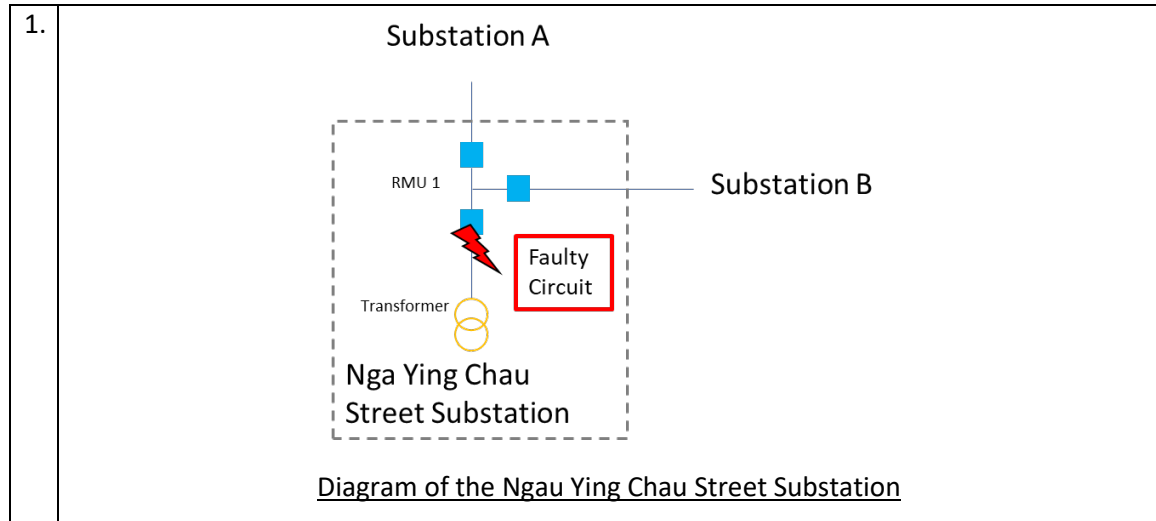
Upon site investigation on 1 January 2024, only the L3 phase CSE of the RMU was damaged while all other components were checked in good condition. Fragments of the insulator were found in the vicinity of the CSE and traces of insulating oil were spread on the wall of the RMU bay at a level aligned with the installation height of the damaged part of the CSE.

The investigation suggests a material flaw inside the CSE to be the root cause of the fault.

Upon examination and testing at site, the concerned RMU remained intact, the faulty CSE will be replaced with a new one which is planned for completion by 31 January 2024, without need for any power shutdown to customers.
