Architectural Services Department

Asbestos Investigation Report for Demolition of Existing Superstructures at Caroline Hill Road Site, Causeway Bay, Hong Kong

(Version 3.0)

August 2016

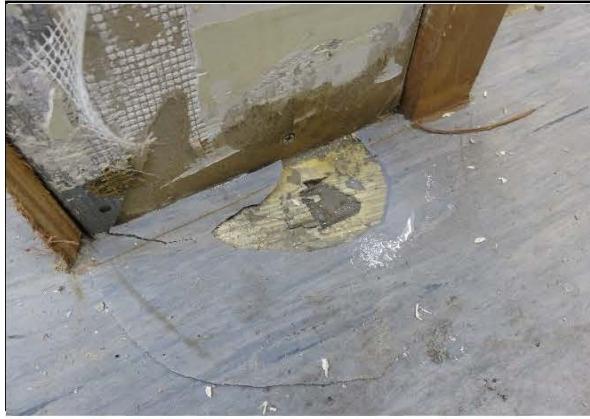
Photo 2167: S2, vinyl floor sheet with mastic in corridor, 9/F, EMSD Headquarters. ACM was identified.
(Lab ID: B/103/16/2)

Photo 2167: Vinyl floor sheet with mastic (ACM) in office area , 9/F, EMSD Headquarters

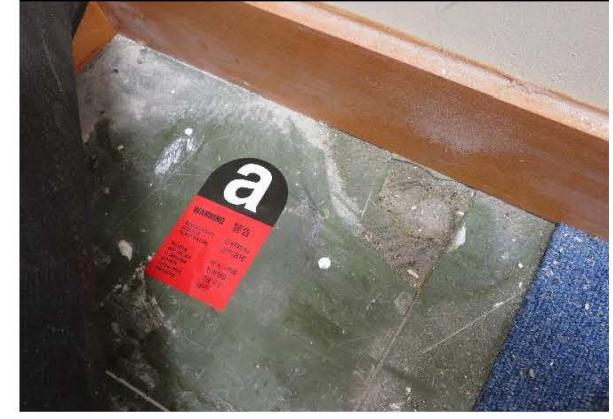
Photo 2175: S3, vinyl floor tile with mastic below floor mat in DCC Ballot Box P,G Room, 9/F, EMSD Headquarters. ACM was identified.
(Lab ID: B/103/16/3)

Photo 2175: Vinyl floor tile with mastic (ACM) in office area , 9/F, EMSD Headquarters

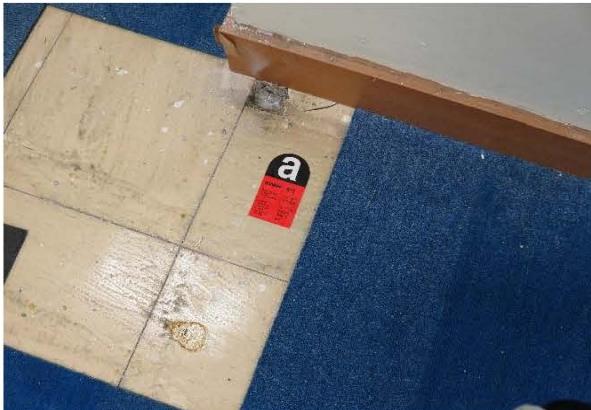
Photo 2173: S4, vinyl floor tile with mastic below floor mat on 8/F, EMSD Headquarters. ACM was identified.
(Lab ID: B/103/16/4)

Photo 2173: Vinyl floor tile with mastic (ACM) in office area , 8/F, EMSD Headquarters

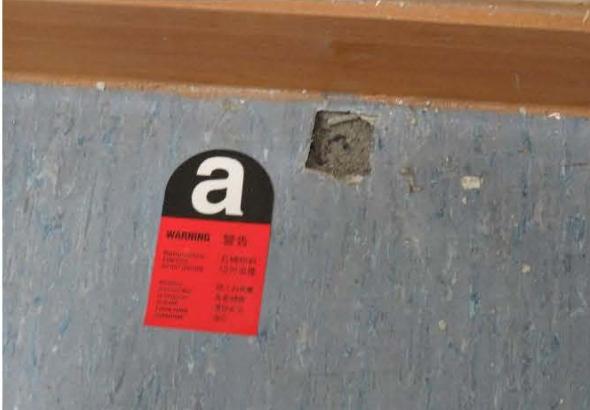
Photo 2177: S5, vinyl floor sheet with mastic in cargo lift lobby, 8/F, EMSD Headquarters. ACM was identified.
(Lab ID: B/103/16/5)

Photo 2177: Vinyl floor sheet with mastic (ACM) in cargo lift lobby on the 8/F of EMSD Headquarters

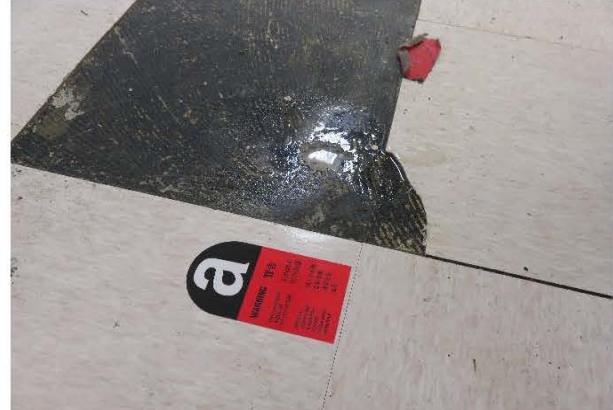
Photo 2180: S6, vinyl floor tile with mastic on 7/F, EMSD Headquarters. ACM was identified.
(Lab ID: B/103/16/6)

Photo 2180: Vinyl floor tile with mastic (ACM) in office area , 7/F, EMSD Headquarters

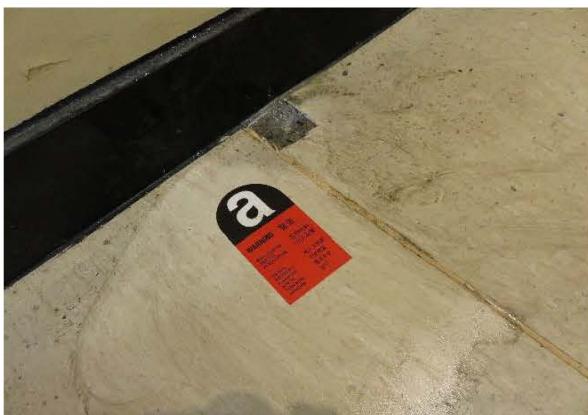
Photo 2183: S7, vinyl floor sheet with mastic in passenger lift lobby, 4/F, EMSD Headquarters. No ACM was identified.
(Lab ID: B/103/16/7)

Photo 2183: Vinyl floor sheet with mastic (ACM) in passenger lift lobby on the 4/F of EMSD Headquarters

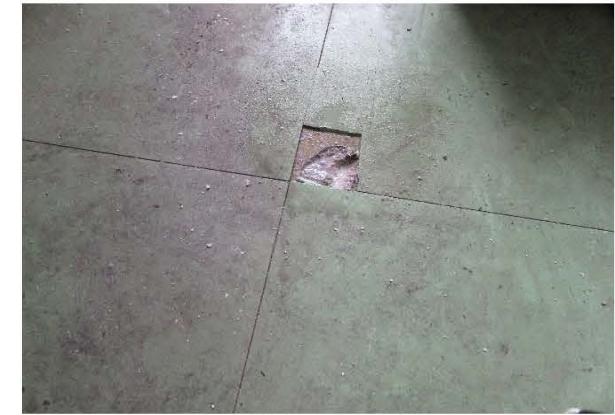
Photo 2187: S9, vinyl floor tile with mastic in Store Room, 4/F, EMSD Headquarters. No ACM was identified.
(Lab ID: B/103/16/9)

Photo 2187: Vinyl floor tile with mastic in store room on the 4/F of EMSD Headquarters

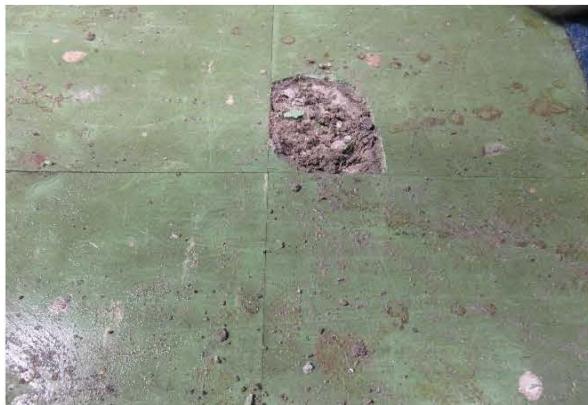
Photo 2189: S10, vinyl floor tile with mastic below floor mat on 4/F, EMSD Headquarters. No ACM was identified.
(Lab ID: B/103/16/10)

Photo 2189: Vinyl floor tile with mastic in office area on the 4/F of EMSD Headquarters

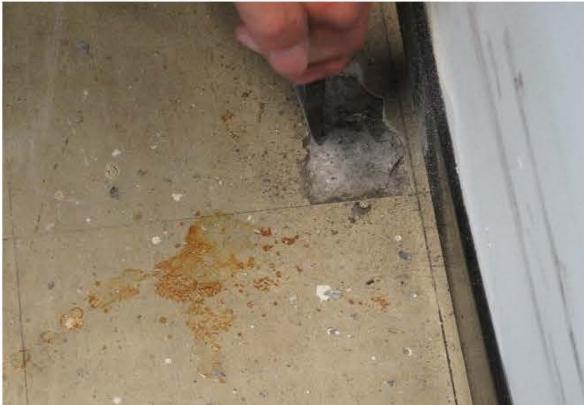
Photo 2191: S11, vinyl floor tile with mastic below floor mat on 4/F, EMSD Headquarters. No ACM was identified.
(Lab ID: B/103/16/11)

Photo 2191: Vinyl floor tile with mastic in office area on the 4/F of EMSD Headquarters

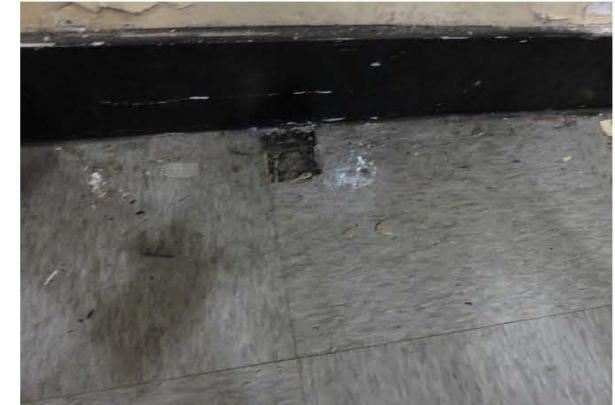
Photo 2193: S12, vinyl floor tile with mastic in cargo lift lobby, 4/F, EMSD Headquarters. No ACM was identified.
(Lab ID: B/103/16/12)

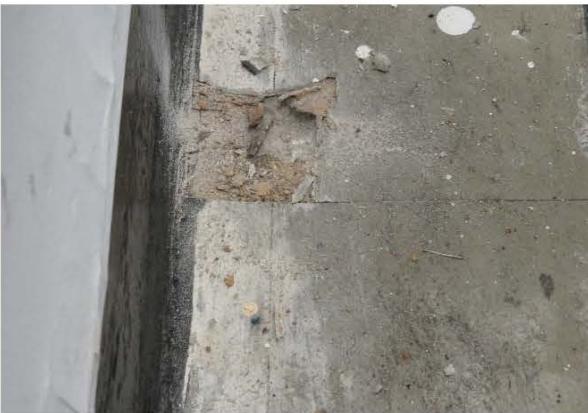
Photo 2197: S13, vinyl floor tile with mastic on 3/F, EMSD Headquarters. No ACM was identified.
(Lab ID: B/103/16/13)

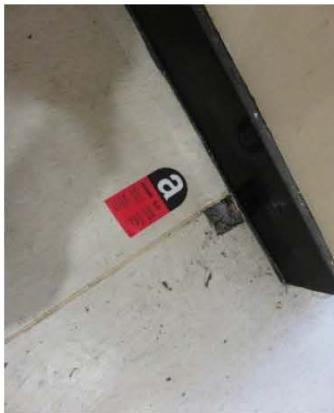
Photo 2202: S14, vinyl floor sheet with mastic in passenger lift lobby, 2/F, EMSD Headquarters. ACM was identified.
(Lab ID: B/103/16/14)

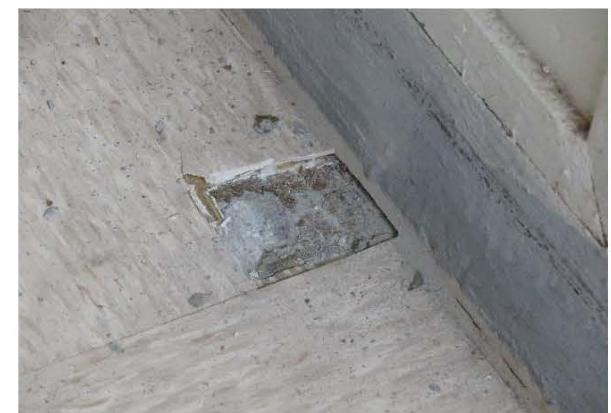
Photo 2204: S15, vinyl floor tile with mastic in Pantry, 2/F, EMSD Headquarters. No ACM was identified.
(Lab ID: B/103/16/15)

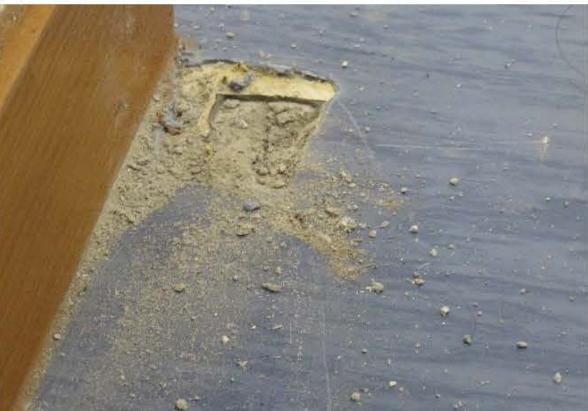
Photo 2206: S16, vinyl floor sheet with mastic on 2/F, EMSD Headquarters. No ACM was identified.
(Lab ID: B/103/16/16)

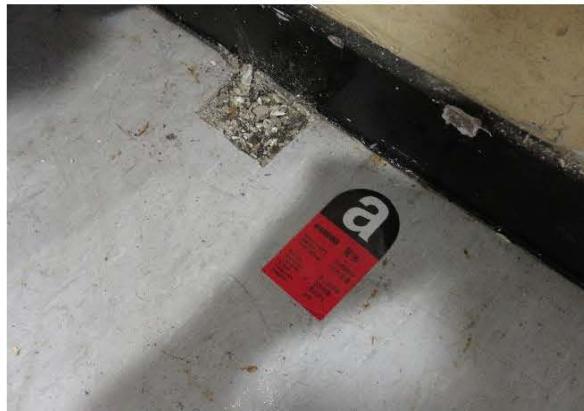
Photo 2209: S17, vinyl floor sheet with mastic in cargo lift lobby, 2/F, EMSD Headquarters. ACM was identified.
(Lab ID: B/103/16/17)

Photo 2209: Vinyl floor sheet with mastic (ACM) in cargo lift lobby on the 2/F of EMSD Headquarters

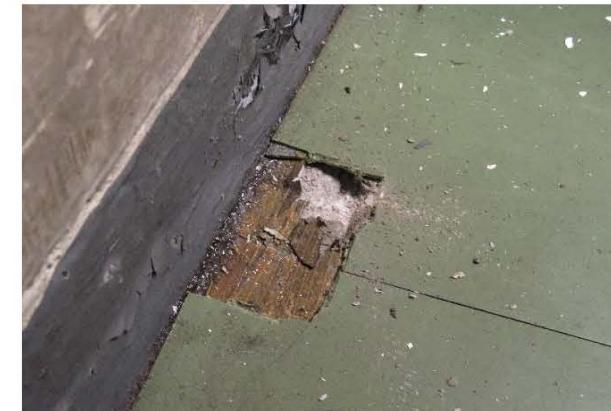
Photo 2212: S18, vinyl floor tile with mastic in cargo lift lobby, 1/F, EMSD Headquarters. No ACM was identified.
(Lab ID: B/103/16/18)

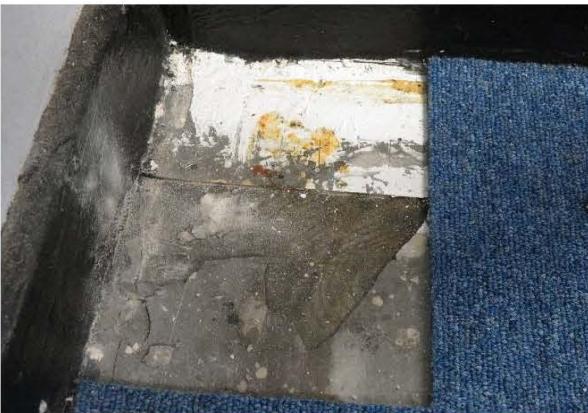
Photo 2214: S19, vinyl floor tile with mastic on 1/F, EMSD Headquarters. No ACM was identified.
(Lab ID: B/103/16/19)

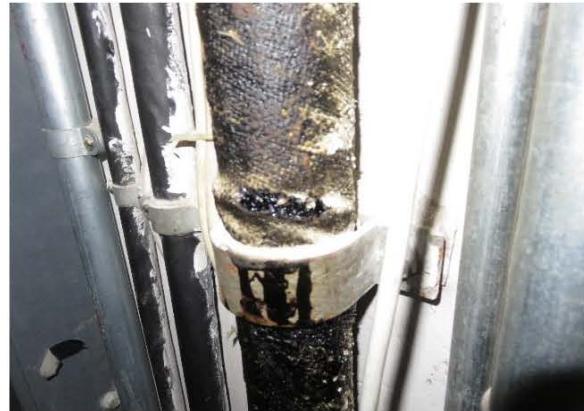
Photo 2216: S20, oil cloth of cable in Switch Room, 1/F, EMSD Headquarters. No ACM was identified.
(Lab ID: B/103/16/20)

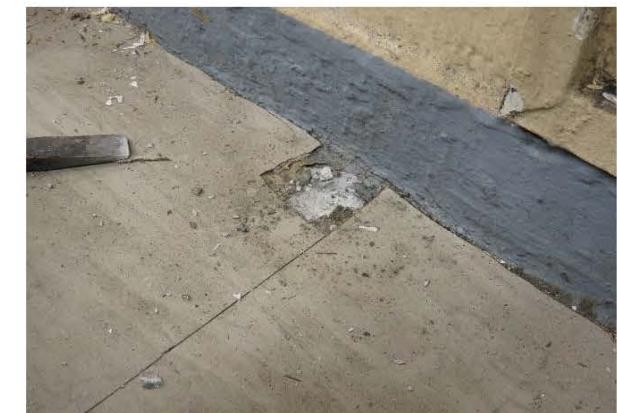
Photo 2219: S21, vinyl floor tile with mastic in Store Room, G/F, EMSD Headquarters. No ACM was identified.
(Lab ID: B/103/16/21)

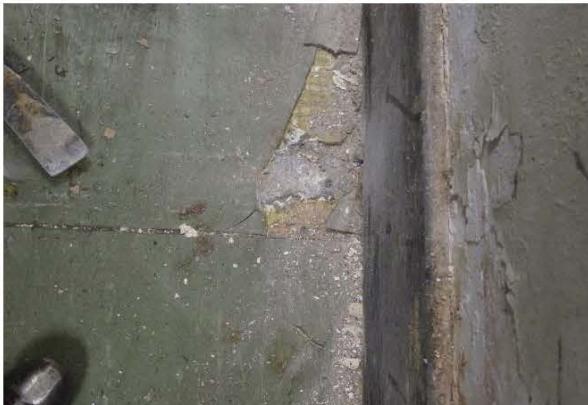
Photo 2221: S22, vinyl floor tile with mastic in Store Room, G/F, EMSD Headquarters. No ACM was identified.
(Lab ID: B/103/16/22)

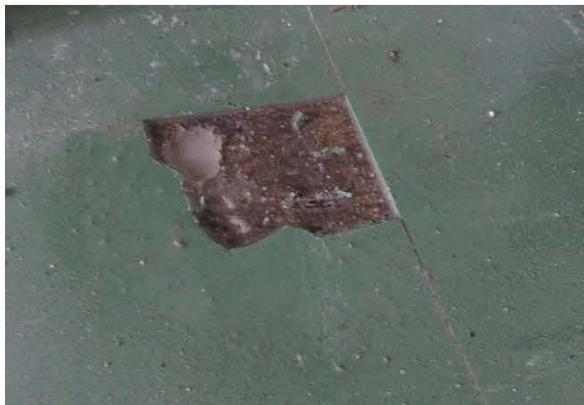
Photo 2226: S23, vinyl floor tile with mastic on 10/F, EMSD Headquarters. ACM was identified.
(Lab ID: B/103/16/23)

Photo 2226: Vinyl floor tile with mastic (ACM) in office area on the 10/F of EMSD Headquarters

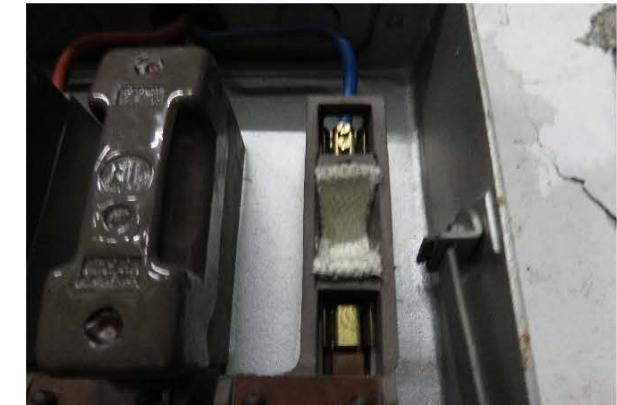
Photo 2135: S24, Arc cloth inside switch box in Chiller Plant Room, R/F, EMSD Headquarters. ACM was identified.
(Lab ID: B/103/16/24)

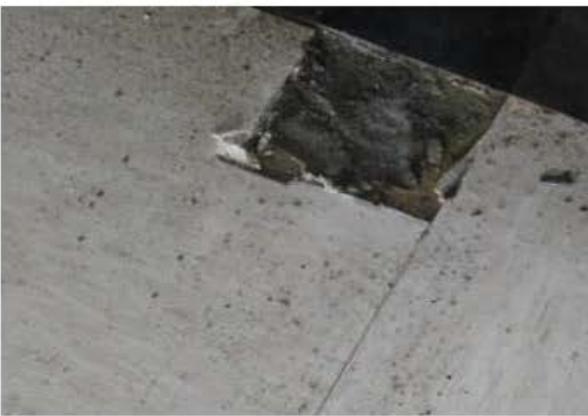
Photo 2231: S25, vinyl floor tile with mastic in Room 603, 6/F, EMSD Headquarters. No ACM was identified.
(Lab ID: B/103/16/25)

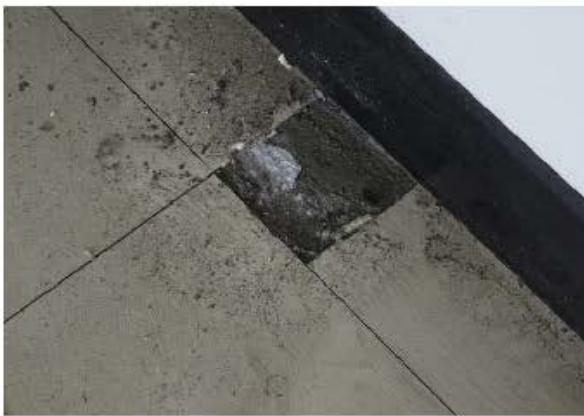
Photo 2234: S26, vinyl floor tile with mastic in Room 504, 5/F, EMSD Headquarters. No ACM was identified.
(Lab ID: B/103/16/26)

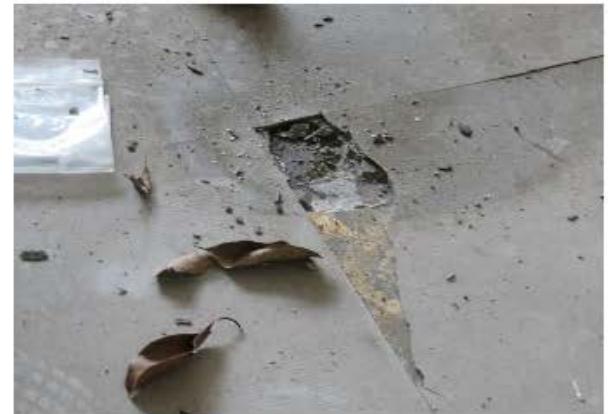
Photo 2427: S30, vinyl floor tile with mastic in living room of Room 1, 1/F, Quarter Block. ACM was identified.
(Lab ID: B/103/16/30)

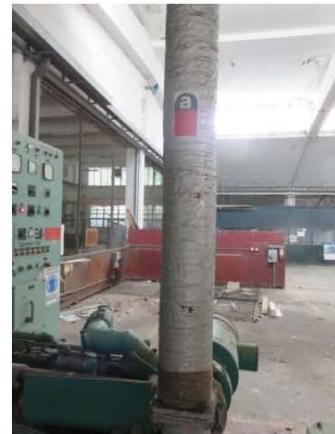
Photo 2434: S35, rope lagging on flue of generator, EMSD Workshop. ACM was identified.
(Lab ID: B/103/16/35)

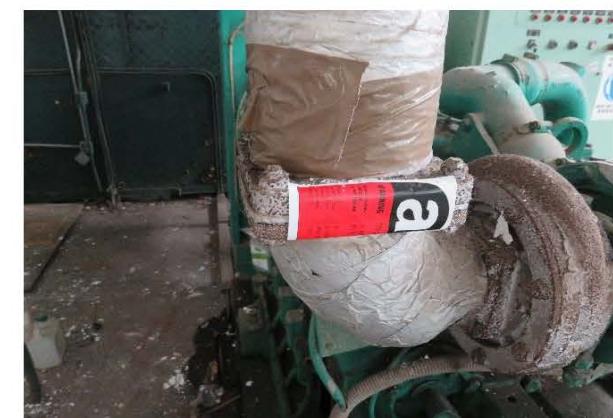
Photo 2435: S36, hard gasket at flue flange of generator, EMSD Workshop. ACM was identified.
(Lab ID: B/103/16/36)

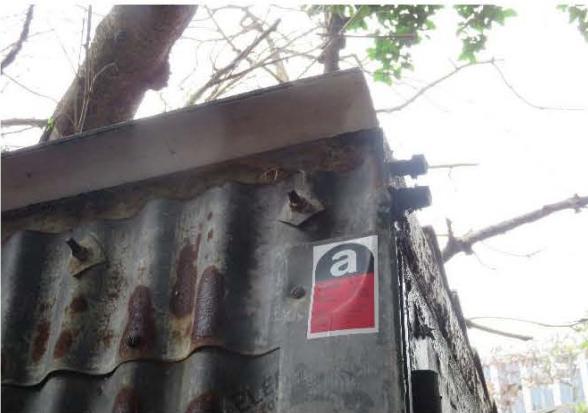
Photo 2445: S40, corrugated cement sheet at roof sheeting of DG Store, EMSD Workshop. ACM was identified.
(Lab ID: B/103/16/40)

Photo 2445: Corrugated cement sheet roofing of DG Store, Workshop

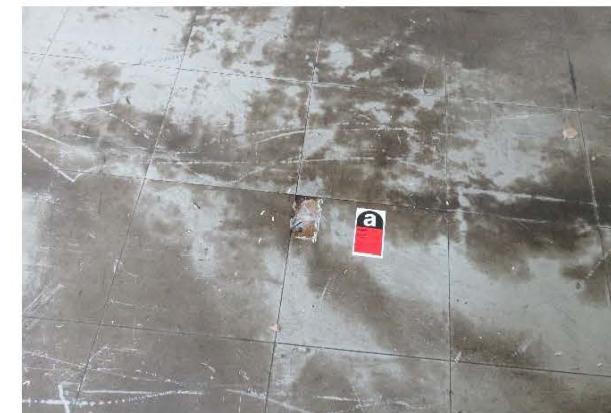
Photo 2454: S42, vinyl floor tile with mastic in Room G11, G/F, Training Centre. ACM was identified.
(Lab ID: B/103/16/42)

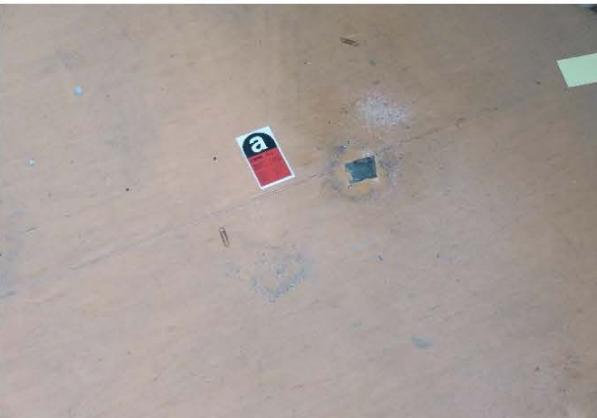
Photo 2458: S46, vinyl floor sheet with mastic on 4/F, Training Centre. ACM was identified.
(Lab ID: B/103/16/46)

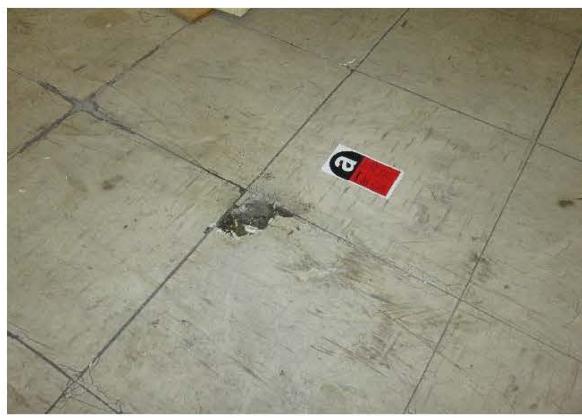
Photo 2459: S47, vinyl floor tile with mastic in CAS HQ canteen, 1/F, CAS Headquarters. ACM was identified.
(Lab ID: B/103/16/47)

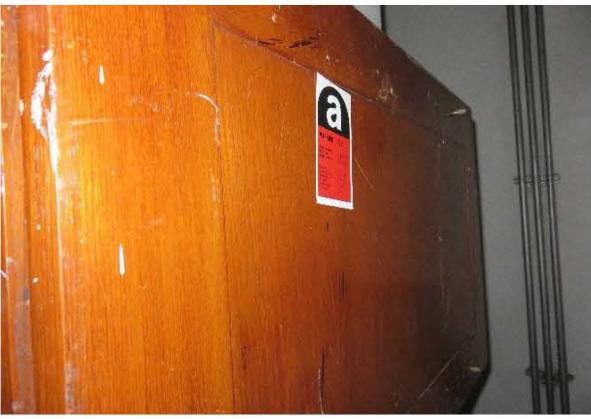
Photo 2467: S49, insulation board inside heater box
in A/C plant Room, 6/F, CAS Headquarters. ACM
was identified.
(Lab ID: B/103/16/49)

Photo 2467: Insulation board (ACM) inside heater box in A/C plant Room, 6/F, CAS Headquarters

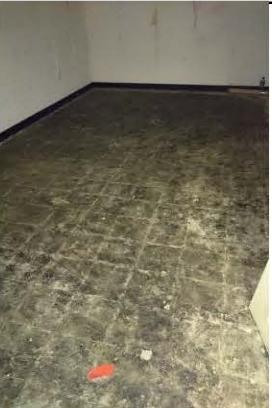
Photo 0006: Vinyl floor tile with mastic (ACM) in Game Room on the 1/F of CAS Headquarters

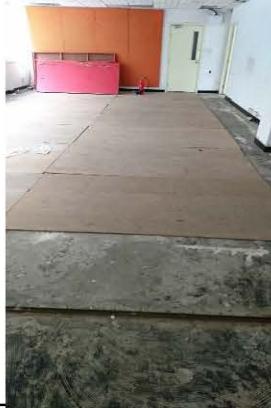
Photo 0007: Vinyl floor tile with mastic (ACM) in Officers' Mess on the 1/F of CAS Headquarters

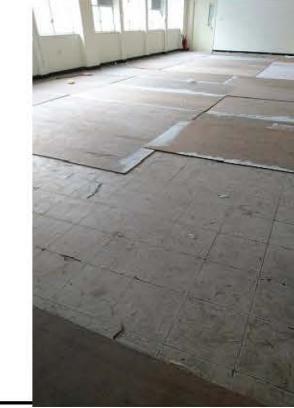
Photo 0009: Vinyl floor tile with mastic (ACM) in canteen on the 1/F of CAS Headquarters

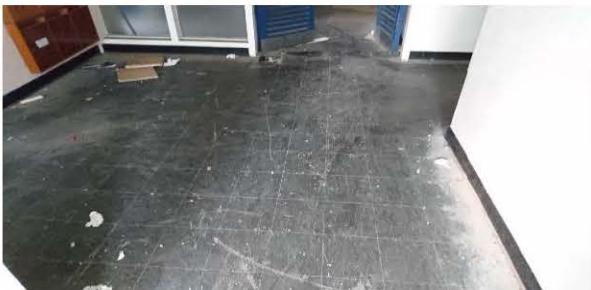
Photo 0015: Vinyl floor tile with mastic (ACM) in lift lobby on the 2/F of CAS Headquarters

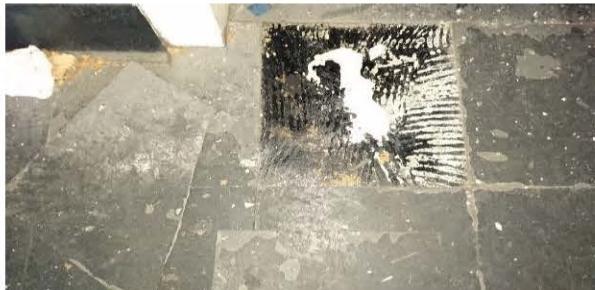
Photo 0016: Vinyl floor tile with mastic (ACM) in lift lobby on the 2/F of CAS Headquarters

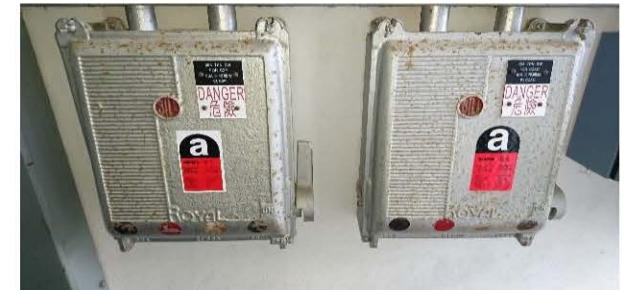
Photo 0018: Switch box with ACM containing arc cloth in Switch Room on the 2/F of CAS Headquarters

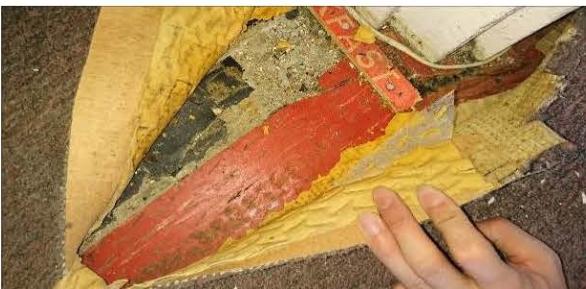
Photo 0032: Vinyl floor tile with mastic (ACM) in office area on the 3/F of CAS Headquarters

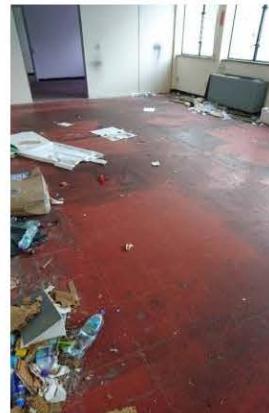
Photo 0033: Vinyl floor tile with mastic (ACM) in office area on the 3/F of CAS Headquarters

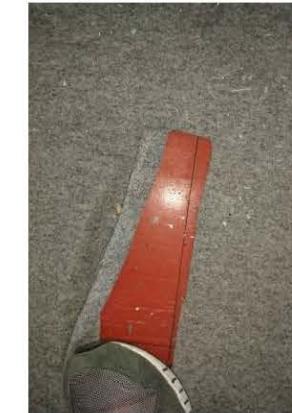
Photo 0034: Vinyl floor tile with mastic (ACM) in office area on the 3/F of CAS Headquarters

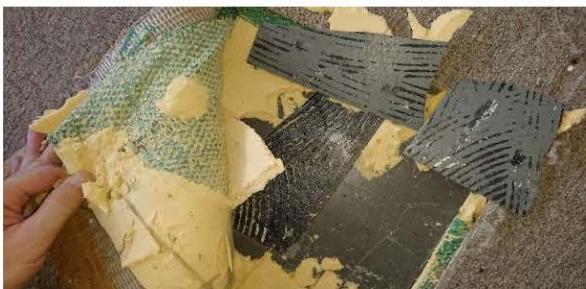
Photo 0036: Vinyl floor tile with mastic (ACM) in office area on the 3/F of CAS Headquarters

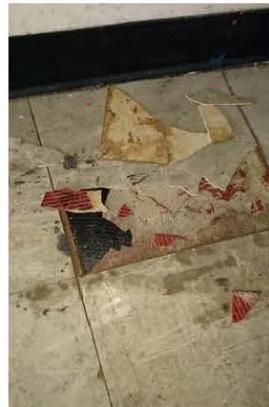
Photo 0037: Vinyl floor tile with mastic (ACM) in lift lobby on the 3/F of CAS Headquarters

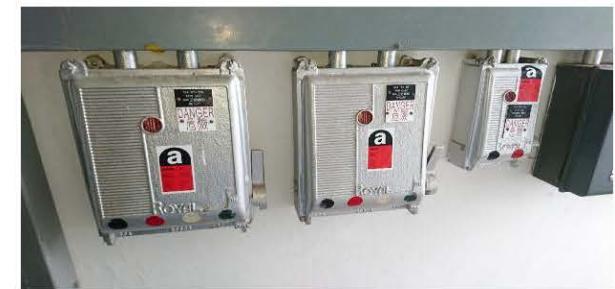
Photo 0039: Switch box with ACM containing arc cloth in Switch Room on the 3/F of CAS Headquarters

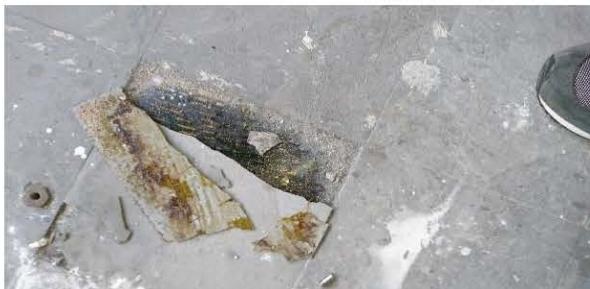
Photo 0042: Vinyl floor tile with mastic (ACM) in office area on the 4/F of CAS Headquarters

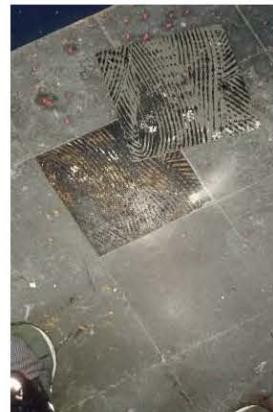
Photo 0043: Vinyl floor tile with mastic (ACM) in lift lobby on the 4/F of CAS Headquarters

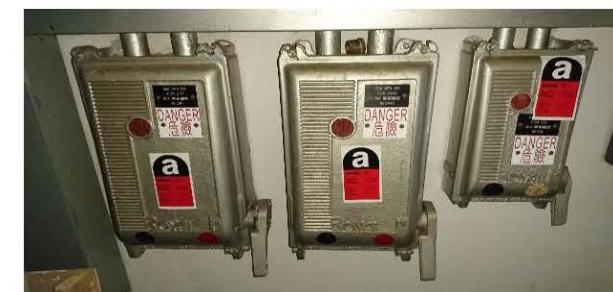
Photo 0044: Switch box with ACM containing arc cloth in Switch Room on the 4/F of CAS Headquarters

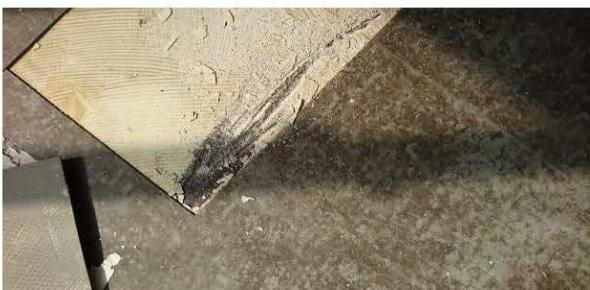
Photo 0045: Vinyl floor tile with mastic (ACM) in lecture room on the 4/F of CAS Headquarters

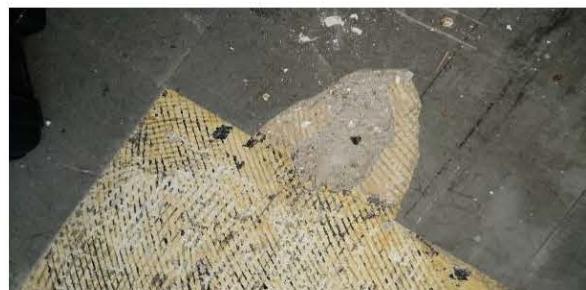
Photo 0046: Vinyl floor tile with mastic (ACM) in lecture room on the 4/F of CAS Headquarters

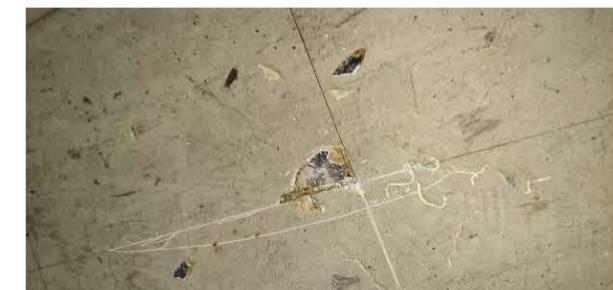
Photo 0047: Vinyl floor tile with mastic (ACM) in office area on the 4/F of CAS Headquarters

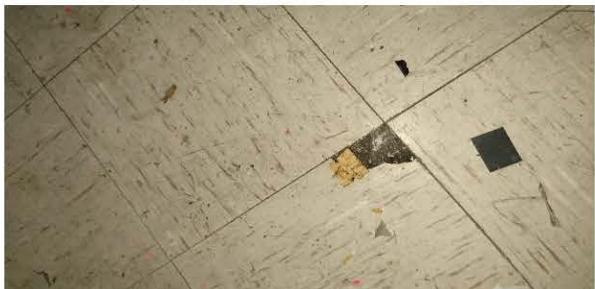
Photo 0053: Vinyl floor tile with mastic (ACM) in lift lobby on the 5/F of CAS Headquarters

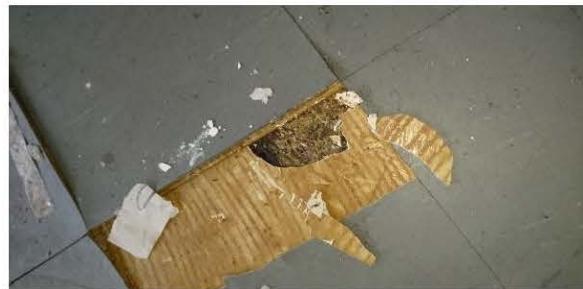
Photo 0054: Vinyl floor tile with mastic (ACM) in office area on the 5/F of CAS Headquarters

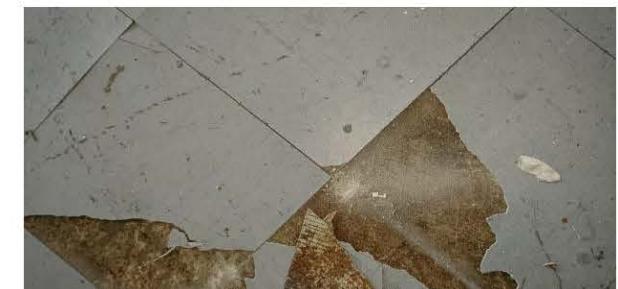
Photo 0055: Vinyl floor tile with mastic (ACM) in office area on the 5/F of CAS Headquarters

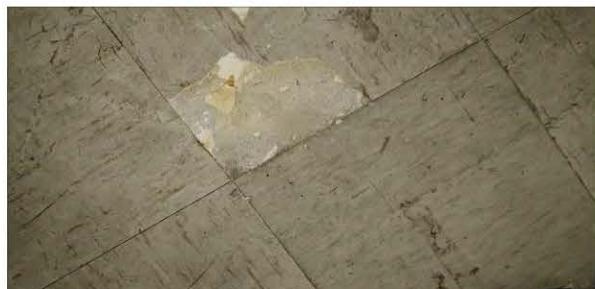
Photo 0056: Vinyl floor tile with mastic (ACM) in office area on the 5/F of CAS Headquarters

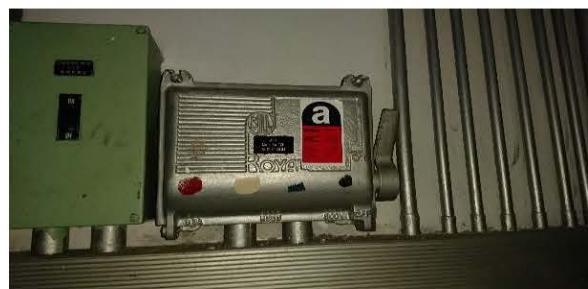
Photo 0059: Switch box with ACM containing arc cloth in A/C Cabinet Room on the 6/F of CAS Headquarters

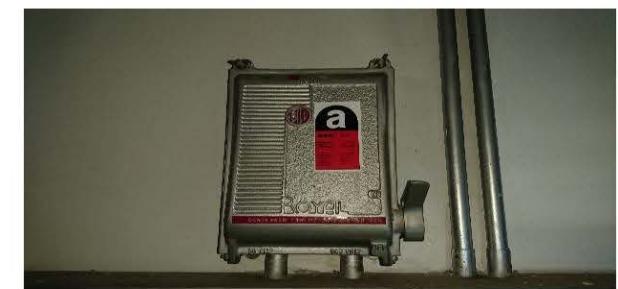
Photo 0060: Switch box with ACM containing arc cloth in A/C Cabinet Room on the 6/F of CAS Headquarters

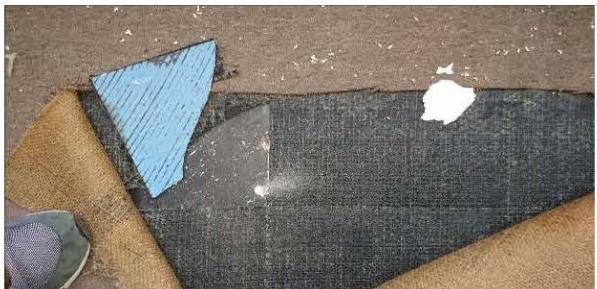
Photo 0074: Vinyl floor tile with mastic (ACM) in office area on the 6/F of CAS Headquarters

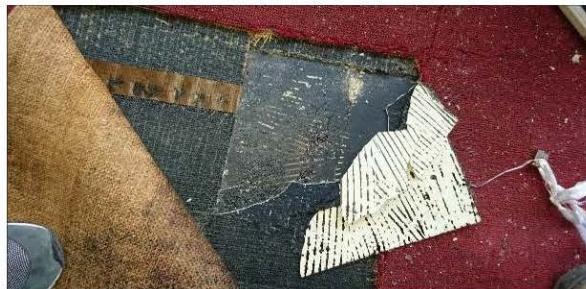
Photo 0076: Vinyl floor tile with mastic (ACM) in office area on the 6/F of CAS Headquarters

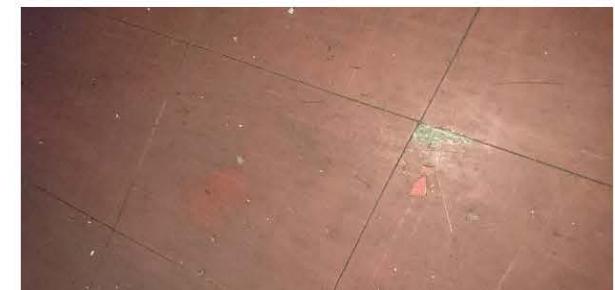
Photo 0081: Vinyl floor tile with mastic (ACM) in lift lobby on the 6/F of CAS Headquarters

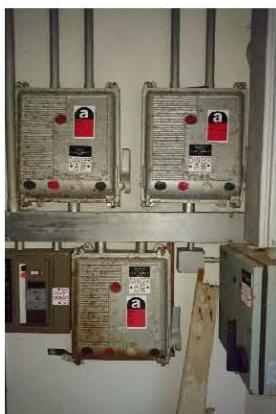
Photo 0082: Switch box with ACM containing arc cloth in Switch Room on the 6/F of CAS Headquarters

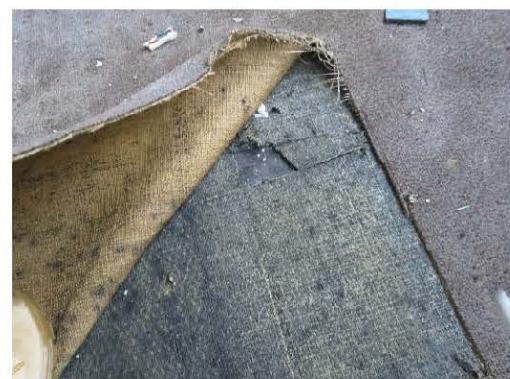
Photo 0086: Vinyl floor tile with mastic (ACM) in office area on the 6/F of CAS Headquarters

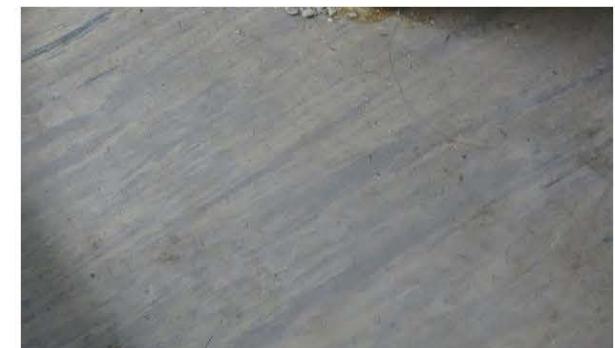
Photo 1857: Vinyl floor sheet with mastic (ACM) in corridor on the 10/F of EMSD Headquarters

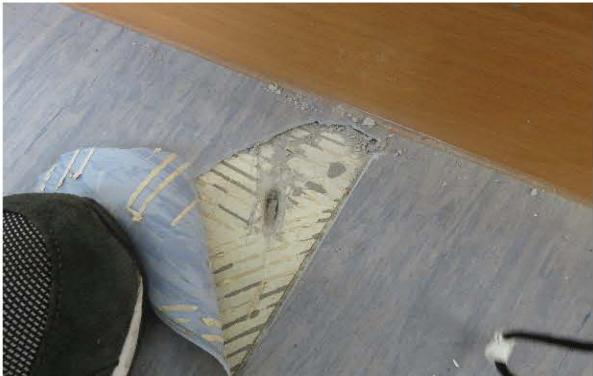
Photo 1859: Vinyl floor sheet with mastic (ACM) in passenger lift lobby on the 10/F of EMSD Headquarters

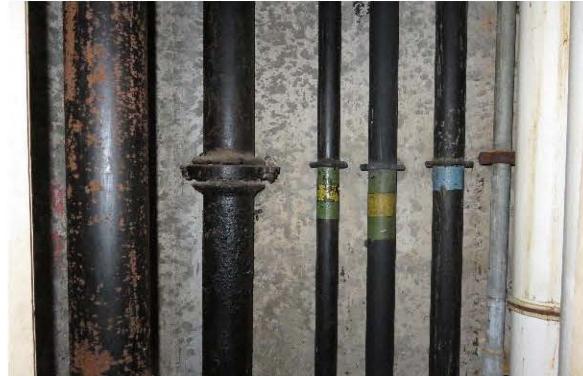
Photo 1867: Sewage pipes were made of cast iron in EMSD Headquarters

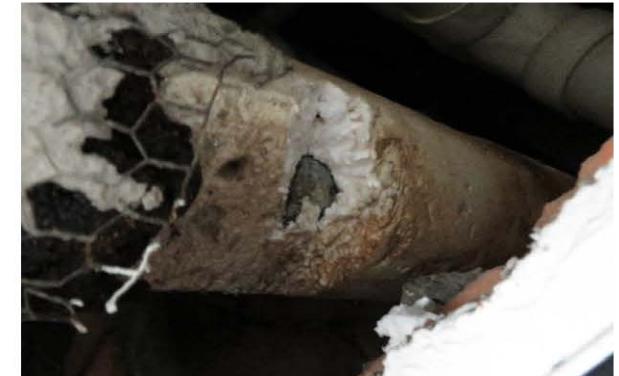
Photo 1869: Foam was identified in the chiller pipes of EMSD Headquarters

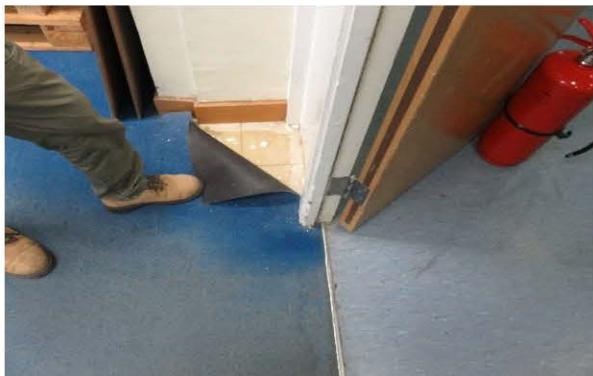
Photo 1884: Photo 1859: Vinyl floor sheet with mastic (ACM) in passenger lift lobby on the 8/F of EMSD Headquarters

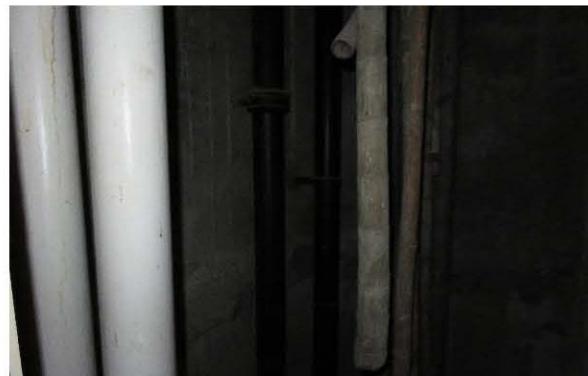
Photo 1909: Rain water and sewage pipes were made of PVC and cast iron in EMSD Headquarters

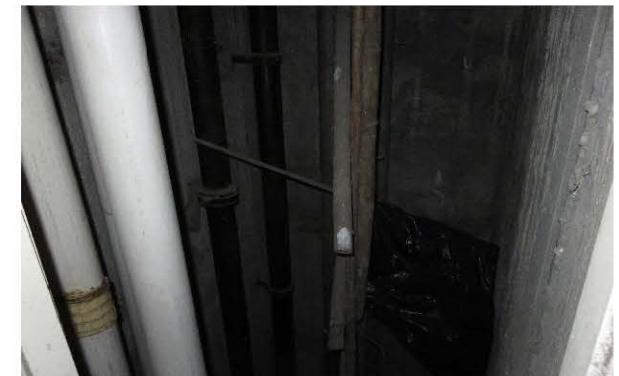
Photo 1940: Rain water and sewage pipes were made of PVC and cast iron in EMSD Headquarters

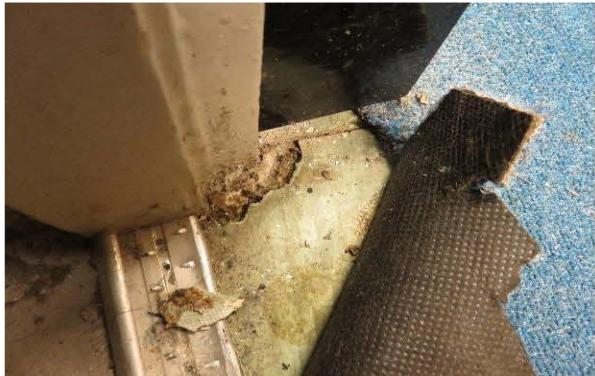
Photo 1993: Vinyl floor tile with mastic (ACM) in passenger lift lobby on the 1/F of EMSD Headquarters

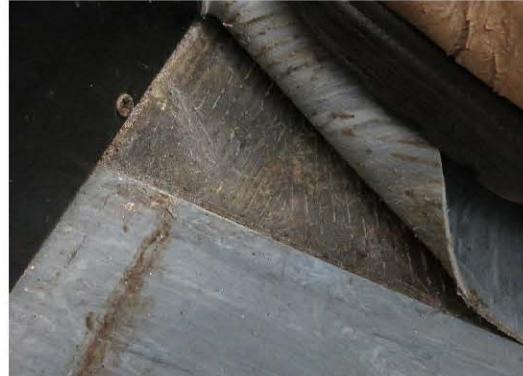
Photo 2007: Vinyl floor tile with mastic (ACM) in office area on the 1/F of EMSD Headquarters

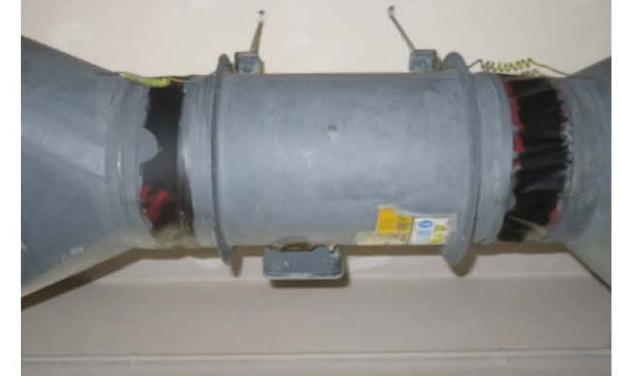
Photo 2047: Plastic flexible joint in E&M Workshop

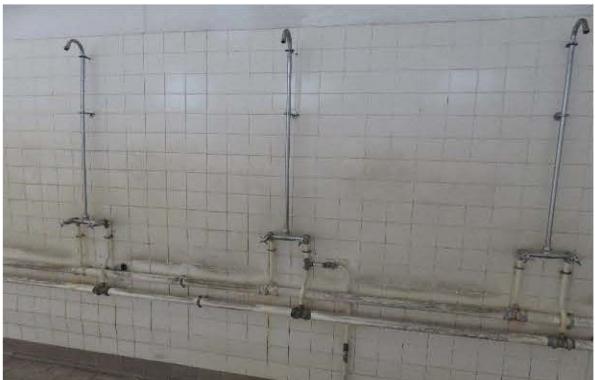
Photo 2049: Copper hot water pipes with PVC lagging in E&M Workshop

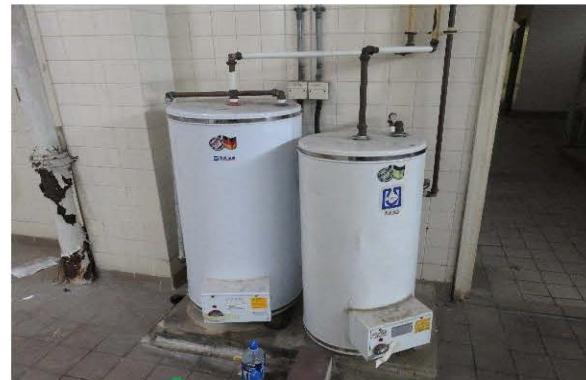
Photo 2053: Electrical hot water boilers at the bath room in E&M Workshop

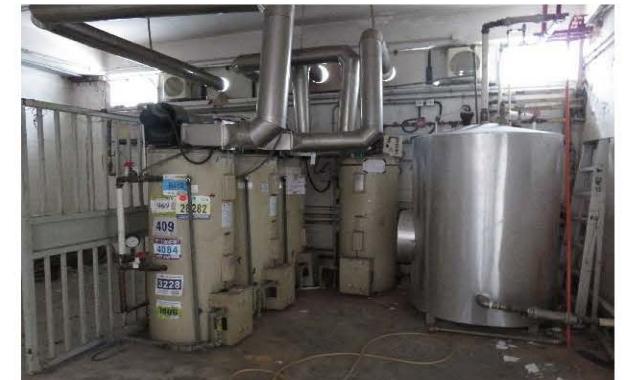
Photo 2055: Towergas hot water boilers at the bath room in E&M Workshop

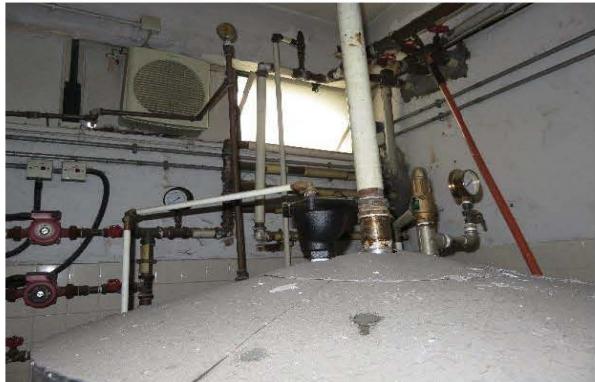
Photo 2056: Copper hot water pipes in E&M Workshop

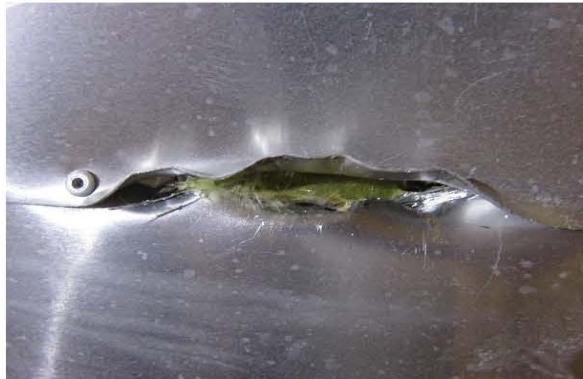
Photo 2057: Glasswool insulation of the heater under the metal casting in E&M Workshop

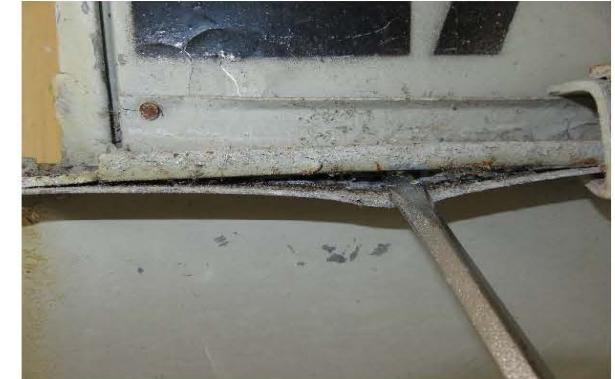
Photo 2066: No ACM flange gasket in the exhaust gas air-duct in E&M Workshop

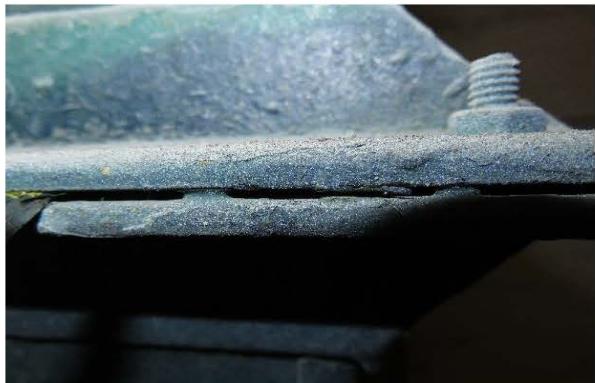
Photo 2080: No ACM flange gasket in the exhaust gas air-duct in E&M Workshop

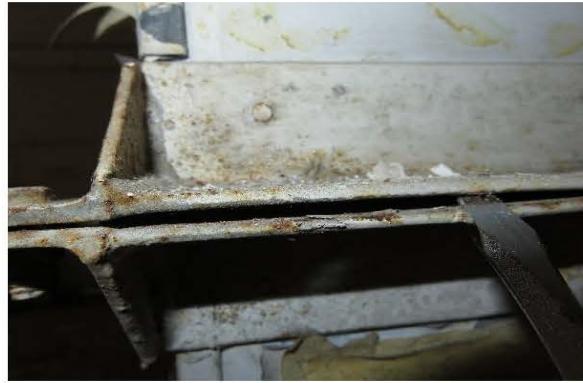
Photo 2082: No ACM flange gasket in the exhaust gas air-duct in E&M Workshop

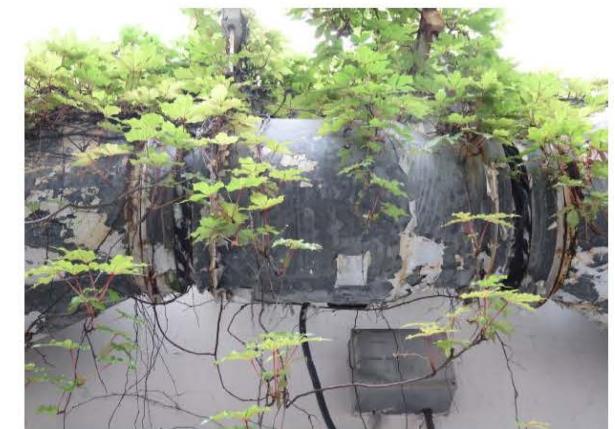
Photo 2086: Plastic flexible joint in E&M Workshop

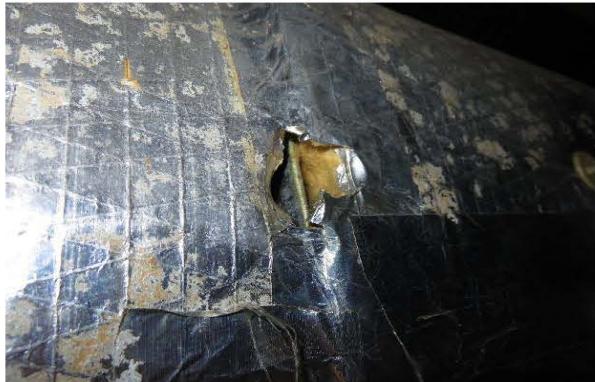
Photo 2092: No airduct gasket at the air-duct above activity room 3 in Post Office Recreation Club

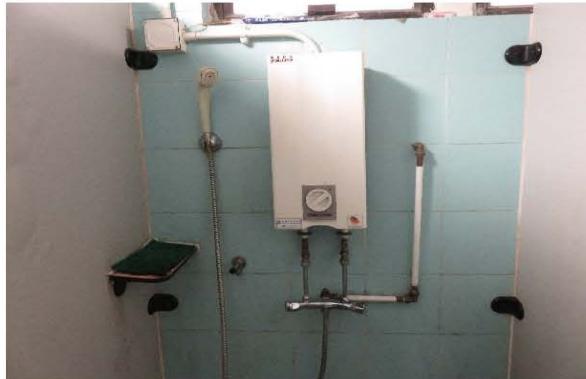
Photo 2098: Electrical hot water heater and hot water pipe with plastic lagging in male toilet in Post Office Recreation Club

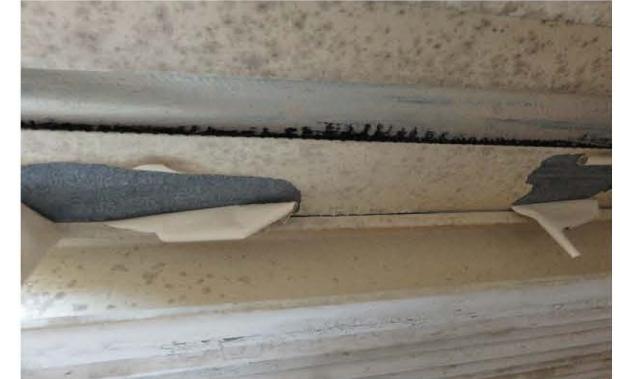
Photo 2104; Black plastic flexible joint for the air-duct inactivity room one in Post Office Recreation Club

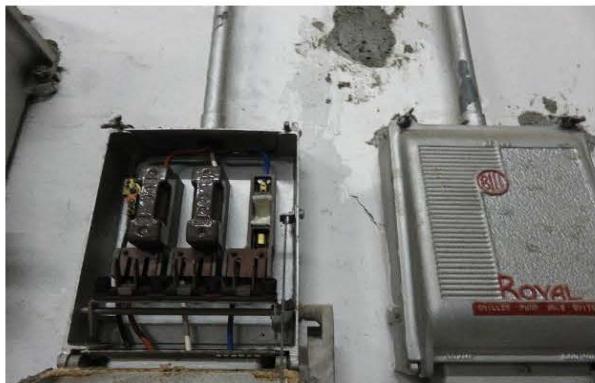
Photo 2133: Switch box with ACM containing arc cloth in Chiller Room on the roof of EMSD Headquarters

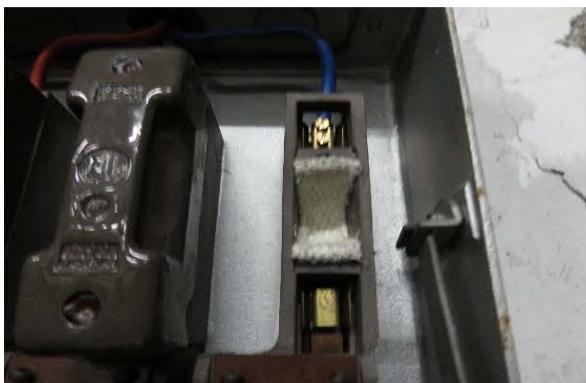
Photo 2135: Switch box with ACM containing arc cloth in Chiller Room on the roof of EMSD Headquarters

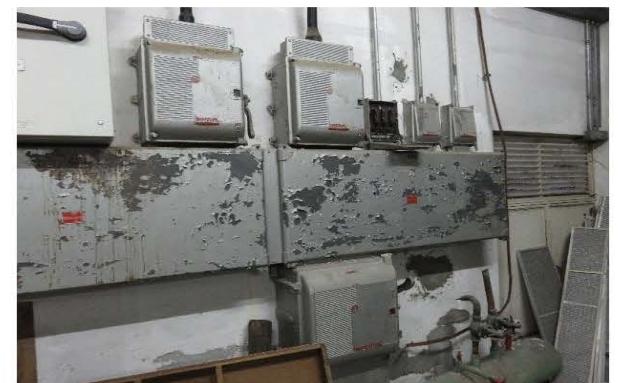
Photo 2136: Switch box with ACM containing arc cloth in Chiller Room on the roof of EMSD Headquarters

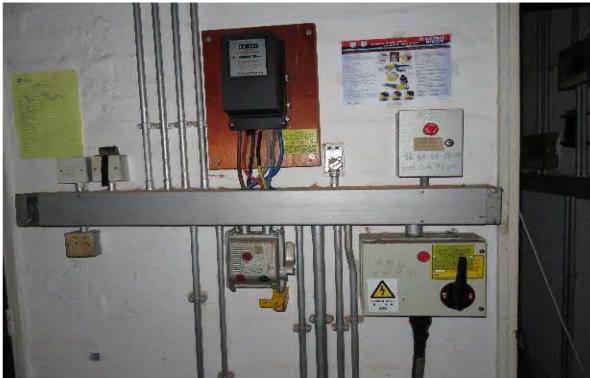
Photo 2138: Switch box with ACM containing arc cloth in Lift M/C & F/S Pump Room on the roof of EMSD Headquarters

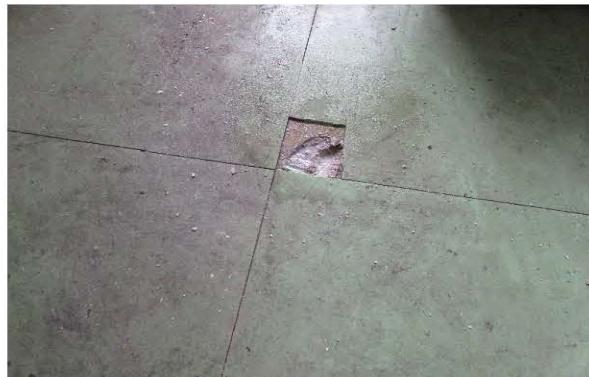
Photo 2185: S8, oil cloth of cable in Switch Room, 4/F, EMSD Headquarters. No ACM was identified.
(Lab ID: B/103/16/8)

Photo 2185: No ACM was identified in oil cloth of cable in Switch Room, 4/F, EMSD Headquarters

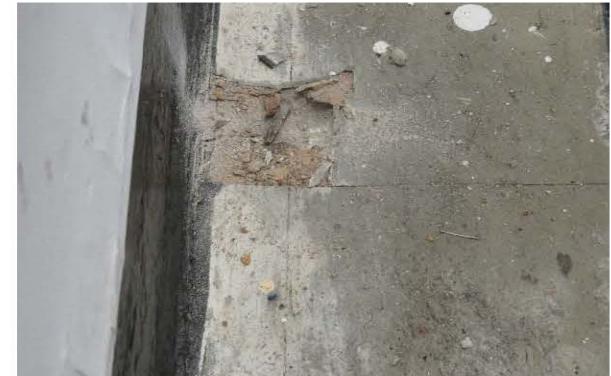
Photo 2193: Vinyl floor tile with mastic in cargo lift lobby on the 4/F of EMSD Headquarters

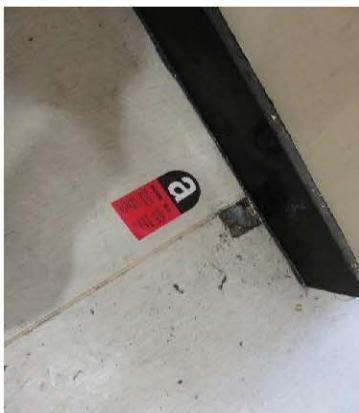
Photo 2197: Vinyl floor tile with mastic in office area on the 3/F of EMSD Headquarters

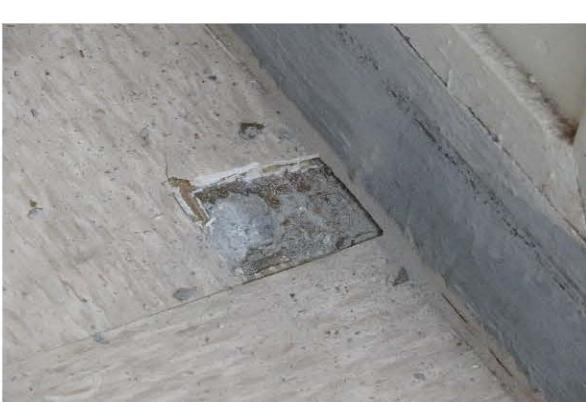
Photo 2202: Vinyl floor sheet with mastic (ACM) in passenger lift lobby on the 2/F of EMSD Headquarters

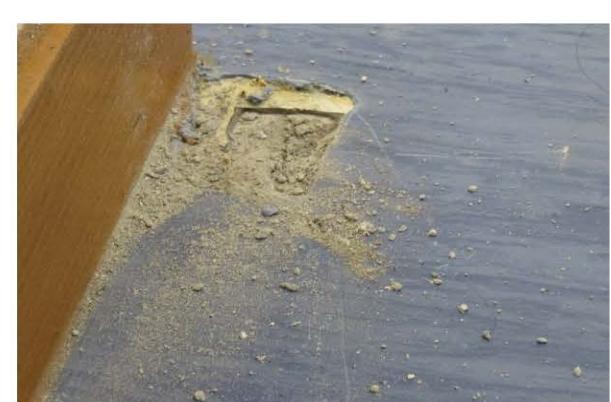
Photo 2204: Vinyl floor tile with mastic in pantry on the 2/F of EMSD Headquarters

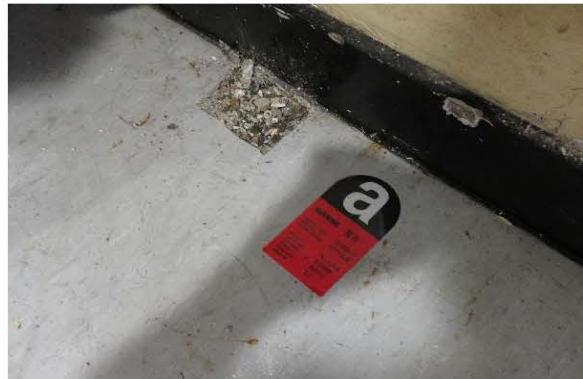
Photo 2206: Vinyl floor sheet with mastic in office area on the 2/F of EMSD Headquarters

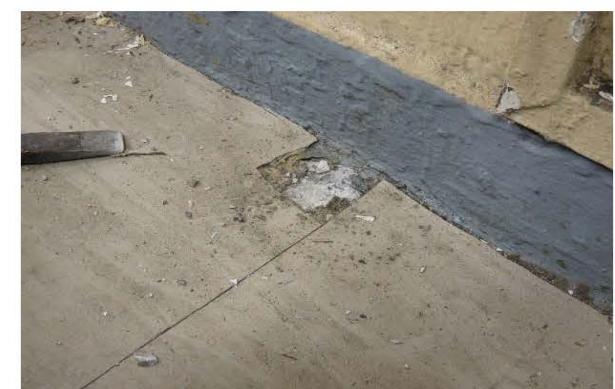
Photo 2214: Vinyl floor tile with mastic in office area on the 1/F EMSD Headquarters

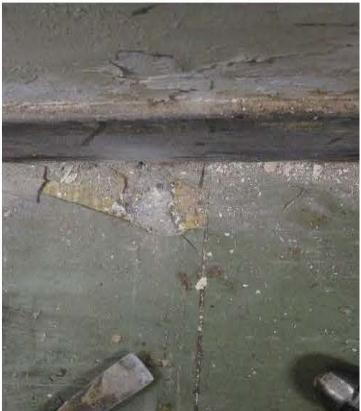
Photo 2219: Vinyl floor tile with mastic in store room on the G/F of EMSD Headquarters
