Architectural Services Department

Asbestos Investigation Report for Demolition of Existing Superstructures at Caroline Hill Road Site, Causeway Bay, Hong Kong

(Version 3.0)

August 2016

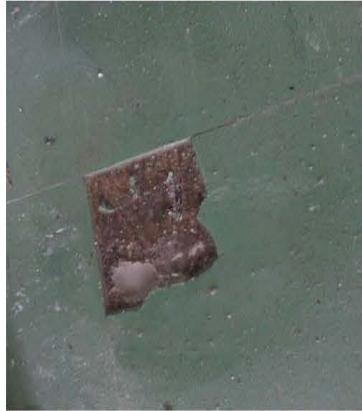
Photo 2221: S22, vinyl floor tile with mastic in Store Room, G/F, EMSD Headquarters. No ACM was identified.
(Lab ID: B/103/16/22)

Photo 2221: Vinyl floor tile with mastic in store room on the G/F of EMSD Headquarters

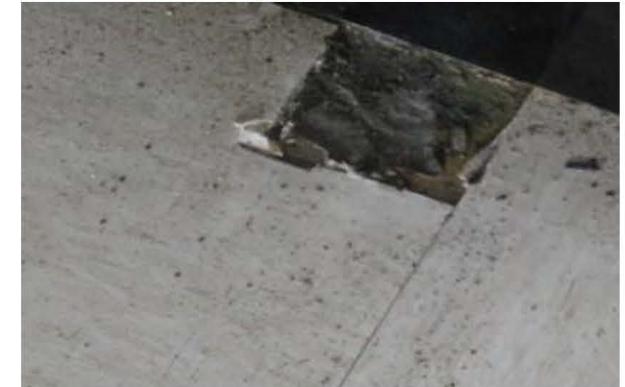
Photo 2226: S23, vinyl floor tile with mastic on 10/F, EMSD Headquarters. ACM was identified.
(Lab ID: B/103/16/23)

Photo 2226: Vinyl floor tile with mastic (ACM) in office area on the 10/F of EMSD Headquarters

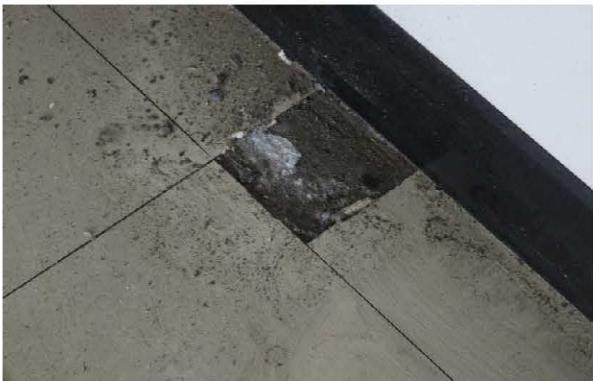
Photo 2231: S25, vinyl floor tile with mastic in Room 603, 6/F, EMSD Headquarters. No ACM was identified.
(Lab ID: B/103/16/25)

Photo 2231: Vinyl floor tile with mastic in office area on the 6/F of EMSD Headquarters

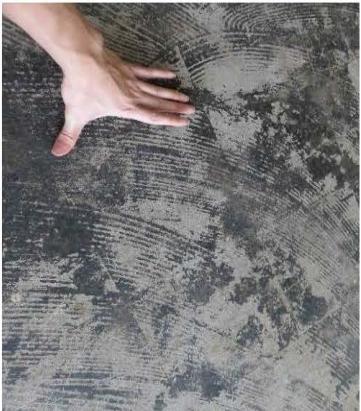
Photo 2293: Vinyl floor tile with mastic (ACM) in anteroom on the 1/F of CAS Headquarters

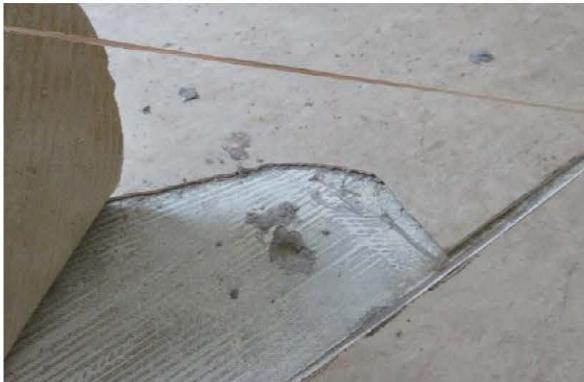
Photo 2294: Vinyl floor tile with mastic (ACM) in corridor on the 1/F of CAS Headquarters

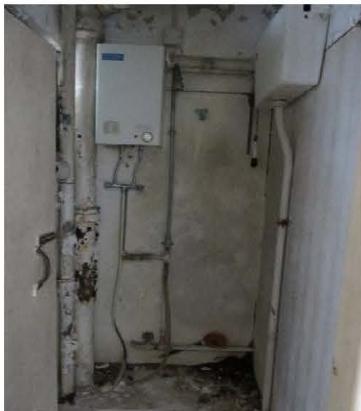
Photo 2324: Hot water pipe with metal lagging in bathroom, 6/F, Quarter Block

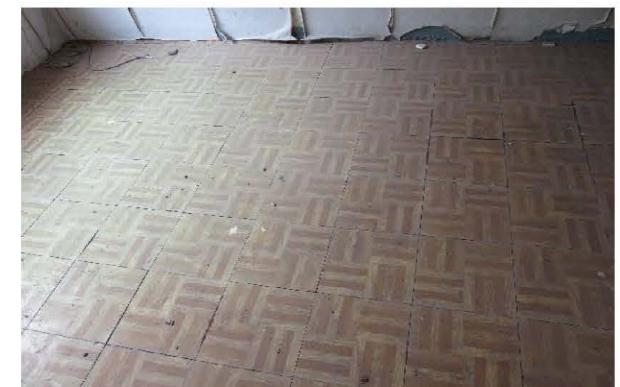
Photo 2339: Vinyl floor tile with mastic (ACM) in living room, 1/F, Quarter Block

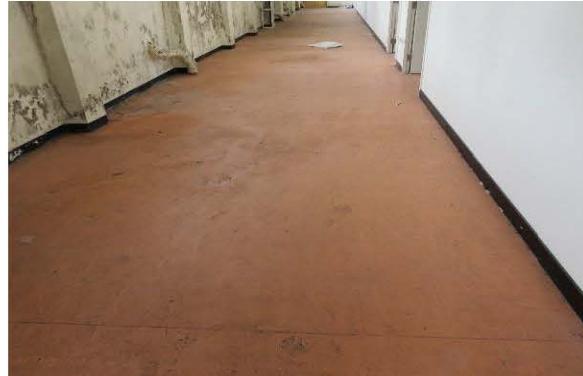
Photo 2346: Vinyl floor sheet with mastic (ACM) in office / workshop area on the 1/F of Training Centre

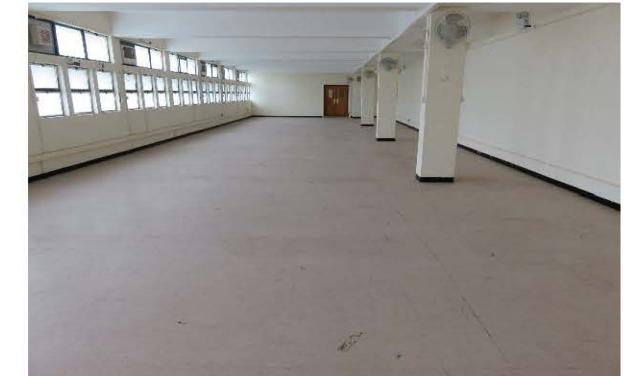
Photo 2358: Vinyl floor sheet with mastic (ACM) in office / workshop area on the 2/F of Training Centre

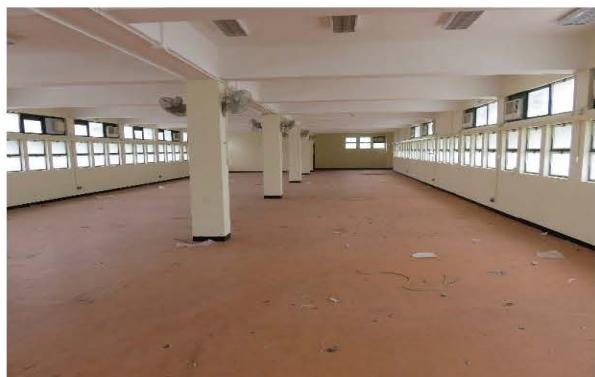
Photo 2359: Vinyl floor sheet with mastic (ACM) in office / workshop area on the 3/F of Training Centre

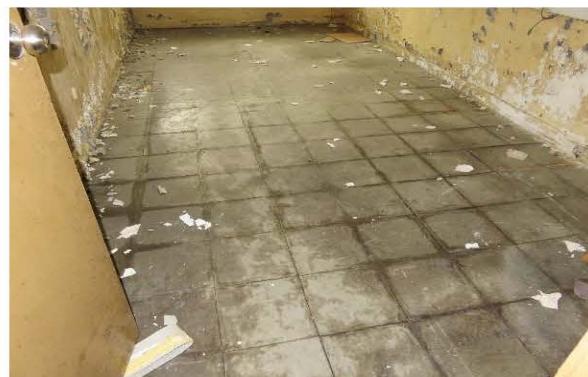
Photo 2361: Vinyl floor sheet with mastic (ACM) in office / workshop area on the 4/F of Training Centre

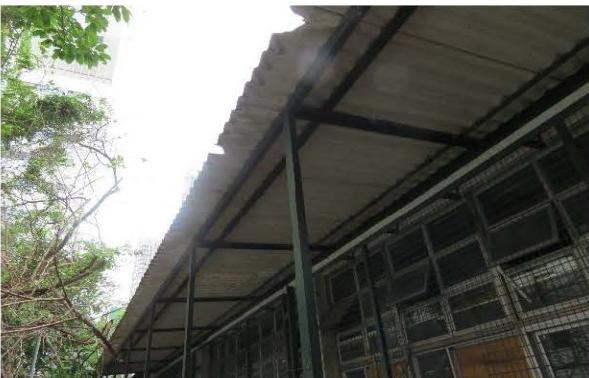
Photo 2371: Corrugated cement sheet on roof of a separate storage at the south-east to the Rooms G07, G08 & G09 in the Workshop

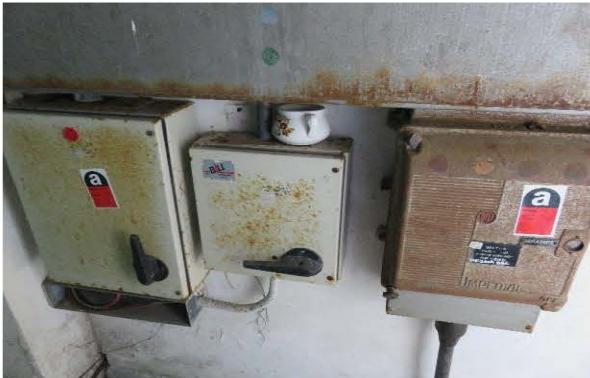
Photo 2377: Switch box with ACM containing arc cloth in Garage of the Workshop

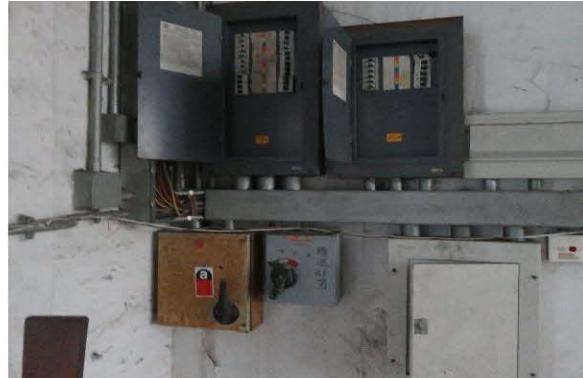
Photo 2378: Switch box with ACM containing arc cloth in Garage of the Workshop

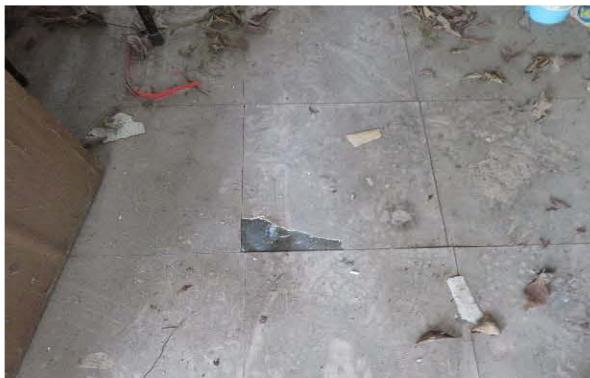
Photo 2421: Vinyl floor tile with mastic (ACM) in office area on the 5/F of EMSD Headquarters

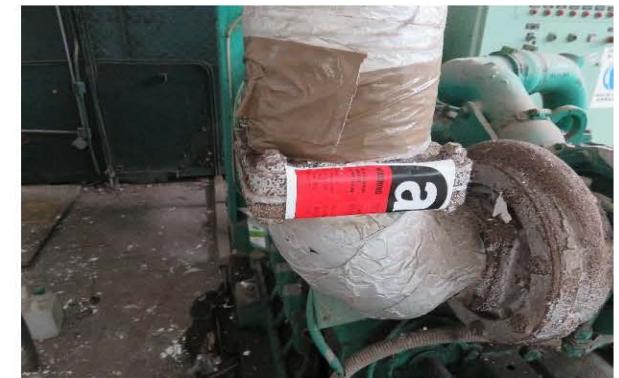
Photo 2434: Rope lagging on flue of generator in the Workshop

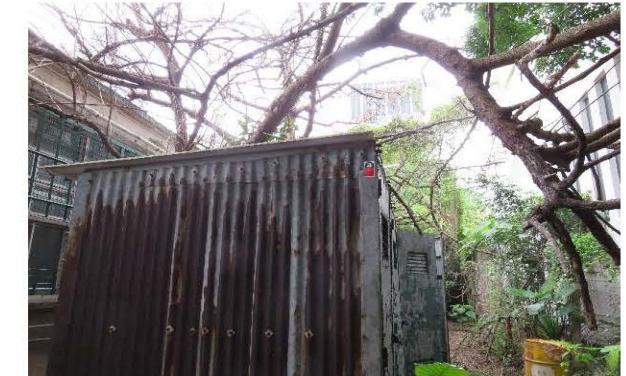
Photo 2445: S40, corrugated cement sheet at roof sheeting of DG Store, EMSD Workshop. ACM was identified.
(Lab ID: B/103/16/40)

Photo 2445: Corrugated cement sheet roofing of DG Store, Workshop

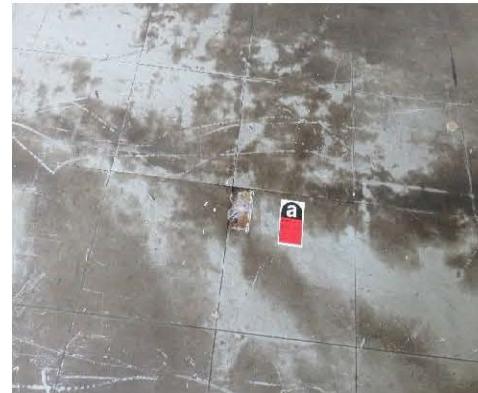
Photo 2453: Vinyl floor tile with mastic in Room G11 on the G/F of Training Centre

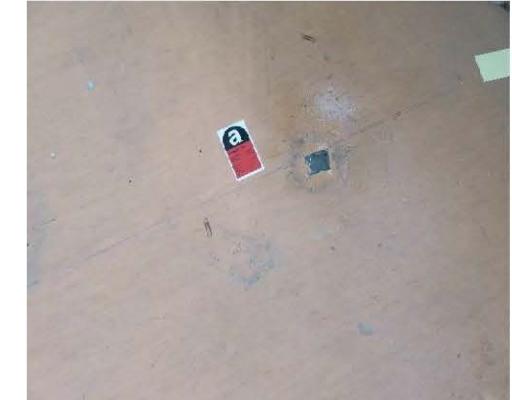
Photo 2454: Vinyl floor tile with mastic (ACM) in Room G11 on the G/F of Training Centre

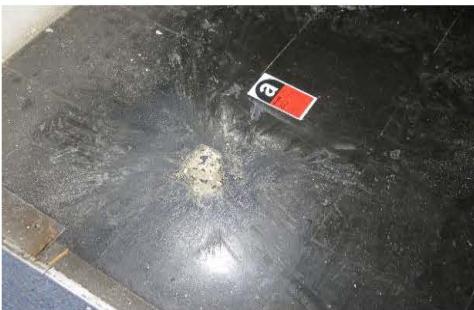
Photo 2458: Vinyl floor sheet with mastic (ACM) in office / workshop area on the 4/F of Training Centre

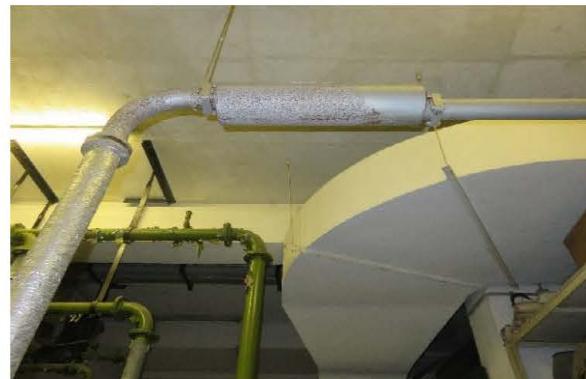
Photo 2476: Rope lagging on flue of generator in the 1st Basement, EMSD Headquarters

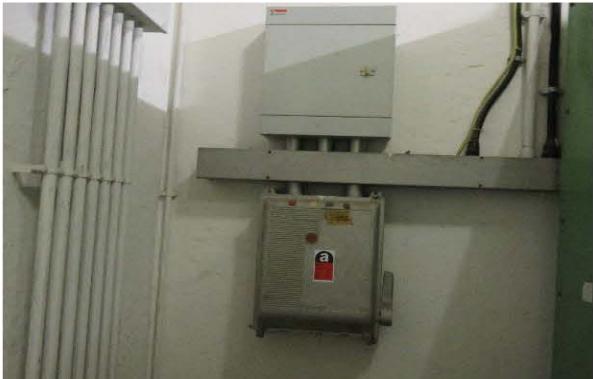
Photo 2482: Switch box with ACM containing arc cloth in Main Switch Room on the G/F of EMSD Headquarters

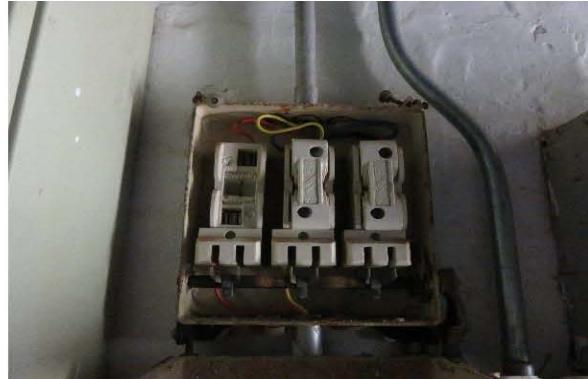
Photo 2483: Switch box with ACM containing arc cloth in Main Switch Room on the G/F of EMSD Headquarters

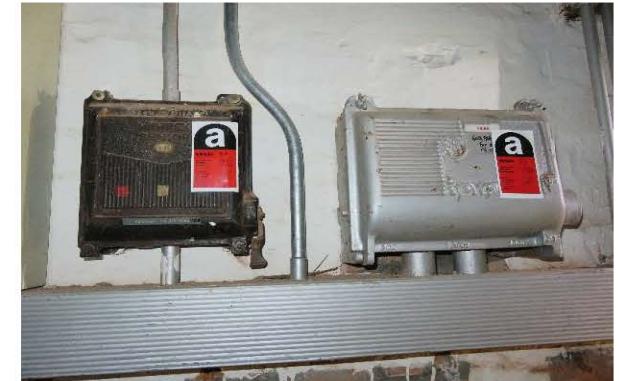
Photo 2490: Switch box with ACM containing arc cloth in A/C Plant & Store Room in the 1st Basement of EMSD Headquarters

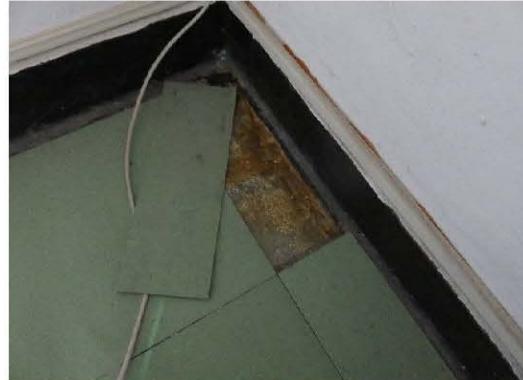
Photo 2501: Vinyl floor tile with mastic (ACM) in office area on the 4/F of EMSD Headquarters

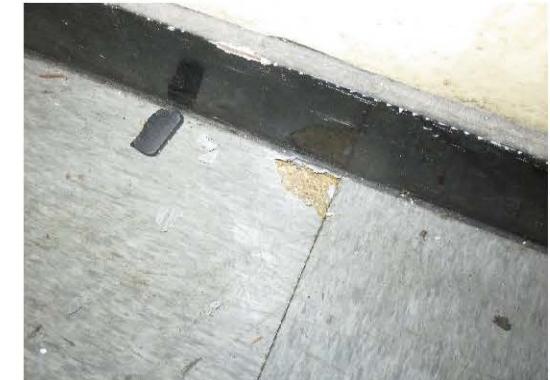
Photo 2502: Vinyl floor tile with mastic (ACM) in store room on the 4/F of EMSD Headquarters

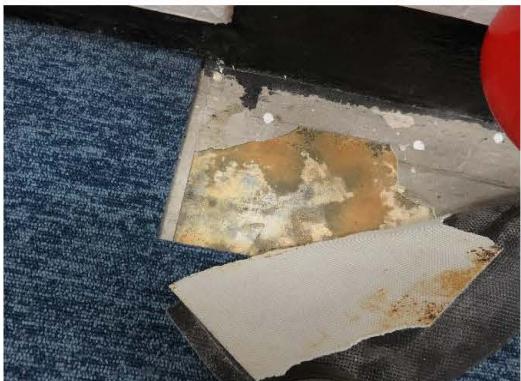
Photo 2505: Vinyl floor tile with mastic (ACM) in cargo lift lobby on the 4/F of EMSD Headquarters

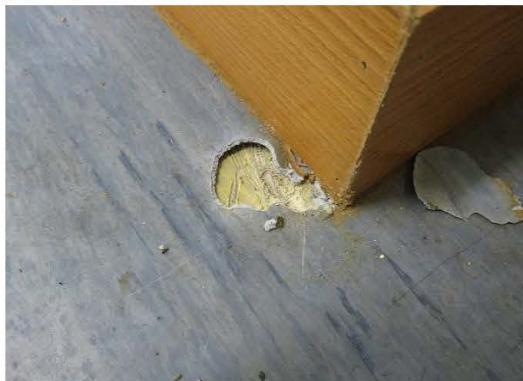
Photo 2509: Vinyl floor tile with mastic (ACM) in office area on the 3/F of EMSD Headquarters

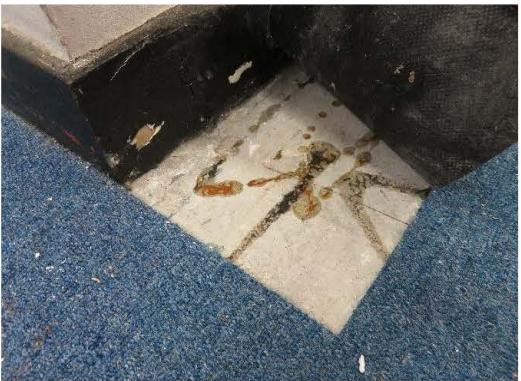
Photo 2512: Vinyl floor tile with mastic (ACM) in pantry on the 2/F of EMSD Headquarters

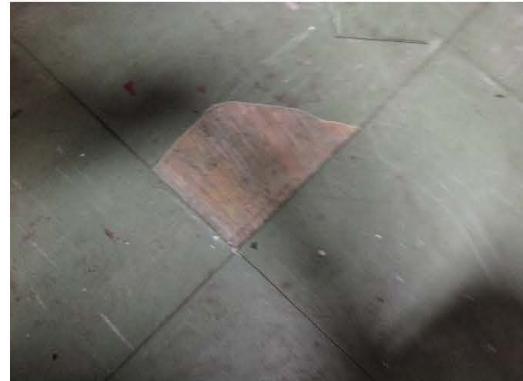
Photo 2515: Vinyl floor tile with mastic (ACM) in office area on the 1/F EMSD Headquarters

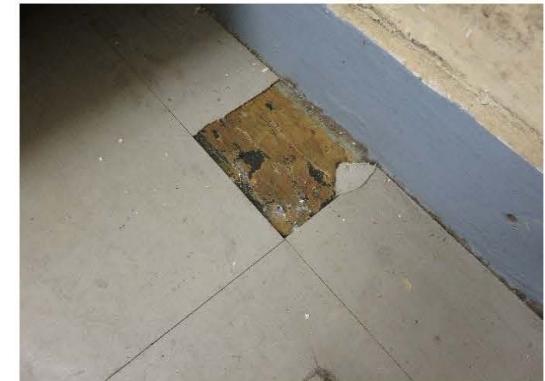
Photo 2516: Vinyl floor tile with mastic (ACM) in cargo lift lobby on the 1/F EMSD Headquarters

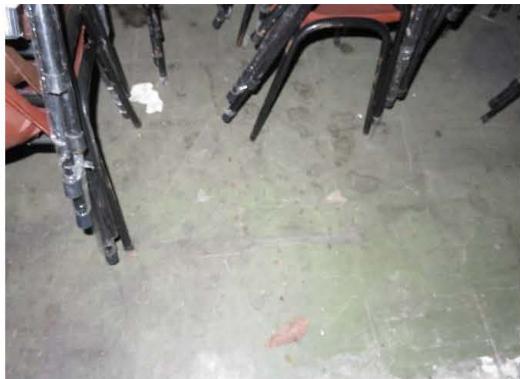
Photo 2518: Vinyl floor tile with mastic (ACM) in store room on the G/F of EMSD Headquarters

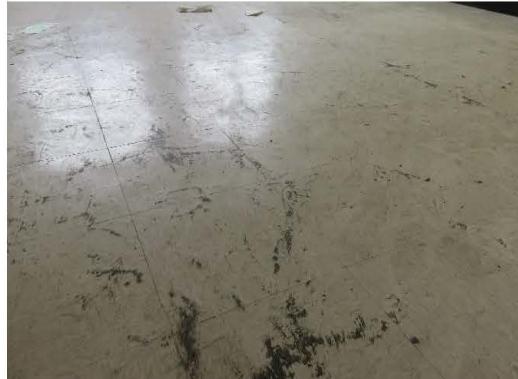
Photo 2519: Vinyl floor tile with mastic (ACM) in store room on the G/F of EMSD Headquarters

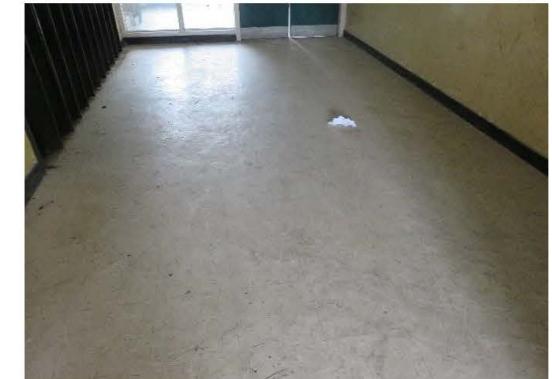
Photo 2527: Vinyl floor tile with mastic (ACM) in office area on the 6/F of EMSD Headquarters

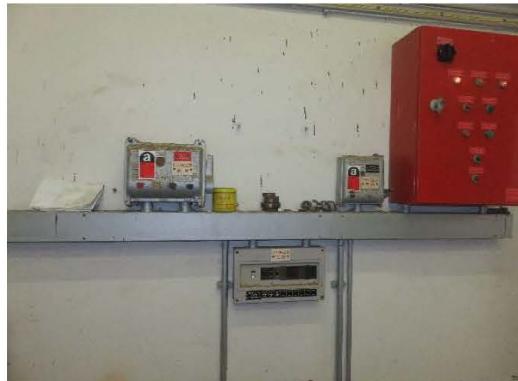
Photo 4584: Switch box with ACM containing arc cloth in Lift Machine Room on the Roof of CAS Headquarters

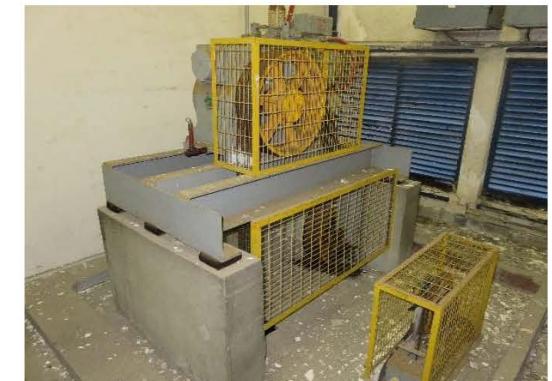
Photo 4585: Lift brake pad/shoe in Lift Machine Room on the Roof of CAS Headquarters

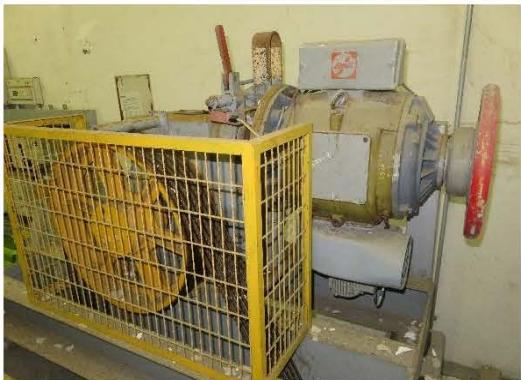
Photo 4586: Lift brake pad/shoe in Lift Machine Room on the Roof of CAS Headquarters

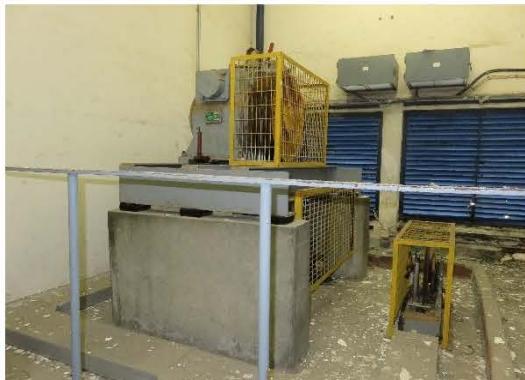
Photo 4587: Lift brake pad/shoe in Lift Machine Room on the Roof of CAS Headquarters

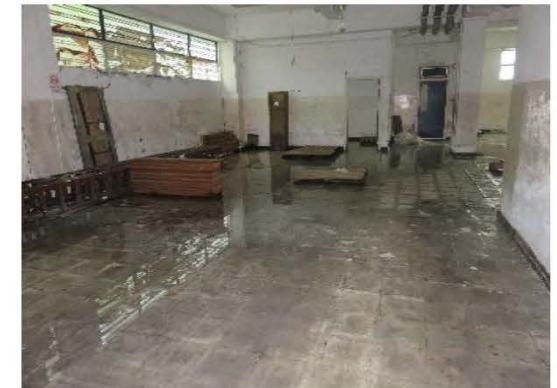
Photo 4605: Vinyl floor tile with mastic (ACM) in office area on the G/F of CAS Headquarters

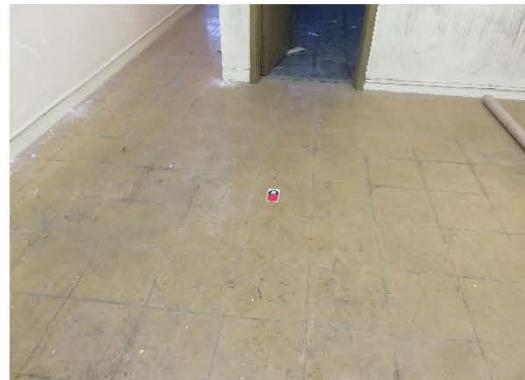
Photo 4613: Vinyl floor tile with mastic (ACM) in Room G11 on the G/F of Training Centre

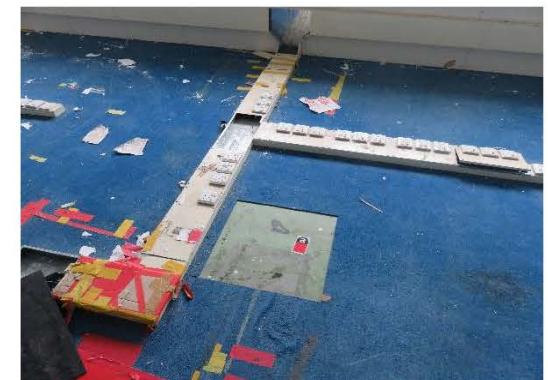
Photo 4624: Vinyl floor tile with mastic (ACM) in office area on the 4/F of EMSD Headquarters
